Identification and Recovery of ATLAS18 Strip Sensors with High Surface Static Charge

2023-12-06

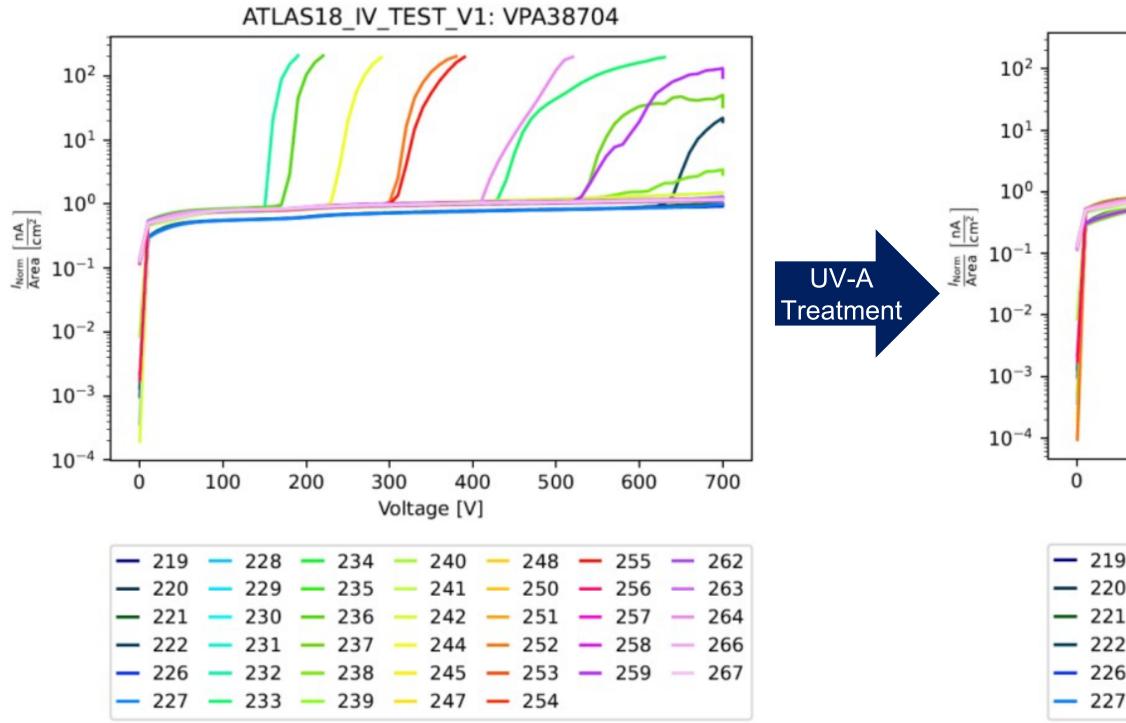
IV Failures and Recoveries

In below example, all but one sensor is recovered by UV-A exposure

- In addition to ionized air and UV-A treatments, some failed IV can be recovered by prolonged exposure to high voltage (eg. additional LTS testing)
 - In many cases, sensors with "soft-breakdown" are selected for and show improvement after LTS test

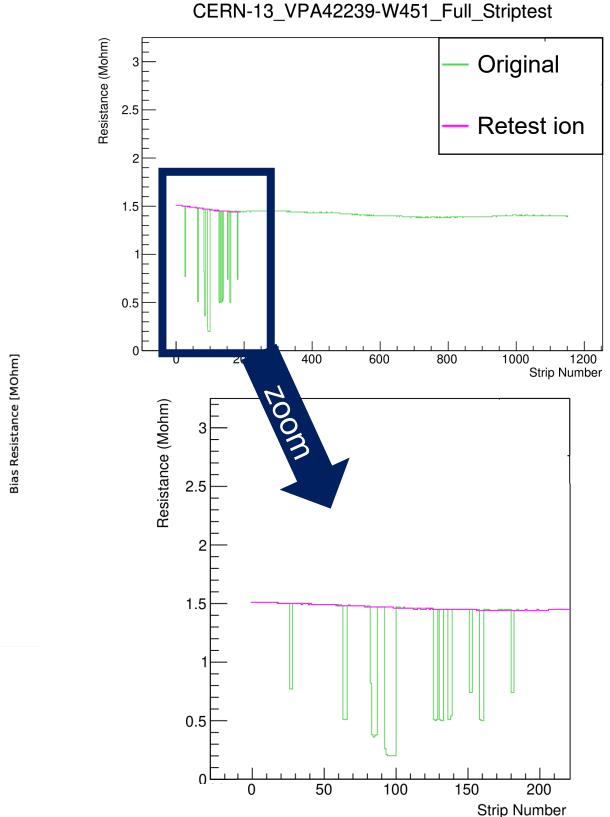
Example: Recovery using UV-A at FZU

Varying levels of success at each site – At CU and QMUL great success using ionized air; At SFU and FZU, more success with UV-A

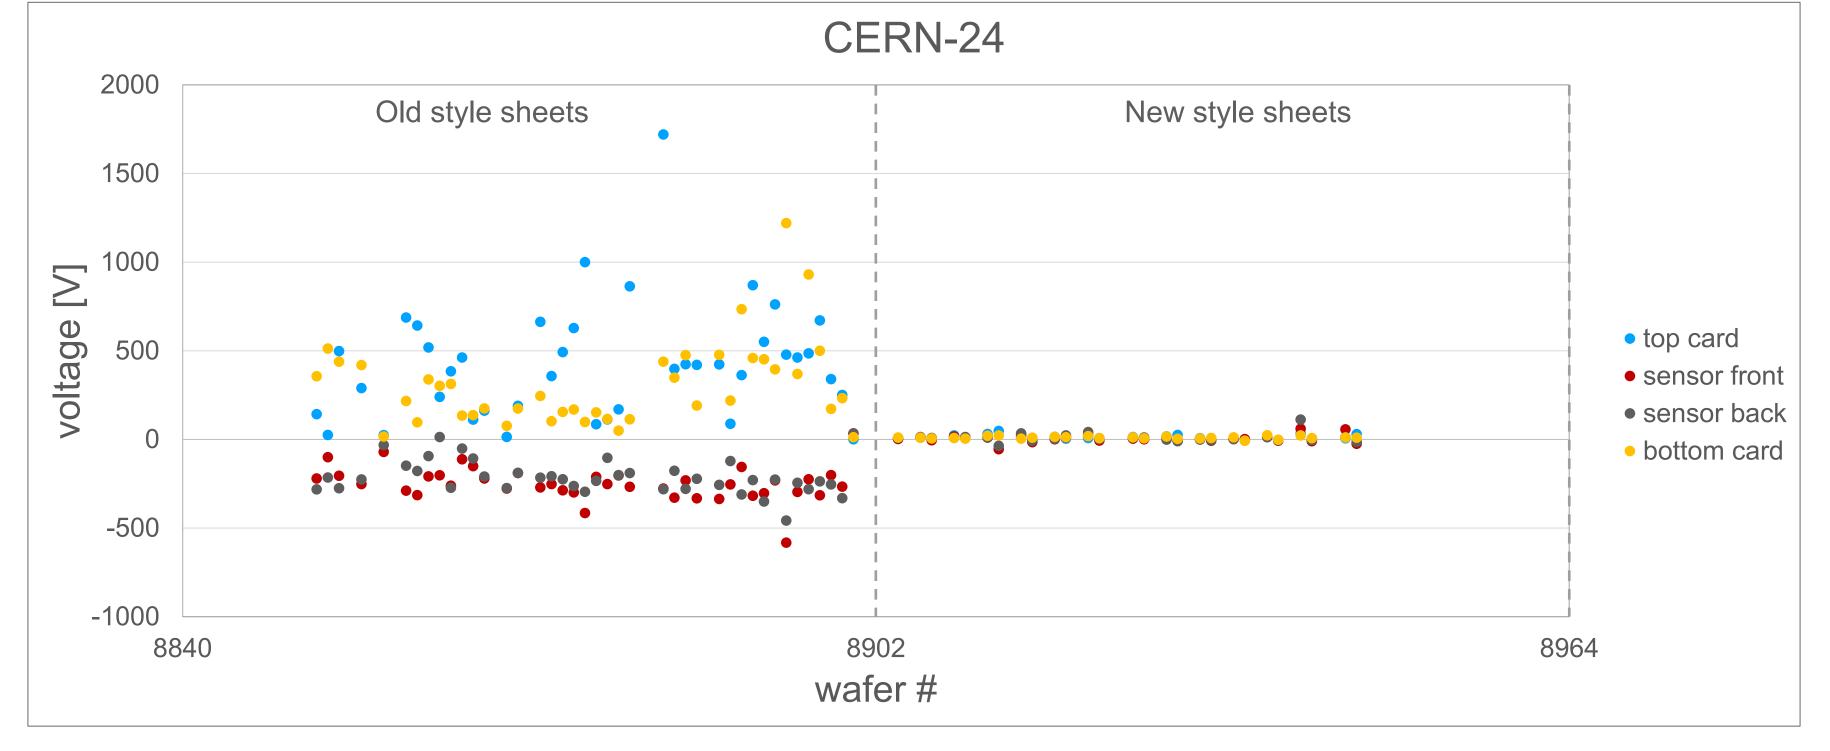
New Packaging Sheets

- Vendor has updated their packaging materials; now using a different kind of sheet, and with matte-matte orientation
- Has significant effect on the measured static charge lacksquare
 - Below plot, two back-to-back batches from the same delivery but with different kind of sheets

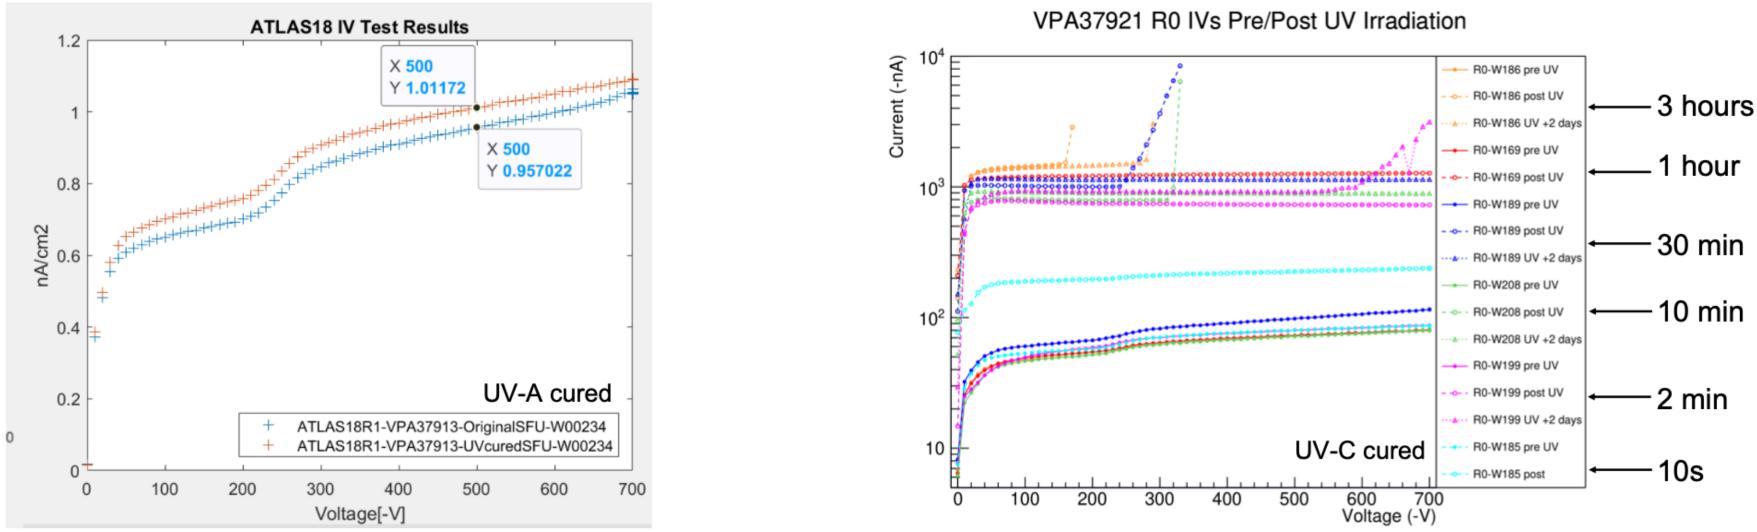
Recovery Methods — UV-C

- Example of sensor(s) whose ST performance was recovered by UV-A (left) and UV-C (right)
- Even after a small, 10s, UV-C exposure the leakage current increases ~3x
- UV-C can induce early BD, which sometimes goes away after time in dry storage

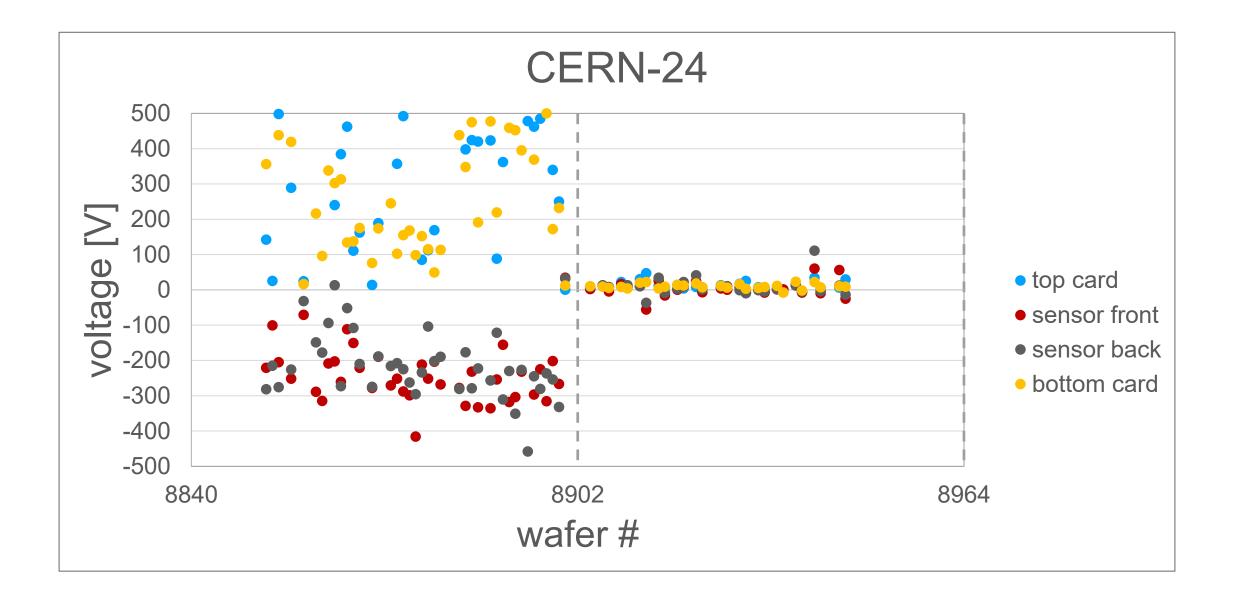
New Sheets

- Scale of the plot includes all data points (>1500V) \bullet
- Rescaling to better show the charge of the second, low static charge, \bullet batch with new sheets
 - Almost all measured static charge is below 100V
