# POPS Operational Issues during October 2022

Joint Accelerator Performance Workshop December 2022

Aramis Schwanka Trevisan and Fulvio Boattini (SY-EPC/HPC)

Date: December 7<sup>th</sup> , 2022

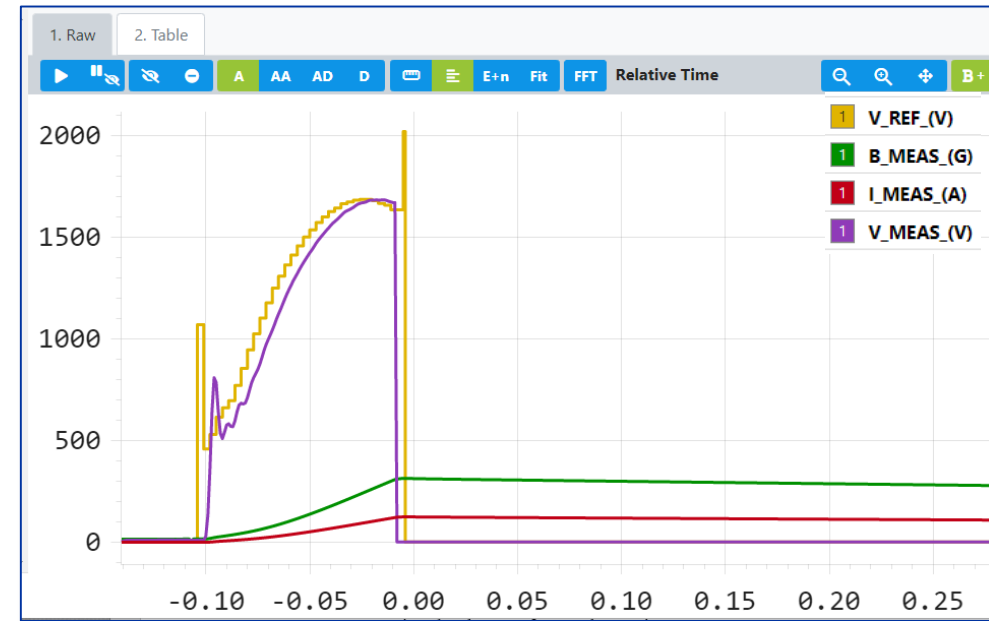
- **September 29<sup>th</sup>, at 09:02:51**
  - Symptoms:
    - POPS not resettable.
    - No communication with the CTRL or PRC cards.
    - No post-mortem data generated by CTRL or PRC.
    - “VS\_COMMS” → Issue between FGC and MC?
      - More specifically: between PBL and PAL cards?
  - Actions:
    - Visual inspection on site
    - P80i environment looked suspect
      - Re-load of CTRL and PRC libraries and files
    - Reset Main Controller

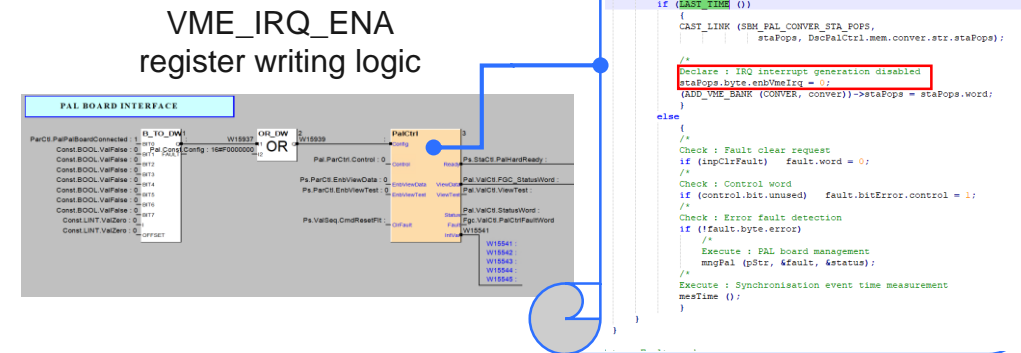
- A common failure path started to emerge: VME\_IRQ\_ENA register

- The master CPU reset the VME\_IRQ\_ENA register written at dual-ported RAM of the PAL card
- Allow PAL and FGC to send Interrupt Request to VME chassis
- No synchronization, no Main Controller.
  - The MC was orderly shutting down in the middle of the run!

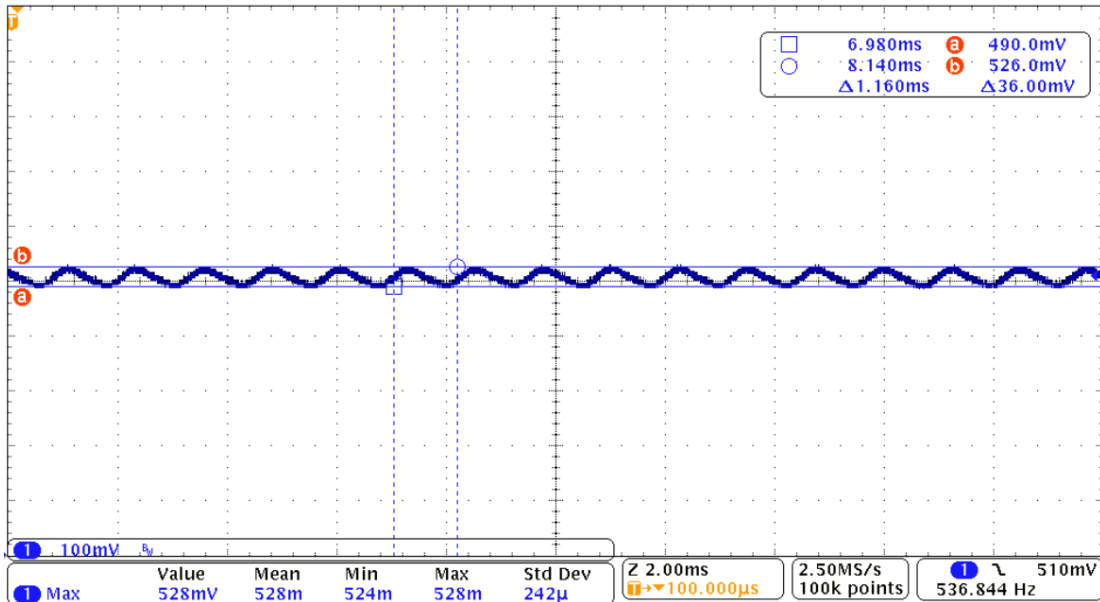
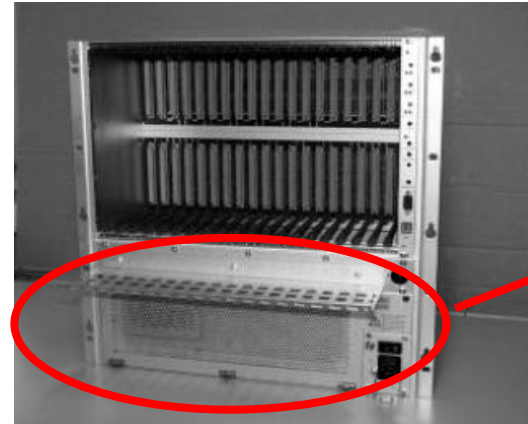
VME (20 slots) - Schroff BGTR 10HE

- **Built-in to the Schroff chassis**
  - +5V (100A), +12V (8A), -12V (6A)
  - The 24V for the fans is taken from the  $\pm 12V \rightarrow$  **Very bad idea!**
  - Specification: max. ripple of 50mVpp
- **POPS measurements:**
  - 5V  $\rightarrow$  ~300mVpp ripple (!)

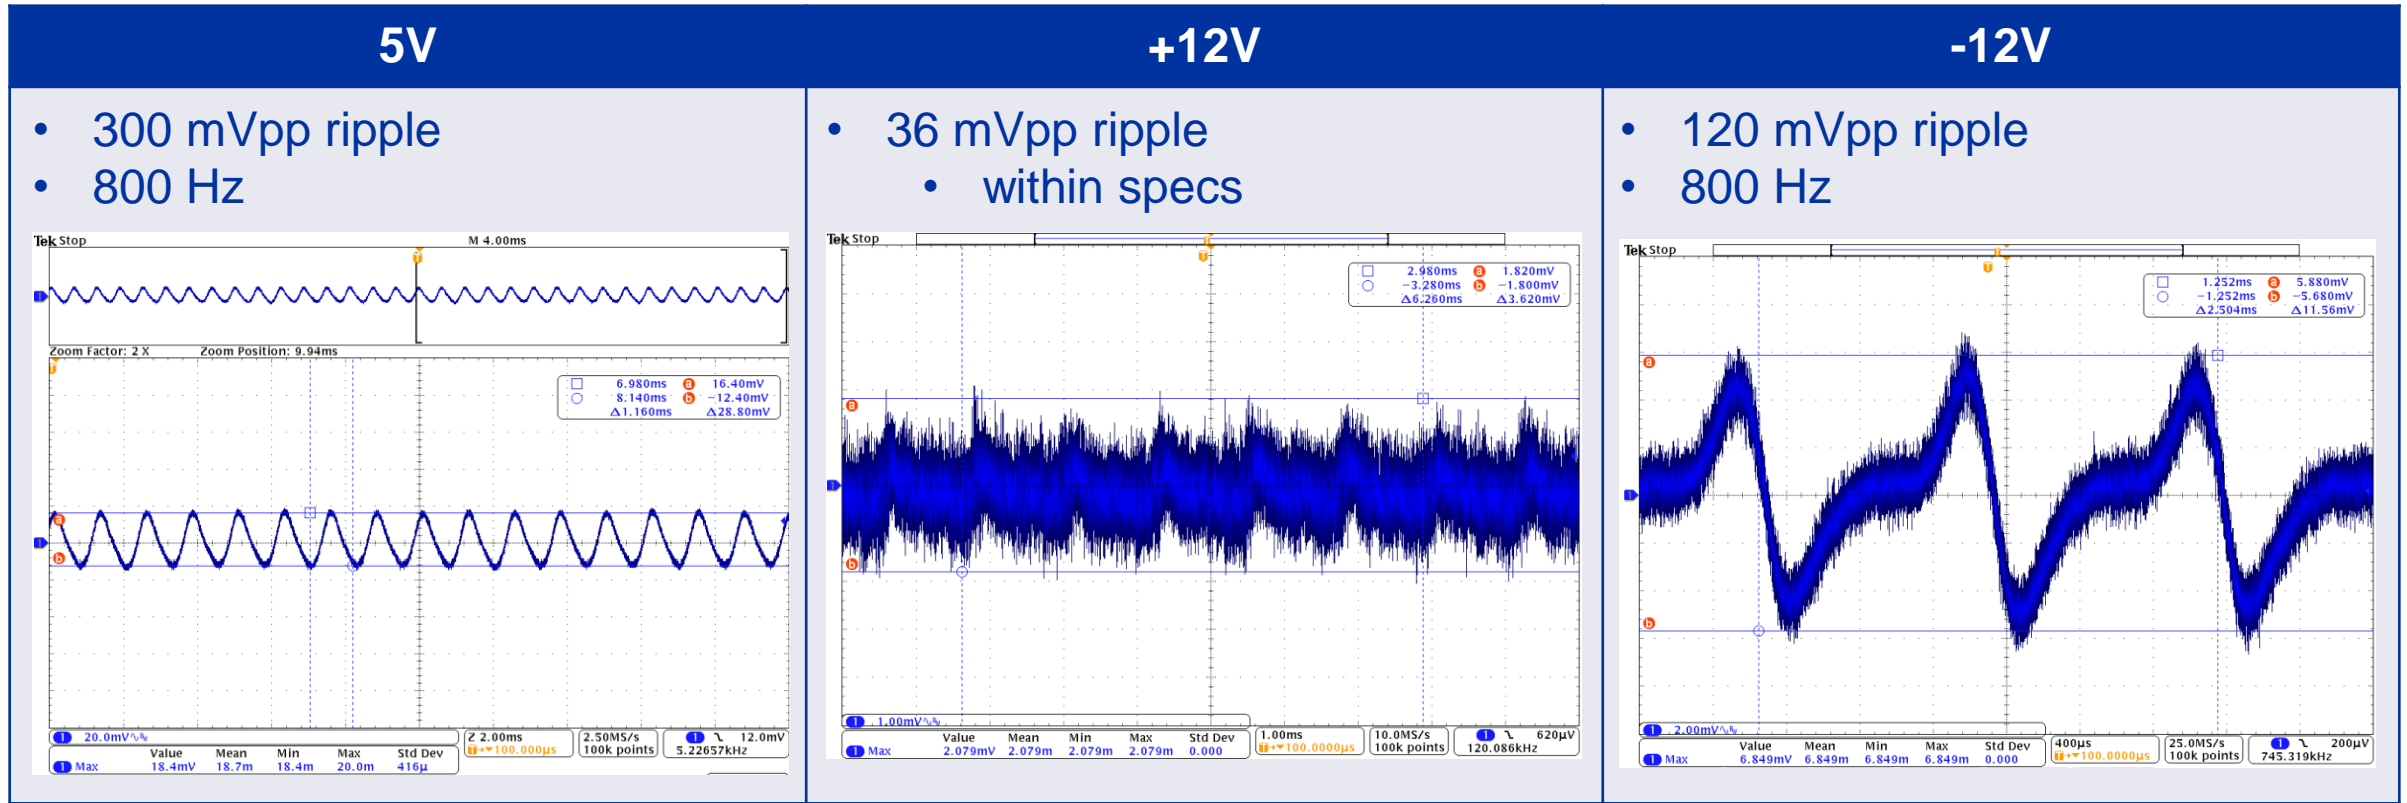
- **Why 800 Hz ?!**
- **To add to the complexity: oscillations behavior non reproduceable after cards swap, MC resets, ...**

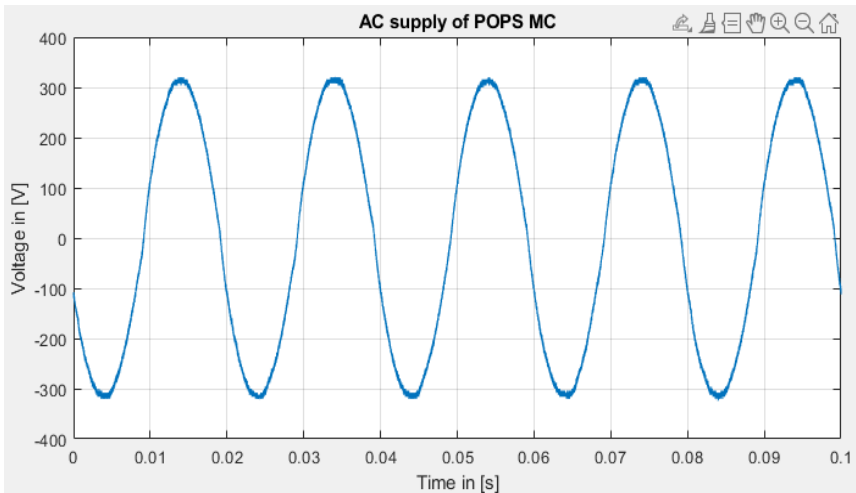
- Can it be caused by its AC Power Supply?

Recent dedicated tests with AC power supply exclude this hypothesis !

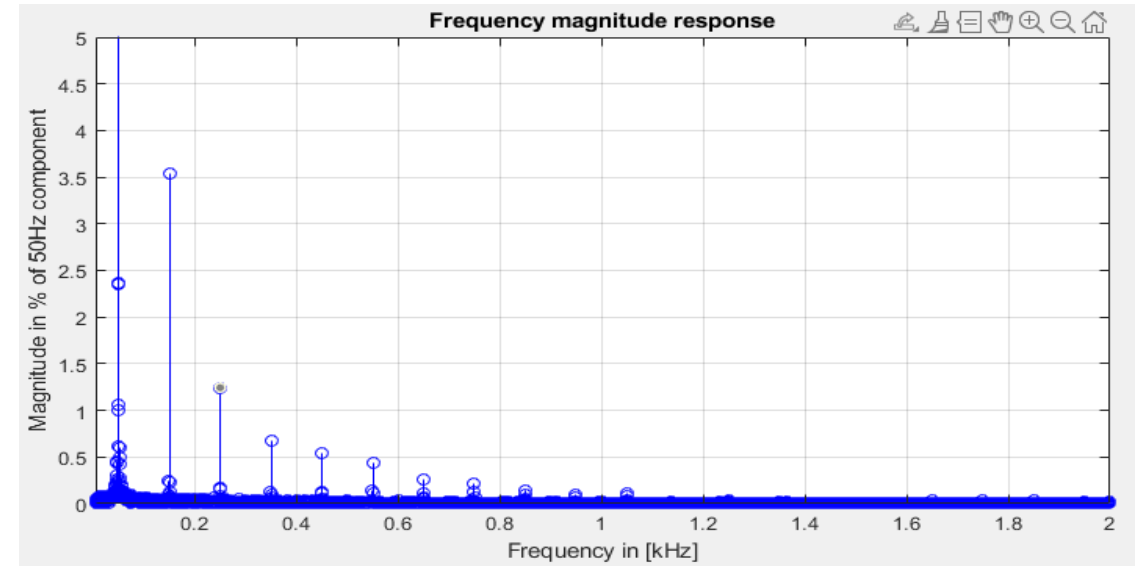
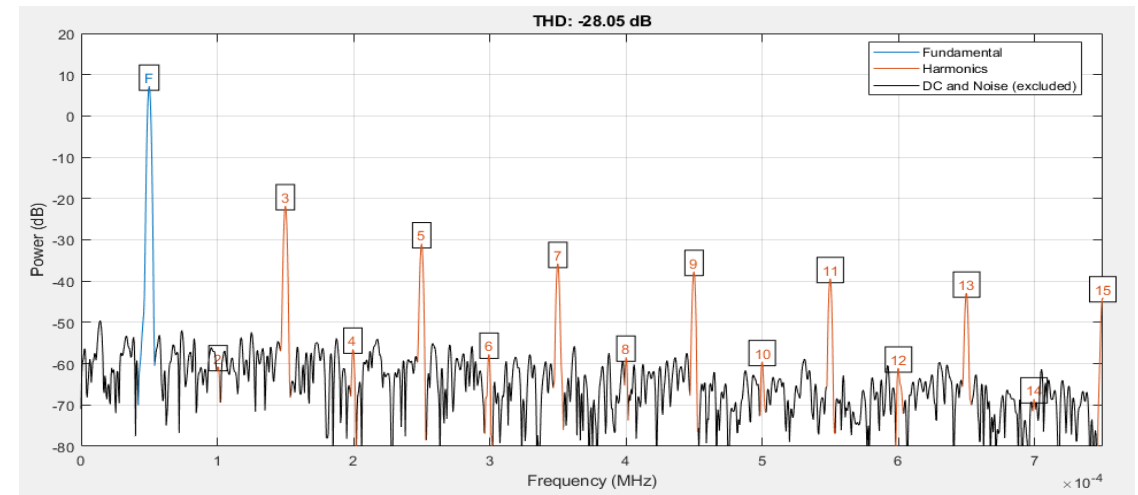
THD ~ 5%  $\left\{ \begin{array}{l} \bullet \text{ EN 50160: 8\%} \\ \bullet \text{ IEEE 519: 5\%} \end{array} \right.$

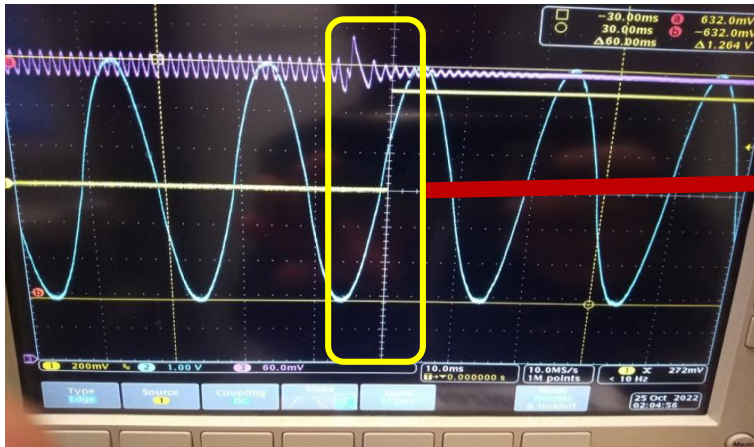
Figure taken during POPS intervention!

5V, SysFail, AC voltages during a real POPS trip

Strengthen the doubt of a PS problem

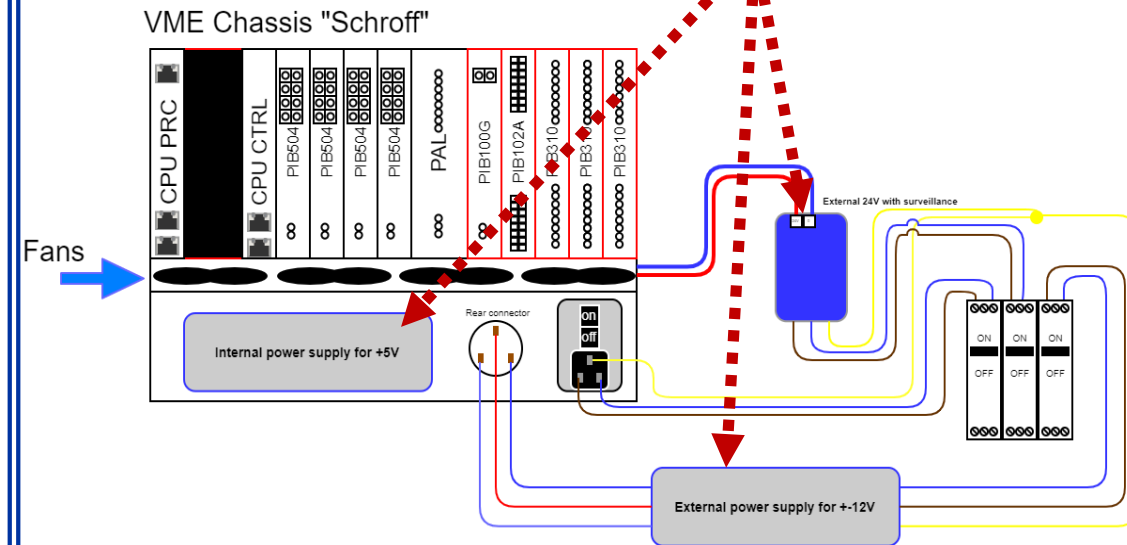
Ripple-free voltage levels in Frankenstein ps

- “Frankenstein” approach: 1 power supply for each voltage level.
