Effect of Multiple Discharges on Accumulated Damage to the DLC Anode Layer of a Resistive Well Electron Multiplier

MPD TPC @ NICA

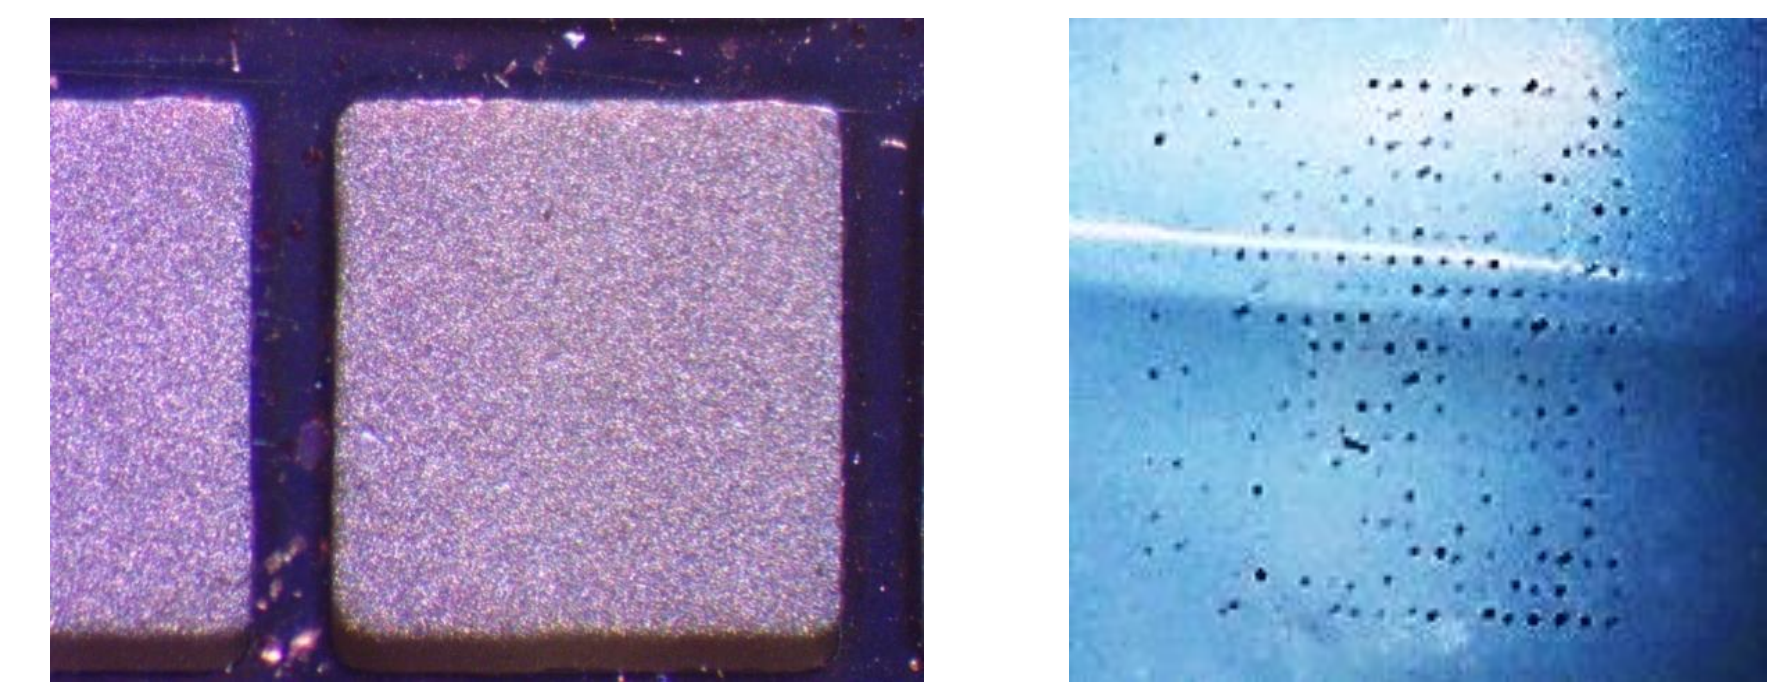
no visible damage to the DLC layer of RWEM after 1 million discharges. For comparison, damage to the resistive kapton after 1000 discharges

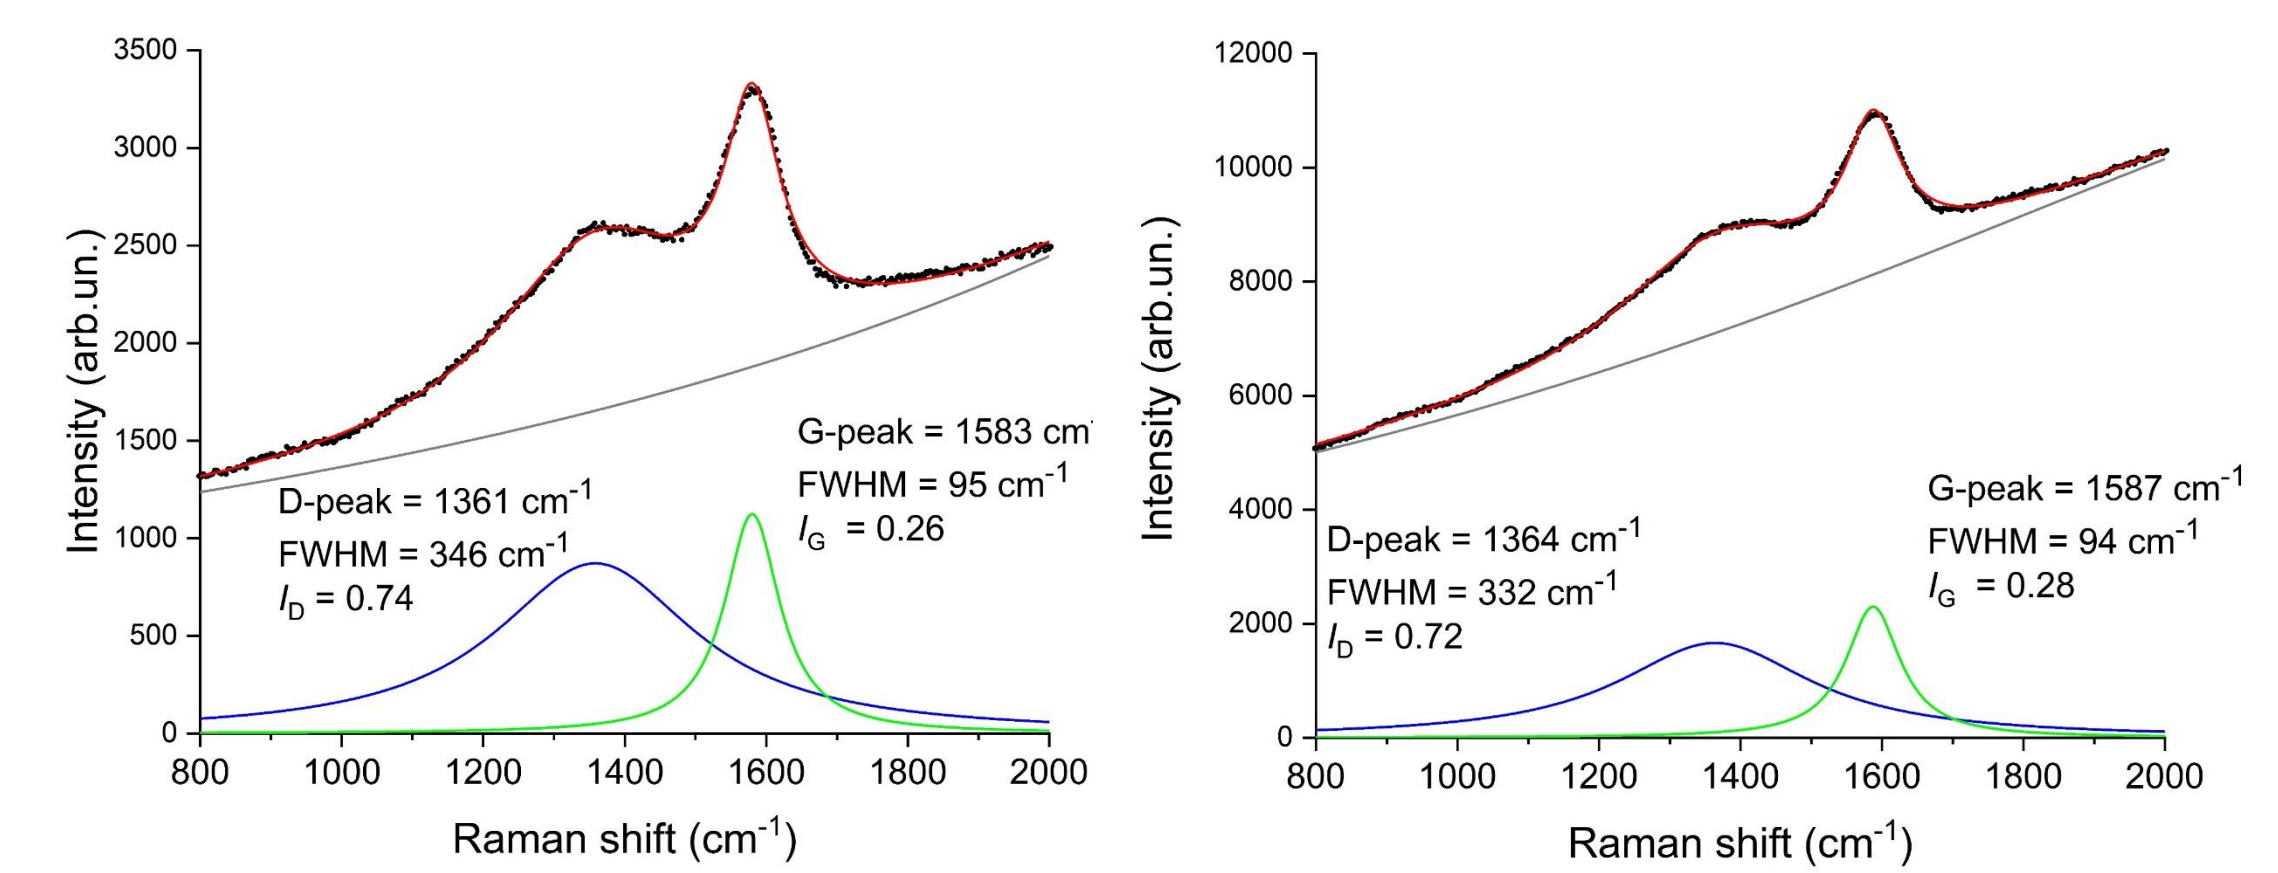
Raman spectra before and after 100000 discharges at 365 pF total capacitance

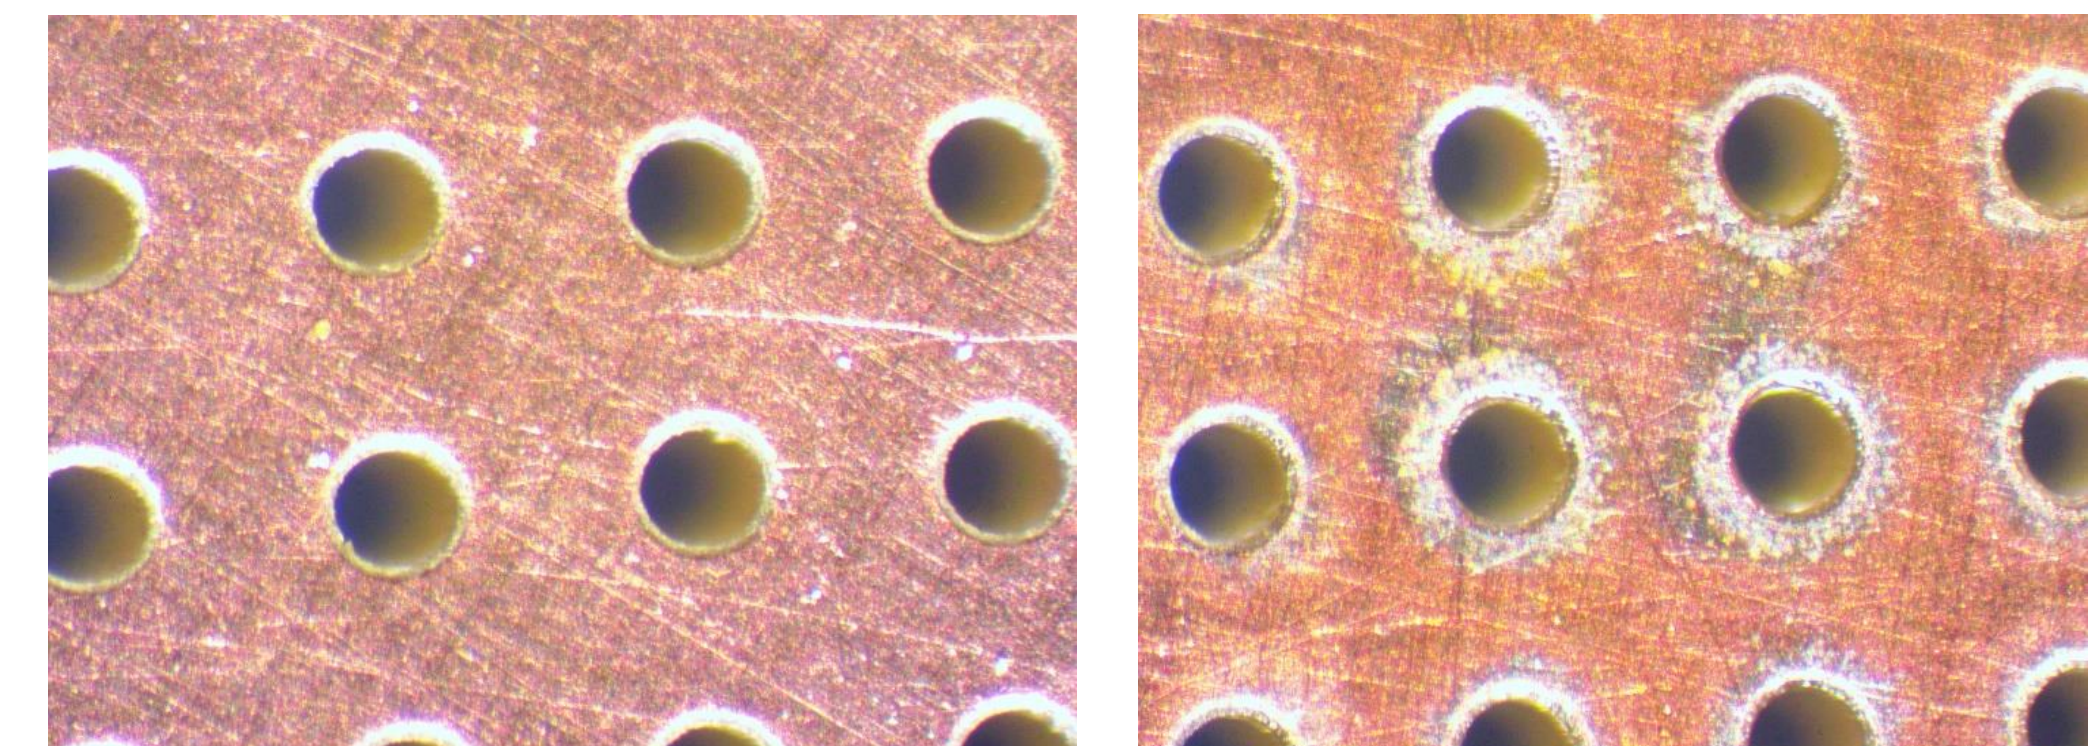
Top electrode metallization before and after 100000 discharges

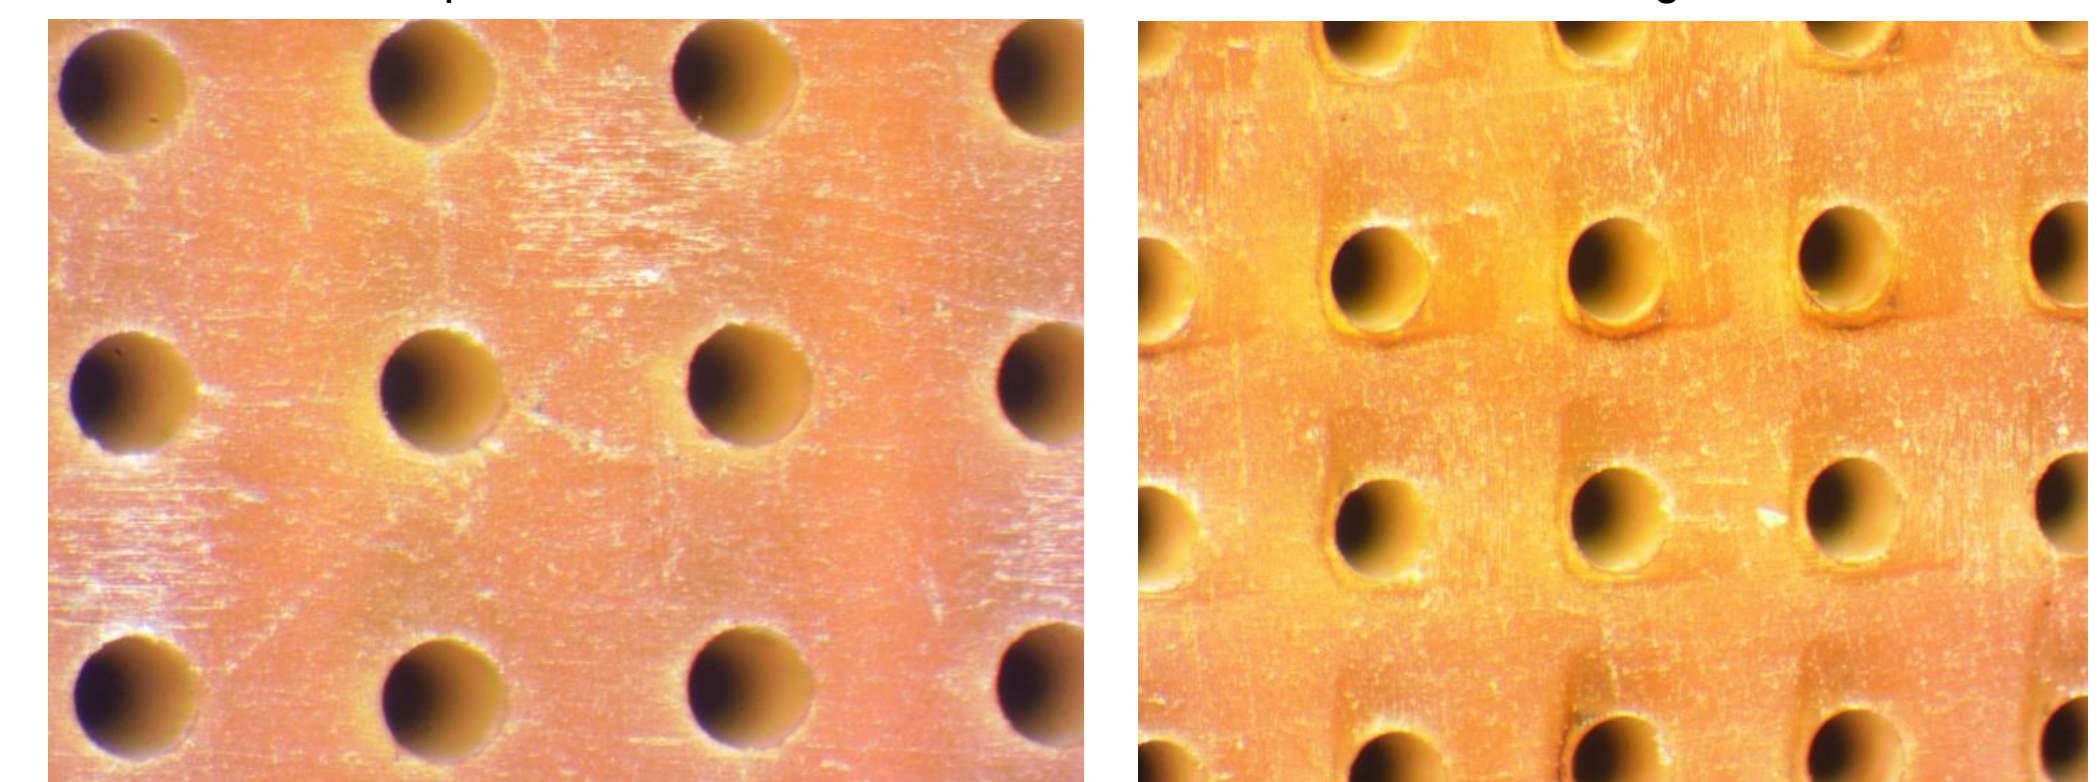
FR4 plate backside before and after 100000 discharges

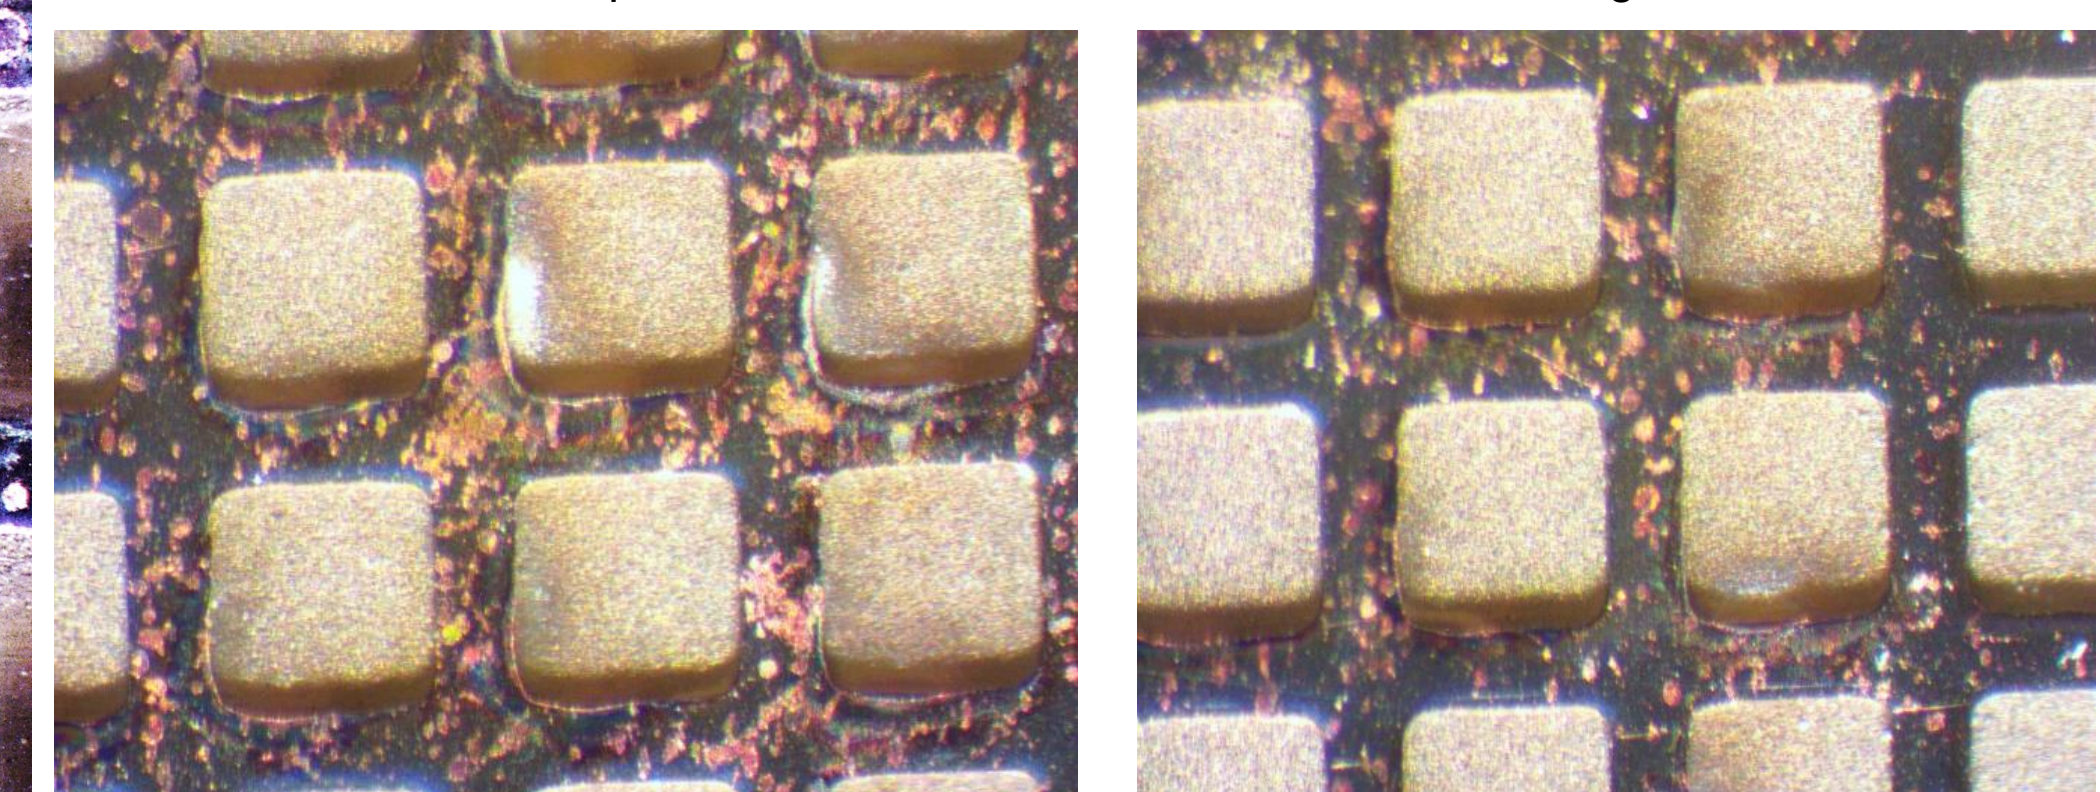
Charge evacuation grid and DLC layer directly below alpha source and on the side. DLC layer erosion and copper deformation is clearly visible

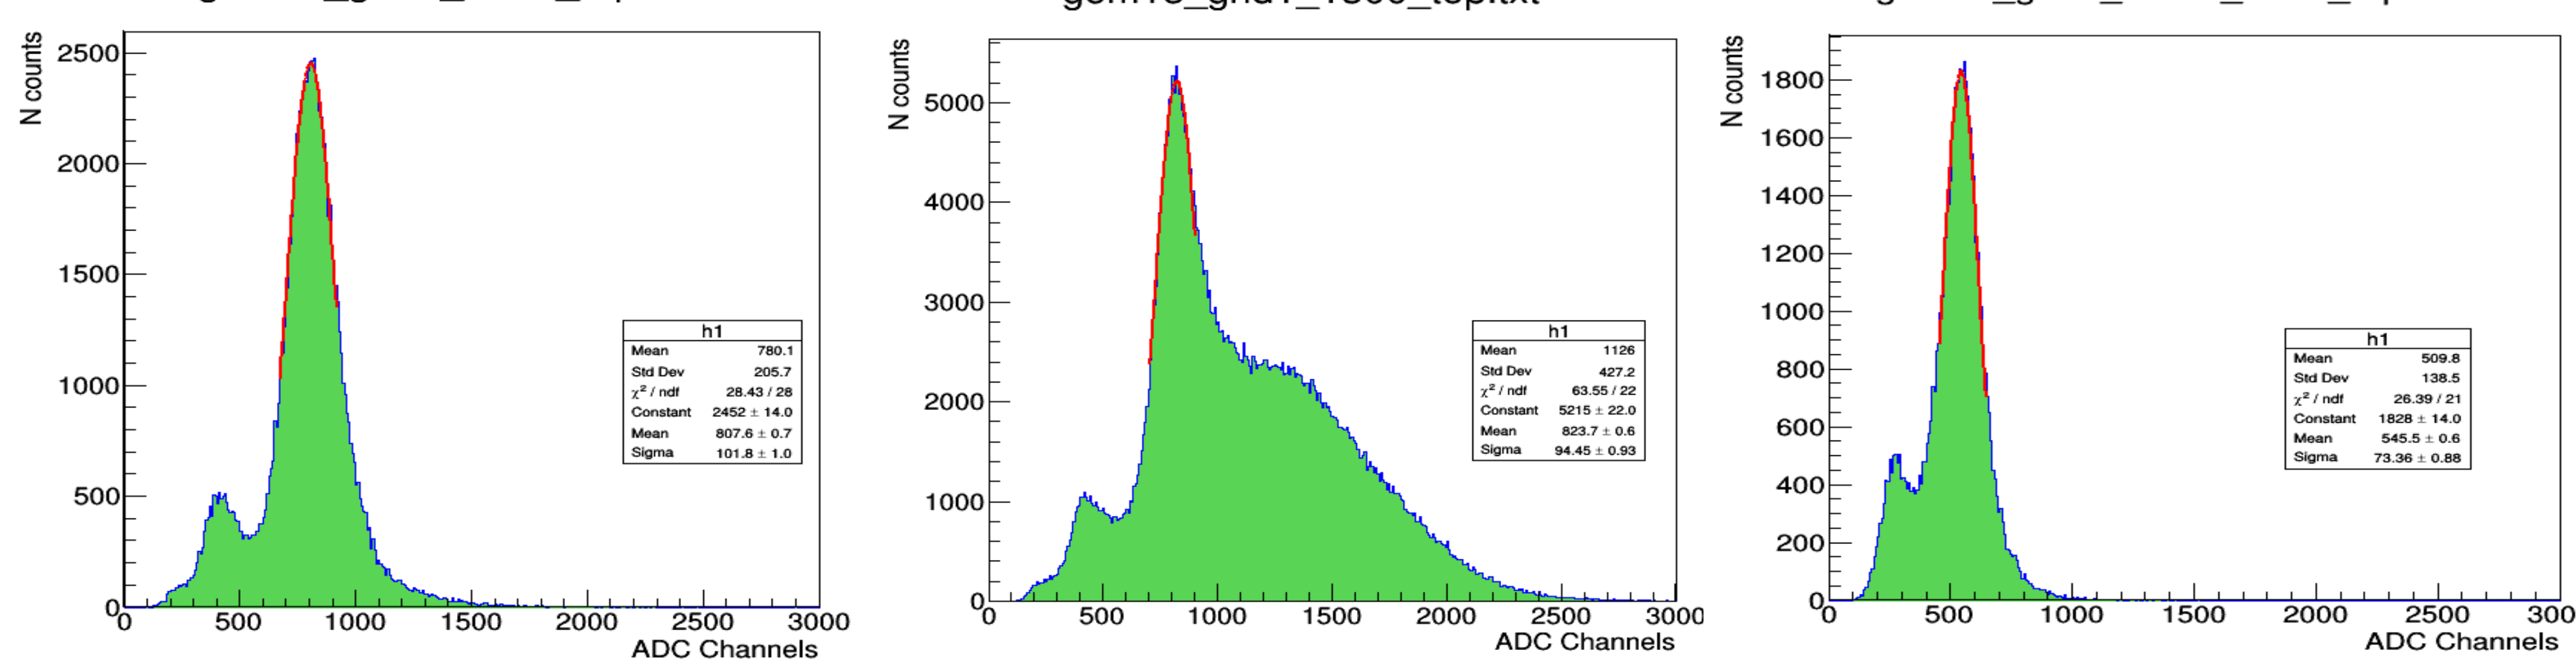
To simulate a large area detector, we added a capacitance in parallel with the test device. At a capacitance of **0.33 nF**, a slight damage of the RWEM perforated structure and DLC layer was observed after **100,000 discharges**. At the same time, Raman spectroscopy did not reveal any significant changes in the structure of the DLC layer. After top FR4 plate was replaced by a fresh one, the detector performance was partially recovered.

Fe-55 spectra before and after 100000 discharges at 365 pF total capacitance, and after top plate replacement

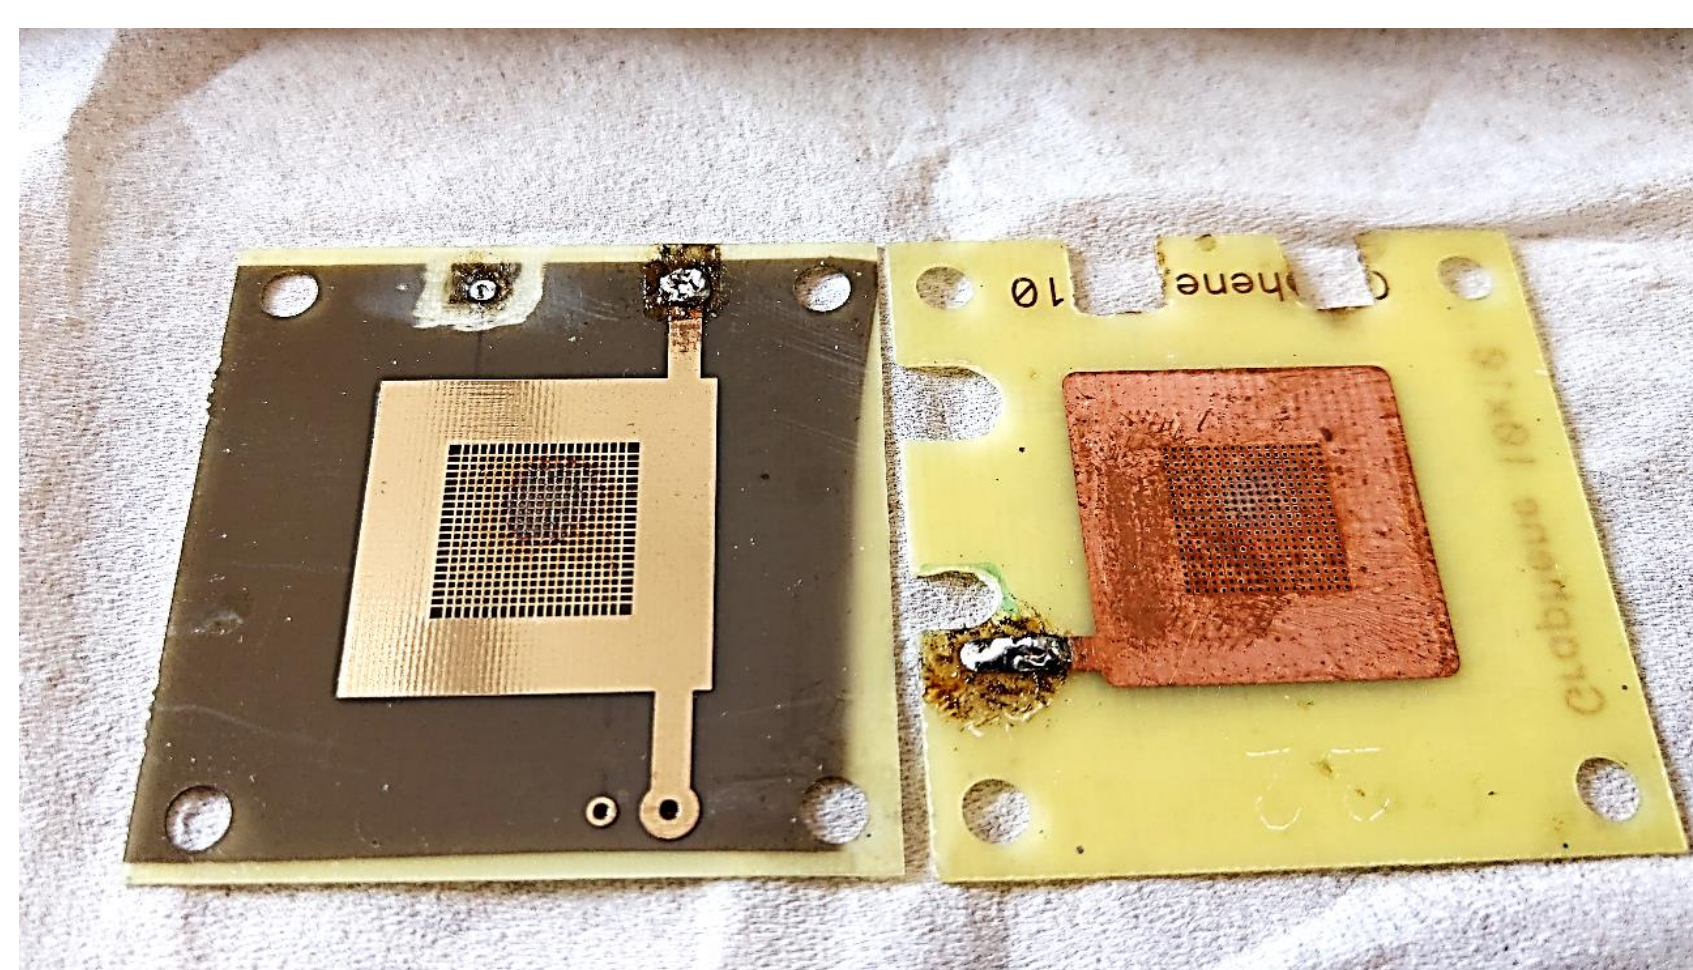
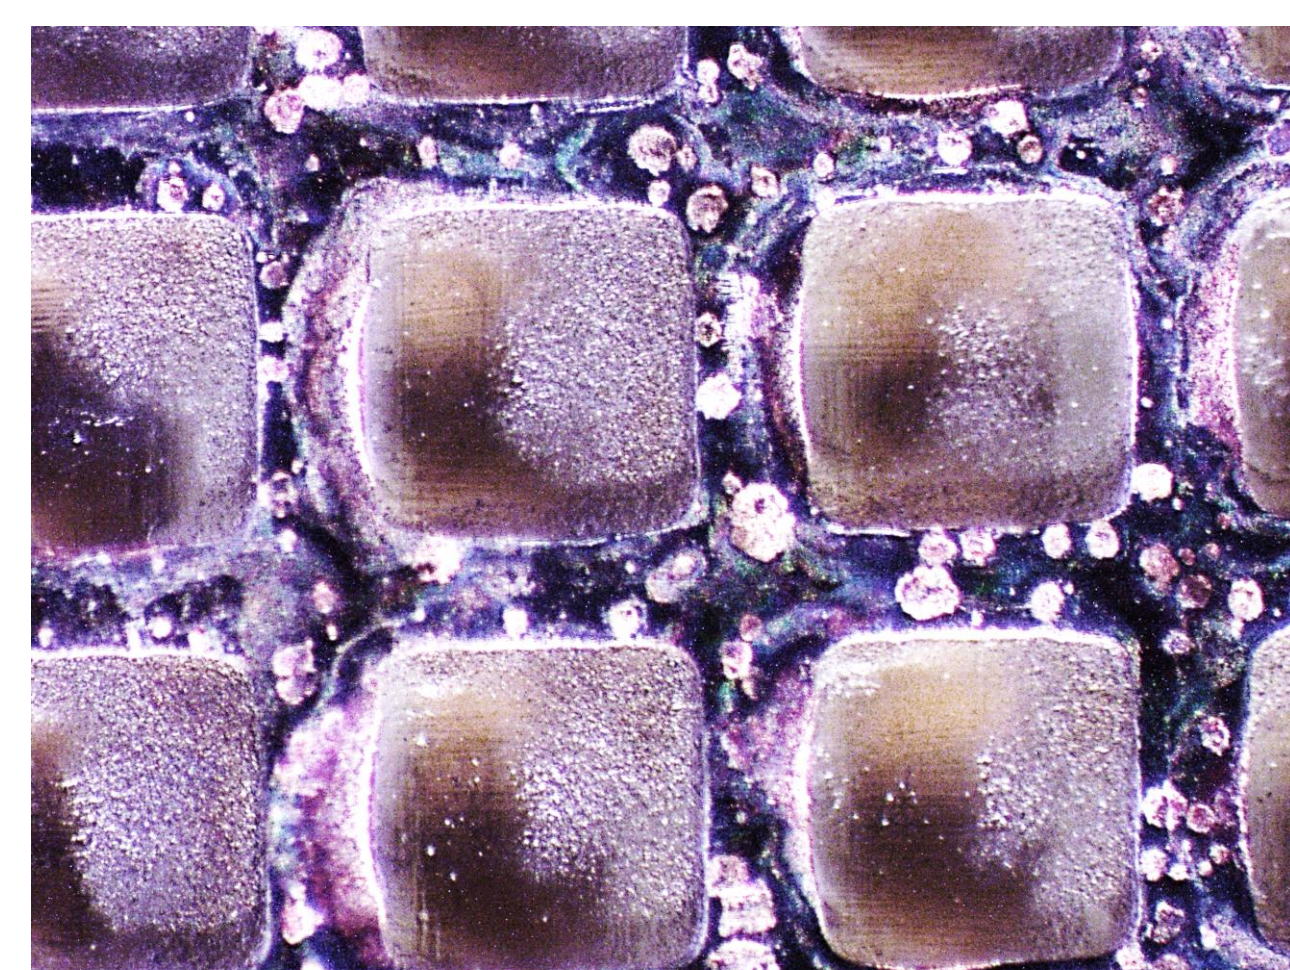
The further increase of the discharge energy by adding a capacitance of **1nF** resulted in significant damage to the detector after the accumulation of **100,000** discharges.
