Challenges and Lessons Learned from fabrication, test and analysis of ~10 MQXFA Low Beta Quadrupoles for HL-LHC

Giorgio Ambrosio and the MQXFA team

ASC
22

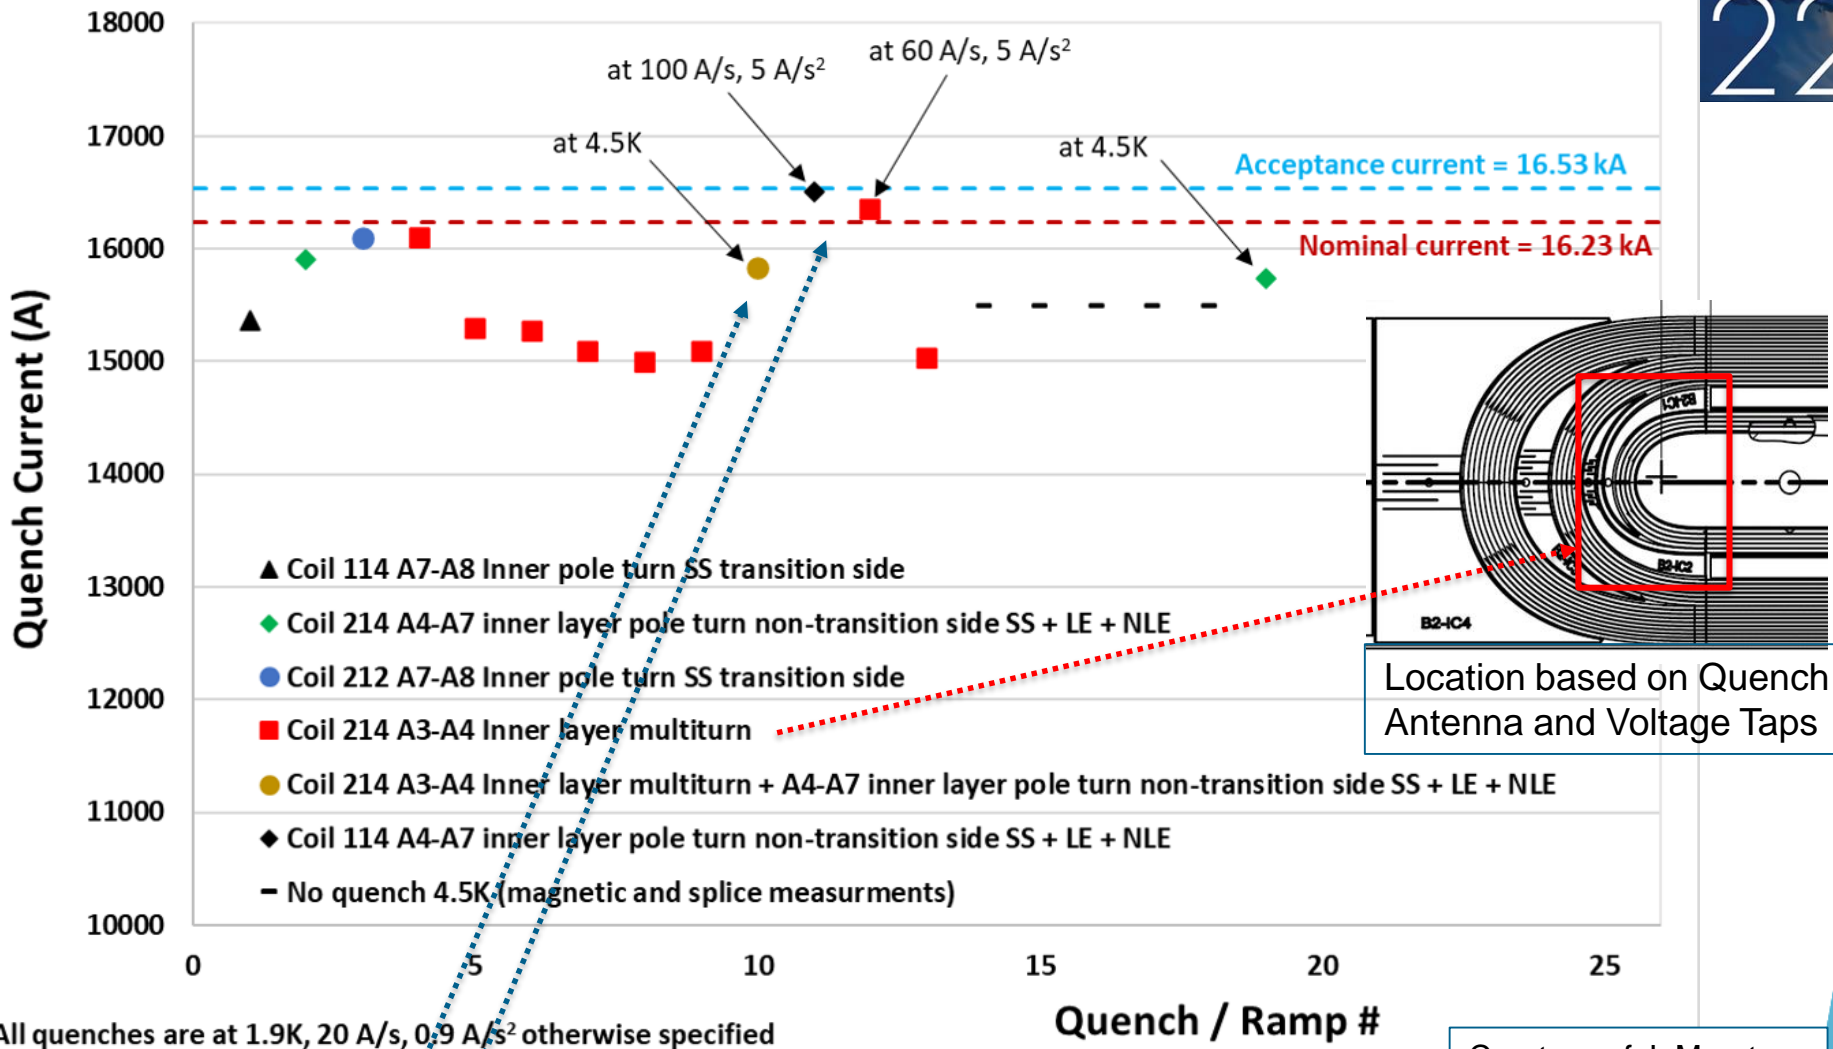
MQXFA07 Training Quenches

- Reverse temperature dependence
- Reverse ramp-rate dependence
- Same features and location in MQXFA08

- Self-field **instability** triggered by a **local issue**, likely affecting only some strands, that pushes more current in adjacent strand(s)
 - Field in quenching turn is between 6 and 9 T

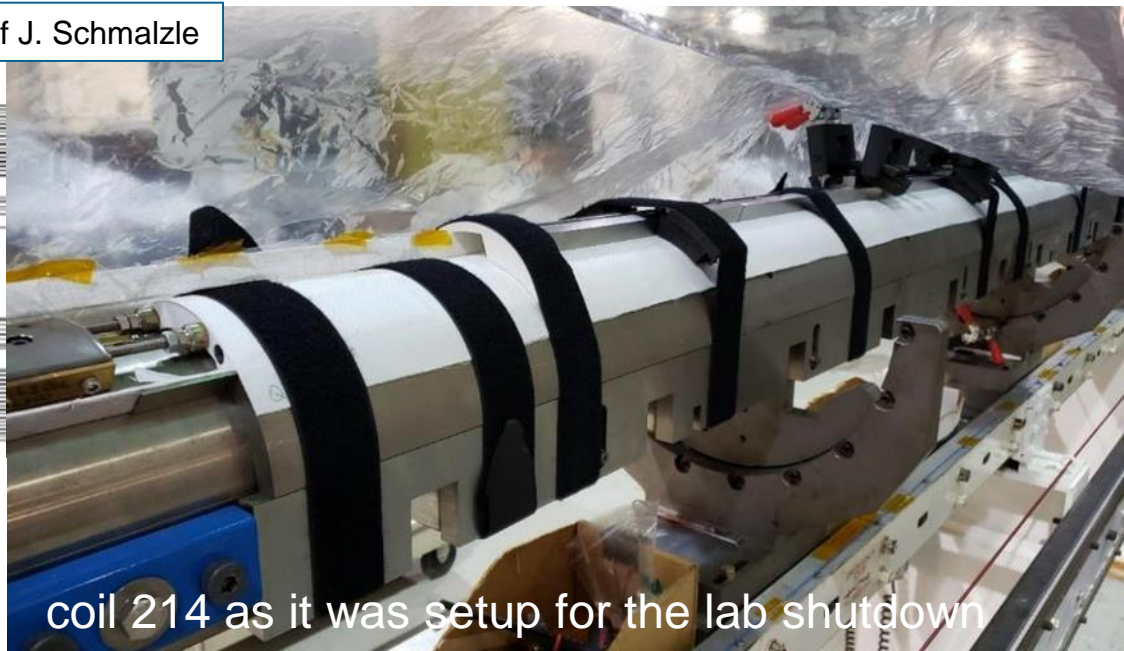
- A few discrepancies during fabrication:
 - Some strands popped out during winding, were fixed, popped out overnight and were fixed a second time (BNL DR AM-164)
 - Limiting coil was affected by COVID lockdown
 - 14 weeks stop after winding & curing of inner layer
 - No other NCR nor traveler data anomaly

coil 214 as it was setup for the lab shutdown

Inner layer coil showing in yellow the position of coil-214 cable affected by DRAM-164

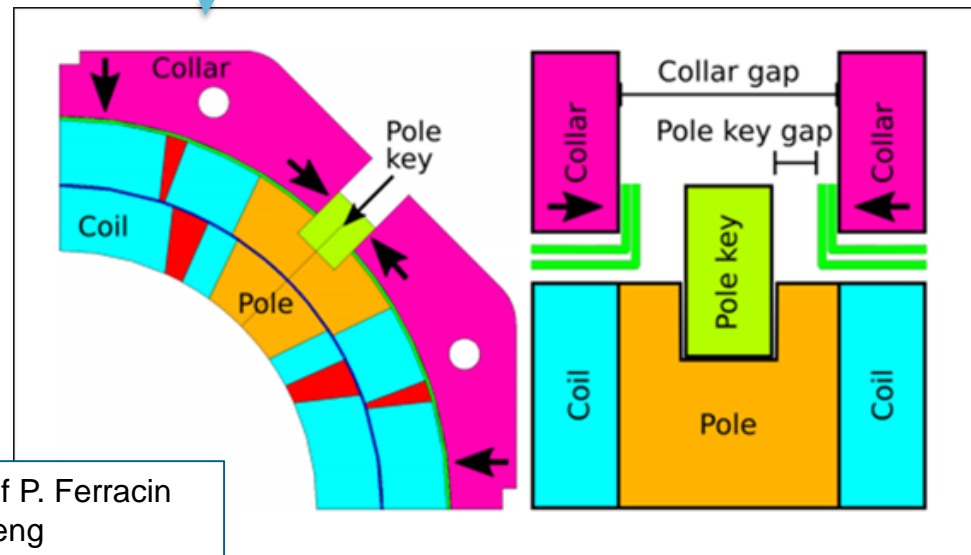
Pole-key gaps in MQXFA07

A pole-key gap asymmetry was found during MQXFA07 and MQXFA08 disassembly:

- Gaps closed in quadrant 3
- Gaps open in other quadrants

- The measured **pole-key gaps** were not as **uniform** in MQXFA07 and MQXFA08 as in past magnets; this is particularly apparent on the **limiting coils (Q3 for both magnets)**
- Only the **total average** (on the 4 keys) was targeted in the **specification**. The underlying assumption was that the **gaps** would be **redistributed** across coils during **loading**.
- **Investigation** of the effect of this non-uniformity on the mechanical performances with **2D** and **3D FE models**
 - **2D effect: preload variation within acceptable range**

- Design change for larger pole-key gaps:
 - From 200 μm to 400 μm - average pole key gap per side
- Revised MQXFA Series Magnet Production Specification:
 - Added spec for minimum gap on each coil at each longitudinal location: 300 μm per side

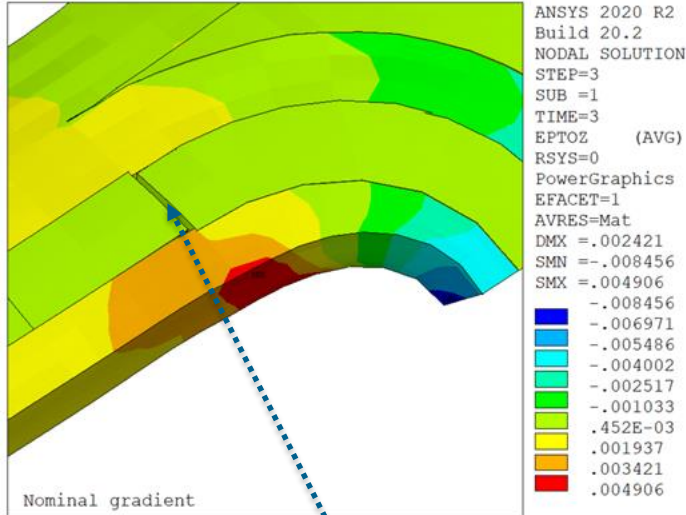
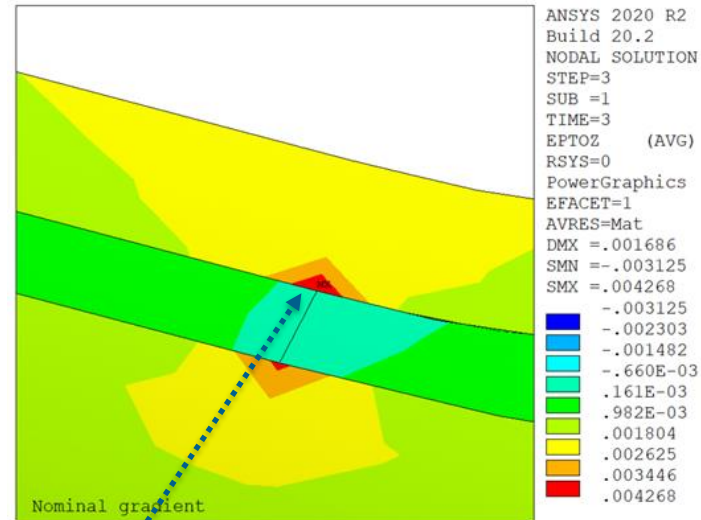
Possible Damage at Wedge-Spacer Interface

- **At cold** the coil with less azimuthal preload ends up with **less longitudinal preload**
- **At nominal current** tension develops between the inner wedge and the end spacer, and a (small) **gap** may open
- This may result in high **longitudinal strain** (up to **0.4%**) in that location
 - This location is consistent with quench data
 - Effect is larger on the pole block, but also visible on the mid plane block

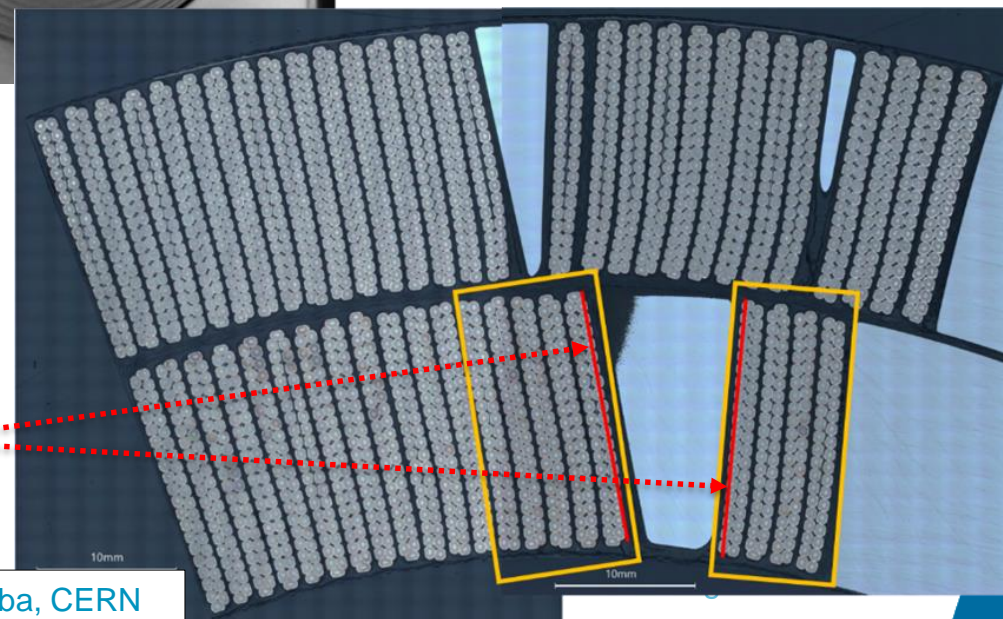
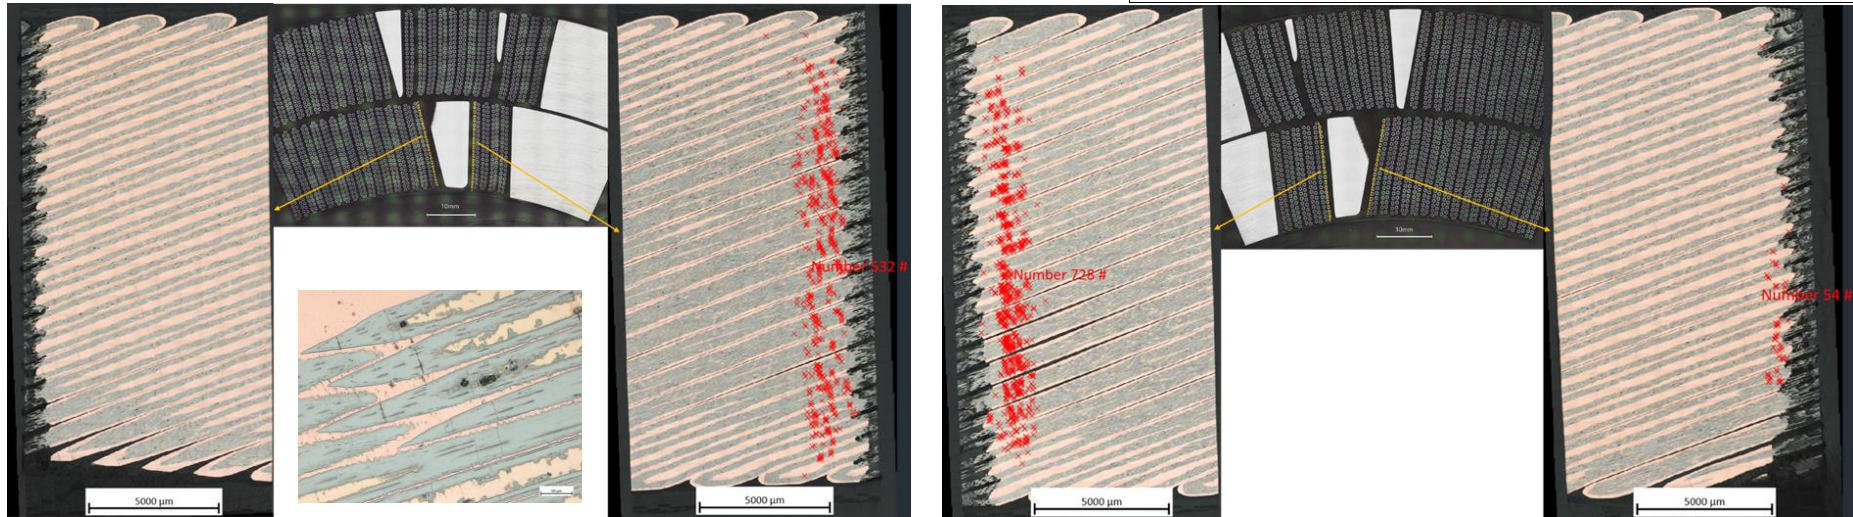
- Longitudinal cuts on cables adjacent to the end-spacer/copper-wedge transition
 - Localized field of **broken filaments (red dots)**, especially at pole block

#	Samples adjacent to W-S transition from coil 214 Lead End	Number of cracked filaments
1	Layer-jump side, cable in midplane block, side adjacent to W-S transition	0
2	Layer-jump side, cable in pole block , side adjacent to W-S transition	532
3	Non-layer-jump side, cable in midplane block, side adjacent to W-S transition	54
4	Non-layer-jump side, cable in pole block , side adjacent to W-S transition	728
5	Same cable of sample 4, side opposite to the W-S transition	0

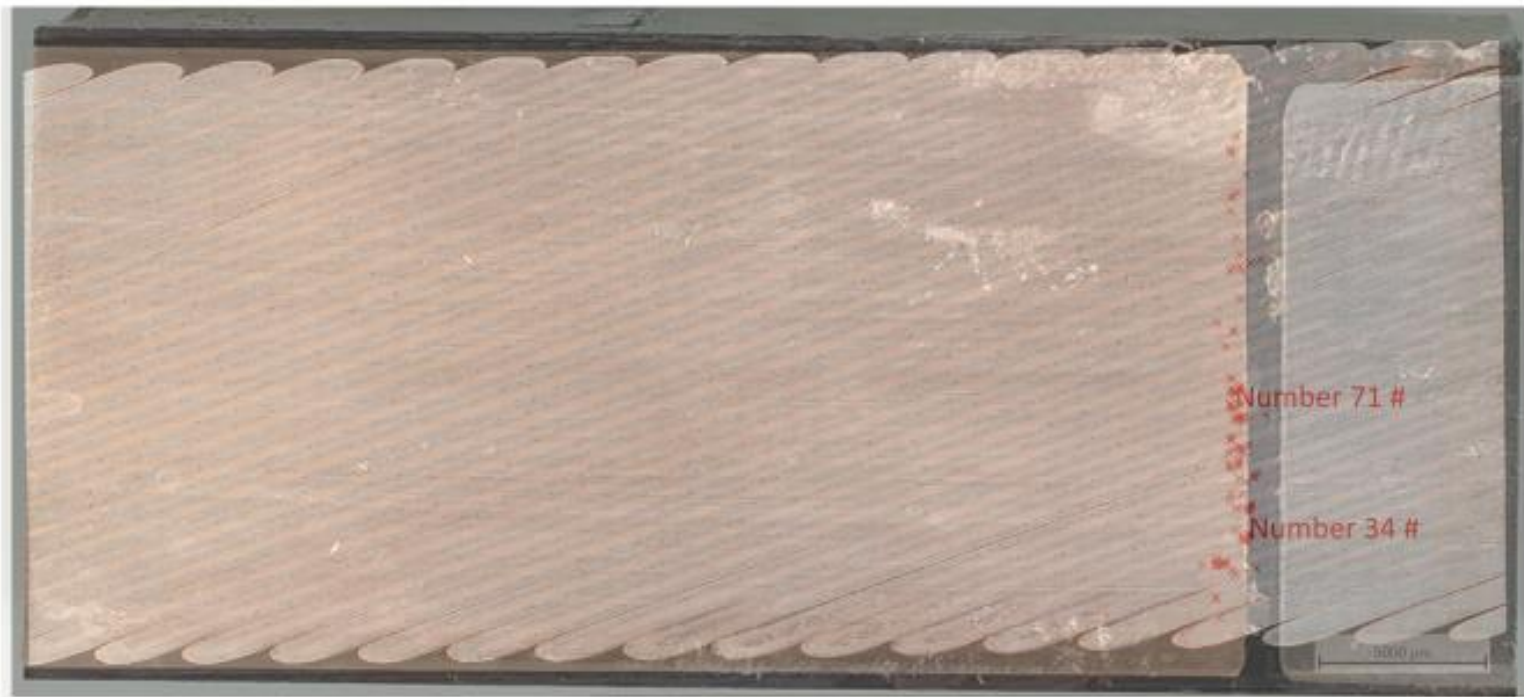
3. End spacer-wedge transitions

- Same features as in MQXFA07
- Metallographic analysis of lead end shows broken filaments at wedge-spacer interface

Crack field is in correspondence to resin/copper wedge interface

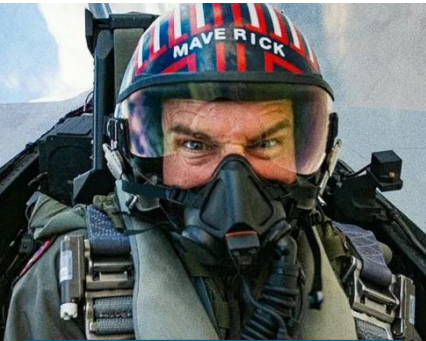
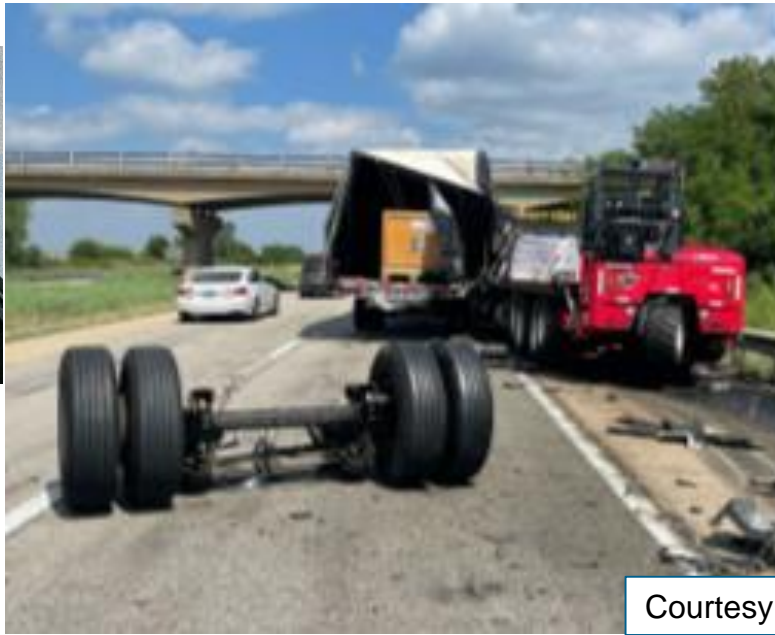
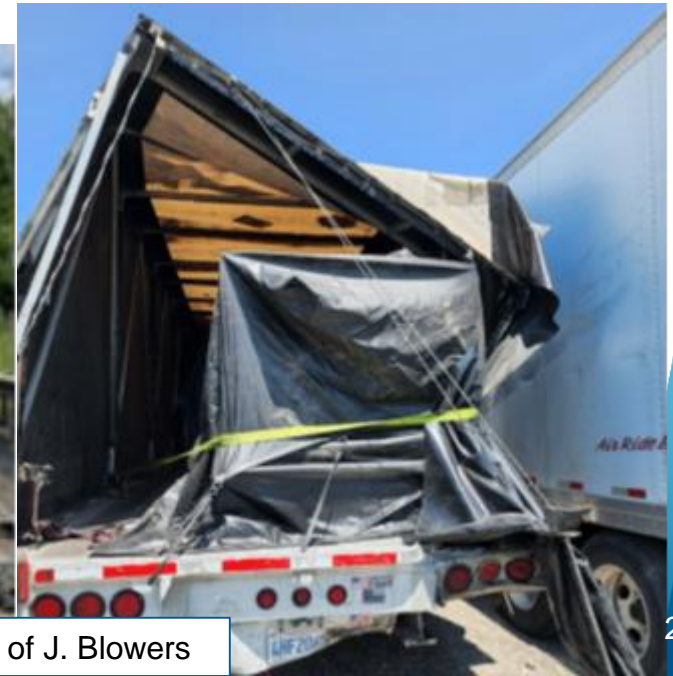
- The truck transporting the MQXFA11 magnet from LBNL to BNL was rear ended by another truck.
- The main hit took place on the right back corner. During the incident the truck rear axle disengaged as displayed below. Nobody was injured.
- The magnet was moved to FNAL. Upon arrival a visual inspection was performed followed by electrical checkout, metrology survey, analysis of the fiber optic sensors and accelerometer data analysis
 - Max shock: 6 or 10 g vertical (depending on the device in the same accelerometer unit)
 - Duration: 5 ms
- All tests and analyses were OK. Magnet was shipped to BNL

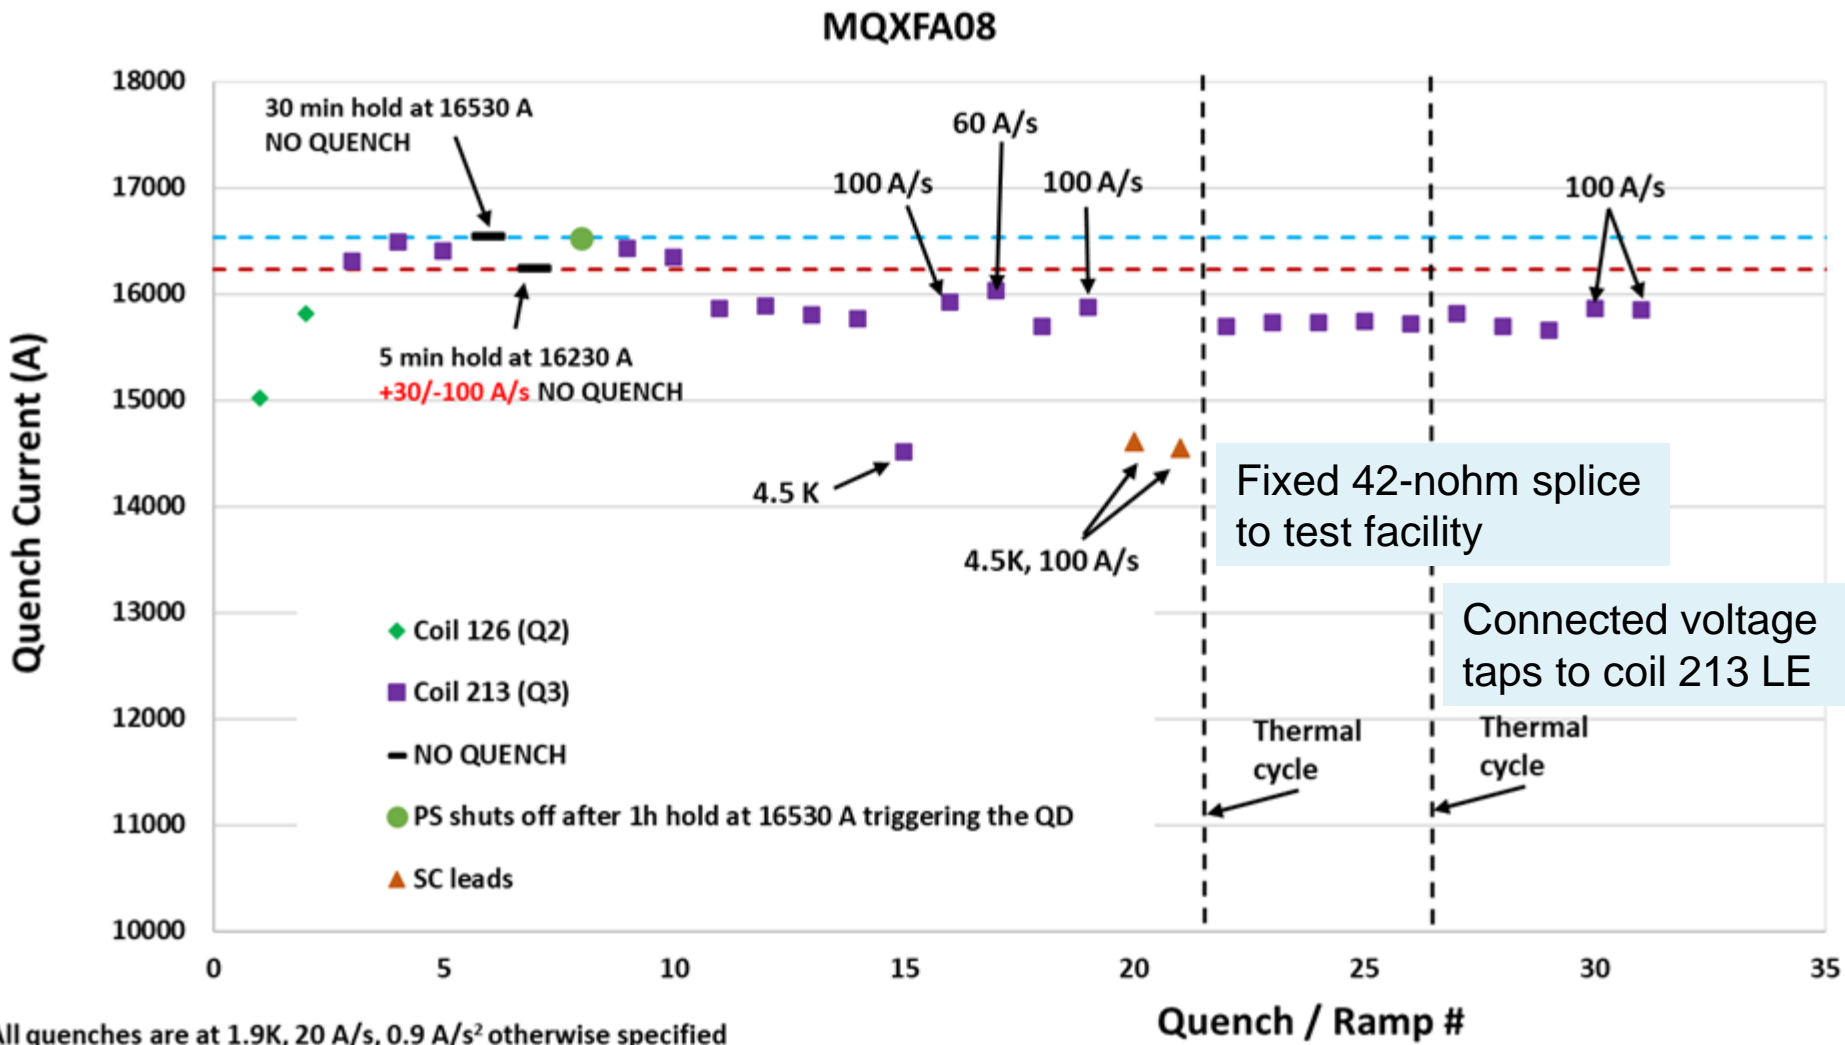
MQXFA08 Quench History

All quenches are at 1.9K, 20 A/s, 0.9 A/s² otherwise specified

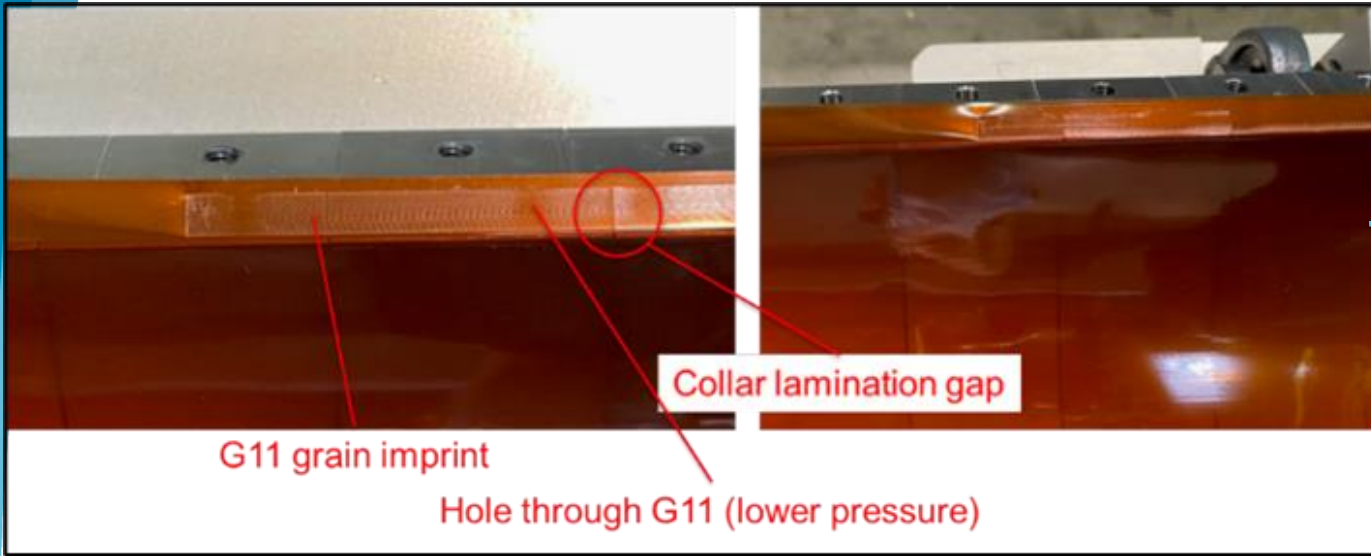
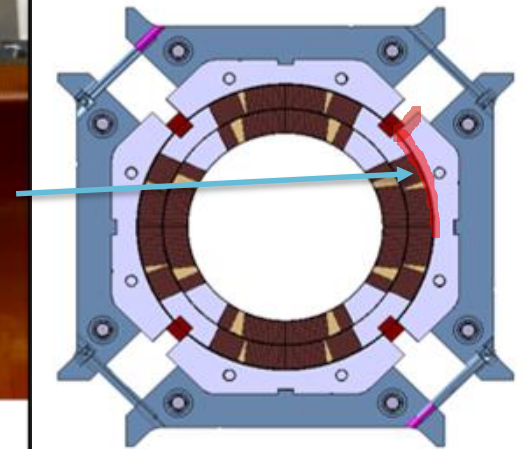
Magnet Dis-assembly

- Pressure imprint in Q3 pole-key gaps
- Unusual marks at wedge-spacer interface in lead end

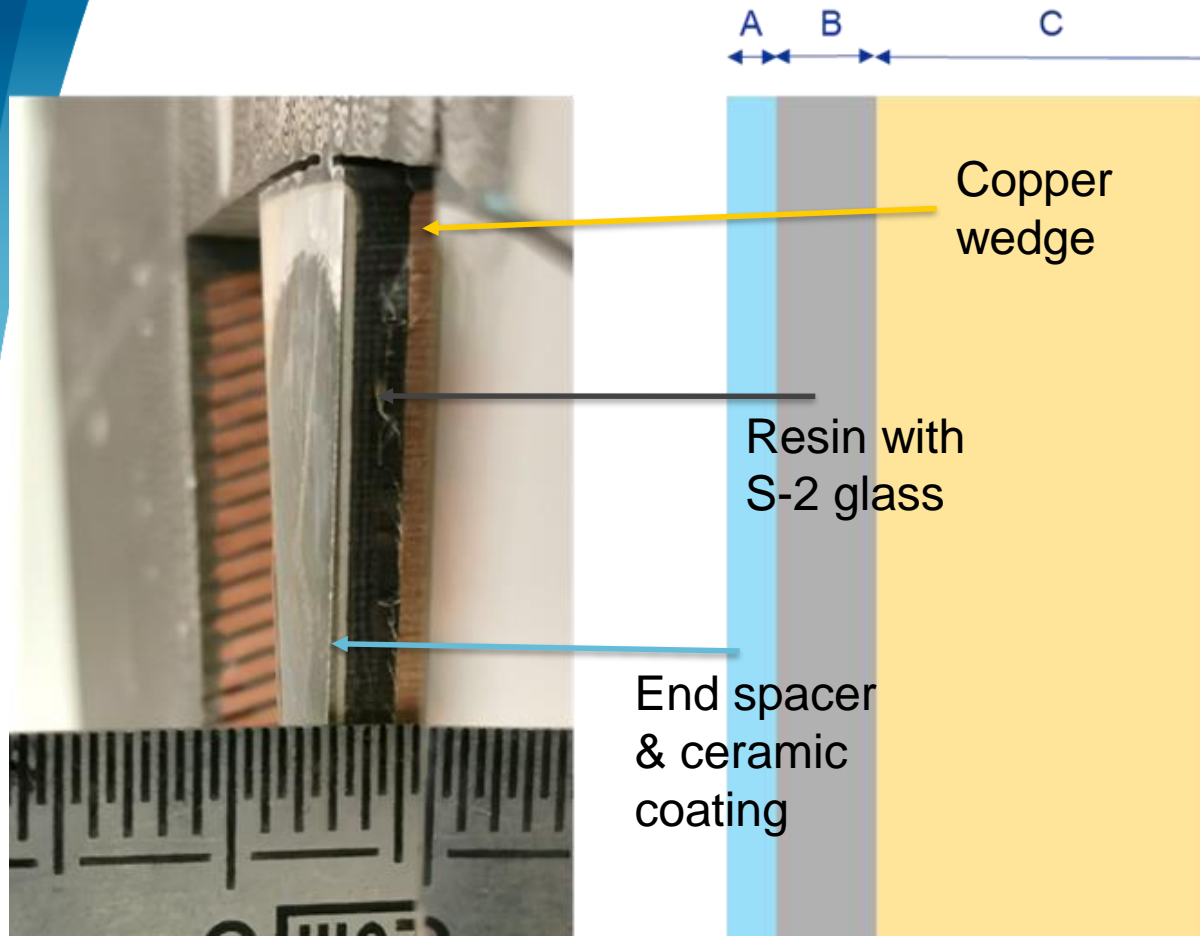
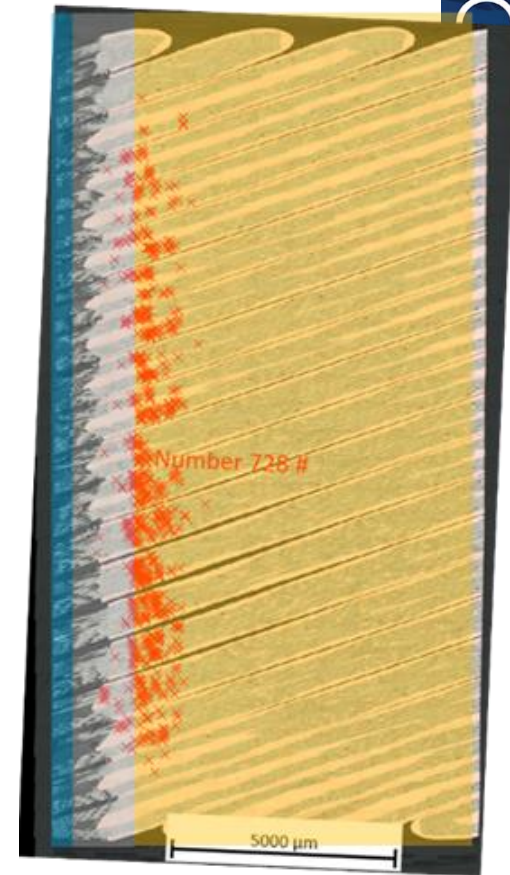
Left: coil section after samples were extracted for metallographic inspection.
 Center: color scheme used to show the position of filament cracks with respect to the W-S transition in the following figure. A: End spacer + ceramic coating $\approx 0,5$ mm; B: resin (filled with S-2 glass) between end spacer and wedge $\approx 1,5$ mm; C: copper wedge.
 Right: color scheme applied on sample with broken filaments.
