# **SOLEIL Power Supply Reliability**

### POCPA Workshop 2023 François Bouvet

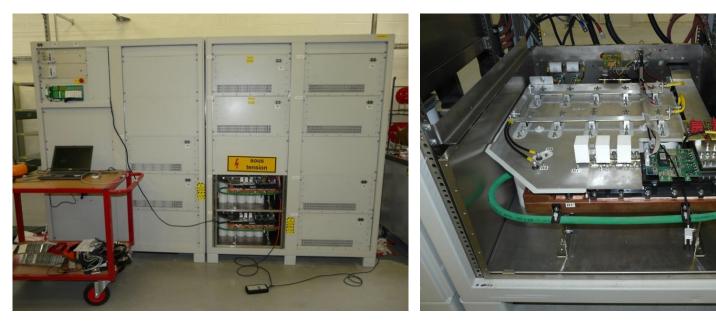
• 3Hz Booster Power supplies: Complete redesign of the power crates in 2013

New crates based on 1200V / 2500A IGBT modules with high thermal / power cycling capability Calculation of IGBT junction temperature excursion: ~17°C Estimation of the IGBT cycling capability: > 200 Million No failure since 2014

Cycle counters are now implemented on our 3Hz power supplies, to accurately follow the lifetime

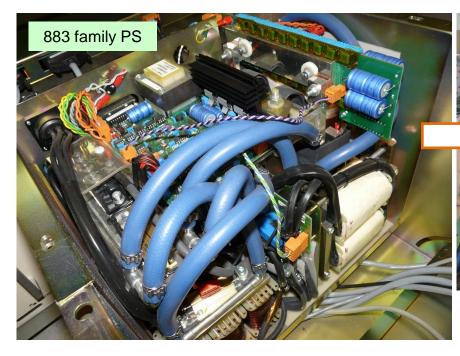
- Too compact
- Too complex
- Poor diagnostics (many interlocks in series  $\Rightarrow$  Identification of faulty element is difficult)
- DANFYSIK support: Ineffective (+ unaffordable)

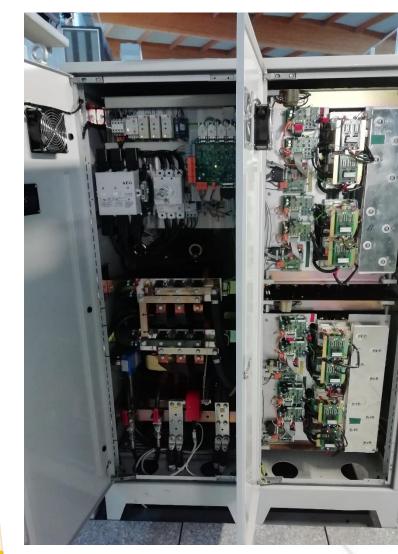
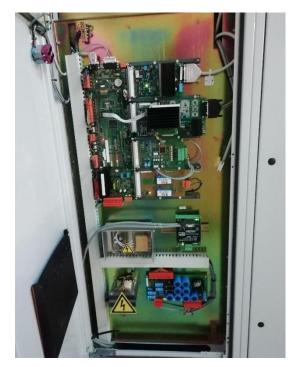
- Many failures with the 859 family PS
- Luckily, we only have 6 of these PS, which power electromagnetic undulators feeding the beamlines
- 9 (!) cards changed since September 2022
- Fortunately, nearly no impact on the beamlines, but many hours of investigation to solve all the problems

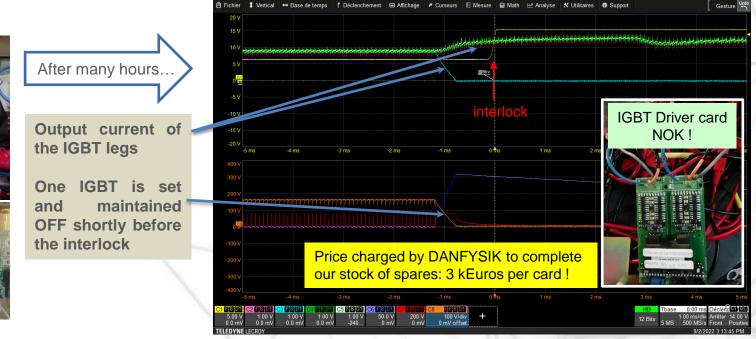
- September 2022: Sporadic "DC Overload" Faults
- The "DC Overload" fault is a sum of many interlocks:
  - Overcurrent at the output of one of the 16 (!) IGBT legs  $\bigcirc$
  - Overcurrent at the output of the power supply Ο
  - Malfunction of one the 16 PCMPMW cards  $\bigcirc$
  - Malfunction of one of the 4 PCMINT cards  $\bigcirc$
  - All these interlocks are serialized on the FQDRINT and REGULATION MODULES SMD cards  $\bigcirc$ and are finally transmitted to the CONTROL BOARD for processing
- Where to start when the fault is not permanent? Here, time and energy are requested...

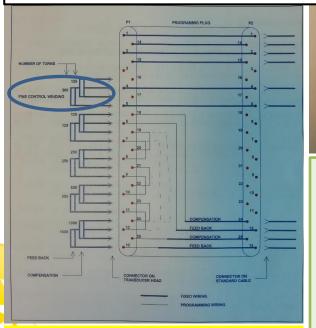
- $\Rightarrow$  No improvement ; Worse: Huge output voltage oscillations, but only for low output current
- $\Rightarrow$  These power supplies cannot operate without the "Fine control winding" of the DCCT

connected to the PS output potentials  $\Rightarrow$  ????

Seems to compensate the oscillations induced by the output stage operation in discontinuous conduction mode: Correct ?

- November 2022: "OCP" Fault
- Decision to replace the DCCT (head + electronic card) with another DCCT reference 
  integrating the electronics (including zero flux detector circuitry)

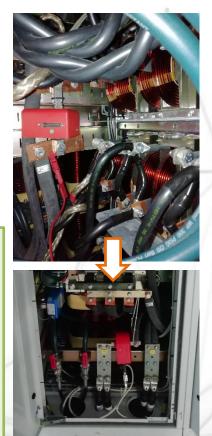
- General observation: DCCT head close to PS output inductors deep inside the rack

- Problem solved by moving the DCCT head at the bottom of the rack, far from the initial location
- Current ripple in the output filter inductors is OK: Emergence of this saturation of the DCCT (only for negative currents, after 15 years of operation) remains a mystery... Any ideas ?

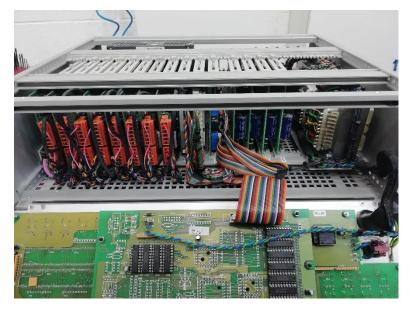
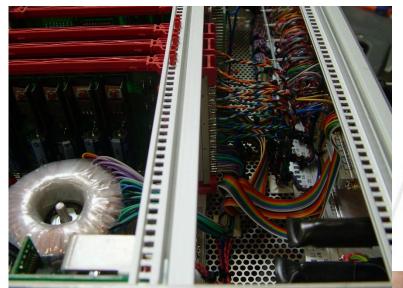
- No backplane cards in some of our power supply crates + lots of cabling/electrical connections
- After 17 years of operation, reliability issues begin to appear
- ⇒ Such kind of design will be avoided for SOLEIL Upgrade
