LINAC2 PERFORMANCE AND HARDWARE REVIEW

Giulia Bellodi - BE/ABP-HSL

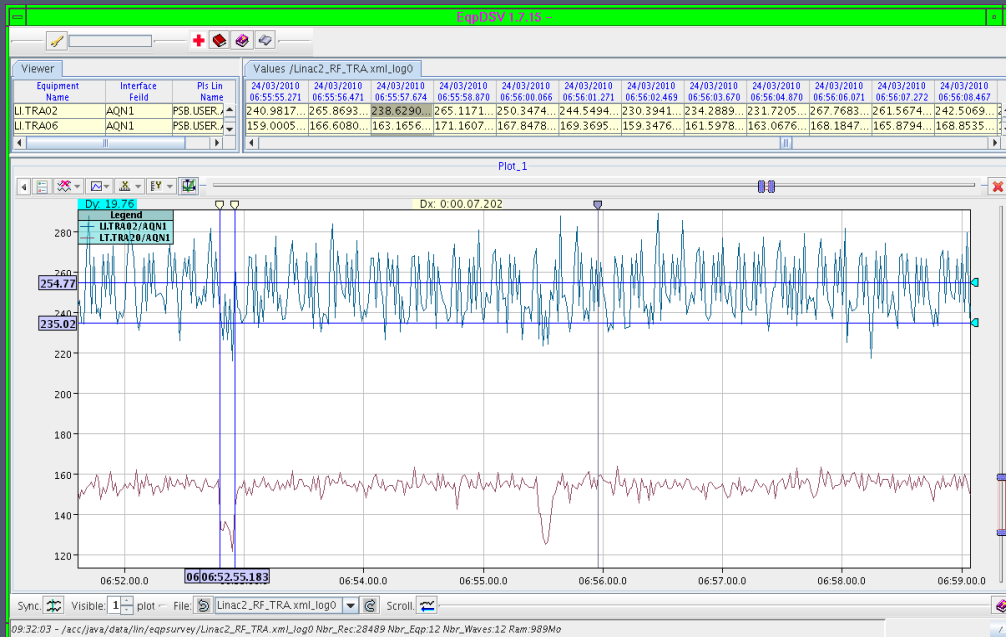
2010 in review: the source dip

- 20 % drop in source intensity
- regular 1h-1h30 periodicity
- single events or in doublets (30 to 60 secs apart).

Seen from end of January, and disappeared in November! Only affected by switching off the cathode heating for a few minutes.

Signs of a **small water leak** were found on the source at the end of the run , with some discharge damage between the plasma chamber and the solenoid coil (drops accumulating and drip running across the cathode to anode circuit, before evaporating, can explain quasi regular period between the dips. after the drip has dried out, no reduction in source performance).

The plasma chamber water circuit was tested using helium leak detection, and no leak was found. For the 2011 run, **the plasma chamber and solenoid have been replaced with reserve items.**

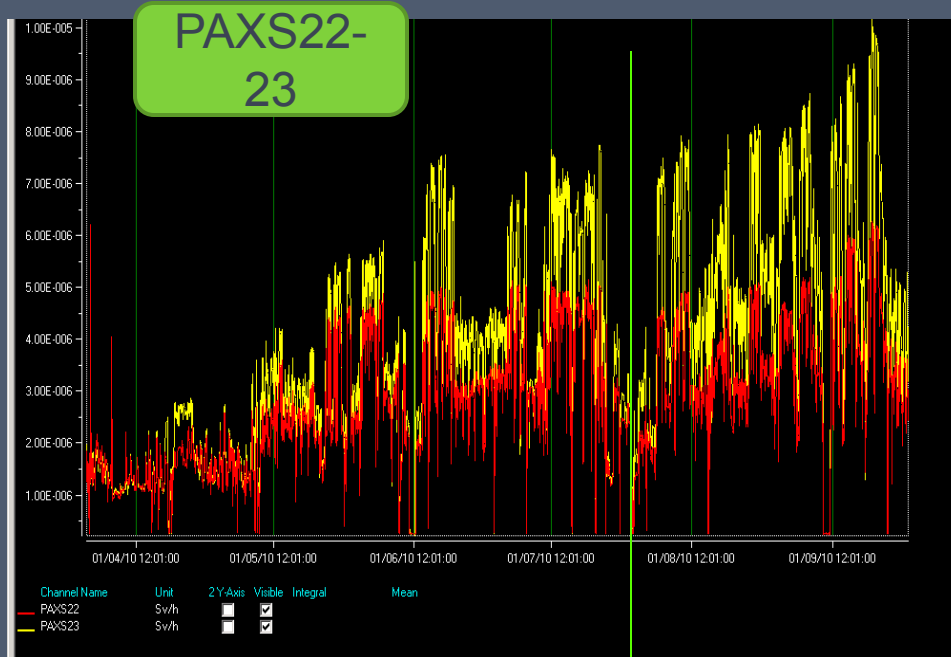
2010 in review : radiation levels

20% increase from Aug-Sept 2010 & regular level 1 alarms

Increase not understood (higher intensity delivered?). Levels temporarily reduced with optics changes, however the problem was just shifted downstream, as new RP measurements revealed (new hot spots in BI line, 15→172 $\mu\text{Sv/hr}$ from 2009 to 2010). New BLMs installed in the shutdown and further optics changes implemented (end of February 2011).

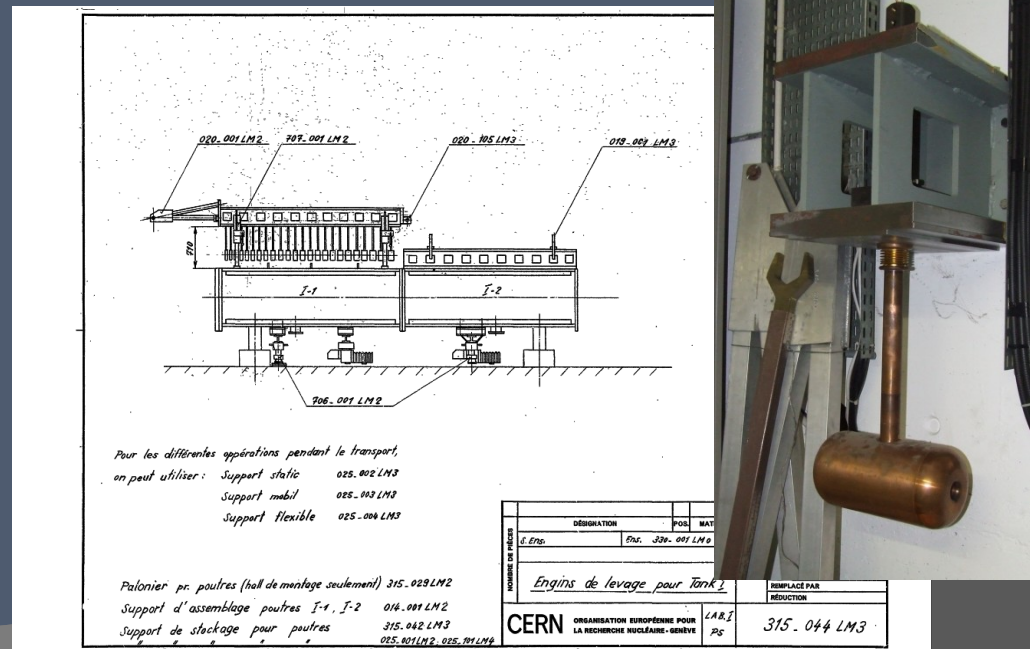
Nightmare 1: DTL quad failure

- 131 quadrupoles, (powered in series of 1, 2 or 3) inside the drift tubes pulsed with $>300\text{A} \sim 700\text{V}$ every pulse. $\sim 500\text{ M}$ pulses to date.
- The drift tubes are suspended to a girder; they are aligned externally and successively introduced into the tanks. A mechanical positioning system on the outside of the girder together with a bellow on the inside allows positioning of the drift tubes with the required precision.
- No maintenance of these circuits (inside the drift tubes) has ever been made.
- 2 vacuum leaks differentially pumped
- MTR in case of fault? \rightarrow R. Scrivens, ATOP days 2009

Short-term operation w/o quadrupoles might be possible with **degraded** emittance growth and transmission to PSB.

For longer term solution, a **repair plan** has been put together:

Cranes were installed with sufficient space to lift out the DTs.

Phased pre-study of first
opening tank.alignment of
inventory, copper and seal
Not clear how to proceed
Still to do:

- Study of how to remove girder. Design of tooling.
- Study of repair.
- Study of tooling for drift
- Study of tooling to leak to girder seal.
- Installation and re-align

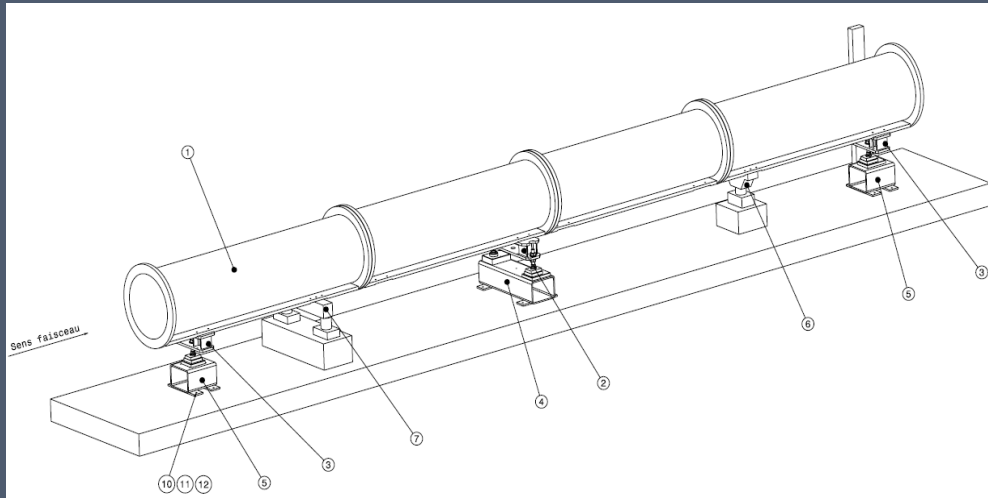
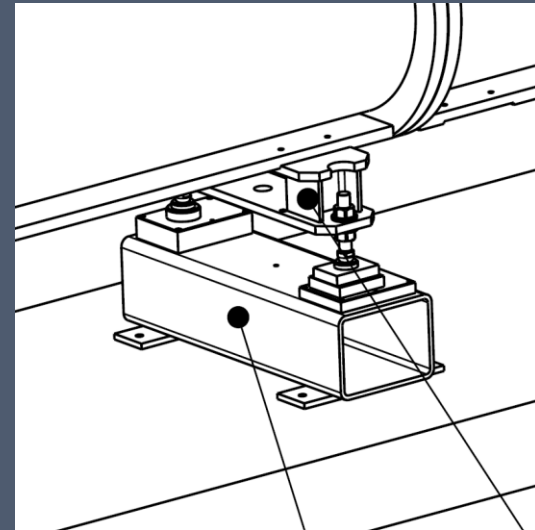
Nightmare 2: inter-tank vacuum

No known plan to vent and replace an inter-section seal if it's not possible to make a secondary vacuum.

Removal of inter-section very complicated (2 more wire vacuum seals)
Solution known for sections displacement only around movable feet.

Need of study to assess:

- Availability of all necessary tooling
- re-alignment procedures?
- possible mitigation strategies..
- Downtime estimate and intervention plan
