# TGC's ageing experience

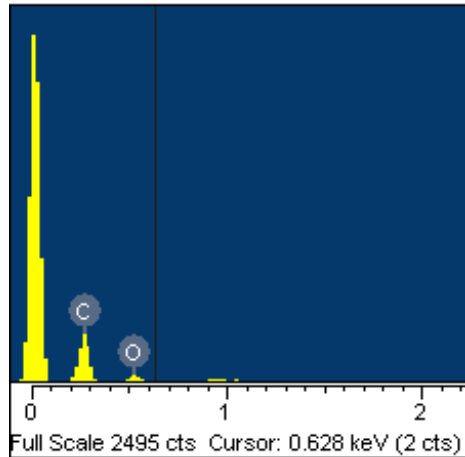
Deposits due mainly to Carbon and Oxygen

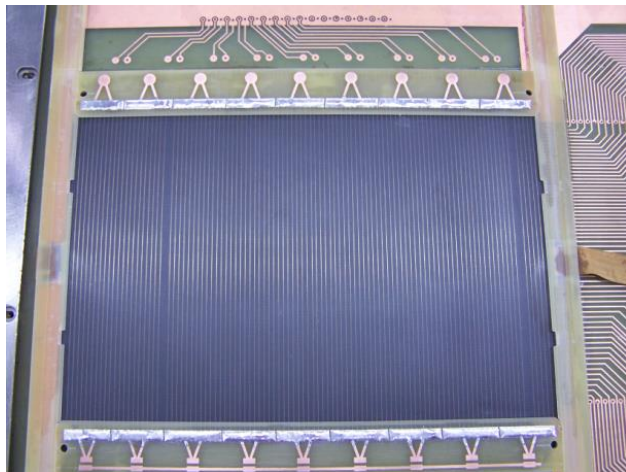
With an electric field of 2.1kV/mm be careful on conductive edges

Concentration of the electric field lines=> continuous sparking along the edges under irradiation

Cover cathode

Cover cathode with graphite at ground

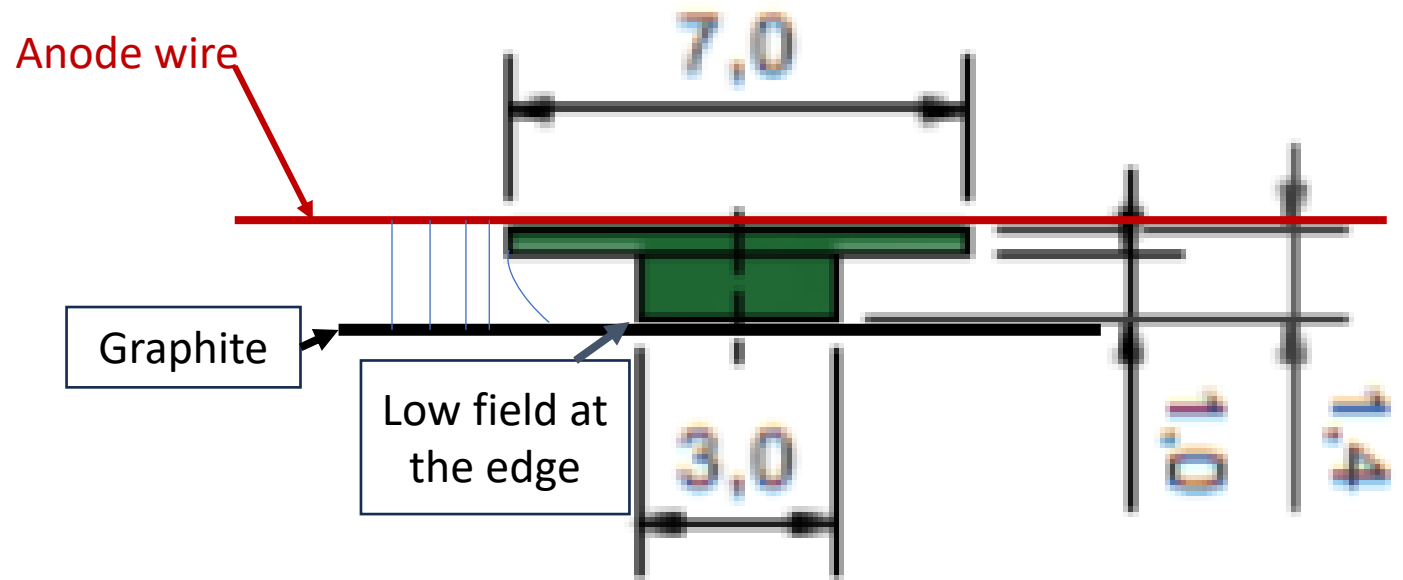
But also the edges of the graphite play a role  
need to reduce the electric field at the edge

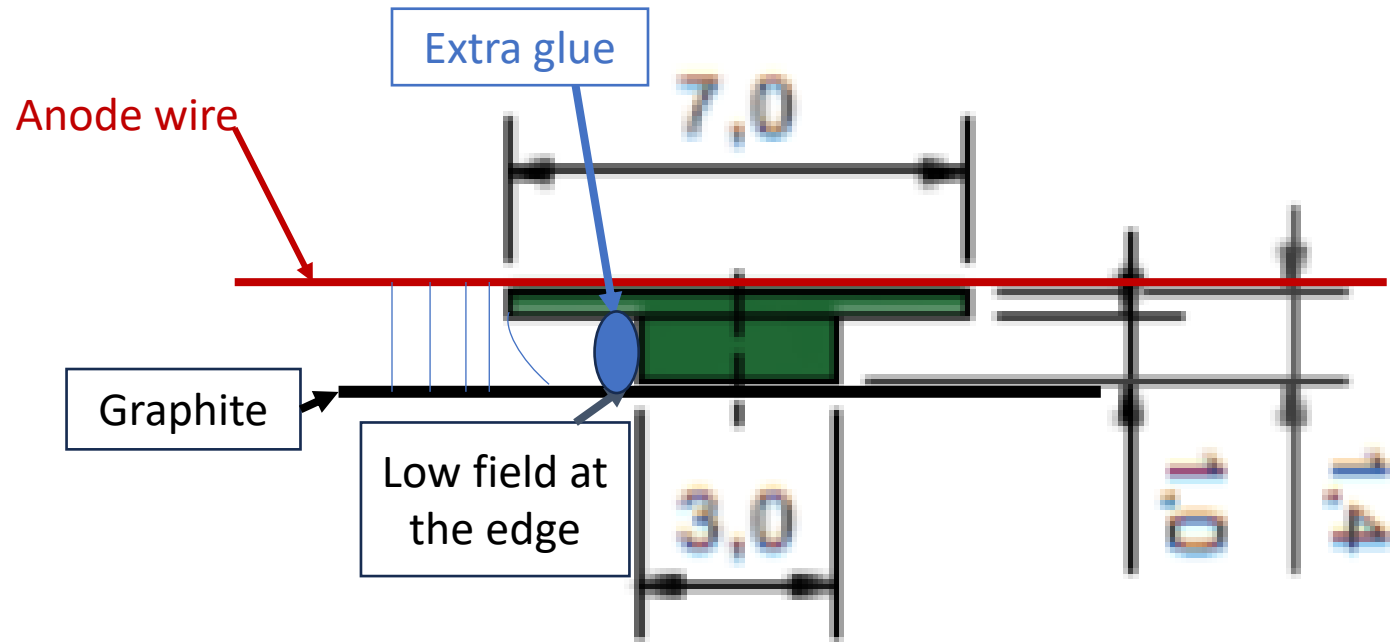
# But if there is extra glue at the leg of the support, long term problems occur

Long term problems occur due to:

Charge up of the glue=>spark

Glue dissolves some of the graphite, leading to continuous sparking

Also glue deposited on the graphite charges up and sparks with time,

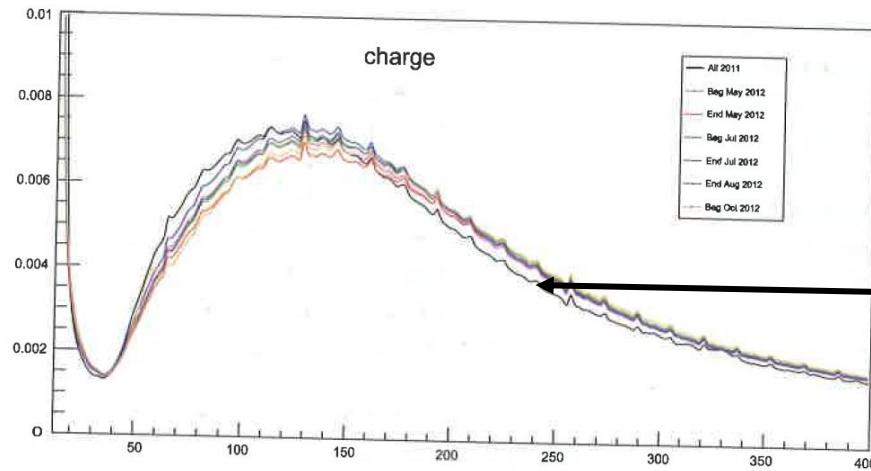
Also by comparing average distributions for 1278 planes  
(one side) one can see no changes, except  
October 2012

- Do not blame everything on ageing
  - The small diminution in the MIP charge was accompanied by a large number of HV tripping chambers.
  - The try to overcome the problem; gas flow was increased to further delude any contaminant.
  - Problem was traced (Roberto) to a different n-pentane supplier that was using different stainless-steel containers.
  - The n-pentane is a very good cleaning agent, but it also cleans the rests of the welding materials.

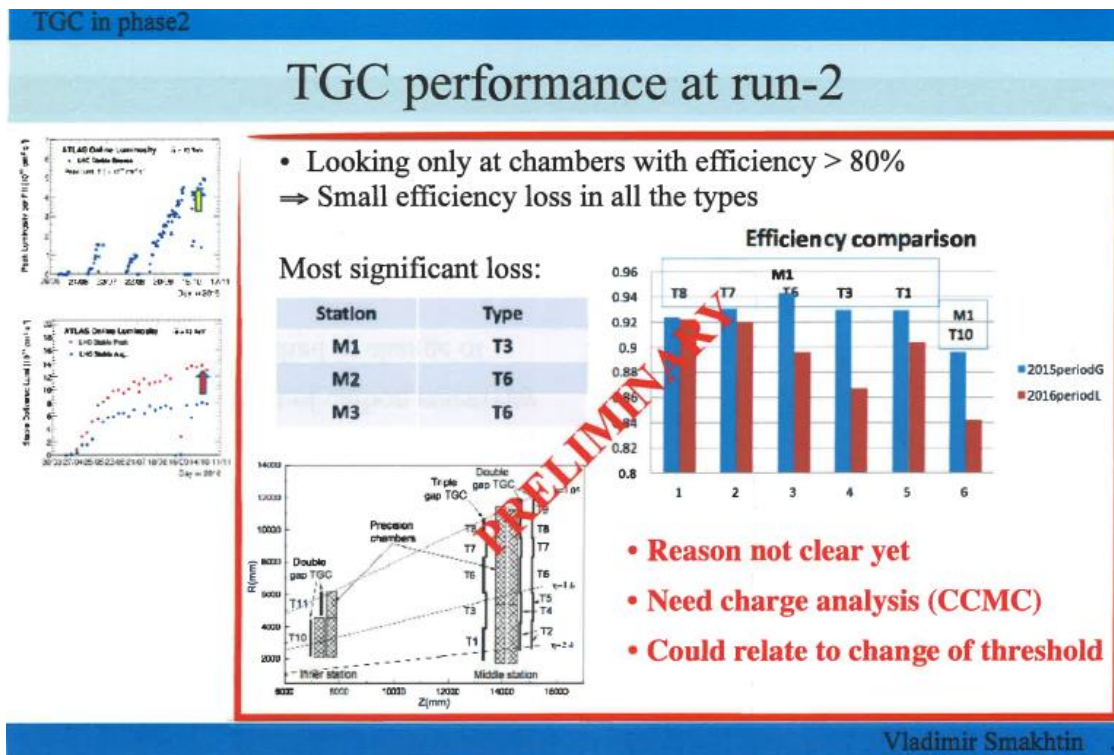
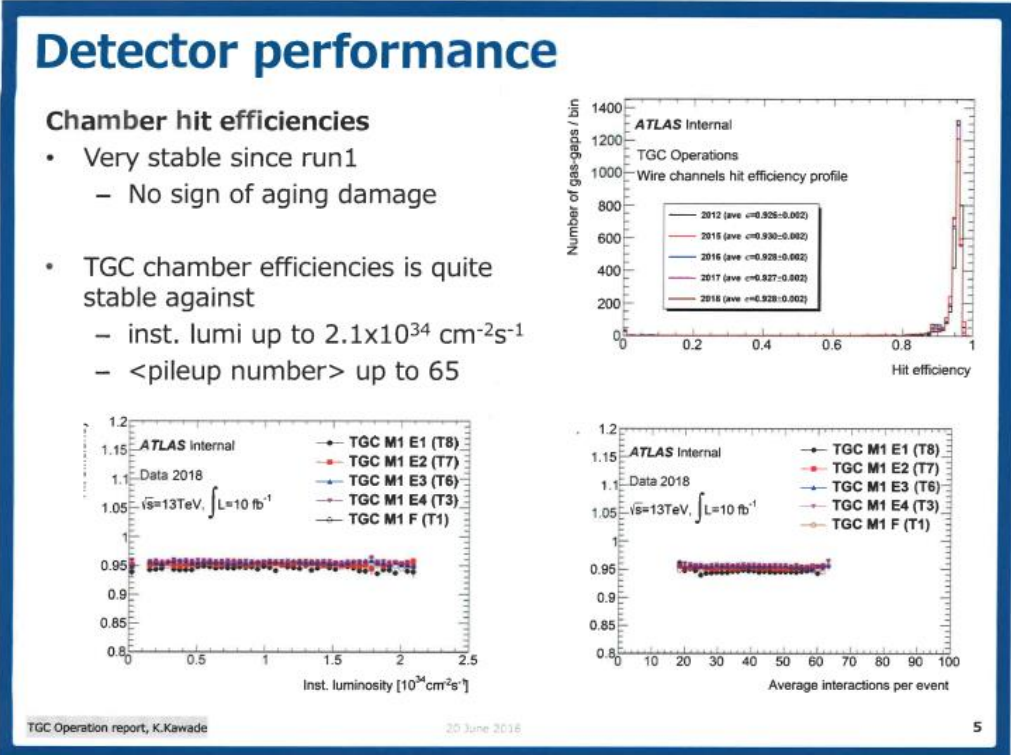
Do not blame on ageing any observed phenomena, without understanding the data being used  
 higher luminosity leads to a higher contamination of low energy particles from material in front

**Analysis of data without momentum cut, leading to wrong conclusion in eff.**

**Analysis of data using momentum cut.  
 No change in detector efficiency from 2012-2018**

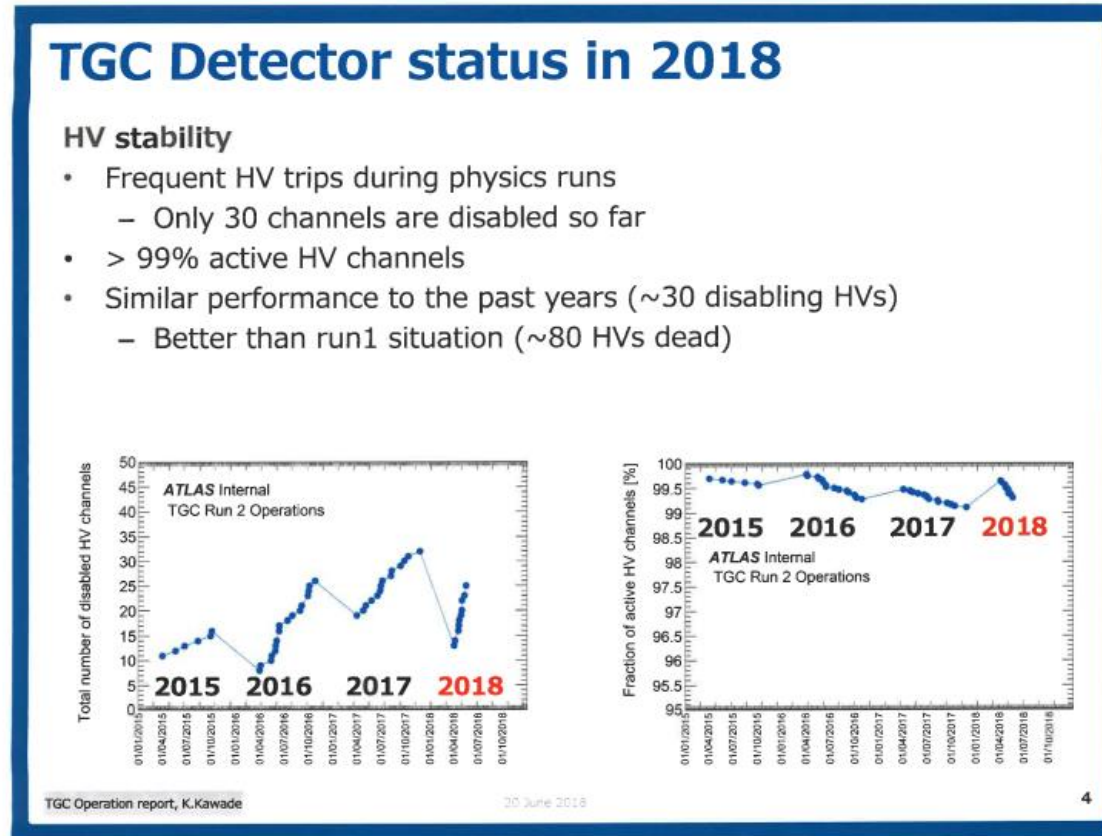
- The strong cleaning effects of n-pentane lead with time to the formation of small bridges of graphite in places where corrections were not properly done, as well as rests of glue with graphite, that charged up with time, leading to HV shorts.
- 35% of these bridges could be burned in an atmosphere of pure CO<sub>2</sub>, while other detectors had to be exchanged.
- These procedure allowed to keep the system operational since 2008 with a high efficiency.
- **But most of these issues could be partially predicted from the start**

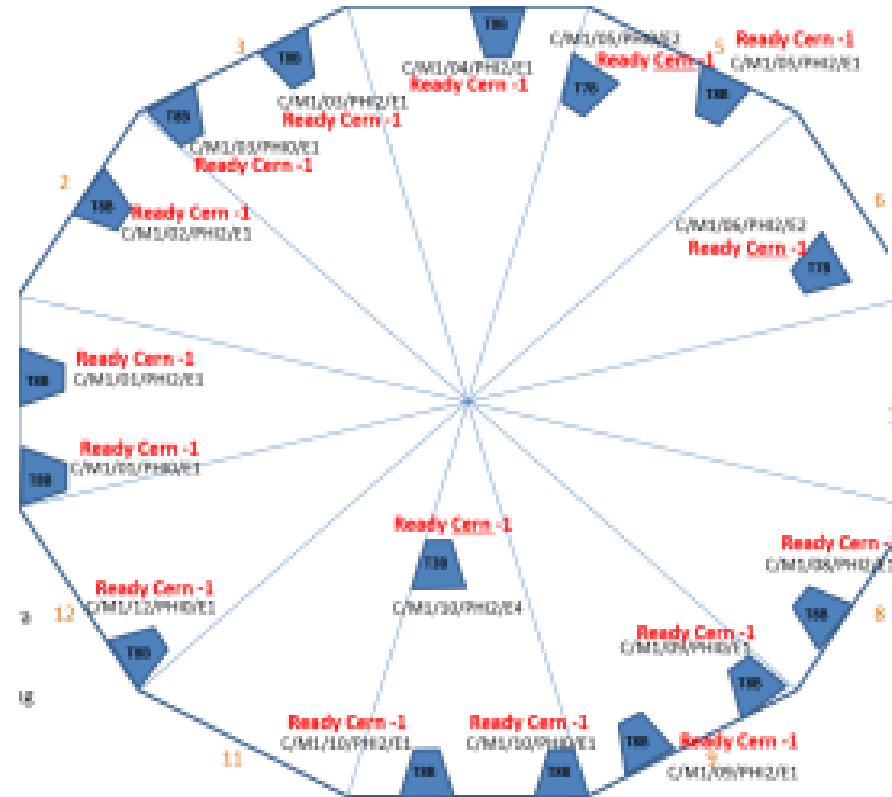
The issues for the detectors to be replaced clearly not related to irradiation but to quality in the construction

- Detectors to be replaced after more than 10 years of continuous operation are the ones that were the least exposed to radiation.
- There is no replacement for a highly qualified technical personnel with understanding of the physical meaning of every step in the detector production. This requires experience and feeling.
