Irradiation effects on GEM detectors operated at RUN1 and RUN2 at the LHCb experiment

M. Poli Lener

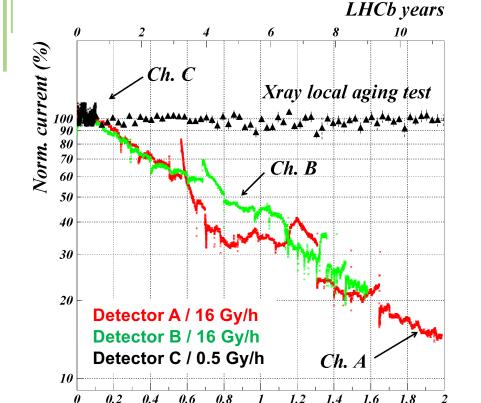
High-irradiated chambers exhibit a drastic current drop during the test

A → -89%

$B \to -80\%$

Chamber C as well as **X-ray** results show no current drops after an integrated charge of **0.16 C/cm²**, while Chamber A & B show Δ G/G ~ -10% after the same integrated charge!

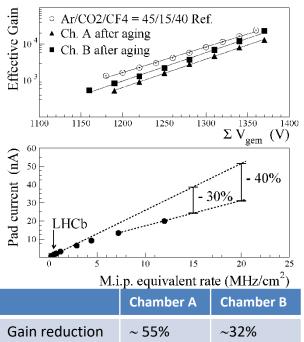
Aged chambers exhibit NO rate capability loss up to ~3MHz/cm² (expected LHCb rate ~0.5MHz/cm²)

Chamber A	Chamber B
Gain reduction	~ 55%	~32%
Rate reduction	~ 30%	~40%
Total reduction	~ 85%	~ 70%

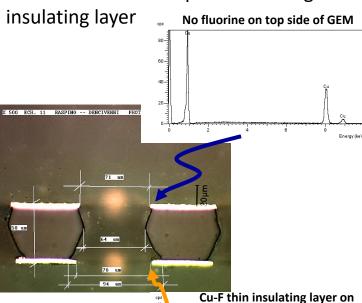
Fluorine etching not only widens the copper hole, but also removes the Kapton inside the hole

Fluorine found on the bottom side of G2 and G3 ⇒ Cu-F compound forming a thin

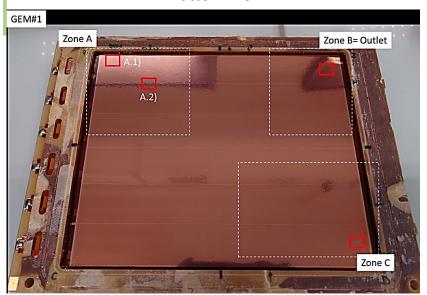
GEM #1 RIGHT analysis

Chemical analysis by EDS on the hole's surrounding areas pointed out **no residue** when approaching the hole's edge Holes and Cu surface are homogenous

Some Cu edges exhibit a molten aspect —

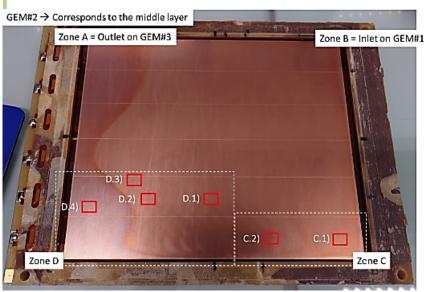
GEM #2 RIGHT analysis

Chemical analysis by EDS on the hole's surrounding areas pointed out a small increasing content of C, N, S (~10%) when approaching the hole's edge

Holes and Cu surface are homogenous

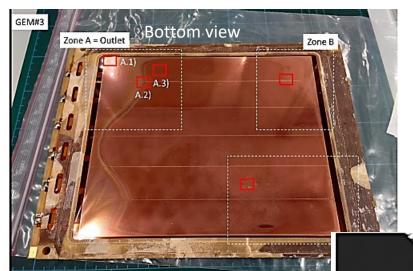
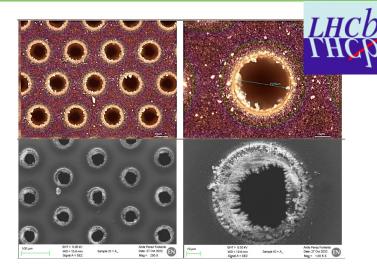
OM and SEM images of the GEM#3 A.2 zone

Micrometric particles are visible surrounding the holes

The hole's edges appear rougher as well as the Kapton into the holes

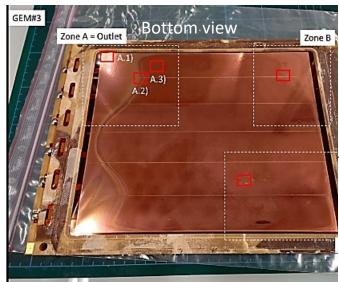
Sulphur residual on the bottom of GEM #3 RIGHT

FIB-SEM inspection confirmed that **the residue** observed on the hole's edges **is also deposited into the hole internal surface** covering the Kapton and modifying the hole's geometry:

- A.1 $^{\sim}$ 2 μ m,
- A.2 \sim 1 μ m,
- A.3 nanometric

- sulphur residual deposit mainly on the third GEM, probably due to the outgassing of the ARALDITE 2012;
- no effect of F-etching on GEM;
 - → No major performance loss observed during LHCb operation
 - → < 100 nA dark current recorded on GEM#3

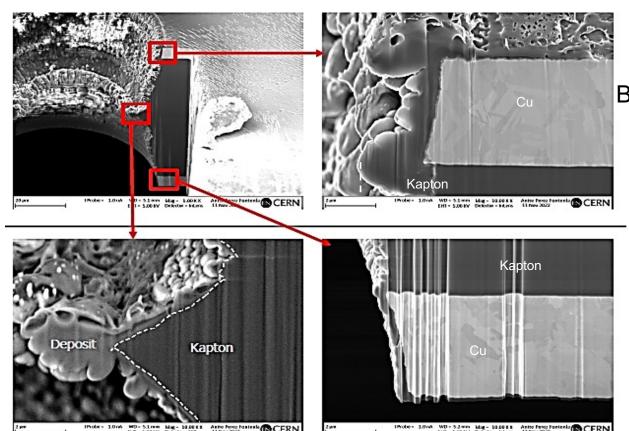
SEM images of the hole cross section on GEM#3 location A.1

Zoom of A.1 hole inside the stained area of GEM#3

A thinner deposit at the bottom of the hole suggests a potential direction of the flow contamination

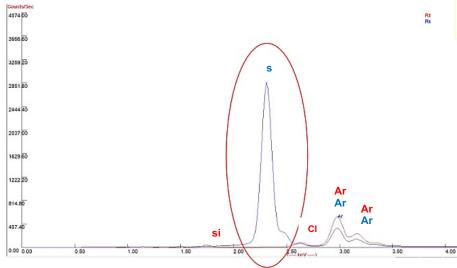
Search detection sulphur on ARALDITE 2012

The XRF analysis highlight presence of sulphur on the ARALDITE 2012 unlike sample 1 (*).

Material Safety Data Sheet shows that the molecule 2.2' used for the hardener was composed with thiol chemical function (R-SH): the sulphur can come from it because during the reticulation polymerization the sulphur remains present in the compound's skeleton
