# **RD50-MPW3 NOISE MEASUREMENTS**

02/02/23

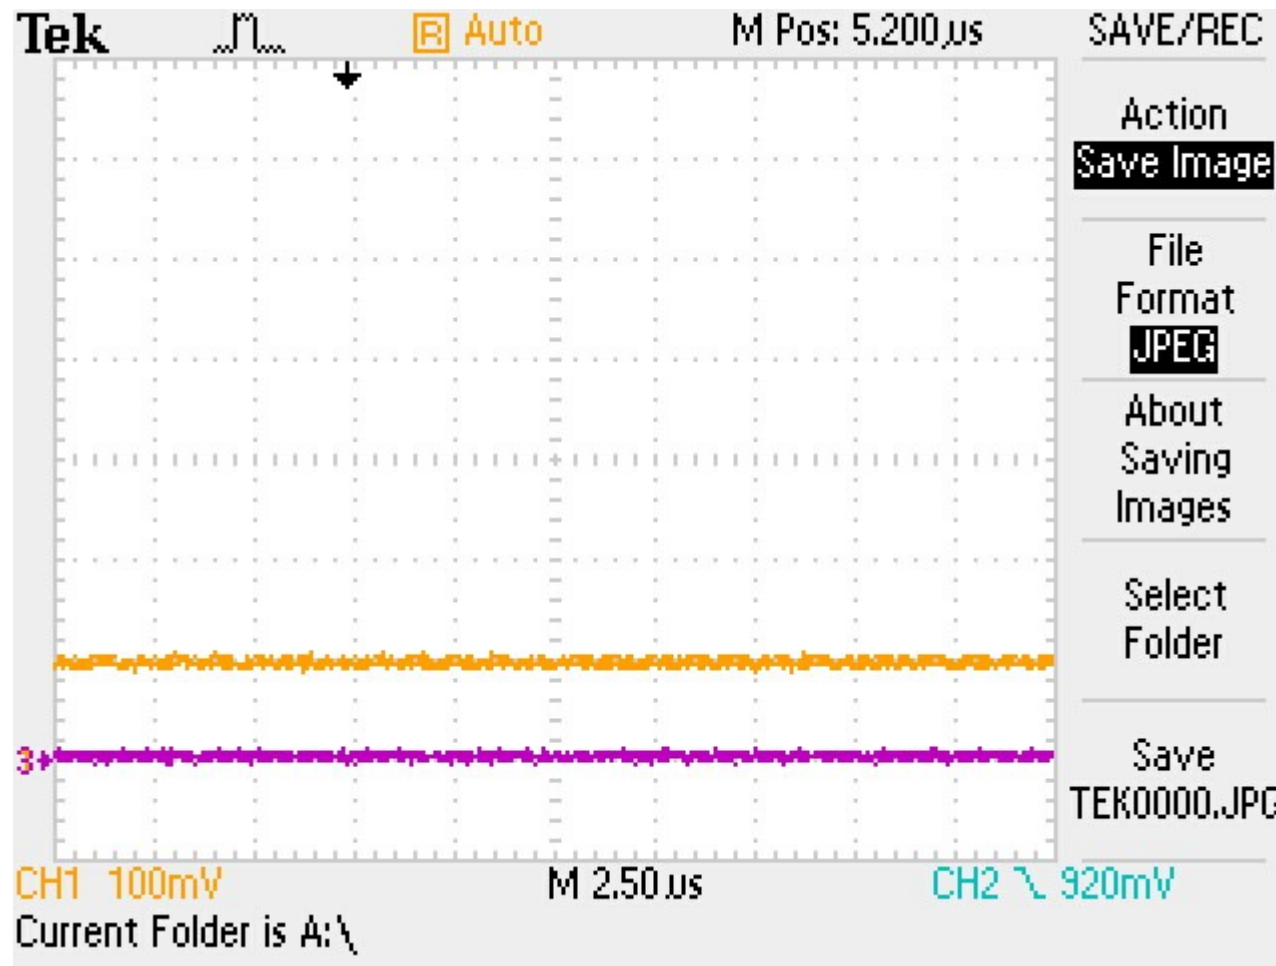
- Compout = purple
- SFOUT = yellow
- DC offset of SFOUT  $\approx$  100mV

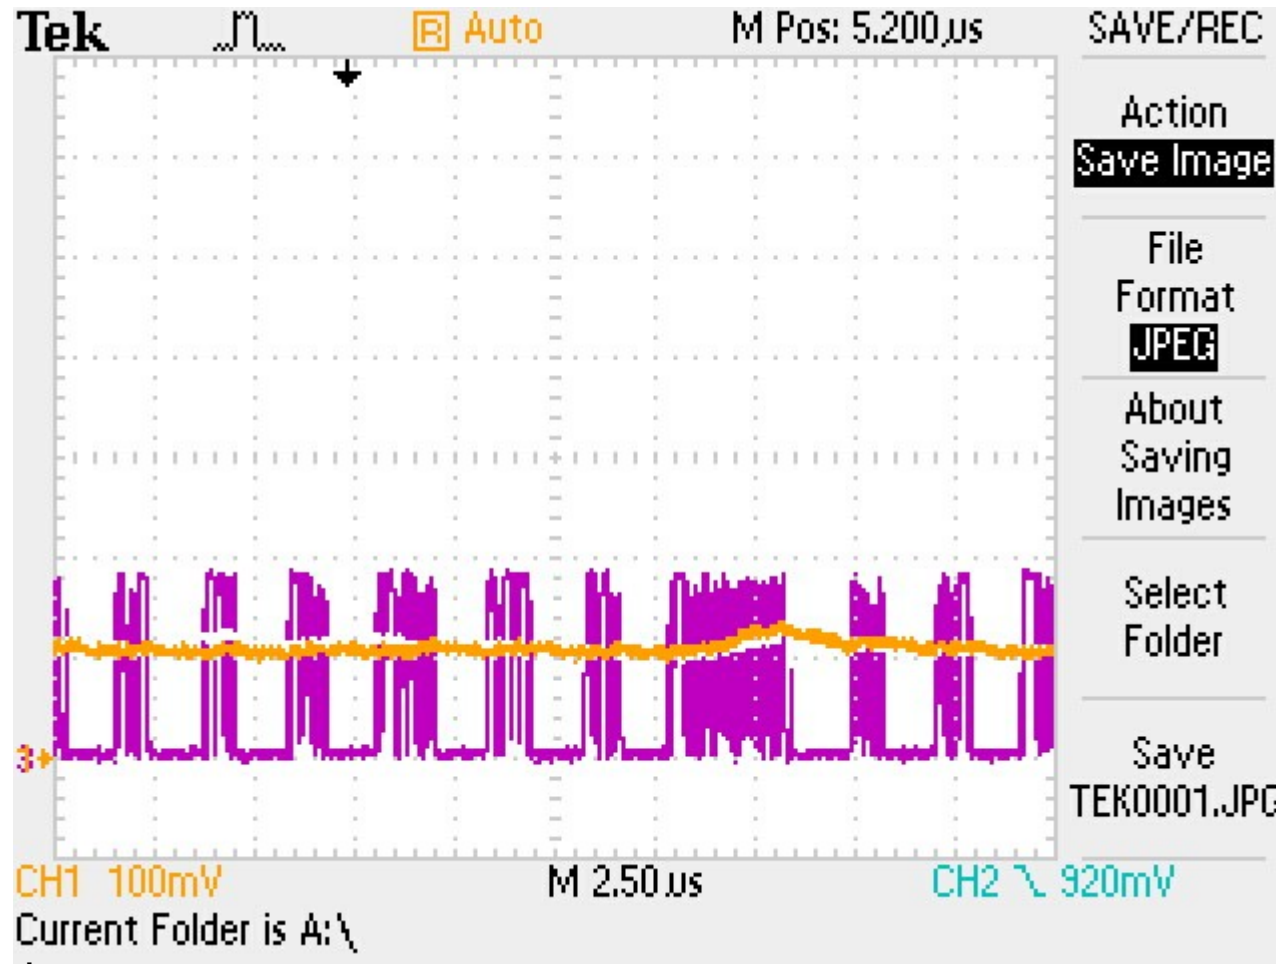
- Compout = purple
- SFOUT = yellow
- DC offset of SFOUT  $\approx$  100mV (no significant change but some “charging” of SFOUT during comparator activity)

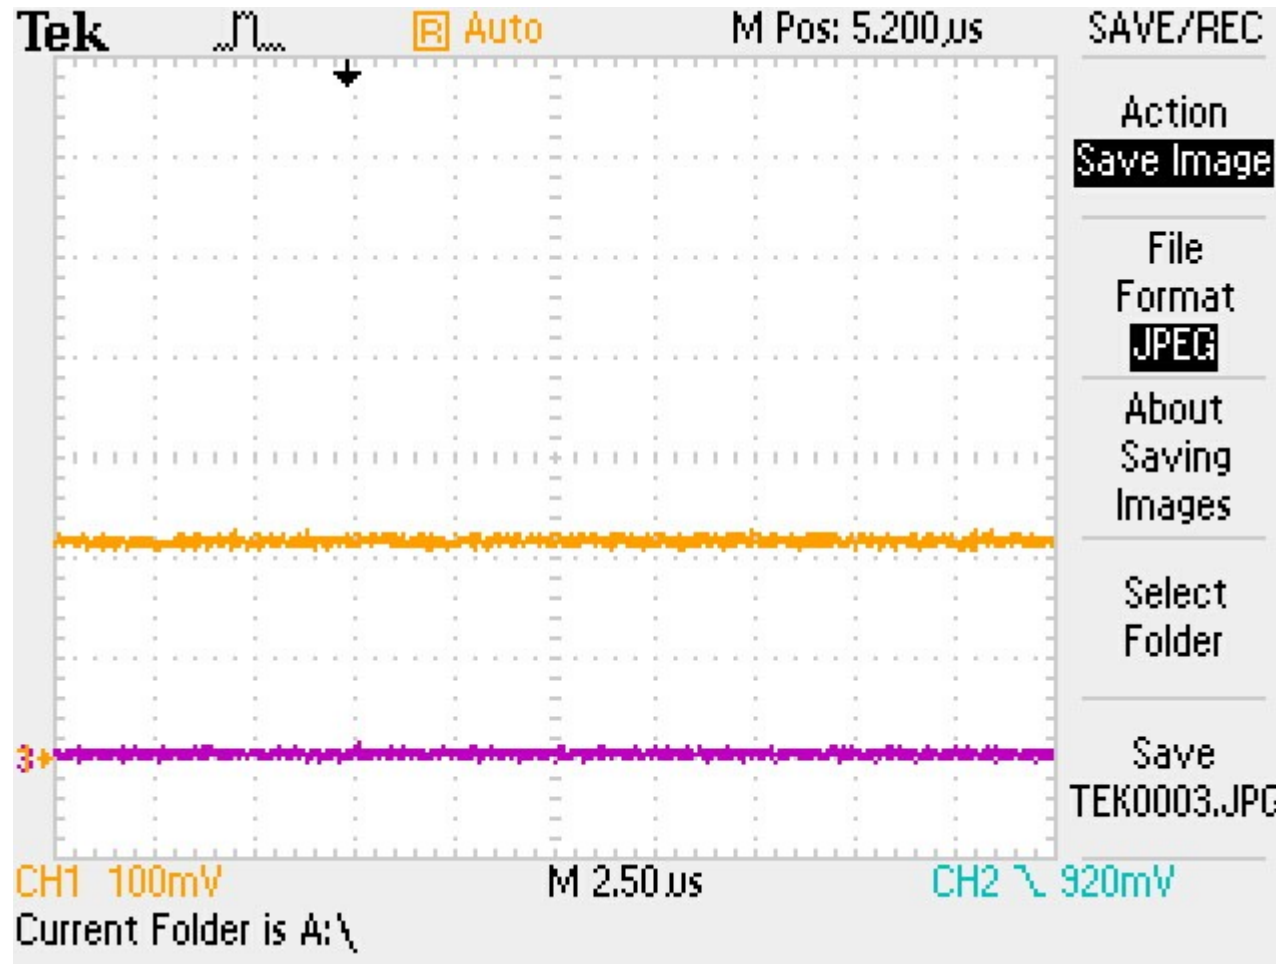
- Compout = purple
- SFOUT = yellow
- DC offset of SFOUT  $\approx 220\text{mV}$  (increase in offset compared with no clock)

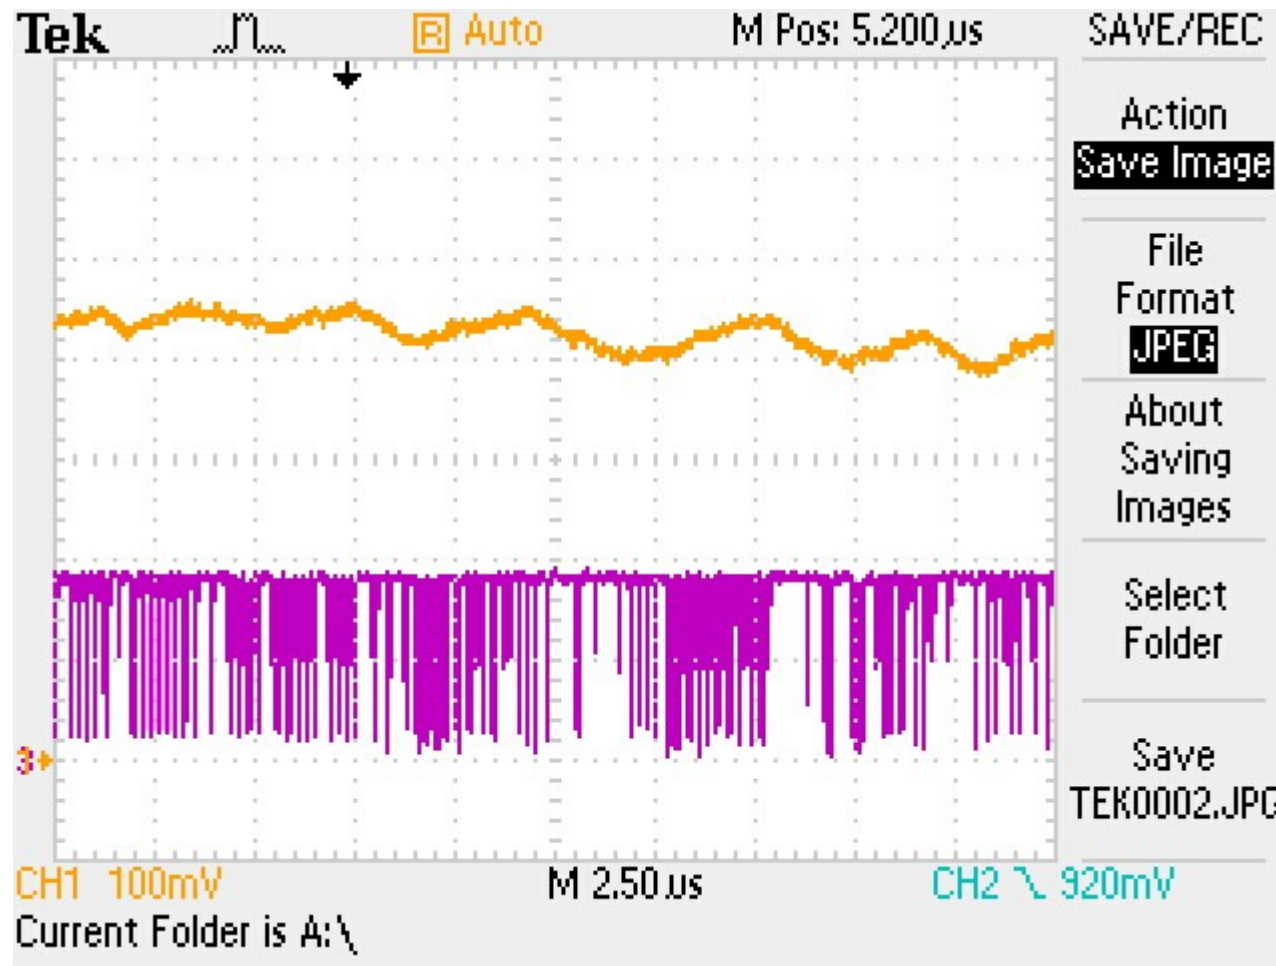
- Compout = purple
- SFOUT = yellow
- DC offset of SFOUT  $\approx$  420mV
