233rd Meeting of the Machine Protection Panel - Join meeting with the Collimation Working group

LHC topics

March 10th, 2023, via Zoom

LHCb VeLo vacuum recovery and vacuum safety system for 2023 (R. Ferreira)

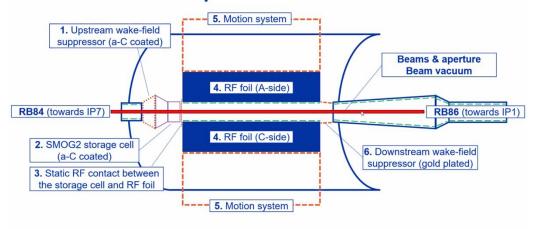
VELO interfaces important for risk assessment

The impacts concern the possible deformation of the RF contacts upstream and downstream of the RF foil (see figure):

- (1) The upstream wake-field suppressor is not expected to have been affected by the incident.
- (3) The foil contact part has no loose part and is not expected to have been affected.
- (6) The downstream wake-field suppressor offers the possibility to be visually inspected through the downstream viewport. It appears that it has not been affected.

The deformed RF foil shape (as simulated) does not present an issue for the machine impedance. The probability to have a loss of a significant amount of RF contacts due to the incident is low.
