Machine Protection Panel Meeting

Analysis of the LHCb VELO RF Foils Incident and First Actions

Rodrigo Ferreira | rodrigo.ferreira@cern.ch

On behalf of the **TE-VSC** Group

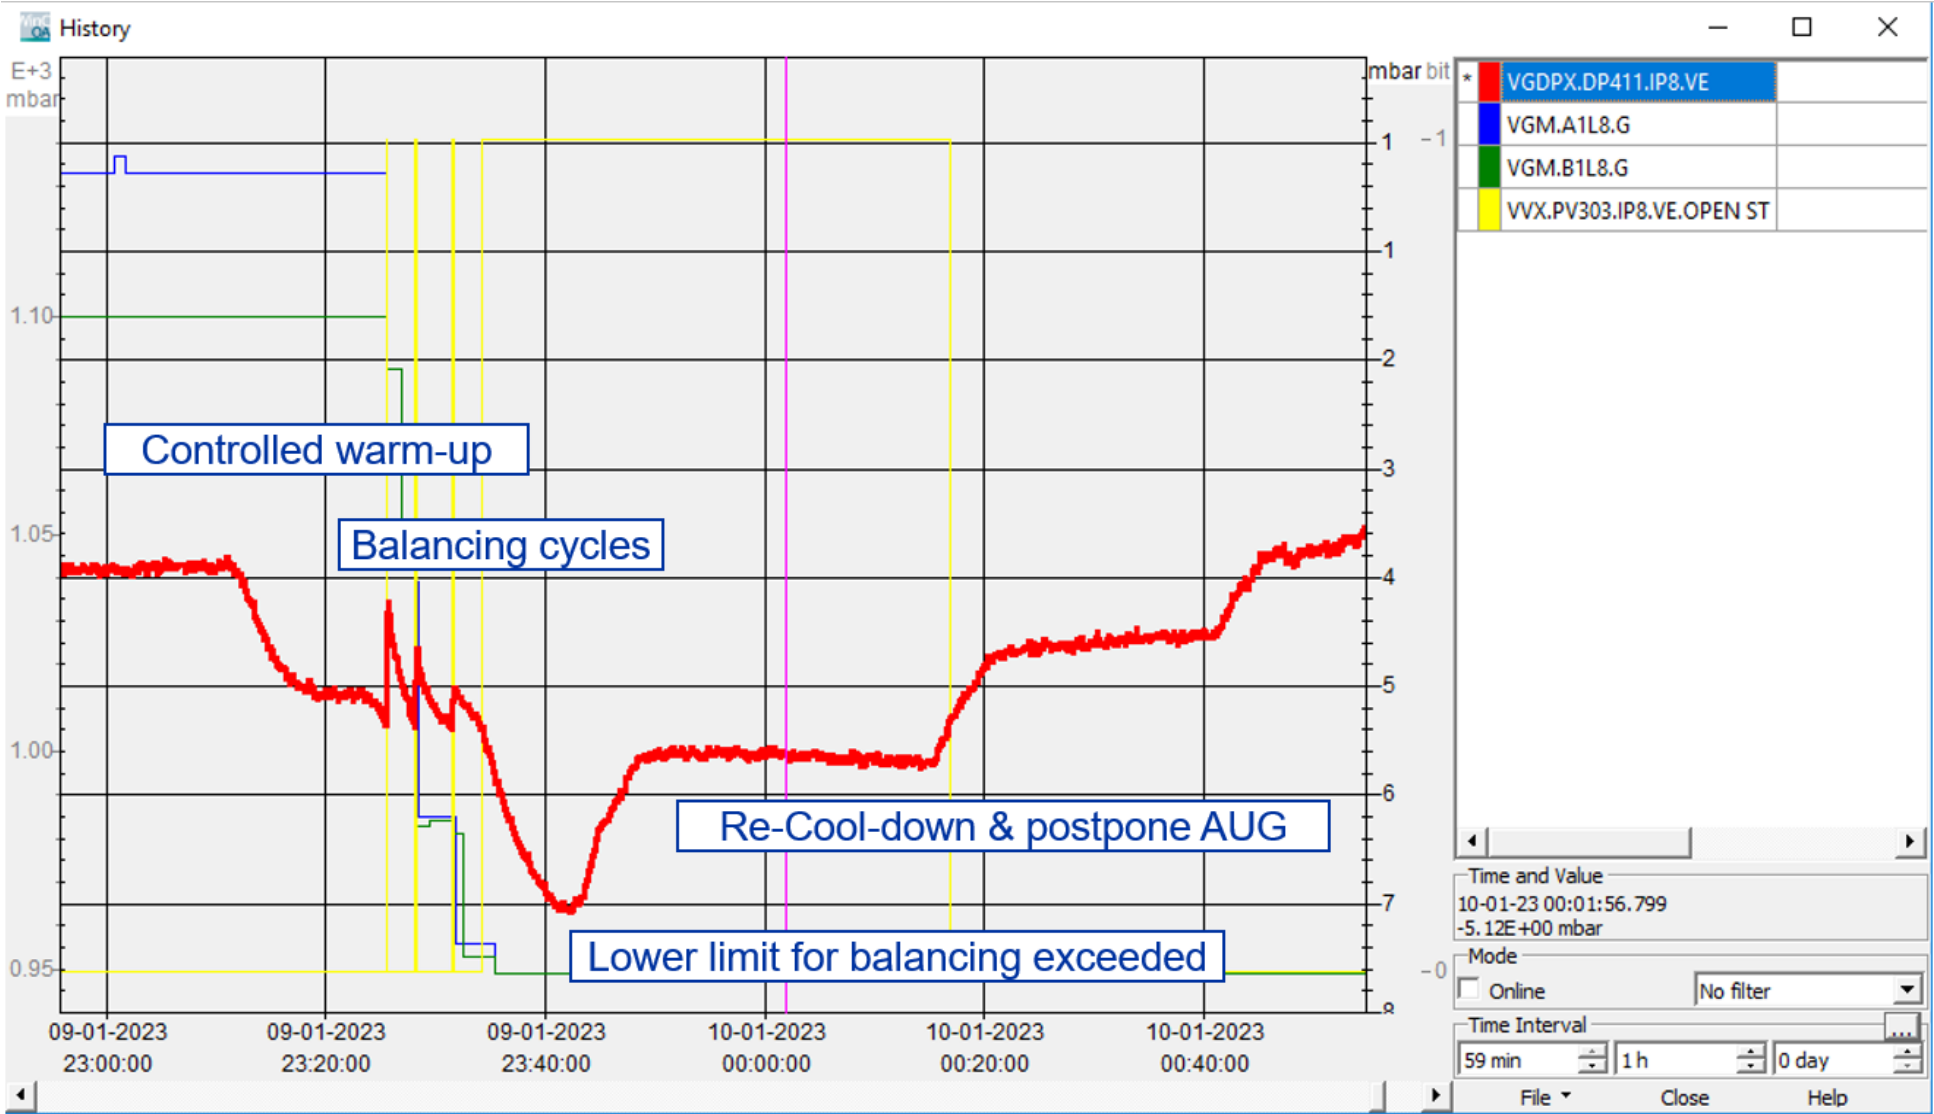
- It was verified that the warmup of the Detector Volume caused a pressure increase that the Balancing System cannot cope with (at the current pressure setting on the injection line)
- Quantity of gas needed to compensate DP on the Beam vacuum volume (injected by the balancing process) requires manual readjustment of the manometer setpoint on GIS neon bottle (which can only be done on-site by a VSC expert)
- TE-VSC requests to stop the warm-up, revert the temperature and wait for the morning.
- TE-VSC requests the postponing of AUG tests planned for the morning of 10/01/2023. LHCb VELO team agrees and will propagate the message towards the LHCb TC.

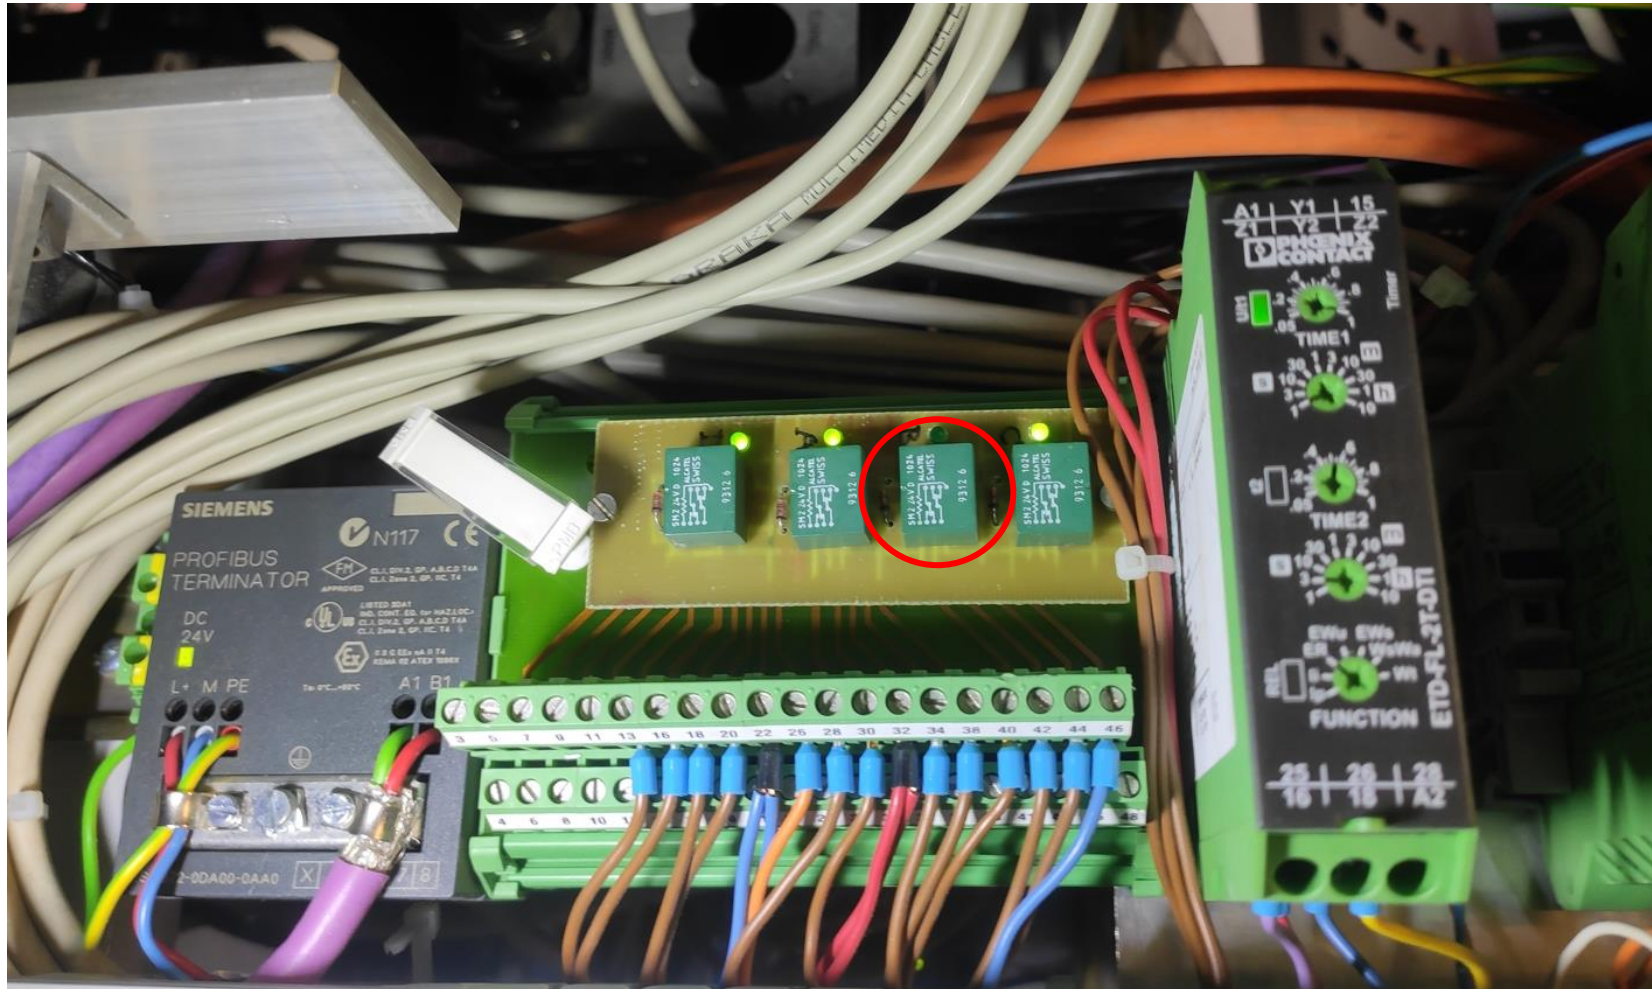
- Differential pressure hits the threshold of the pressure switch used in the Safety System (10 mbar by specification, but around 9 mbar in reality).
- At this point the Safety System should have opened the Overpressure Safety Valve. In reality, the relay used to read the pressure switch is faulty (a hidden failure, only detectable by proof testing) and short-circuits the power supply.
- The combined resistance of the wiring (around 5 Ohm) is high enough that the power supply does not totally shutdown but the voltage drops from **24V** to **9.8V**.
- Due to the failure of this relay the safety system fails to actuate the safety valve and equilibrate the pressure differential between the two volumes (the closed pressure switch status is never read).
- Additionally, the low voltage of the power supply causes a second problem in the control system.

Safety System Relay Assembly (faulty relay marked in red)

- Measuring of line voltages and inspection of mechanical and opto-relays – **Power Supply issue identified.**
- Disconnection of all pressure switch cables – **Root cause of failure identified as OS413B relay short circuit.**

1. **Add redundant power supplies** and a redundancy module that allows pre-emptive detection of individual equipment failures.
2. **Introduce a precise, reliable way to detect power supply failure** by adding a line voltage monitoring relay with a configurable threshold (rather than simply actuating a relay with an arbitrary operating voltage).
3. **Re-implement safety system logic** using SIL3 rated **Safety Relays** (rather than the existing homemade solution with signal relays and hand-soldered wires).
4. **Replace existing time-relay** (discontinued) with a modern version for which spare parts can be acquired.

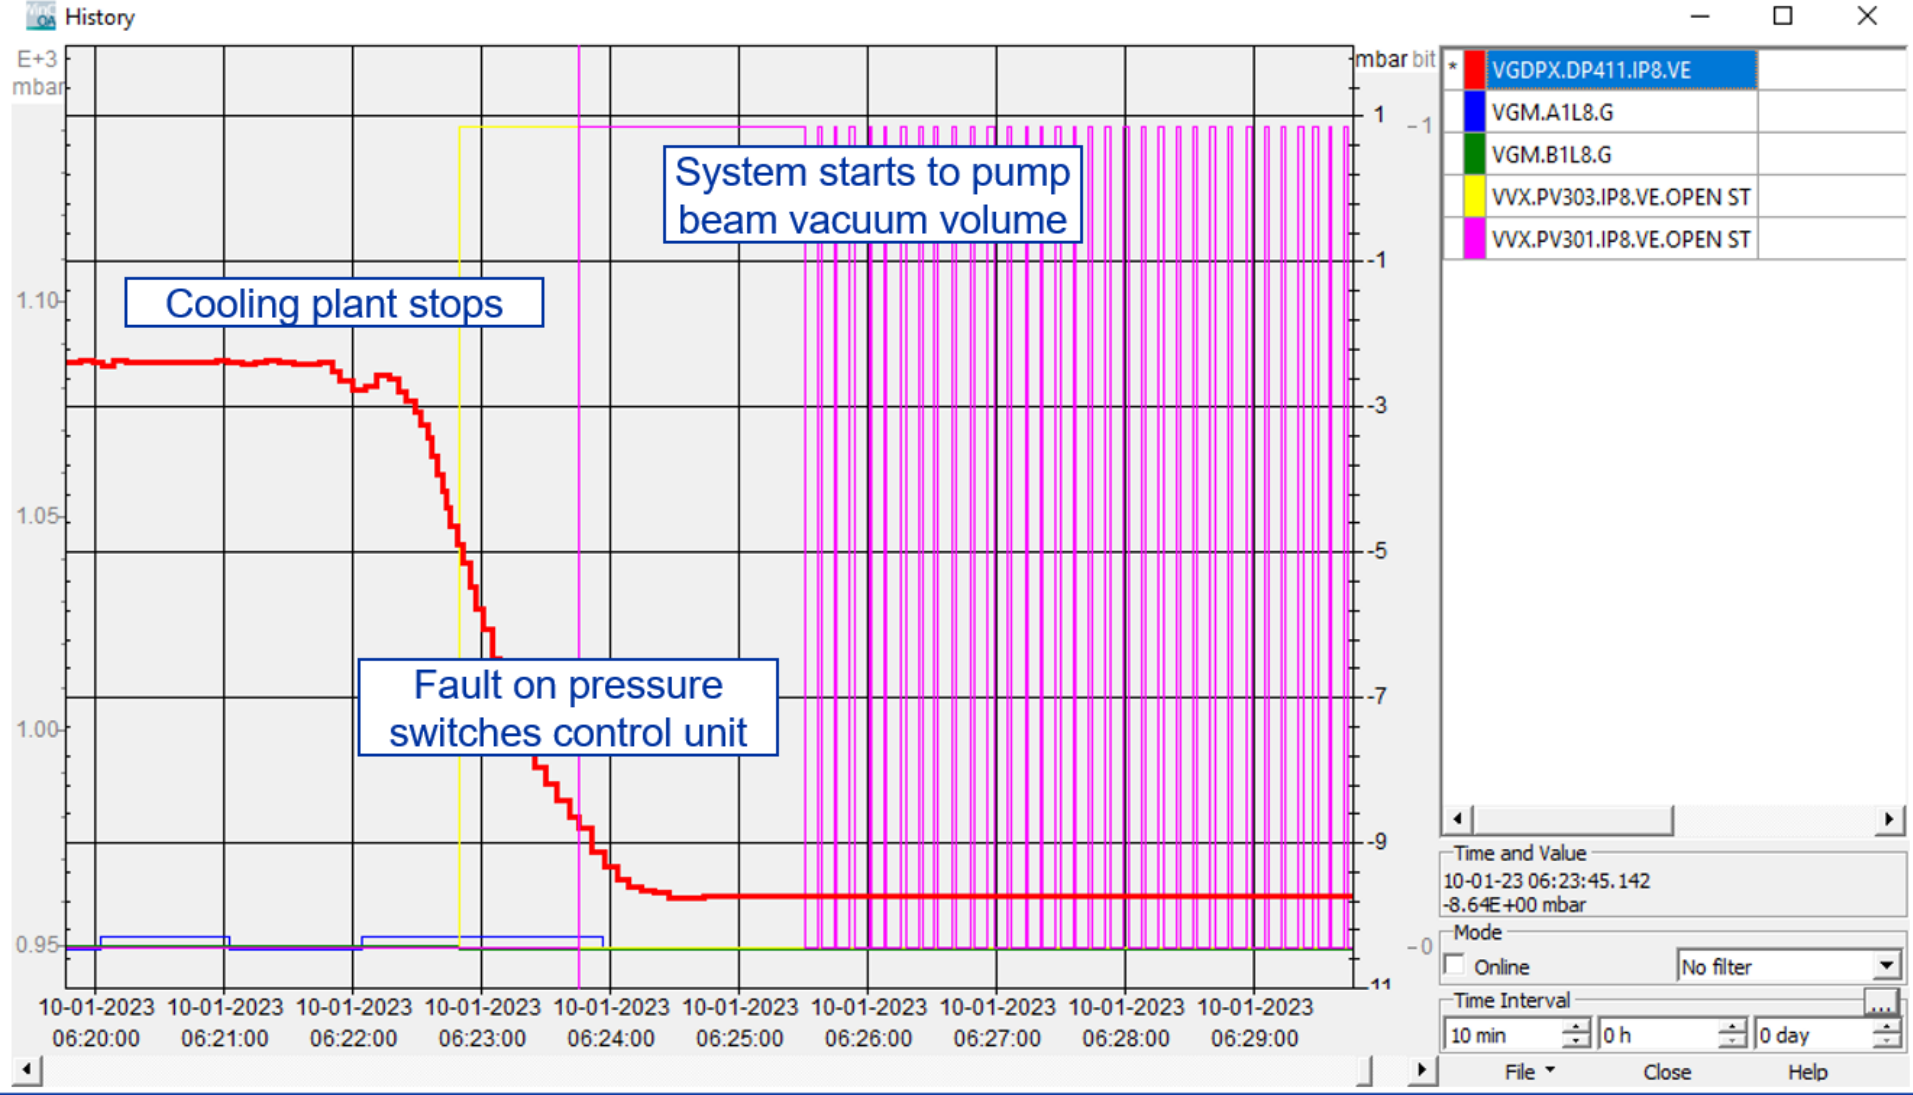
The balancing system acts according to what it sees: it proceeds to pump the beam volume in an effort to equalize a perceived differential Beam **overpressure** (while in reality it is the Detector volume that is **overpressurized** due to the uncontrolled warmup of the detector volume).

- Differential Gauge reading freezes (for an unknown reason, given that the differential pressure continued to increase and the gauge is rated at -133/133 mbar)

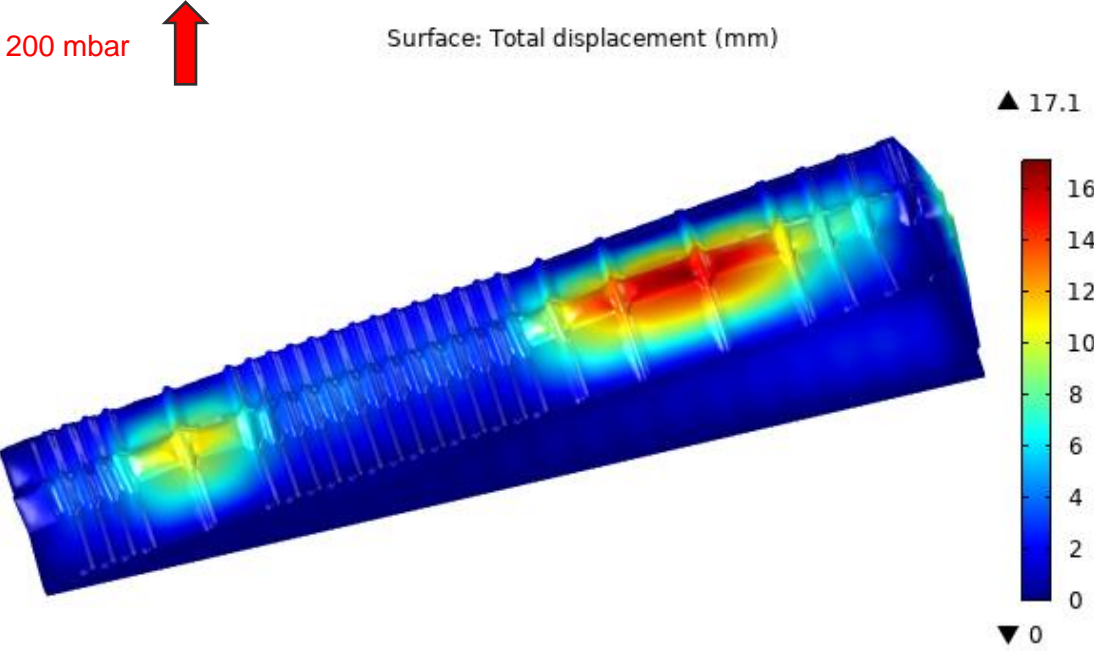
- The deformation was estimated by highly non-linear, elasto-plastic FEM simulations (for more details see EDMS 2820818)
- The simulations are in good agreement with specific tests performed at Nikhef labs on a short RF foil up to 200 mbar
- The 200 mbar pressurisation led the VELO RF foil to 'inflate'

A maximum total deformation of around 17 mm is expected in the most flexible area (less ribs) at 200 mbar.

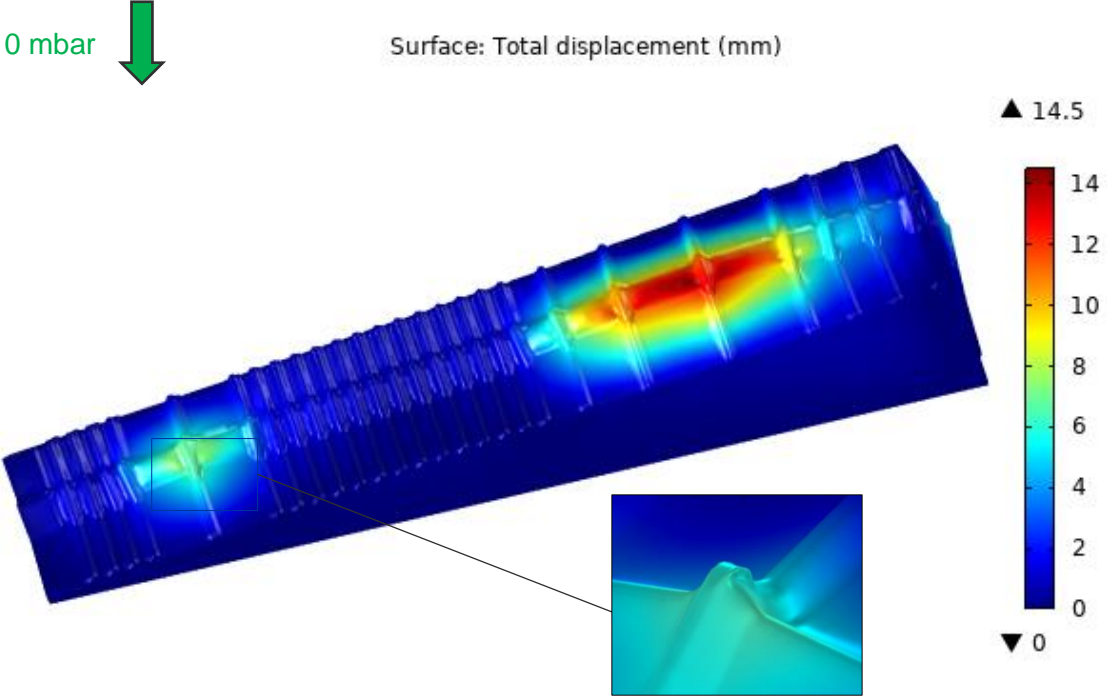
A residual total deformation of around 14 mm is expected in the same area when the pressure returns to 0 mbar. Local instabilities are present in the ribs (verified by experiments).
