PSB Quadrupole

A. Newborough, M. Karppinen

PSB Main Quadrupole Magnets

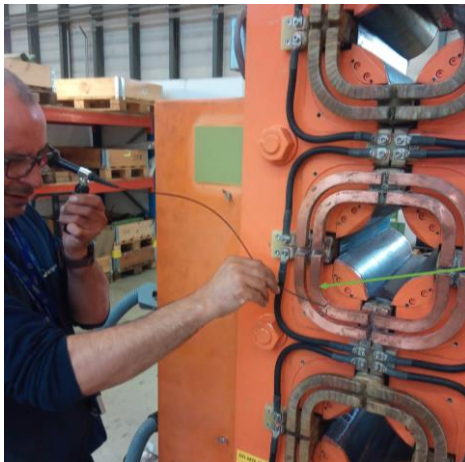
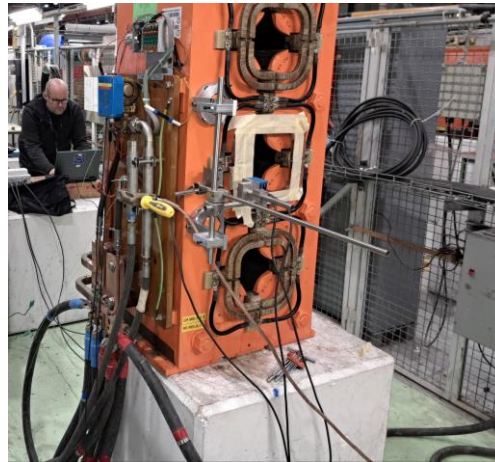
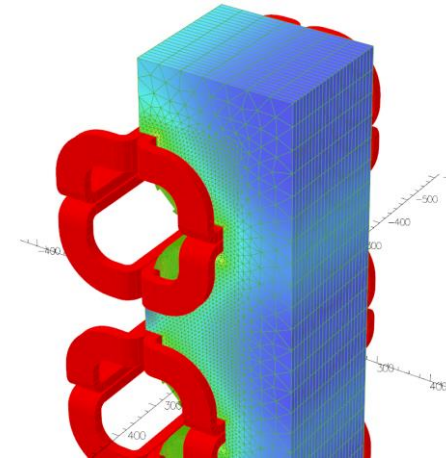
- Ultrasound (EN/MME) and endoscope (TE/MS) inspections have not identified any erosion of the cooling channel or original brazed joints, further checks will be made on the QDE5 magnet once removed from the machine.
- SEM analysis (EN/MME) of the brazing confirms Ag-Cu-P brazing including traces of Cadmium material (which is a typical brazing filler to avoid flux).
- Simulations show a modest force (~ 250 N) on the coil and brazed joint, measurements on the spare (repaired QFO91) magnet show no movement during the magnetic cycle.
- Investigation will continue with the QDE5, but clear priority is to make the magnet operational.

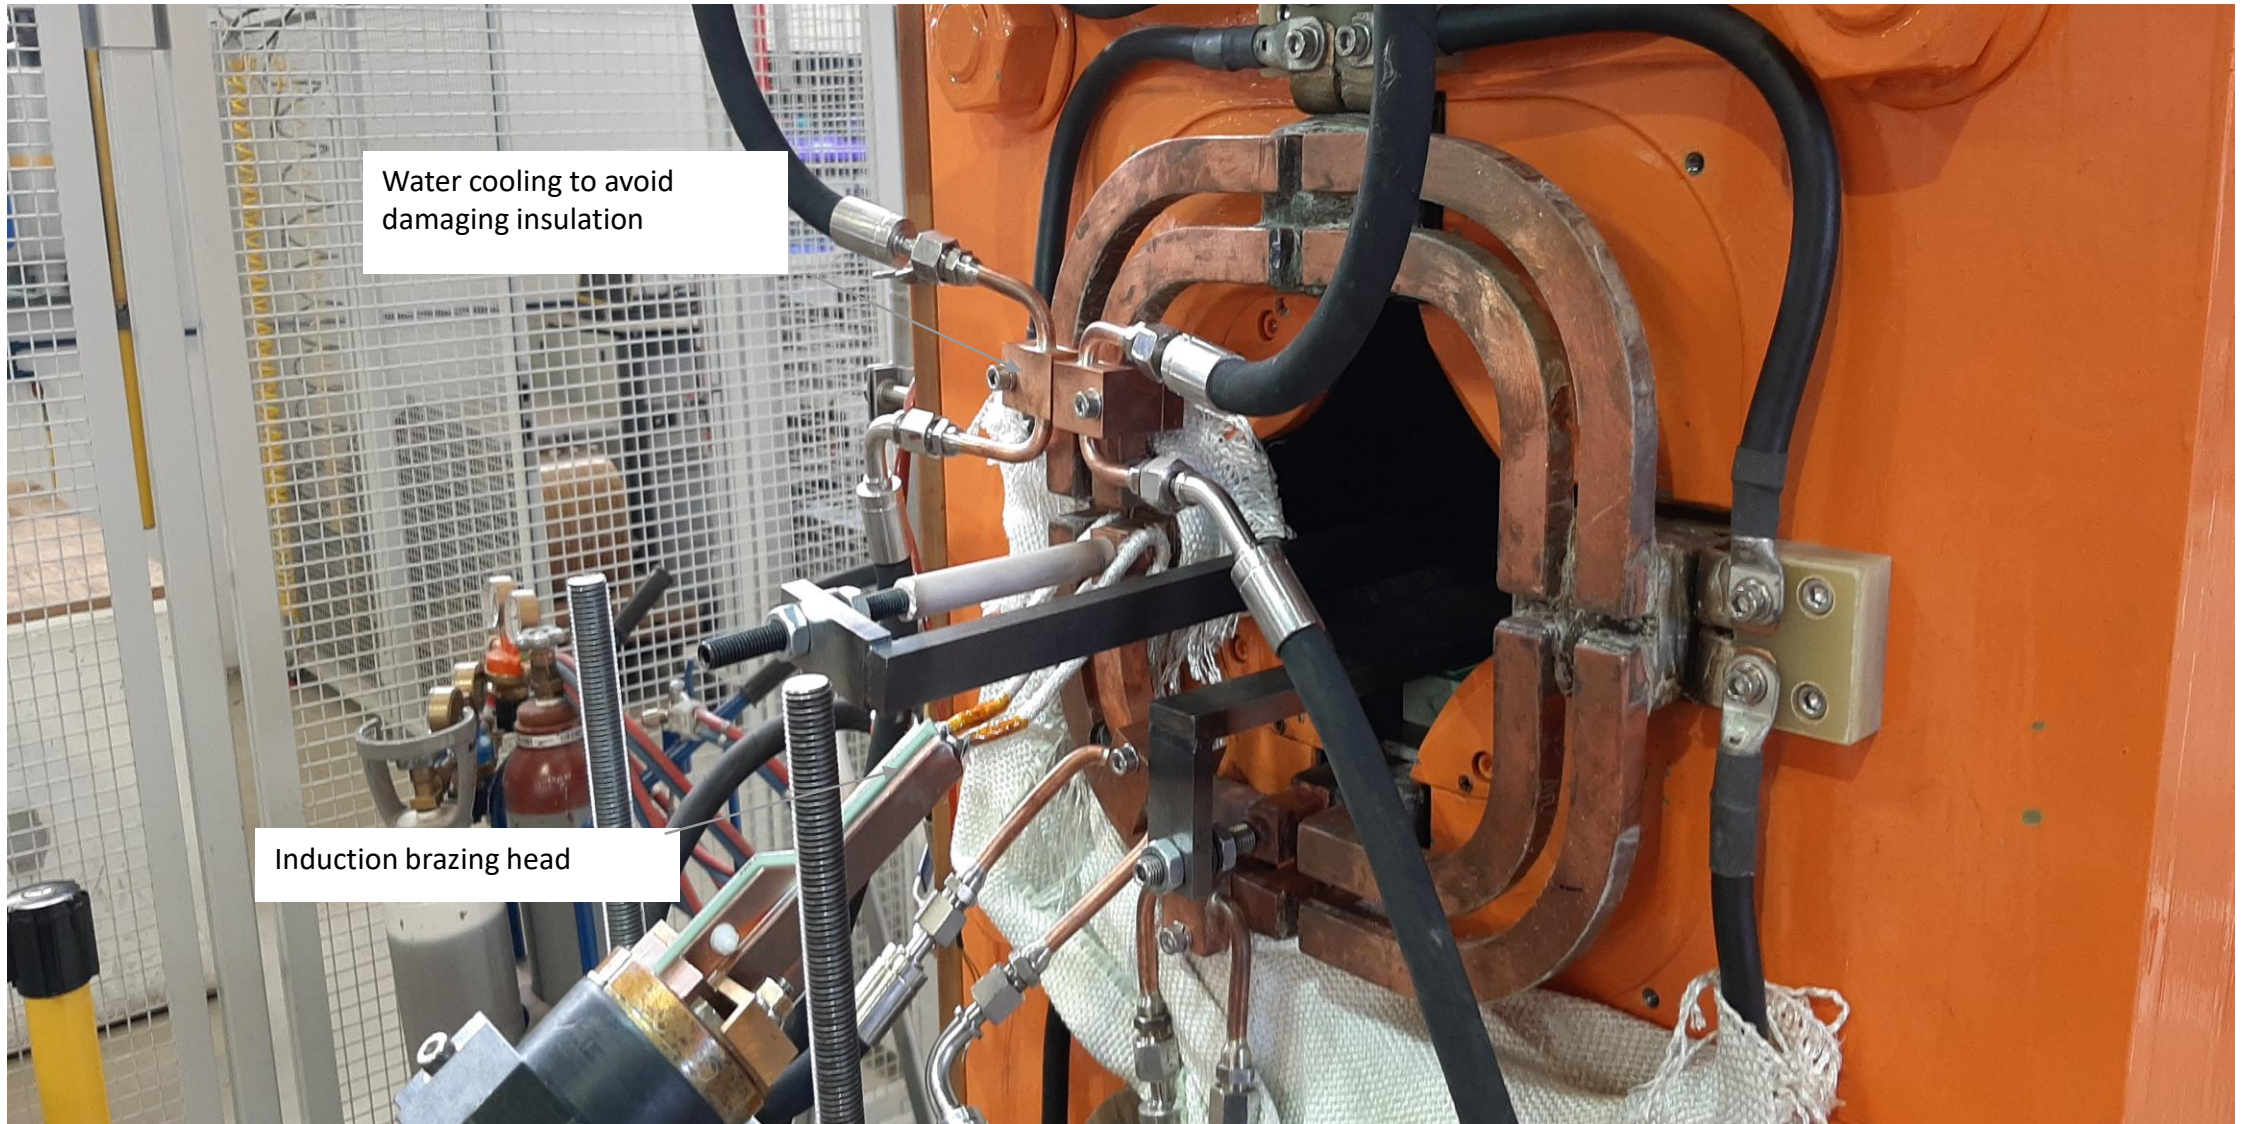
Water cooling to avoid
damaging insulation

Induction brazing head
