PS Booster magnets Task Force

Today's understanding of the failure modes

Meeting 1 – 21.03.2023 – Subtask-2: Analysis and understanding of the failure modes

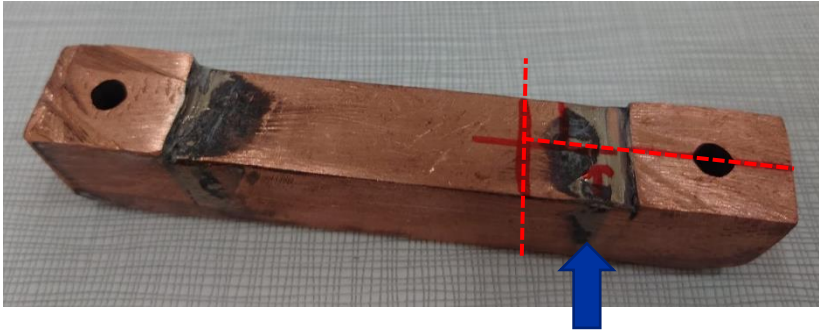
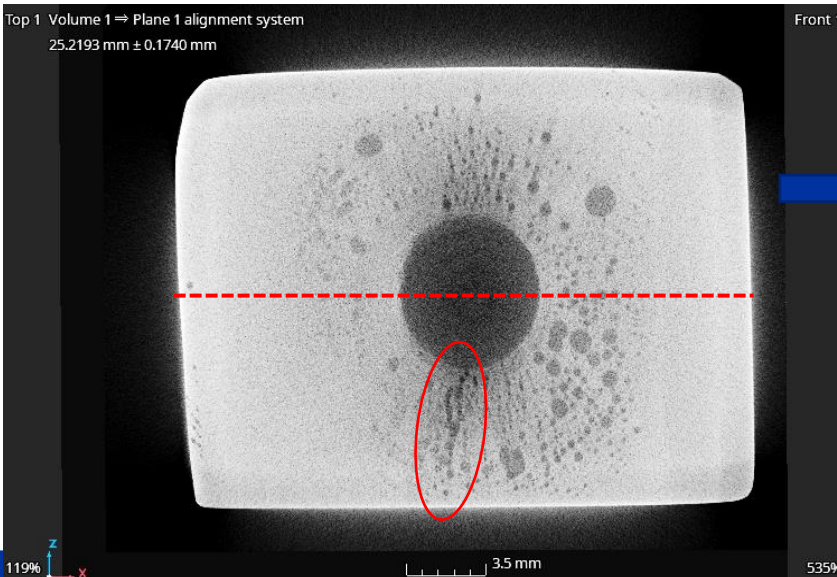
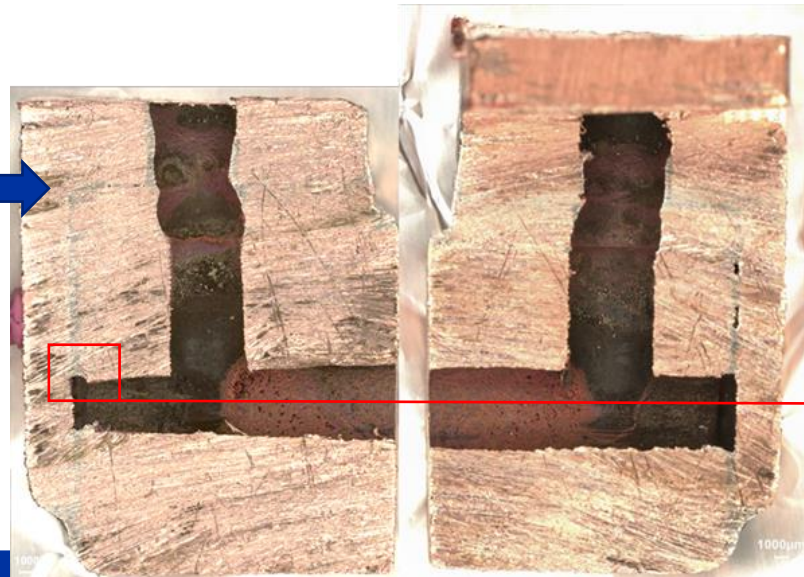
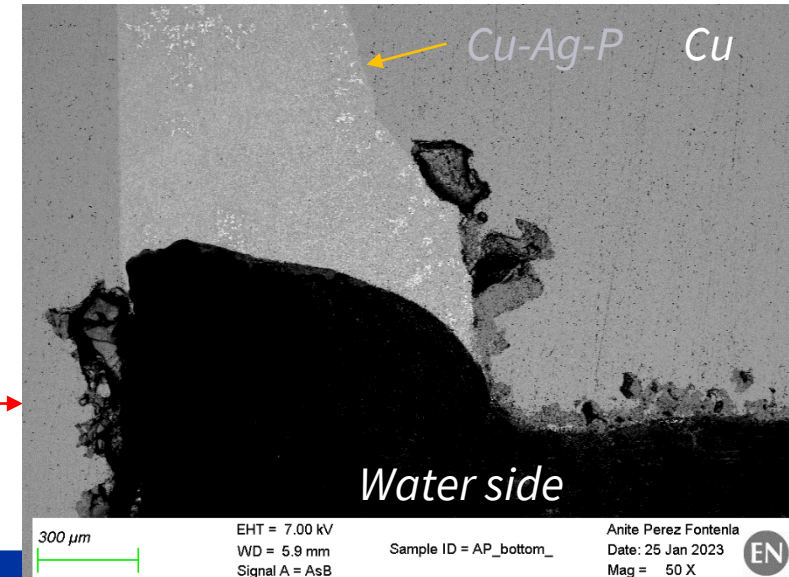
**Sample #1: Non-leaking joint
From PSB main quadrupole
50 years in service
EDMS 2817755**

1. NDT (voxel size= 21 μm)
 - Brazing interfaces present numerous cavities and discontinuities
 - Radially aligned features are clearly visible
2. Chemical analysis:
 - Cu-Ag-P braze metal is confirmed and Cd traces (?) were detected punctually
 - S is univocally present locally on the corrosion products (up to 5.5 wt. %)
3. Microscopic examination:
 - The bulk Cu is attacked and large gaps are visible at the vicinity of the brazing alloy
 - The oxidation of the Cu phase within the braze material varies depending on the area
 - It is likely that the Cu has been selectively corroded due to galvanic corrosion phenomena

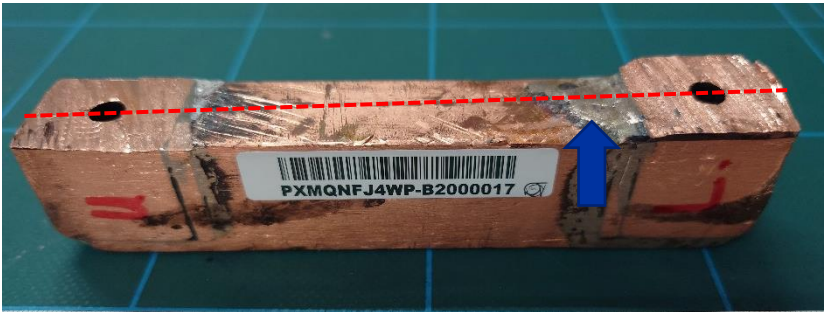
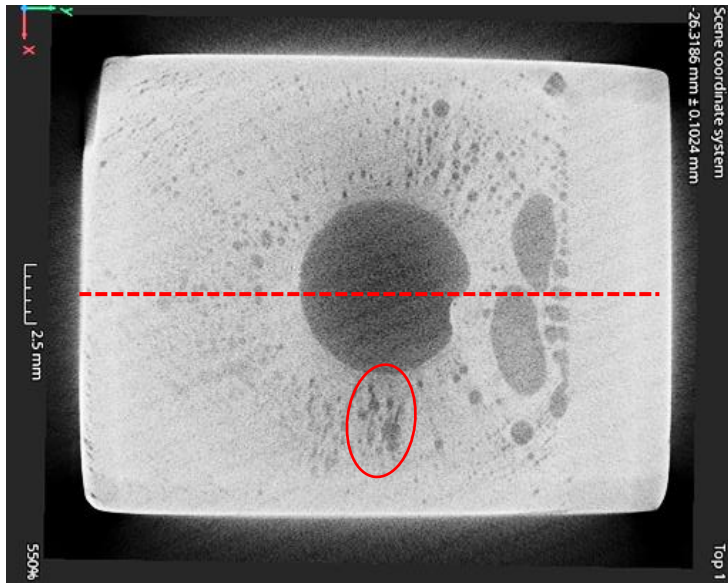
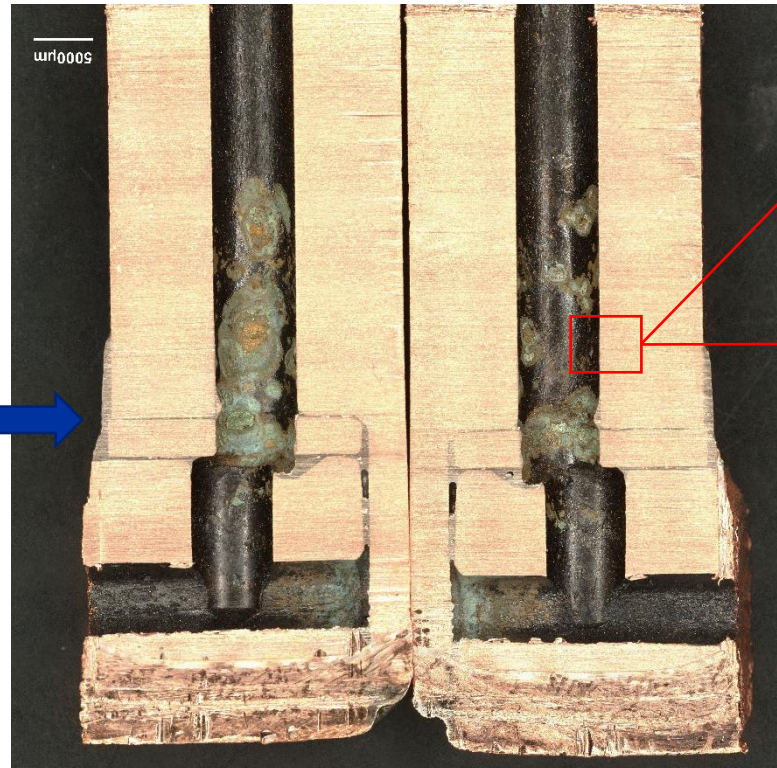
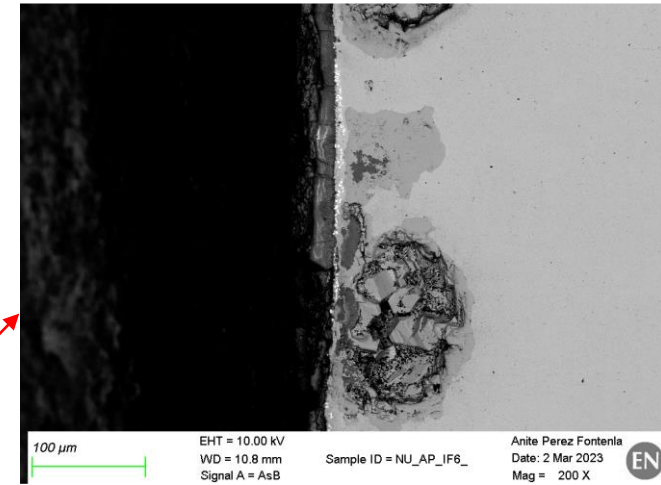
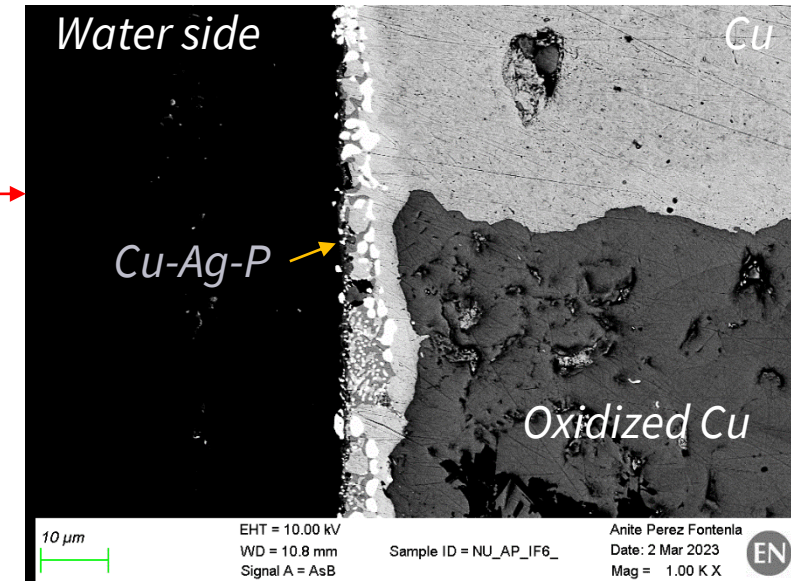
**Sample #2: Non-leaking joint
From PSB main quadrupole
2 weeks in service (2022)
EDMS 2855110**

1. NDT (voxel size= 21 μm):
 - Brazing interfaces present numerous cavities and discontinuities
 - Radially aligned features are slightly visible
2. Chemical analysis:
 - Traces of “S” well below 1 wt. % \rightarrow much lower than samples that have been in service for longer periods
3. Microscopic examination:
 - Same type of corrosion phenomena
 - Lower progression

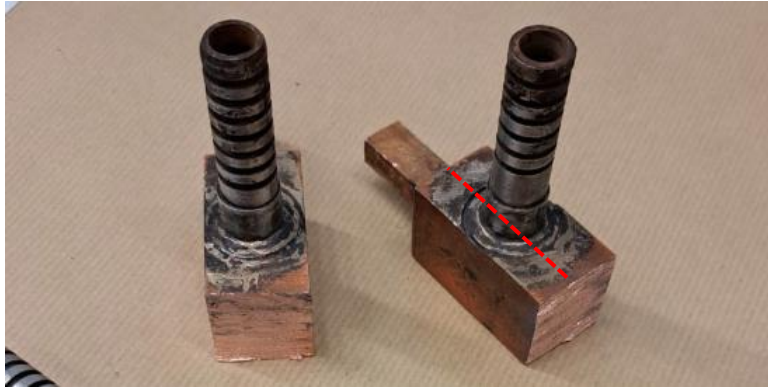
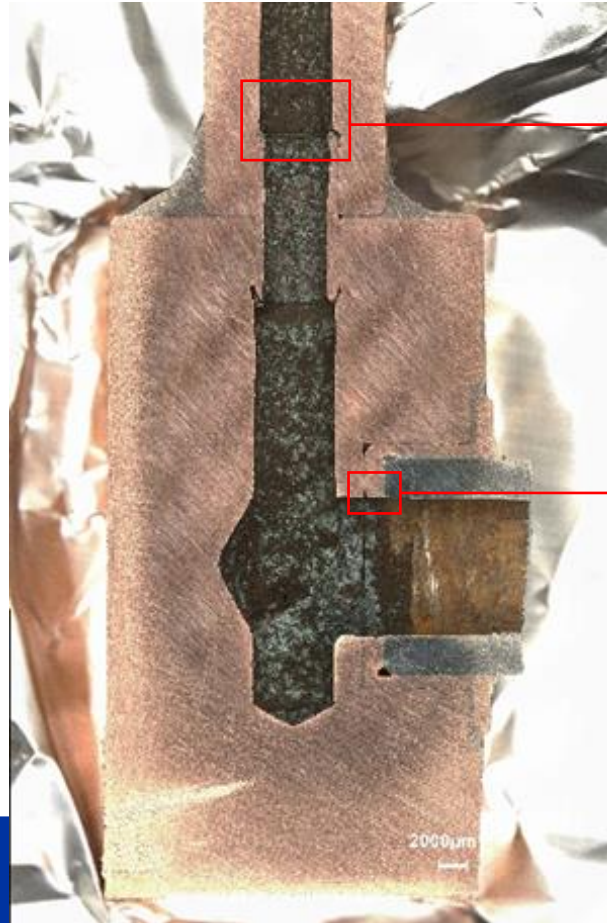
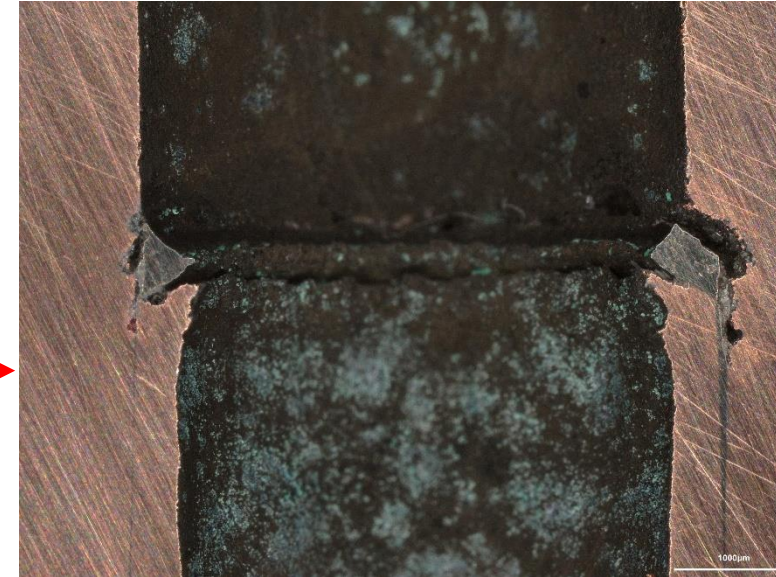
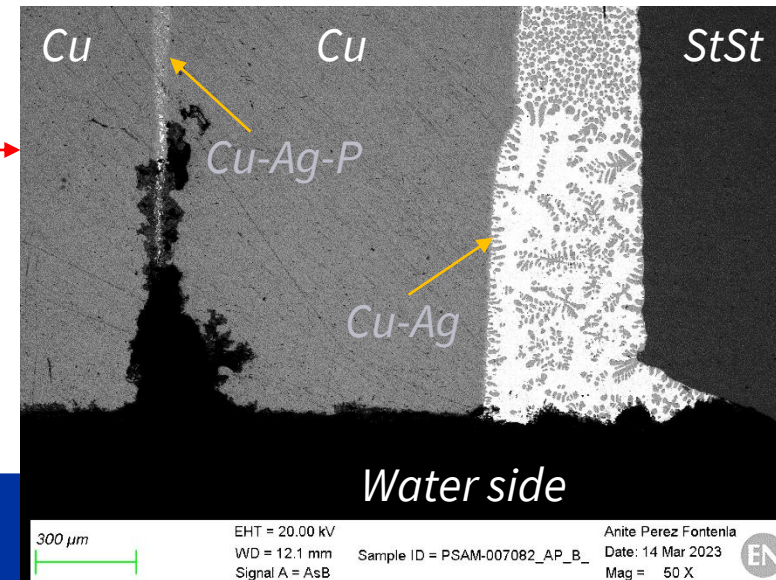
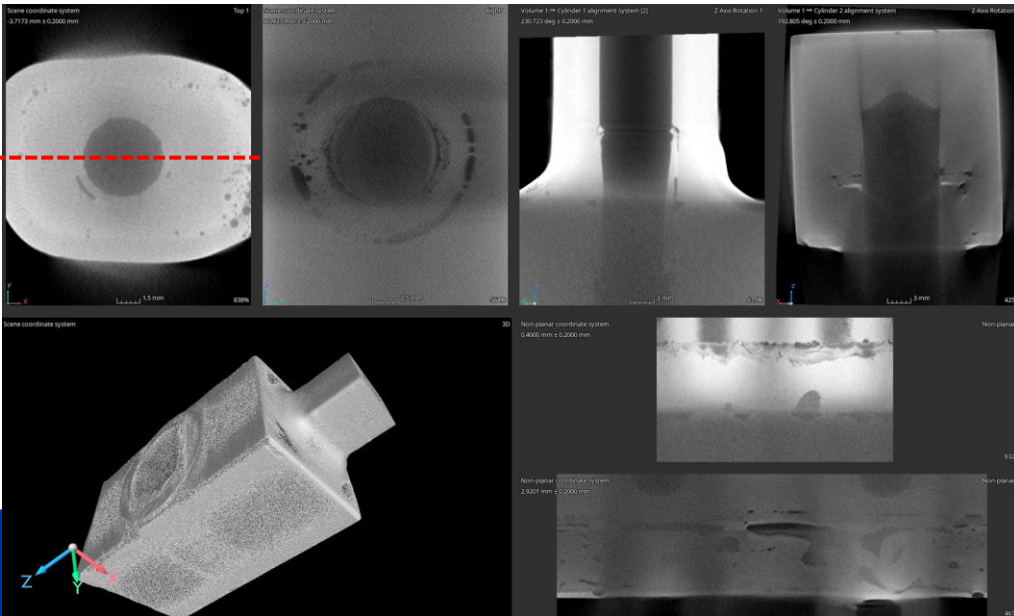
Sample #3: Non-leaking joint From PSB bending dipole Installed until LS2 EDMS under preparation

1. NDT (voxel size= 40 μm):
 - Brazing interfaces present numerous cavities and discontinuities
2. Chemical analysis:
 - "S" (up to 5.5 wt. %)
3. Microscopic examination:
 - Same corrosion phenomena
 - Cu-Cu joints (Cu-Ag-P brazing) highly affected
 - Cu-StSt joint (Cu-Ag brazing) less affected

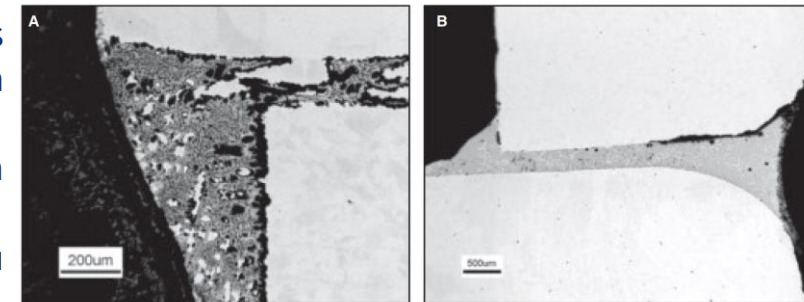
Fig. 4 — Cross-sectional views of damaged brazed joints. A — Severe interfacial attack and attack within the braze; B — severe interfacial attack from the air side with limited interfacial and braze metal attack from the water passage.

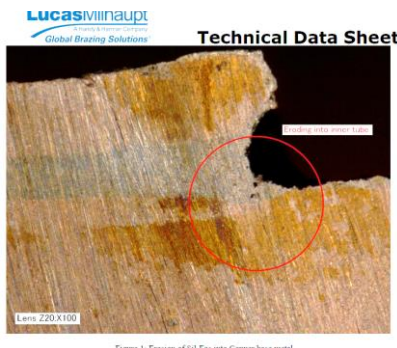
Figure 1 Erosion of Si-Foil into Copper base metal

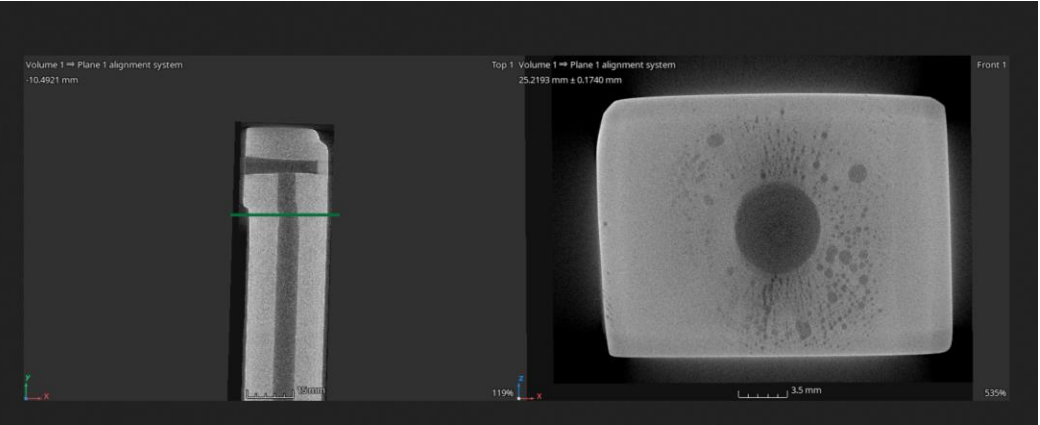
Sample #1

Poor quality of the brazed joints
