SPS WS wire
breakage

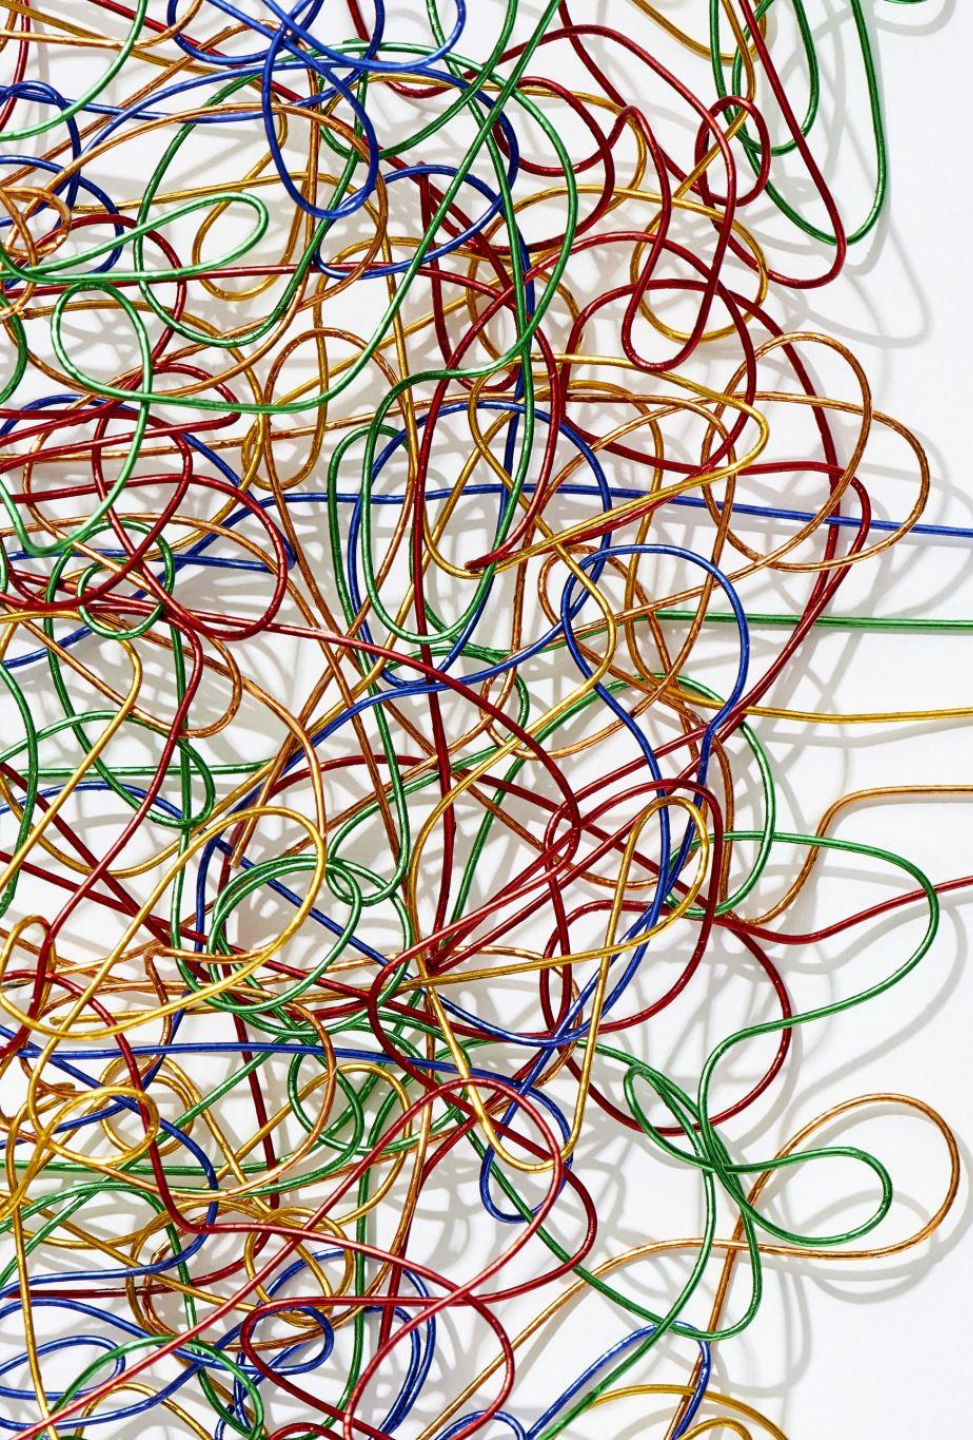
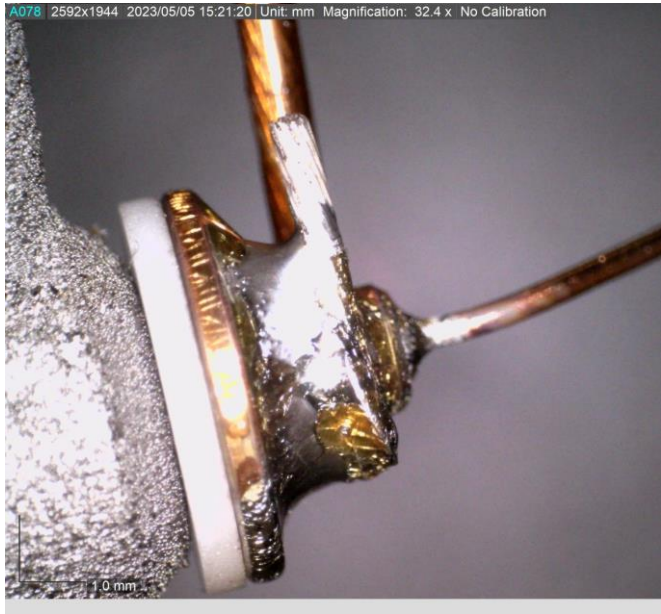
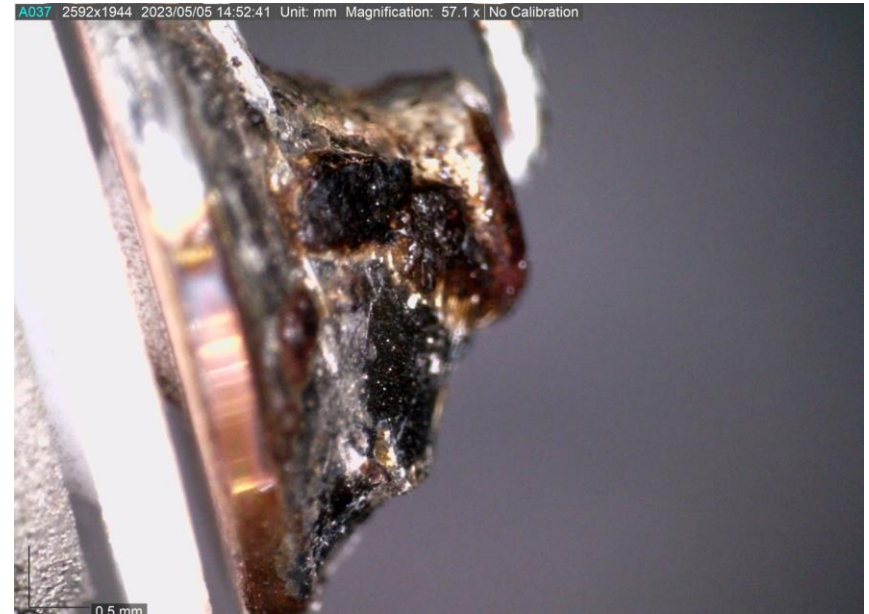
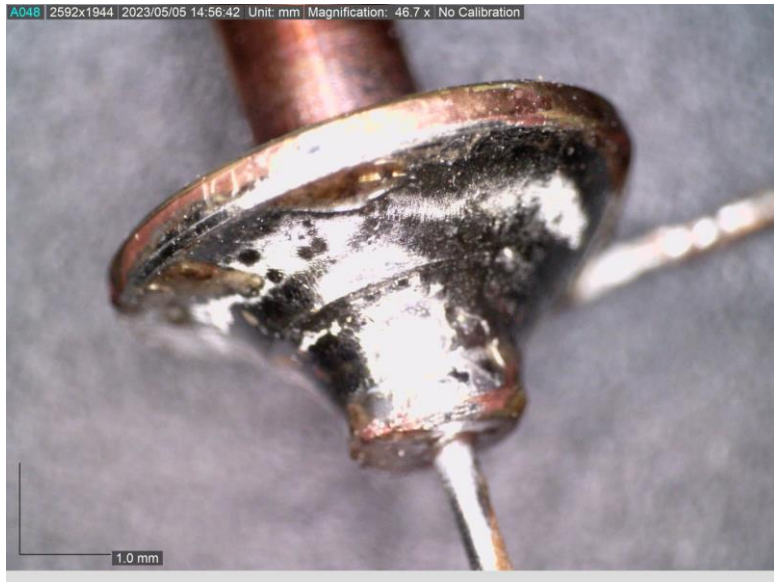
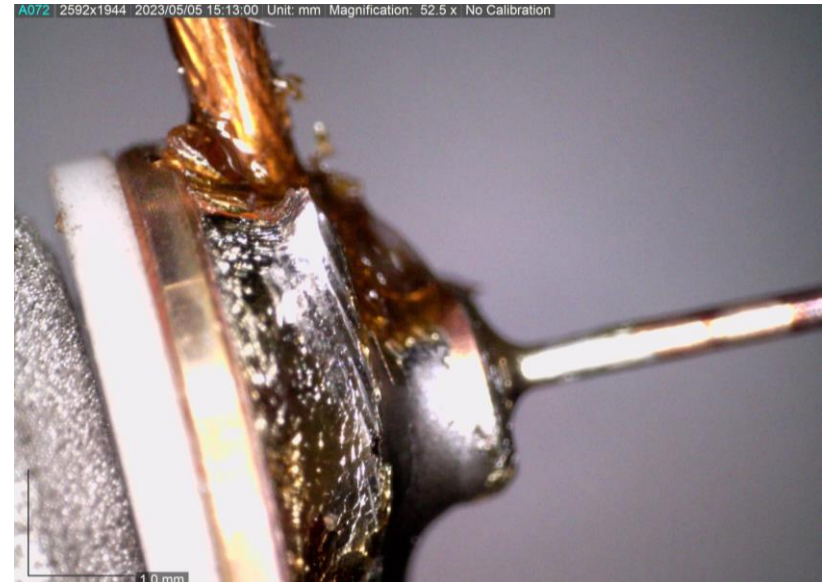
- First results from C wire imagery
- The C wire is present on all four forks
- Sharp fracture breakage presents in most of the sample, in one case a necking is visible
- More results in the coming days
