How to upgrade a pixel detector

lessons from Phase-1 being applied to Phase-2 CMS Pixel Upgrade

Rachel Bartek

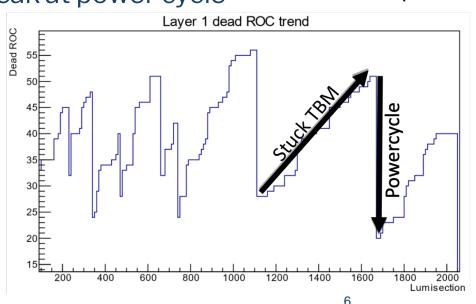
Run 303838 Sep. 2017

- Phase-1 has many more modules than Phase-0, therefore needs more power, but the number of cables was fixes
- Use DC-DC converters to step from 10V to 3V
- 1184 converters based on rad-hard FEAST2 ASIC from CERN
- Used enable/disable in FEAST2 chip to power cycle stuck TBM modules
- After about 30 fb⁻¹ DC-DC converters start to break at power cycle

- At end of 2017 5% converters broken
- Over 40 fb⁻¹ for this year as of last week
- DC-DC converters used in phase 2
 - Insert panic here

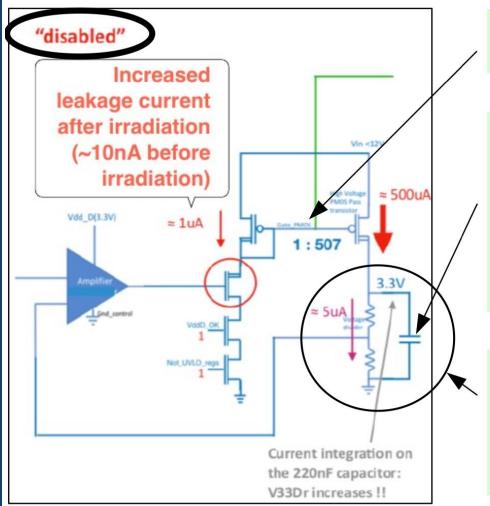
amplifying current mirror

capacitor charging up in the disabled state causing voltage spikes well beyond 3.3V

part providing current to the drivers of the power transistors

- All 1200 DC-DC converters replaced in YETS 2017/2018
 - 65 broken
 - 333 high current
- Work around in 2018: power cycle from the power supply
 - Reduce to 9V so currents smaller during on/off sequence
- Permanent fix FEAST chip new version

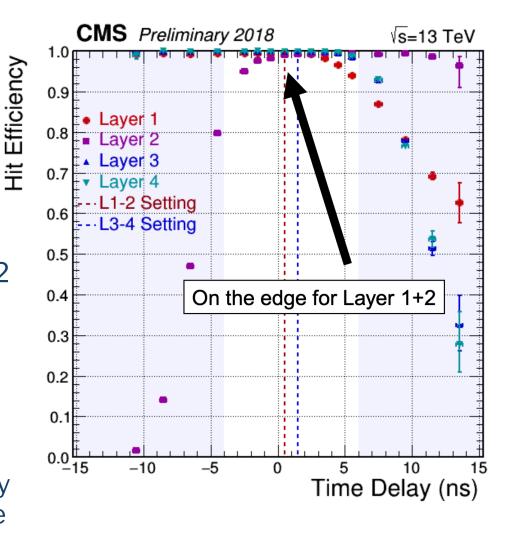
- Layer 1 shifted by ~12 ns with respect to layer 2
 - Cannot adjust upstream because layers 1 and 2 are on the same clock line
 - Layer 1 uses PROC600 while layer 2 uses PSI46dig
 - PROC is faster
- The new layer 1 installed during LS2 has a delay register in the new TBM to compensate for the differences in PSI46dig and PROC600 timing

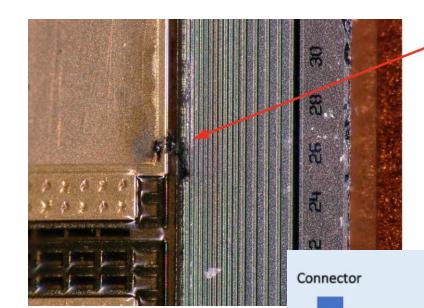
Spark between the sensor's guard rings and test pad

- Two layer 1 modules damaged in 2018 during 600V test
 - For the rest of 2018 we ran at 450V
- Sylguard encapsulation of FPix provides spark protection
- When layer 1 replace during LS2 HDI edge increased by 3 times enabling L1 to run at 800V during run 3
- For Phase-2 we are Parylene coating modules

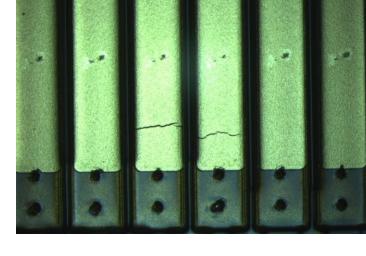
- Phase 1 FPix HDI had lots of problems: over/under etching, shorts between bonds, poor bondablility
- For Phase 2 we are spending more for the HDIs but the saving labor on iterating with vendor and visual inspection
