J.Zhang^{*,1}, P.Arnold¹, J. Fydrych¹, P.Nilsson¹, M. Chorowski², J. Polinski²¹ European Spallation Source (ESS) ERIC, Partikelgatan 2, Lund, Sweden² Wroclaw University of Science and Technology, Wybrzeze, Wyspianskiego 27, 50-370 Wroclaw, Poland

Abstract: The European Spallation Source (ESS) is a neutron-scattering facility which will use a pulsed 2.0 GeV proton beam generated in the linear accelerator (LINAC) for releasing high-energy neutrons in the ESS target station. The 2K superconducting linac comprises 13 spoke and 30 elliptical cryomodules. The cryogenic distribution system (CDS) connects the cryogenic plant with the 43 cryomodules through a 400 meters long cryogenic multi-transfer, 43 valve boxes and an endbox.

The CDS consists of 373 control valves in total. There are 8 and 10 control valves in each elliptical and spoke valve boxes, respectively, and 3 valves in the end box. The control valves are used for regulating or blocking the process helium flows. The seat tightness of the CDS valves is crucial especially for warming up individual cryomodules, which is required for potential short-term maintenance or repair activities in the cryomodule while keeping the others i

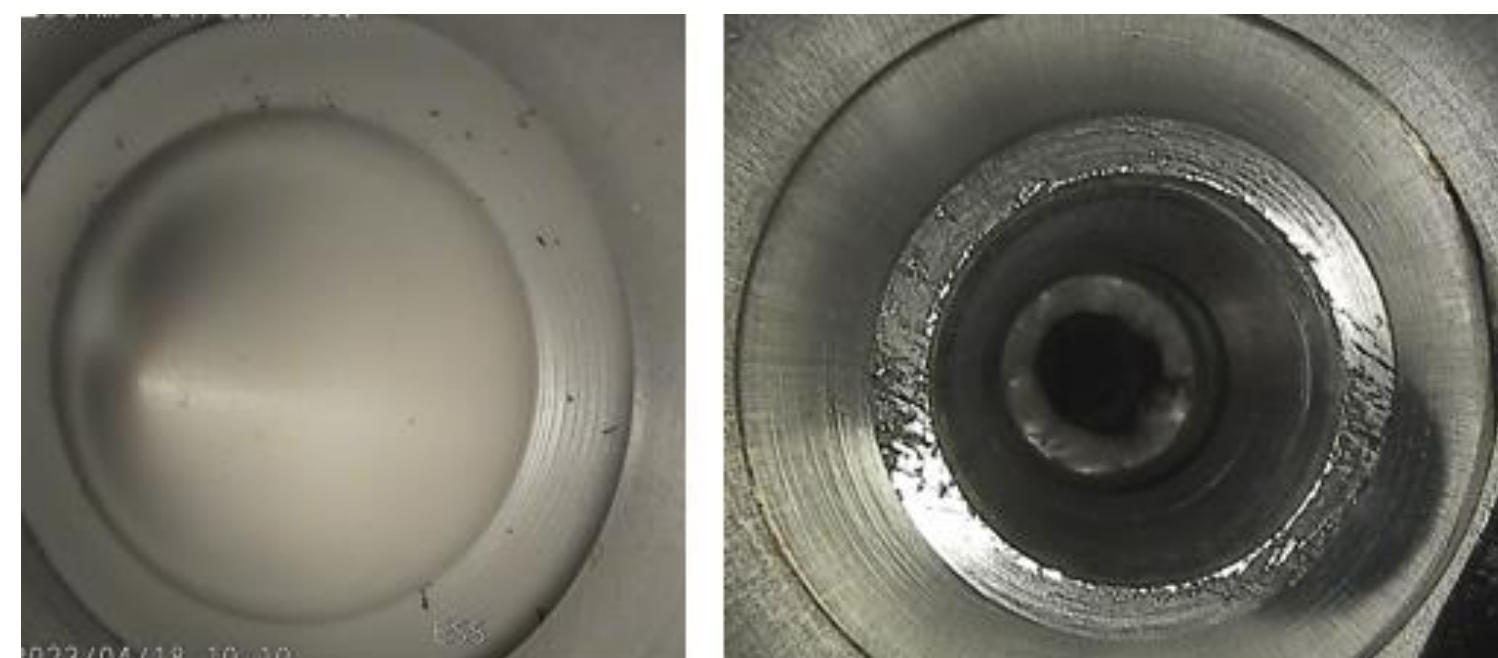
- Debris or dust was found on valve seat seal and some valve seats had scratches.
- After 2 times CDS commissioning, there are more than 40 leaky valves had new seal installed.
- Some valves showed that some valve seat started leaky after a period of cold commissioning, which means that the debris comes from installation or other parts of the system.

Debris on the valve seat seal Scratched seat surface for one valve after 1st CDS commissioning

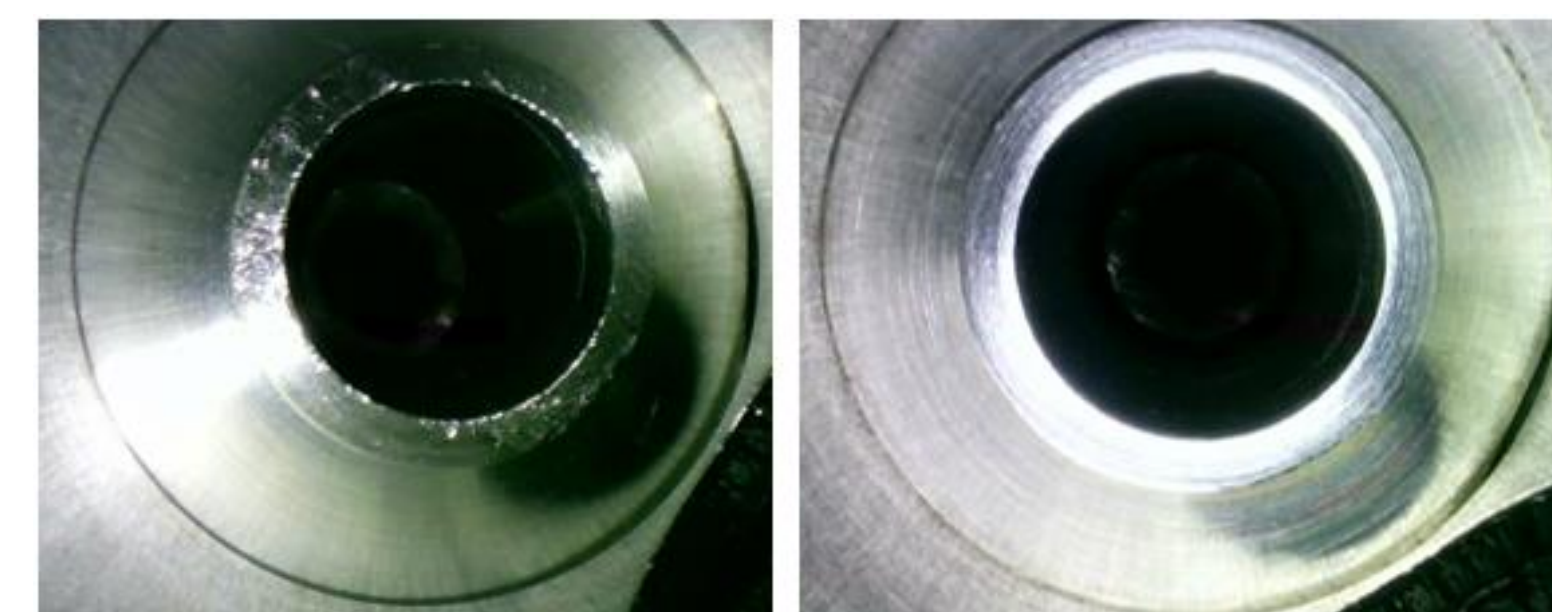
The valve seat surface before (left) and after(right) seat grinding

- Due to deep scratch on the valve seat surface, some control valves were still leaky after installing a new seat seal.

- ESS ordered the special valve seat surface grinding tool from WEKA and performed control valve surface grinding on 4 valves.

- All of the 4 grinded control valve were seat leak tight after leak test.

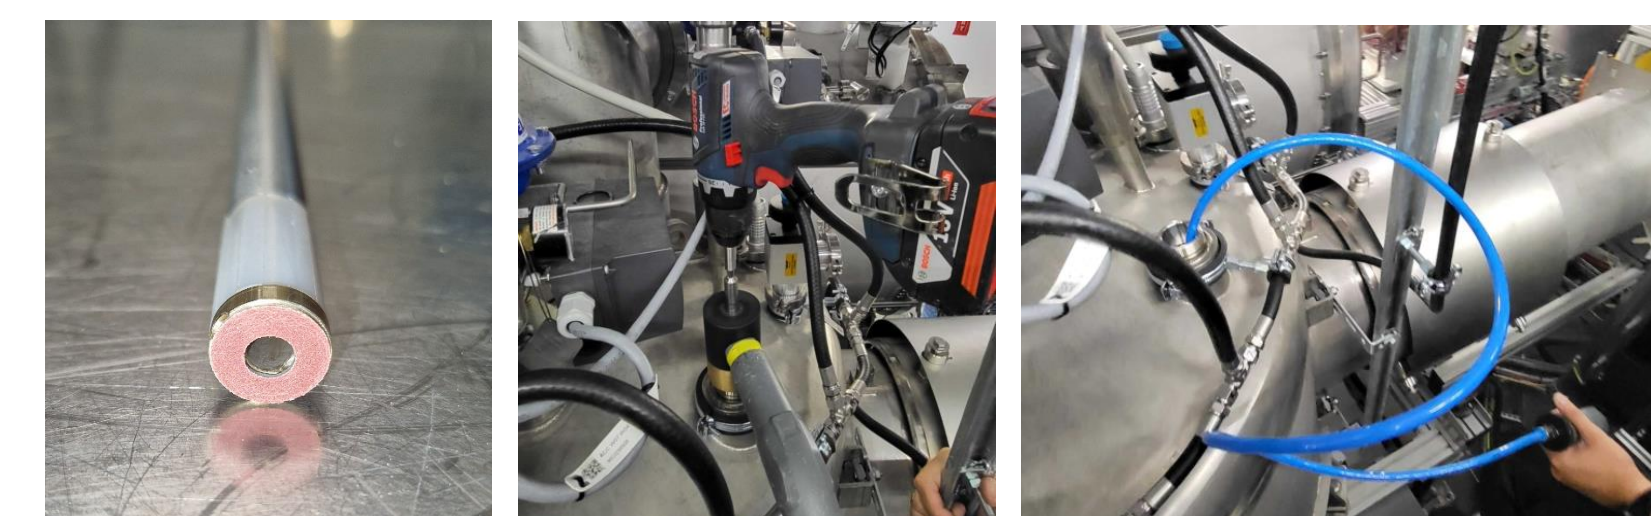
Sand paper Grind with drill Vacuum debris

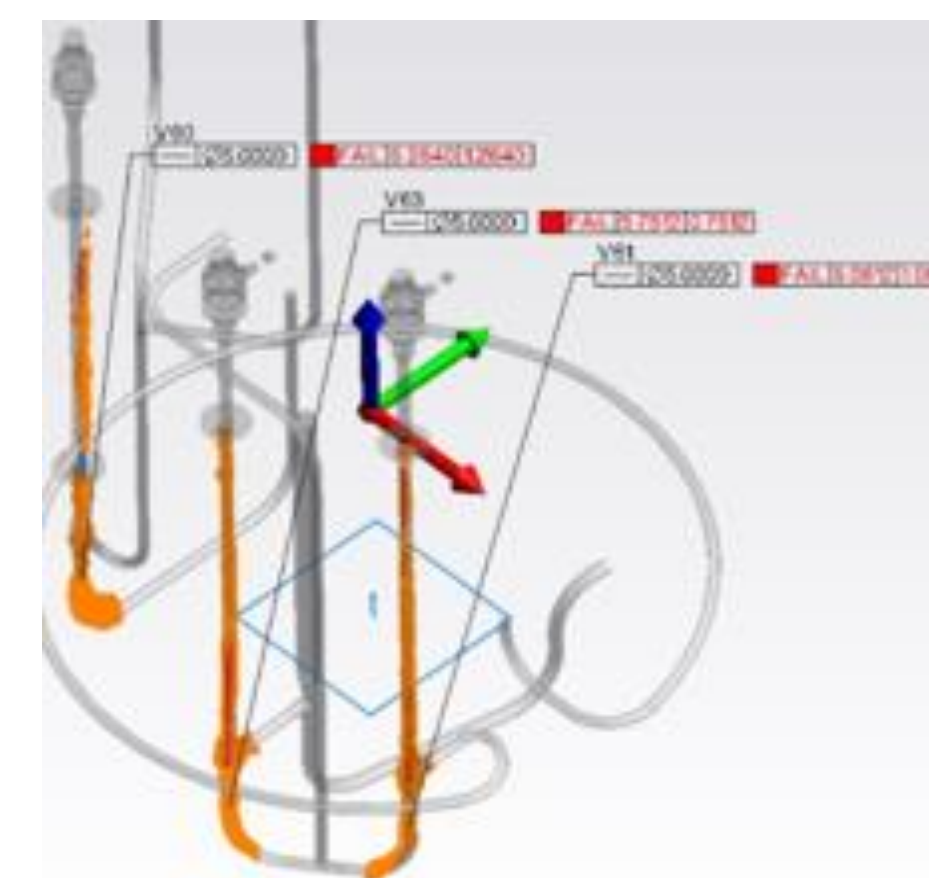
- 24 out of 30 Thermal Shield (TS) return valves CV61 in CDS-el were leaky with the leak rate between 10 and 100 mbar.l/s.
- The misalignment of CV61 and CV63 were investigated by ESS with caliper gauge and by WUST with an optical method by using camera to measure the valve deflection.
- All 30 CV61 in CDS-el were replaced with smaller digital on-off valve which has no regulating function, as a result, half of CV61 are not leaky any more.
- In HBL-200, 3 valves (CV60, CV61 and CV63) were rewelded on the top to relax the pipe.
- Another 3 high deflected leaky CV61 were performed with valve body rewelding on top flange as well.

A misalignment of 6 mm in the valve body showed in three valves

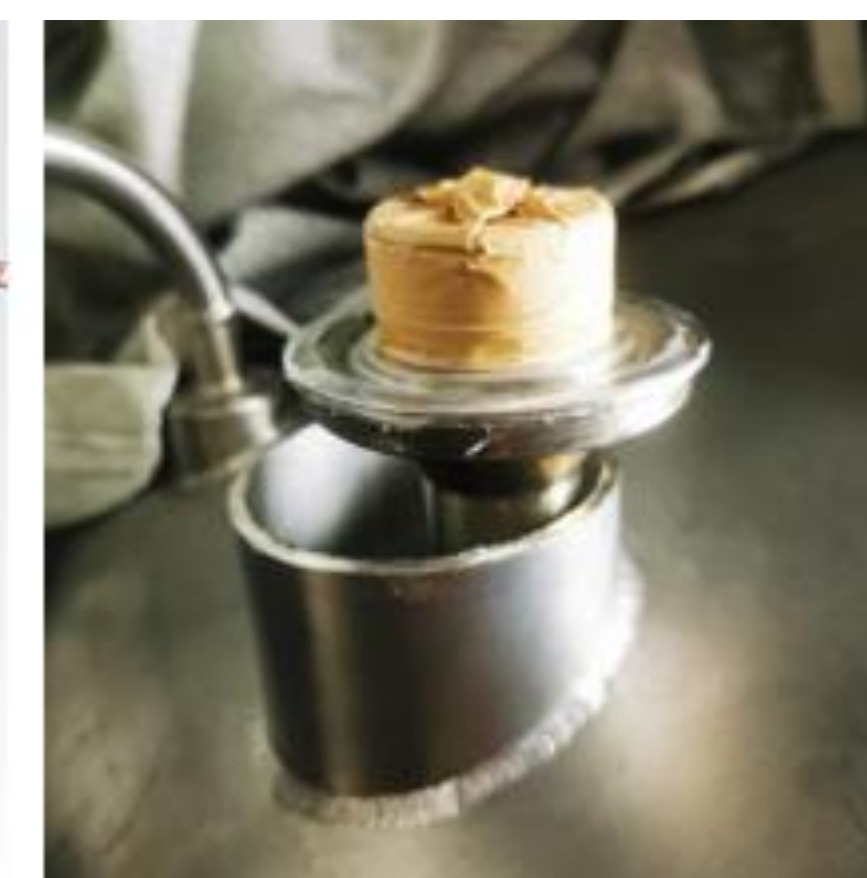
The top welding of the valve body was cut open to relax the pipe

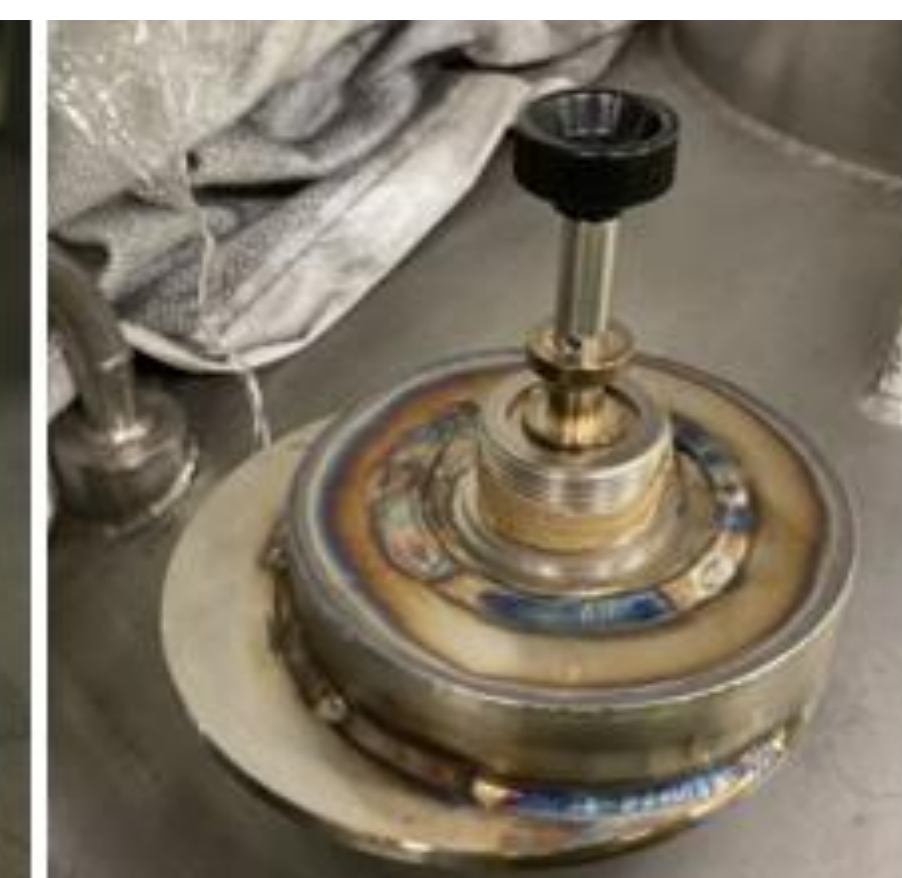
Valve top was rewelded and checked straightness by caliper gauge

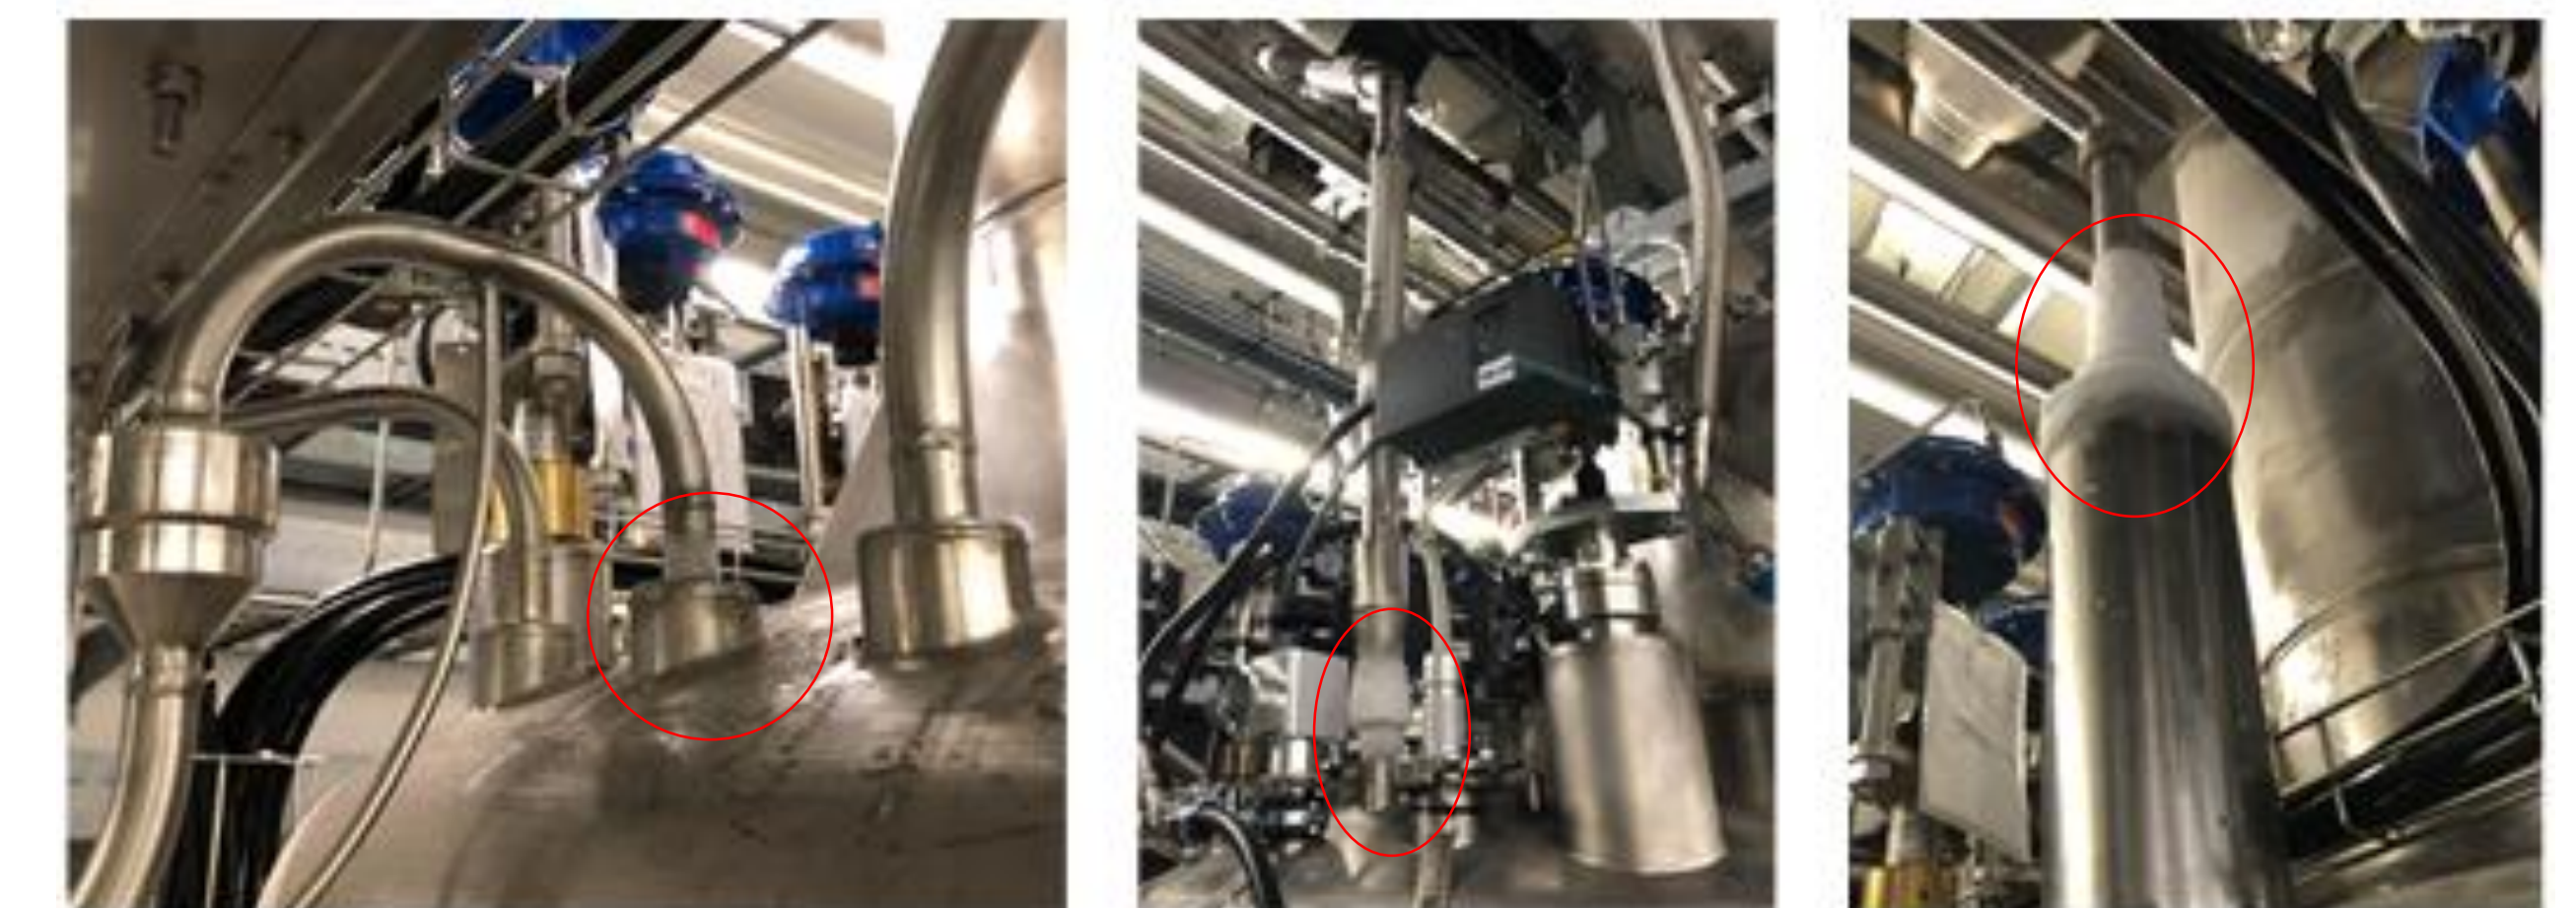
Cold spots due to valve seat leak from cold side to warm side
