Circuit of 77 octupole spool pieces in MBA dipoles (part of combined MCOD)

120 A circuit using a 120 A converter (RPLB type) with QPS input (exceptionally)

A. Verweij, 8 March 2011, MP3 mini workshop

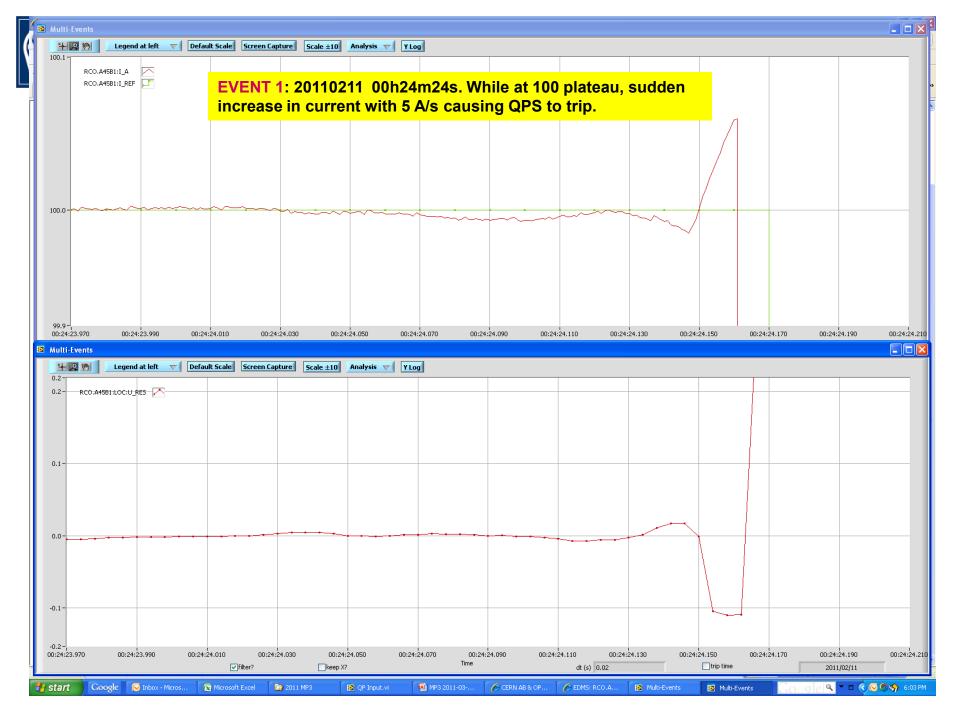
Strong noise in V_meas and V_ref already present during 100 s before the trip

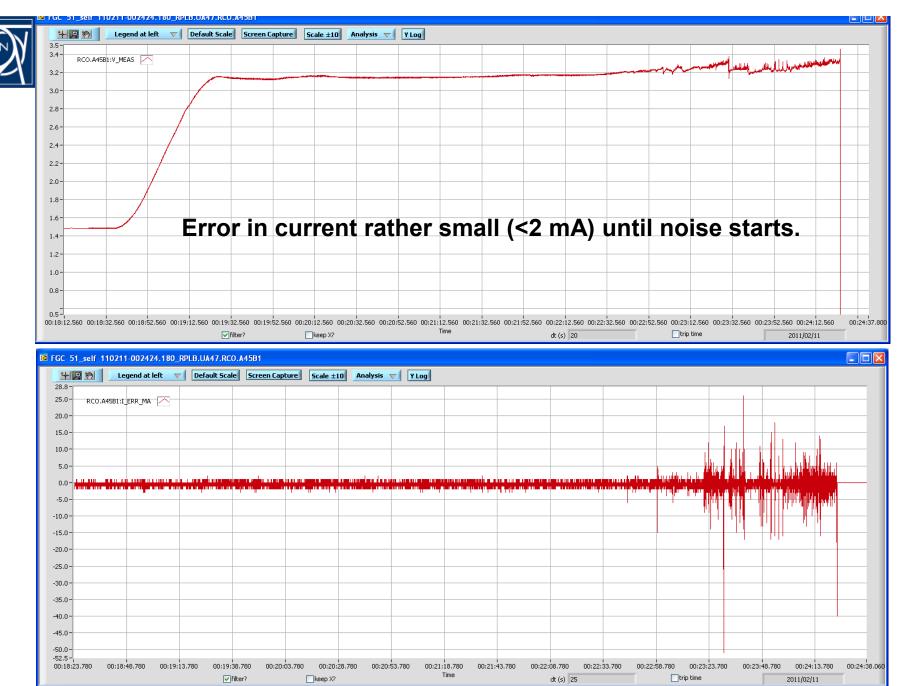
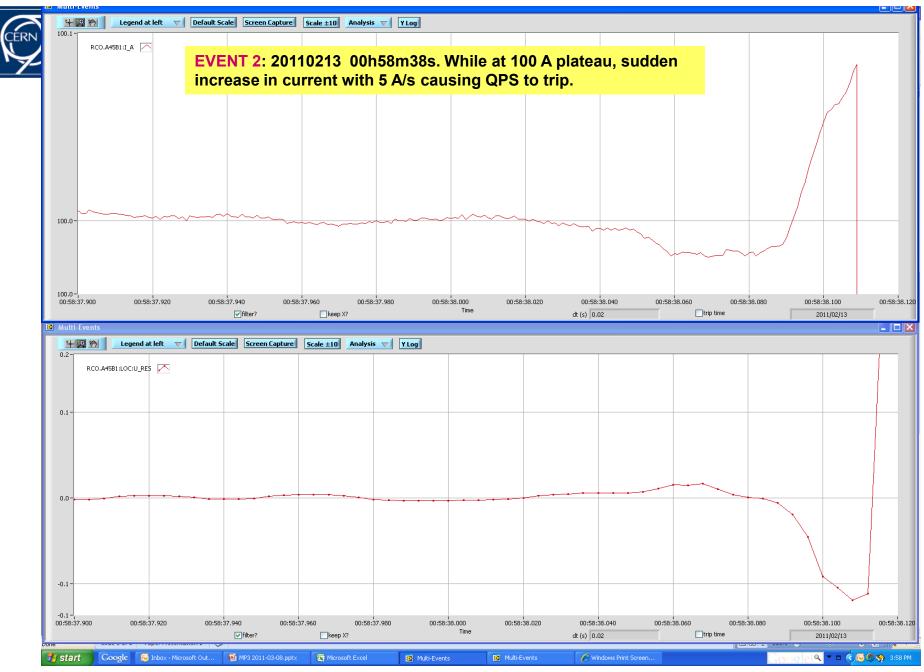
Strong noise in V_meas and V_ref already present during 50 s before the trip

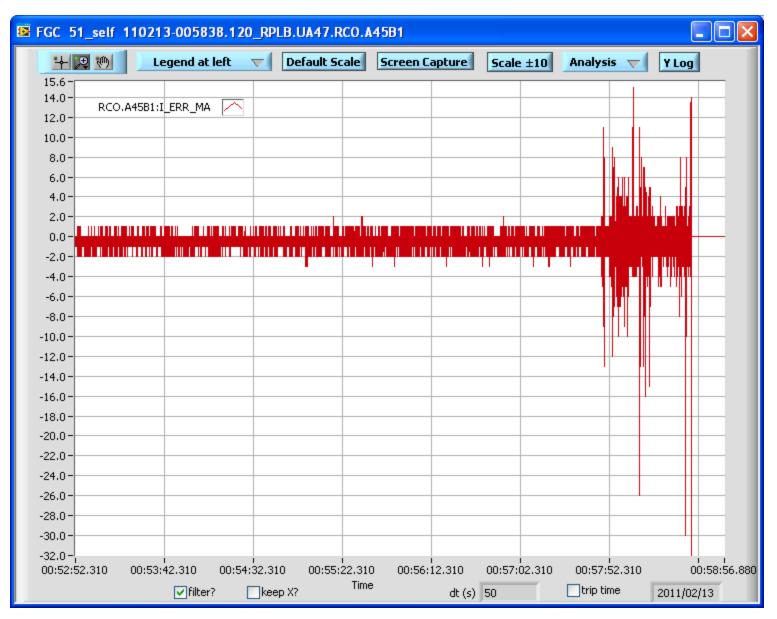
Error in current rather small (<2 mA) until noise starts.

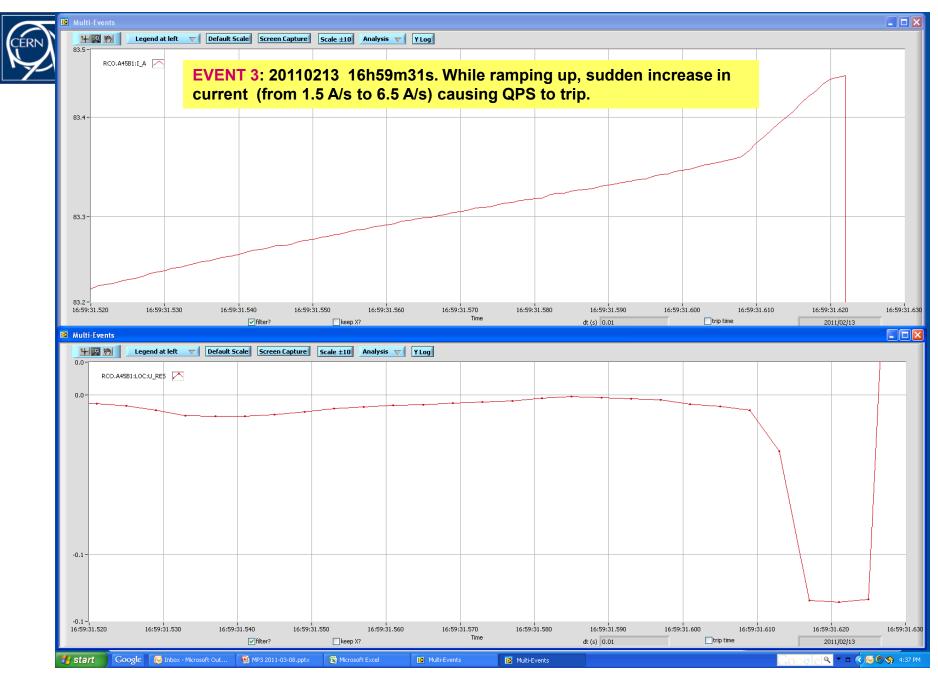
Noise in V_meas and V_ref already starting 4 s before the trip

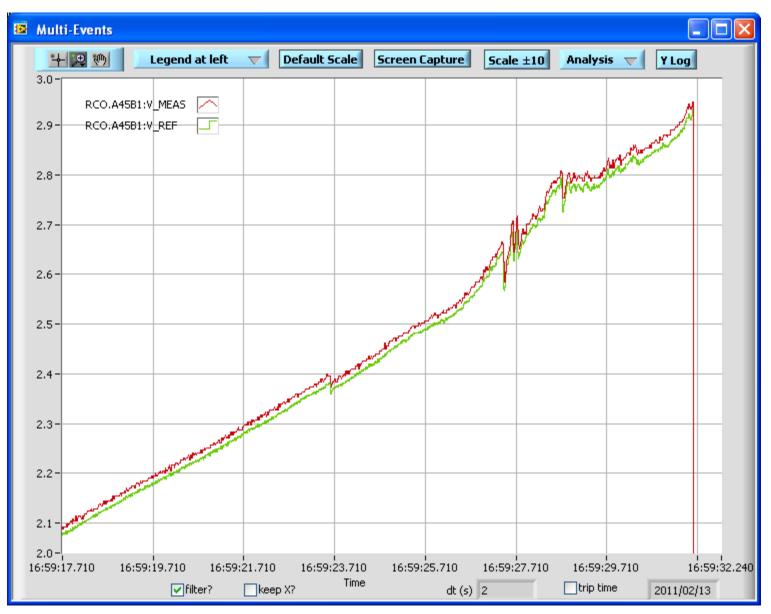
Error in current rather small (<2 mA) until noise starts.
