LHC BLM

Firmware Update during TS1-23

238th Machine Protection Panel Meeting

14/06/2023

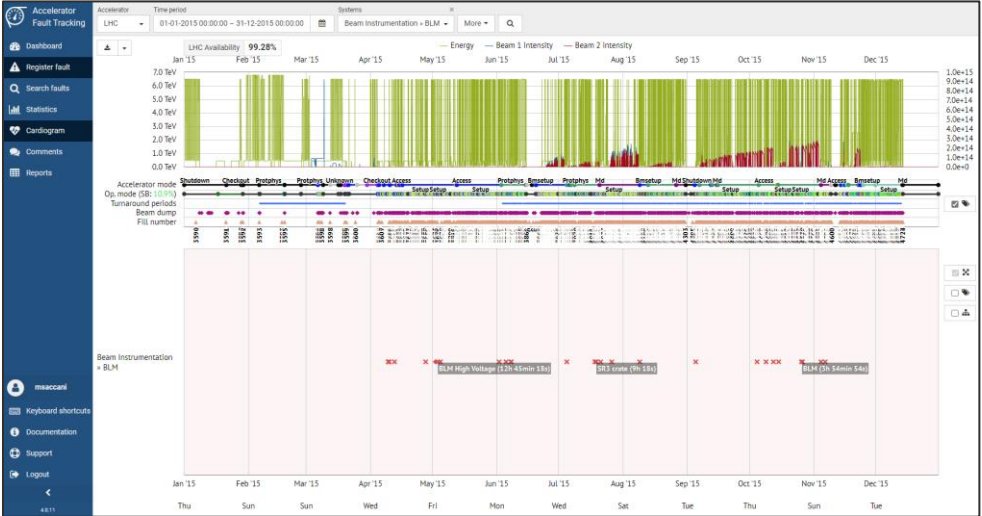
BLM AFT cardiogram view (2015)

This issue may have been present since Run1.

Partially solved by decreasing the rack temperature during Run2.
But the temperature was increased during LS2, and not lowered after.
 → Temperature set back from 23 °C to 16°C on the 24th May 2023.

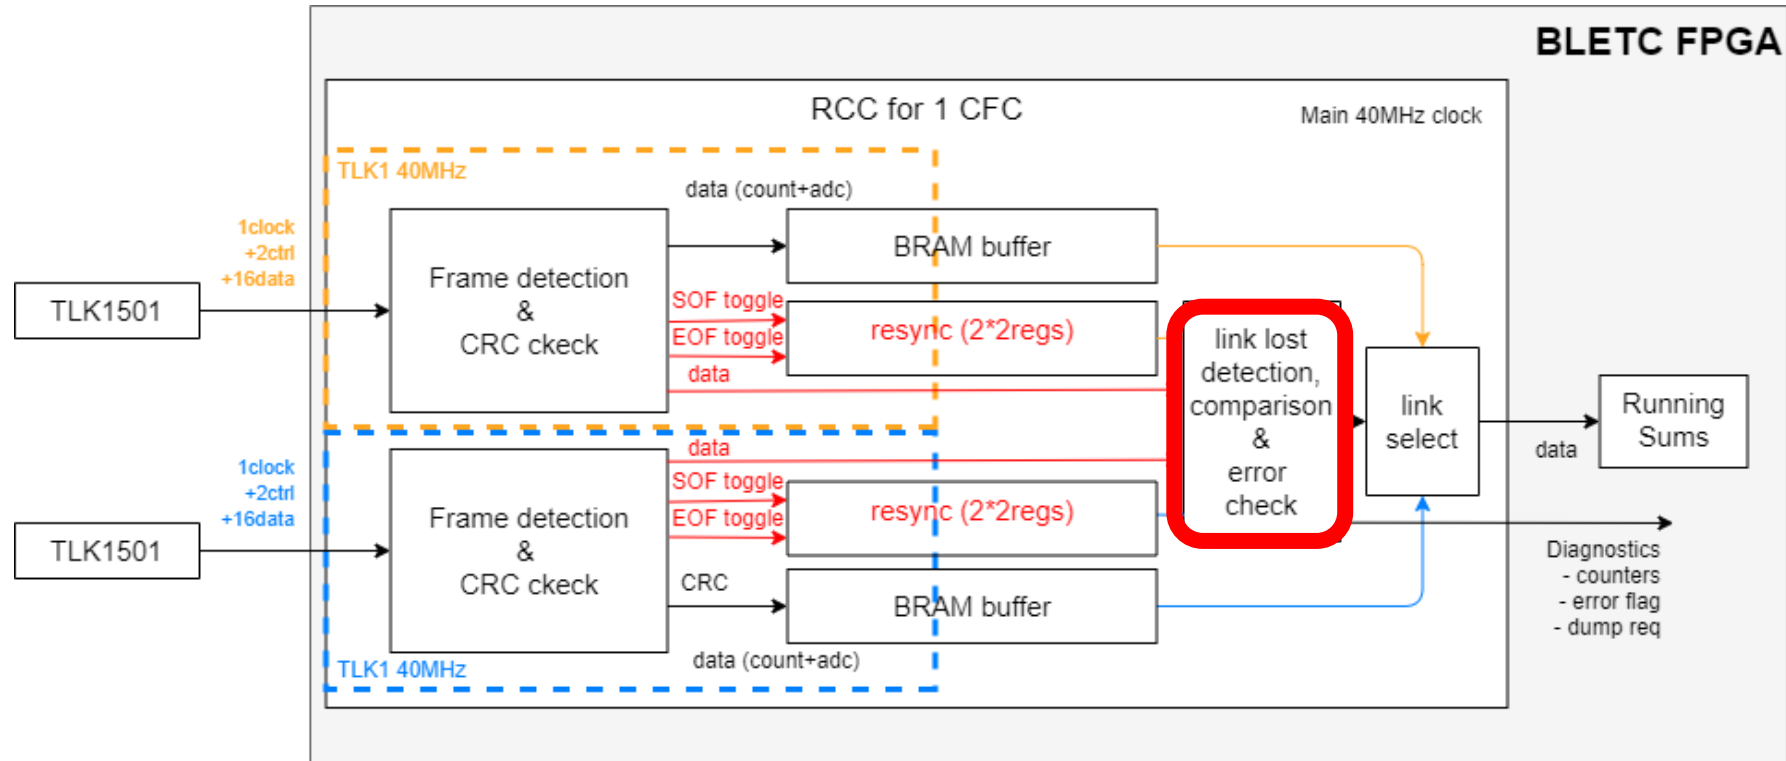
Data reception in the processing FPGA

- An investigation on the spurious dumps in April/May 2023 allowed to identify the **source of the issue**.
- Failure case: **1 intermittent faulty link** leading to a spurious failure of the entire decision-making process for both links !
- The **Frame ID check** $\text{frameID}(n+1) = \text{frameID}(n)+1$ is **done twice on the same frame**: on the good link, then on the bad one.
- Happens in **very specific conditions**: temperature & weak tunnel transmitter make 1 link unstable
- FW code to be updated: fully synchronous decision process (no clock domain crossing) → easy to update and simulate

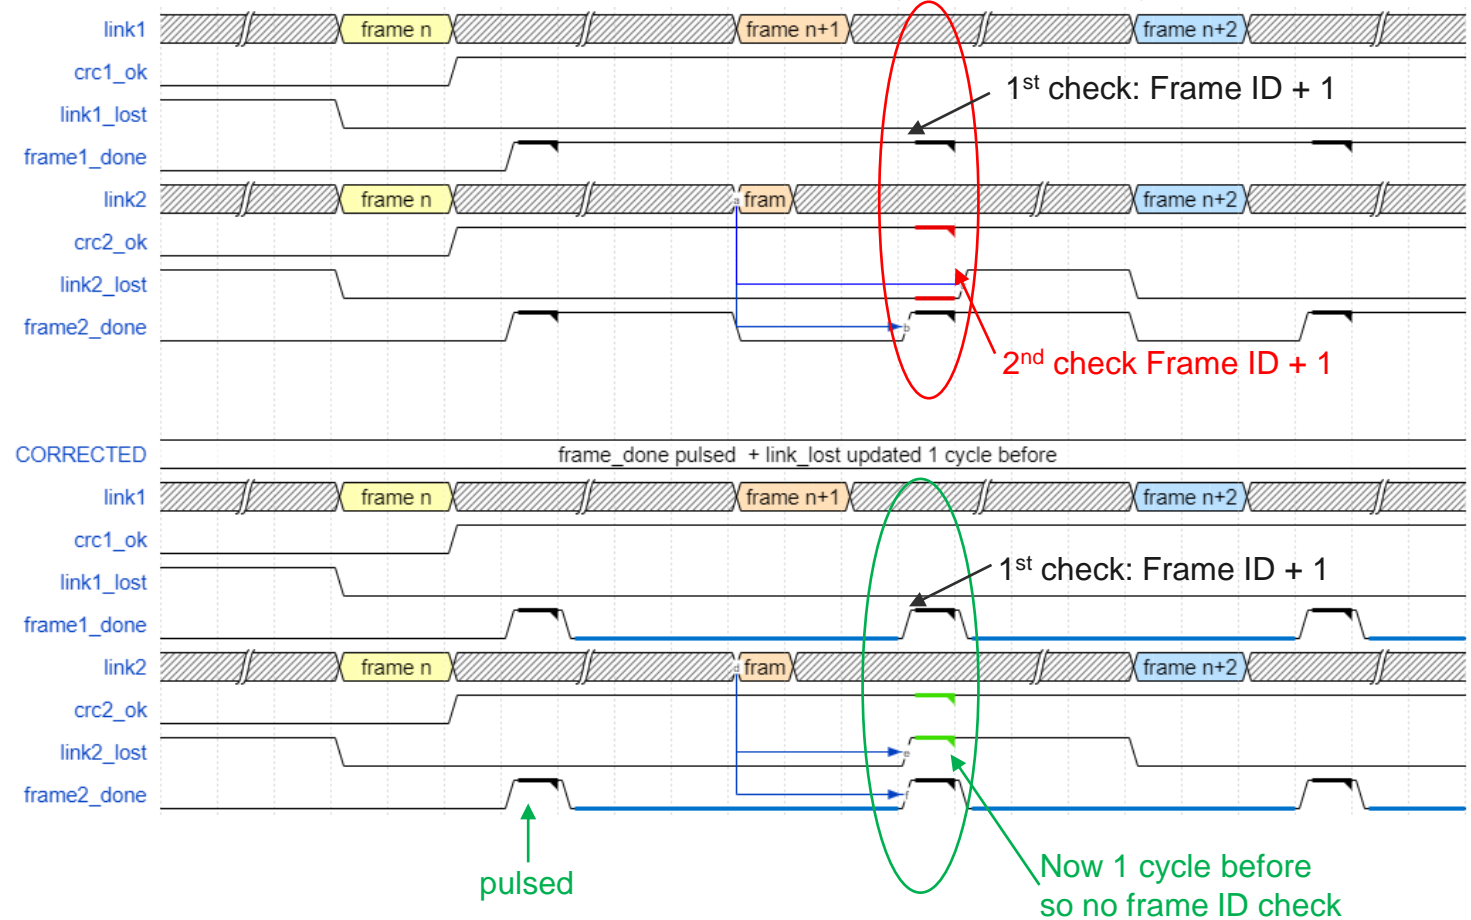
If one link is shifted and the end of packet is missing, the good link is used, but the **bad link is taken into account for the Frame ID check**, as the corresponding “lost” flag arrives **1 cycle to late** and the CRC_ok is not reset.

Consequence 2 FID errors are both frames are compared consecutively.

- 1- at high temperature: optical diode unstable, and the deserialiser TLK1501 at the limit (resynchro cycles + CRC errors, + lost frames).
- 2- when one link is good and the other recovers and stops continuously.
- 3- when the bad link received frame is shifted by exactly one 25ns clock cycle

Temperature → incomplete frame
Link1 is good & Link2 intermittently faulty
Bad link is shifted by one 25ns cycle

Correction: 2 changes in the RTL code

- frame_done is now **pulsed**
- lost_link flag generated **one cycle before**.

Validation: non-regression tests played in simulation.

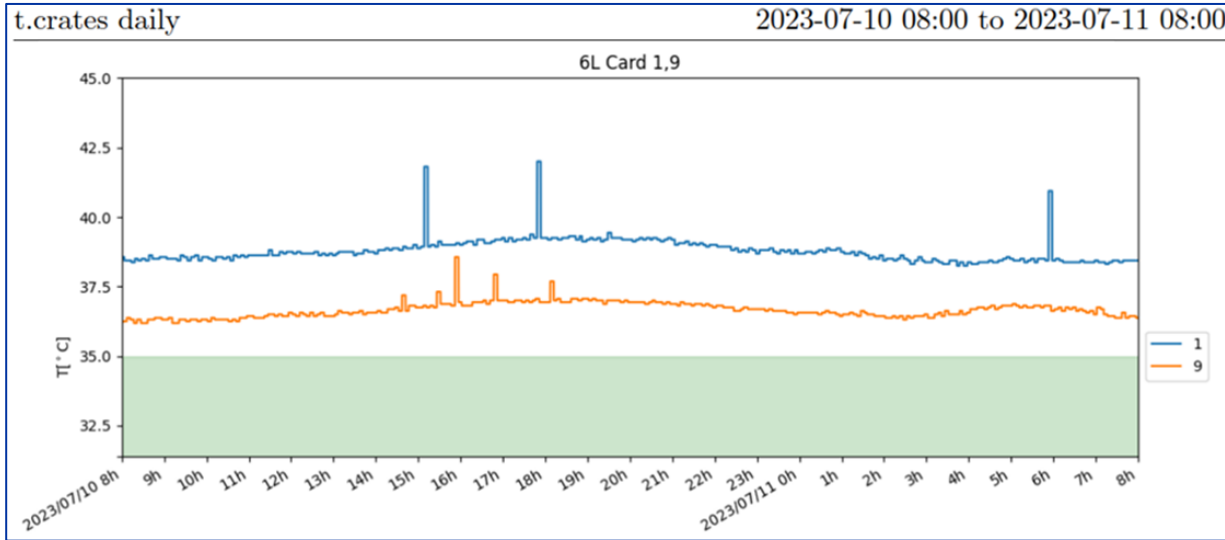
BLM Electronics Temperature Report at 6L

- ➔ Still a few hot boards and weak links
- ➔ No spurious dump detected since the upgrade.

The new firmware v1.2.4 was deployed during TS1-23 on the 19th June 2023 (<https://issues.cern.ch/browse/BIBML-509>). We have CRON jobs to get daily reports: temperatures & optical link diagnostics.
