Session 7: Availability, efficiency and equipment reliability

LHC inner triplet fault

S. Le Naour,
Joint Accelerator Performance Workshop 2023

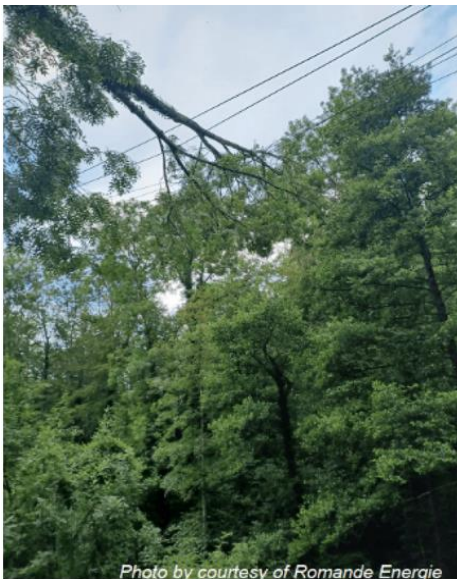
Photo by courtesy of Romande Energie

The reason for the electrical glitch that caused the safety systems in the LHC to dump the beam and several magnets to quench was found: a tree on the Swiss side (about 55 km from CERN in the Canton of Vaud) fell on the power lines and disrupted the power system.

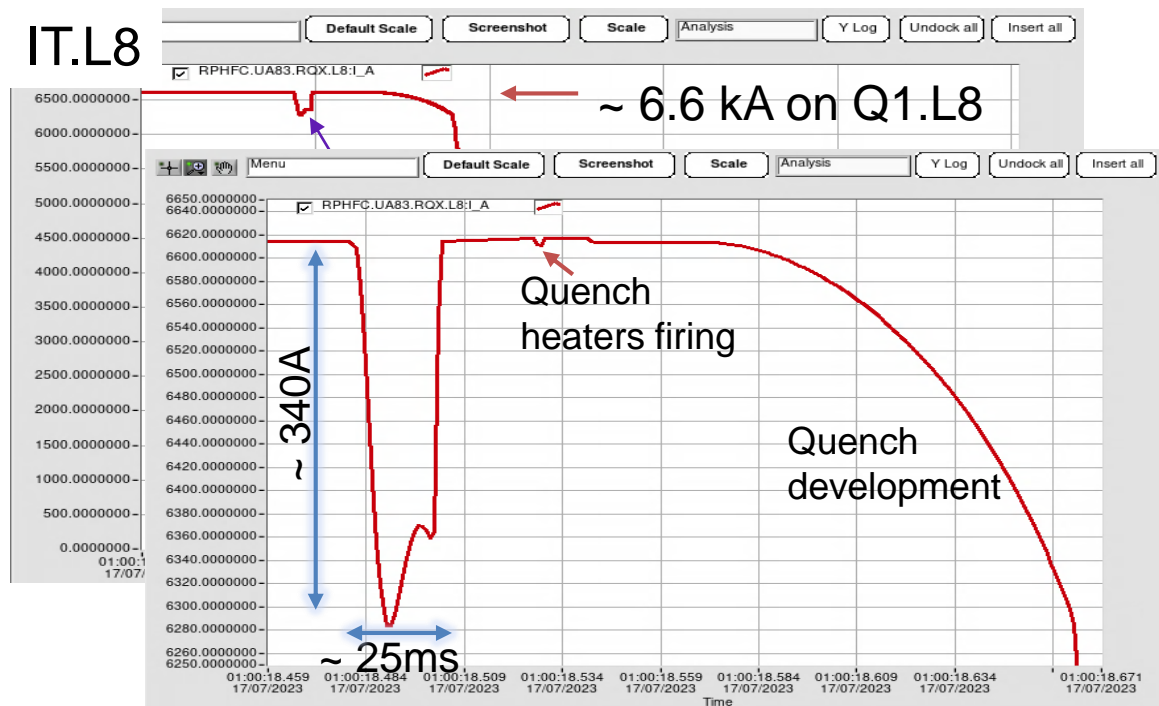
Signals measured by the quench detection system (QDS) are similar for a large current variation or a symmetrical quench (quench development in two adjacent coils). For the magnet protection, the quench heaters are triggered. Similar event occurred in Aug 22, without damage.

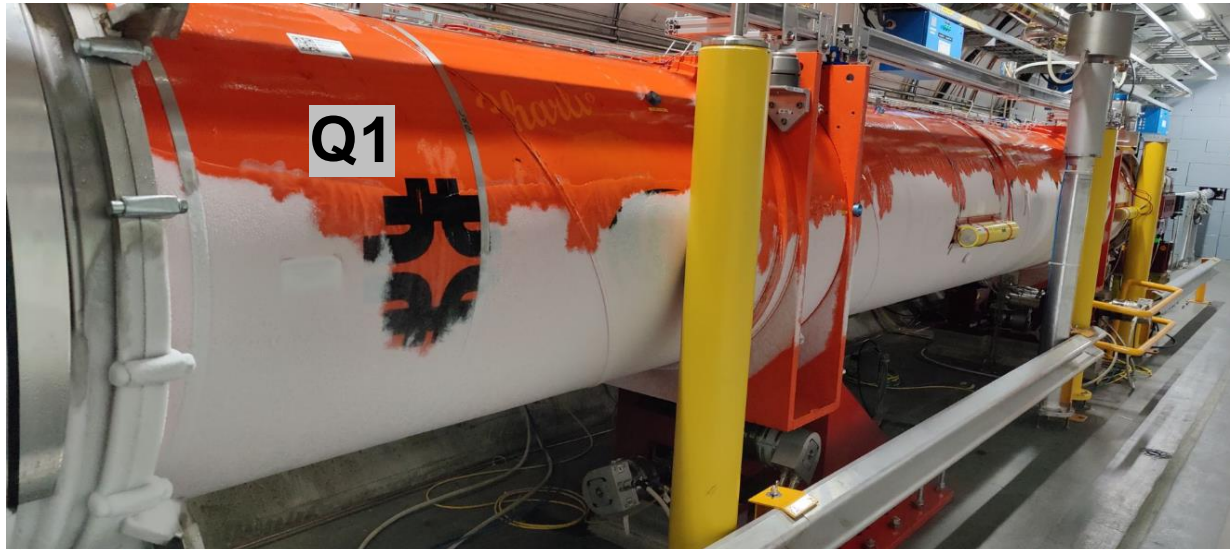
30s after the quench, a significant leak appears in the vacuum vessels of IT.L8 assembly.

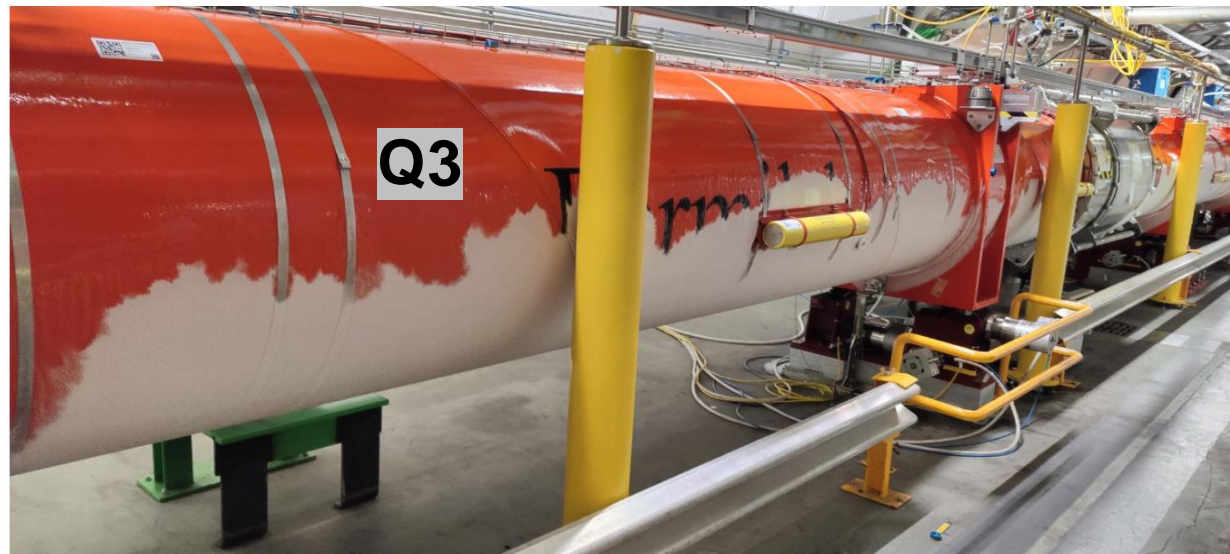
8 hours after the quench, the pressure in the vacuum vessels is at **1bar** and the average temperature of the cold masses is **150K**

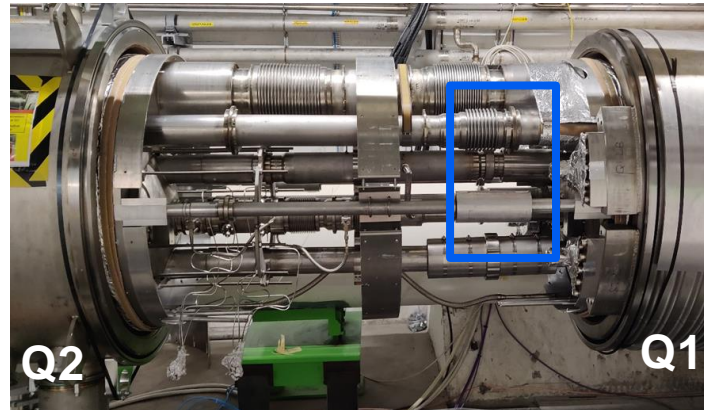
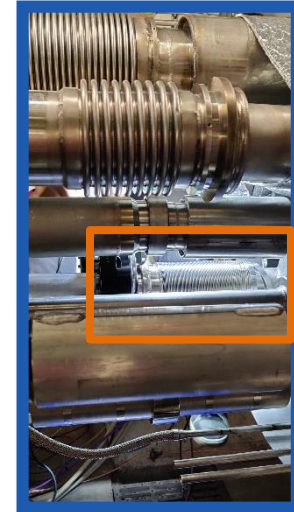
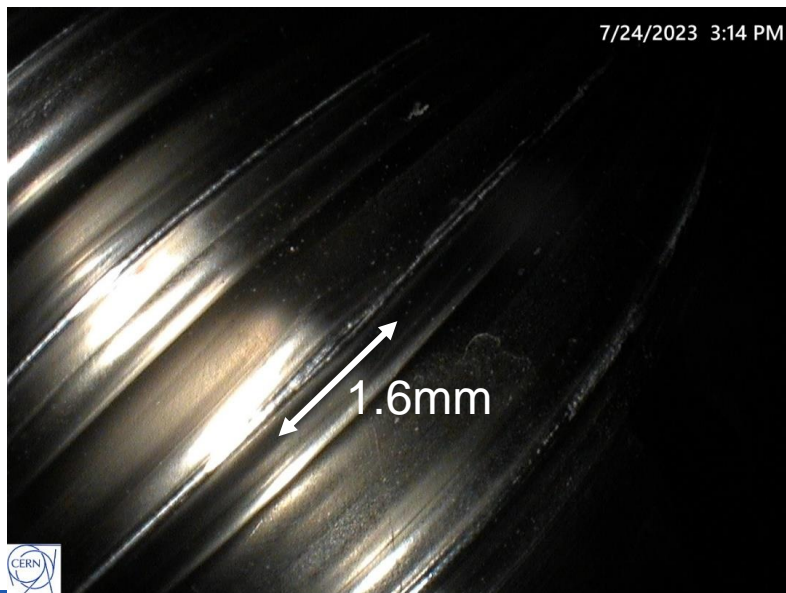
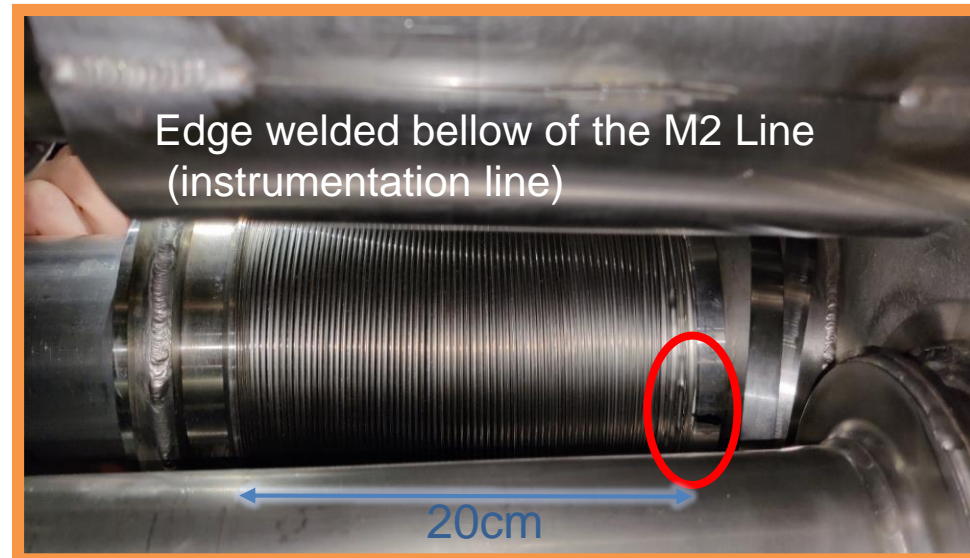
The leak is found on an edge welded bellow of the instrumentation line (M2)

Details of the repair: LMC on 2/08/12 : [indico 1309715](#)

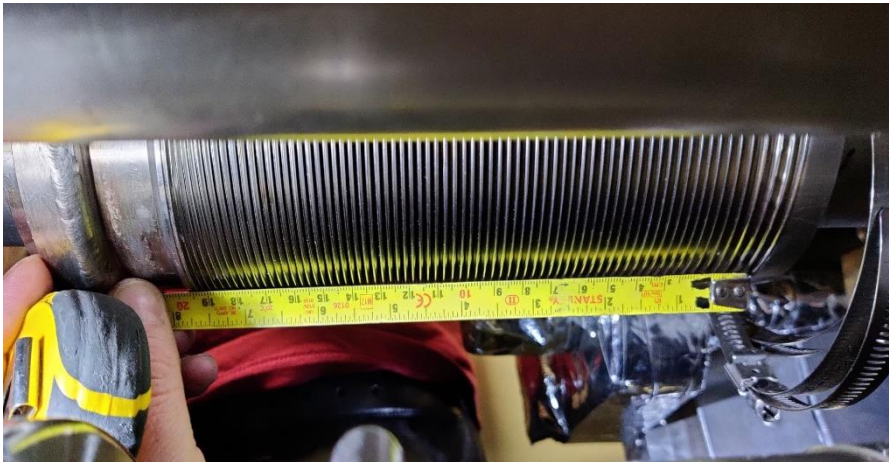
The bellow is extended over the specification length

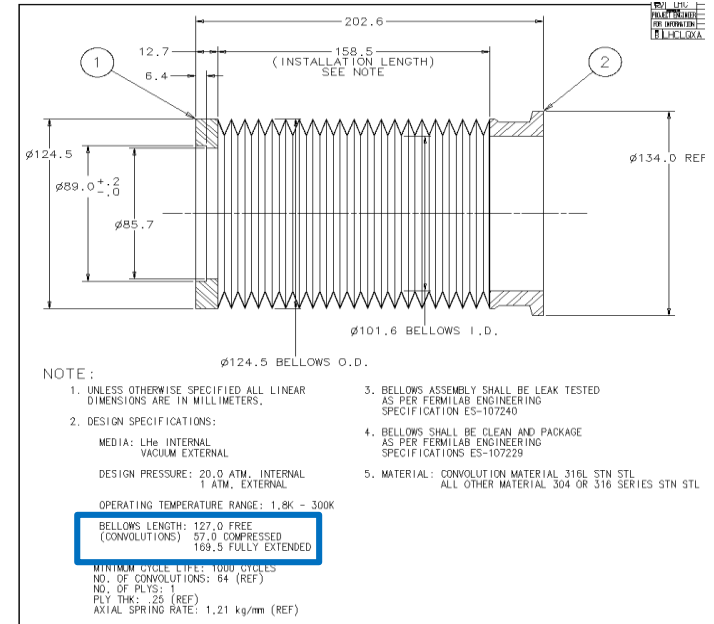
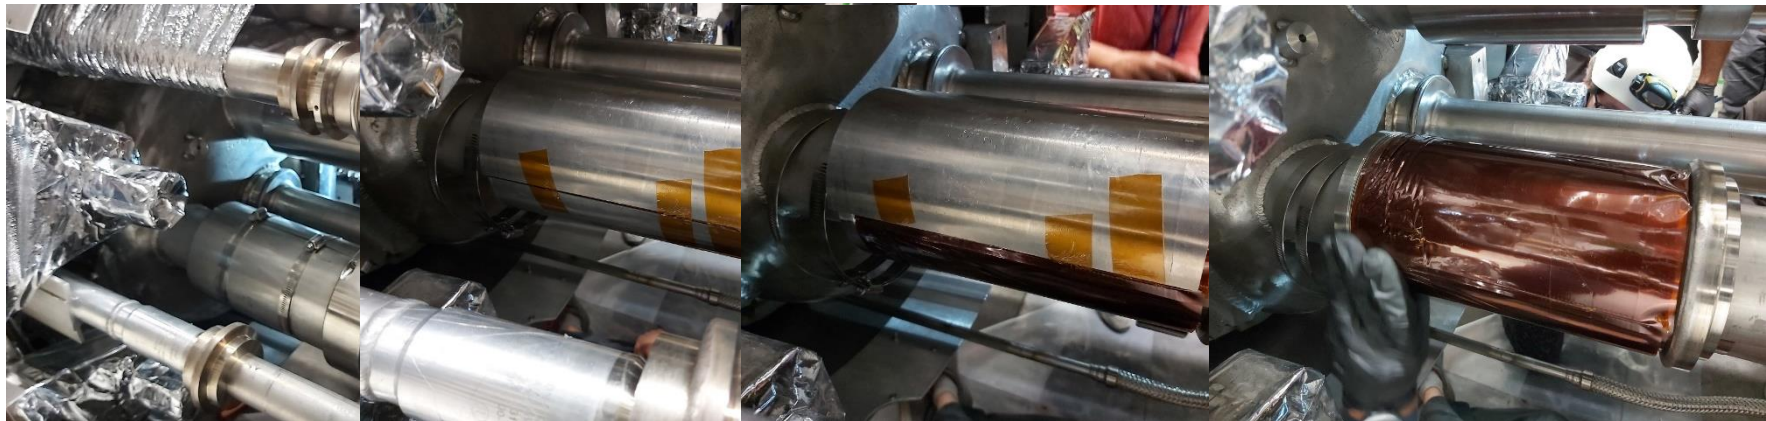
Protection shells of the bellow in place (buckling prevention)

Guiding shells position at room temperature. At cold, the bellow is extended by 8-12 mm.

Kapton layer to reduce bellow friction. The Kapton is pinched at the top of the bellow convolutions.

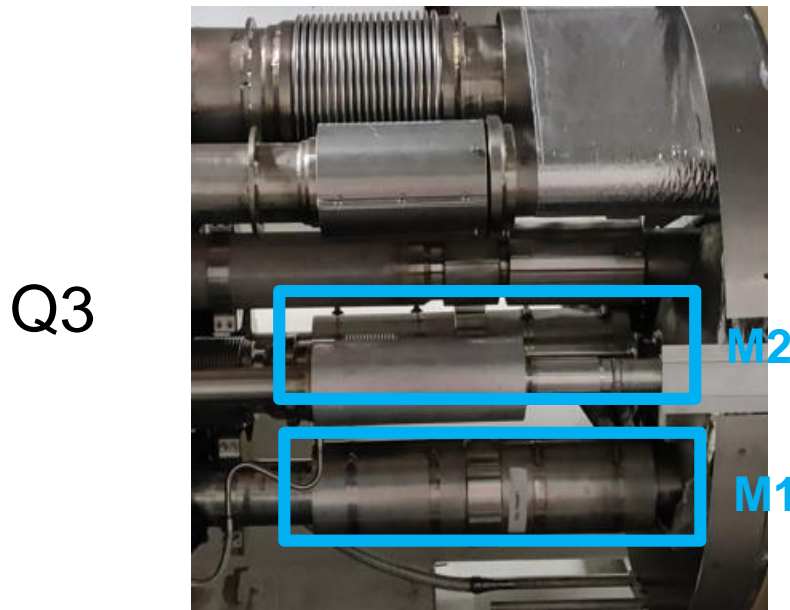
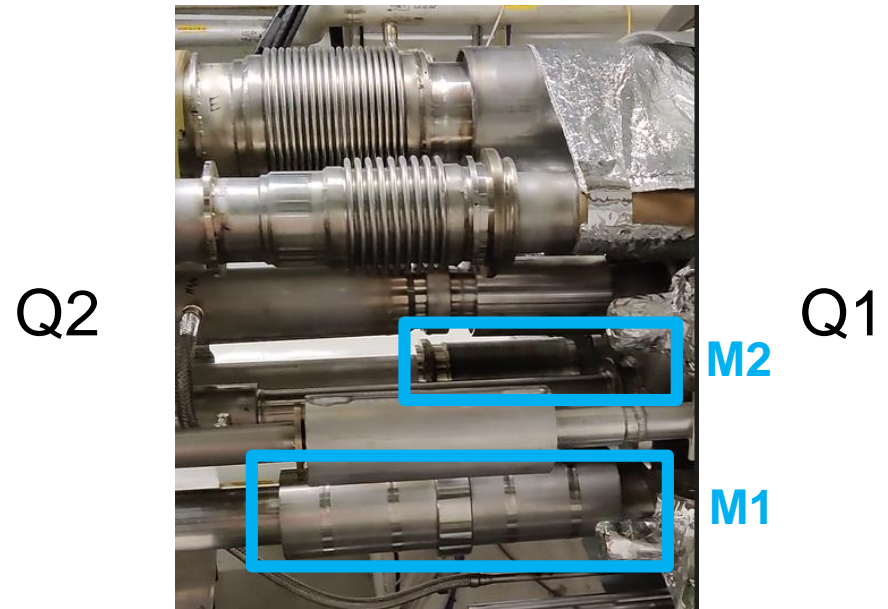
Edge welded bellows in IT interconnection

Localised on M1 (busbar line) and M2 (instrumentation line), the edge welded bellows are installed in pairs. Only M2 line in Q1-Q2 interconnection contains a single bellows.

Protection and guiding shells are correctly adapted for bellows in pairs, but they are at the limit for the single one.

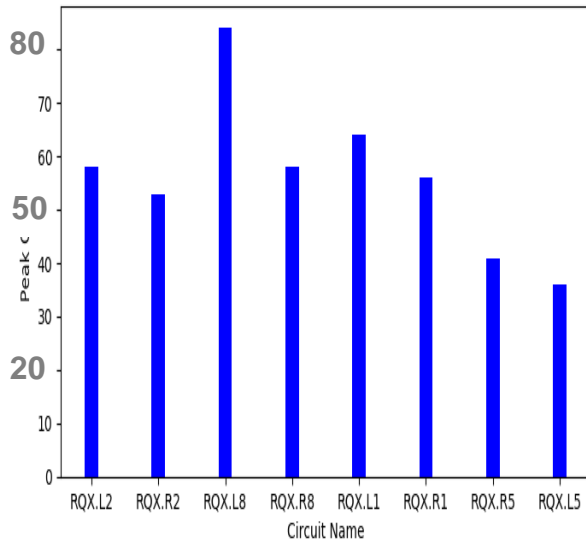
Even if the guiding shells are at the limit of the bellow flange (M2 line –Q1-Q2 IC), the IT.L8 experienced many pressurisations since its installation (84 cycles above 10 bars).
