Updates from Japan group

On behalf of the ATLAS ITk Japan group
Studies mainly by K. Imamura (Kyushu U.), K. Itabashi (KEK),
H. Nose (U. Tsukuba), T. Ogawa (Waseda U.), K. Sugawara (U. Tsukuba)

2024/02/02 at ITk Pixel module QAQC Japan-LBNL discussion

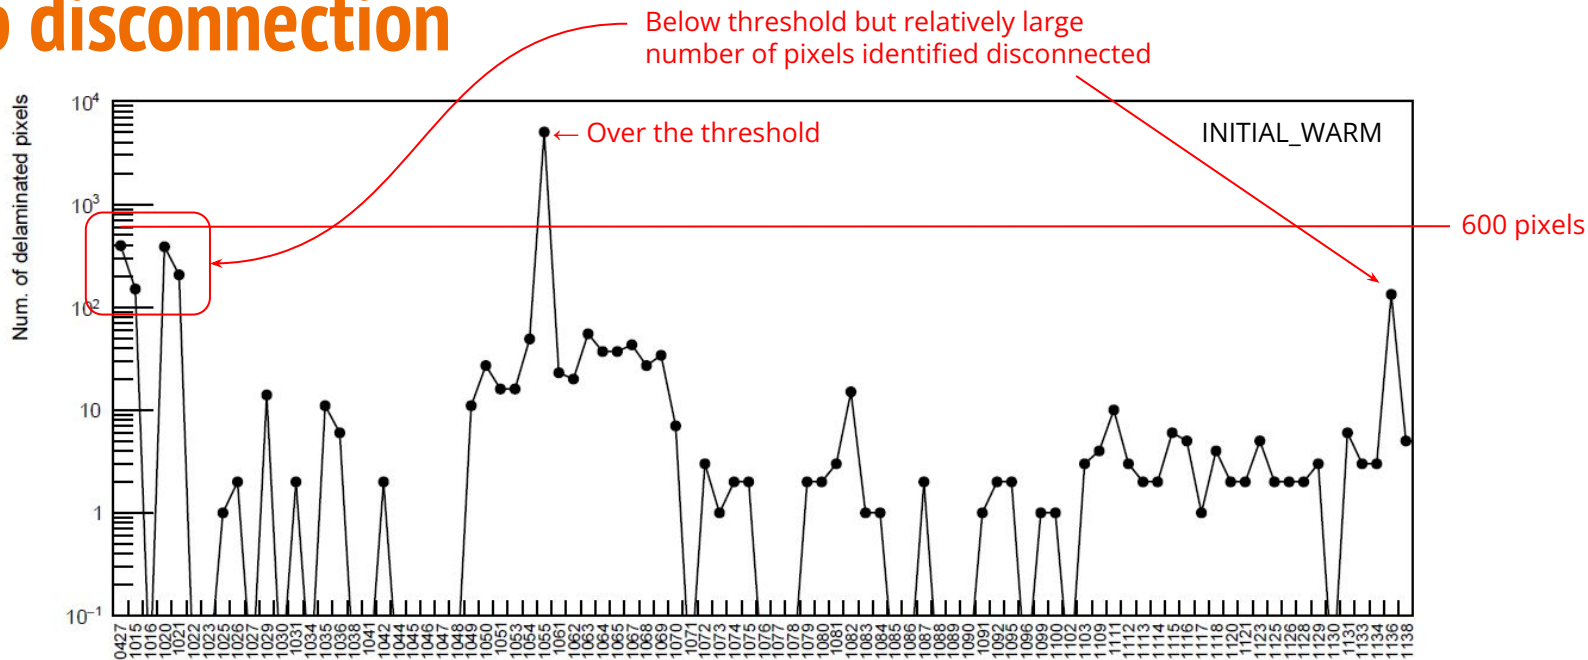
- AND of all the three types of scans
 - Observed 6 modules with some disconnection (out of them, 1 failed the threshold)

- Observed 6 modules partly with disconnected bumps
 - 0427 FE2, 1015 FE2, 1020 FE4, 1021 FE4; these share the same dicing line → Potential cause in the dicing process identified, and confirmed that will not happen in the production
 - 1055 FE3, 1136 FE4: these chips are from the wafer edge → Known that bump formation is incomplete for these chips (so should not have been used...)
- All 6 cases have been understood, and feedback given to the manufacturers

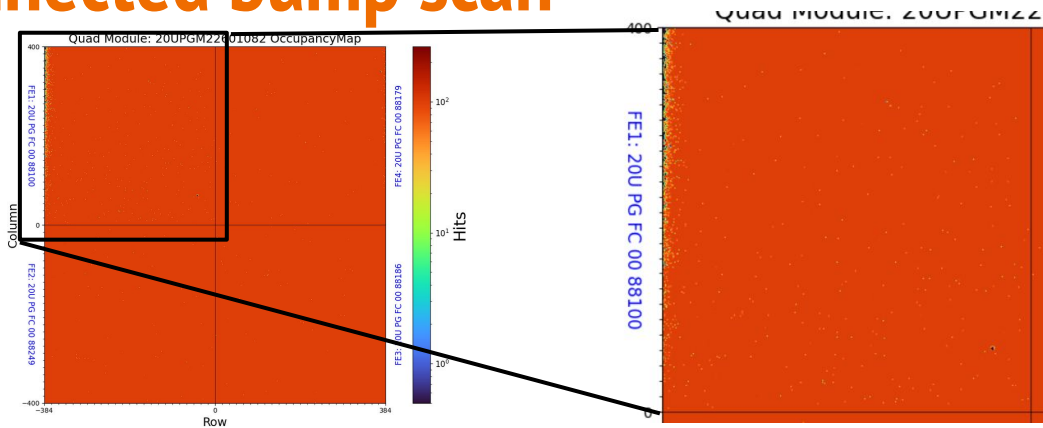
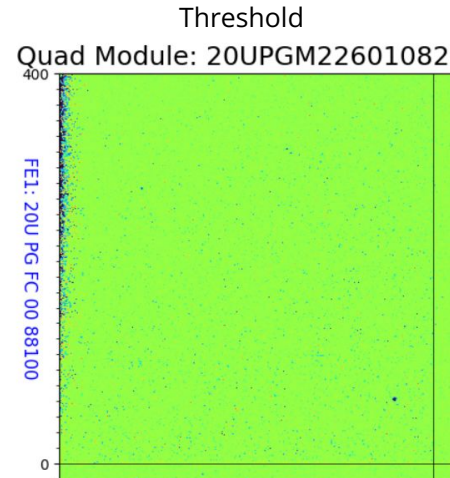
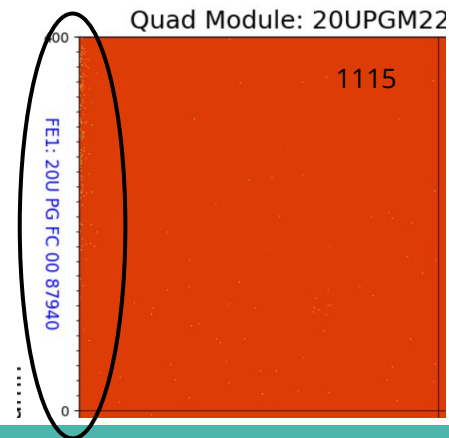
Disconnected bump scan

- There seems frequent cases where occupancy in discbump scan is low due to mis-tuned thresholds?
- Similar pattern observed even after LLC enabled
 - Though the effect is marginal...

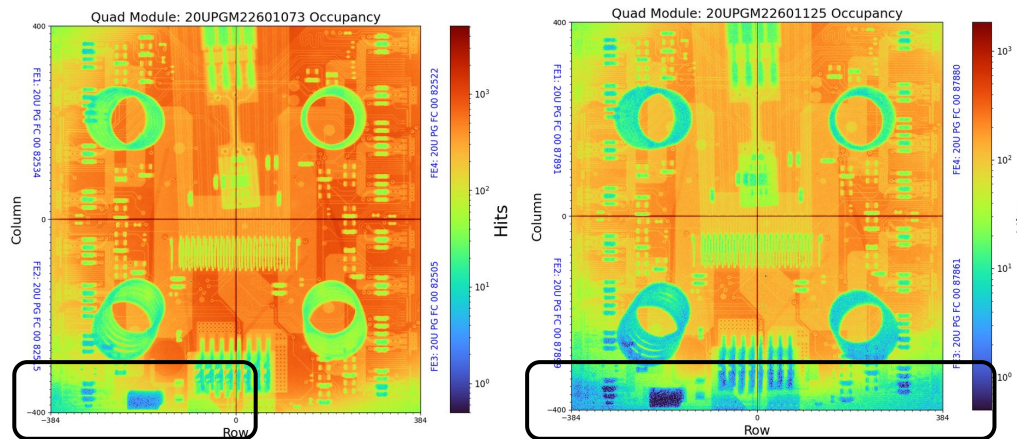
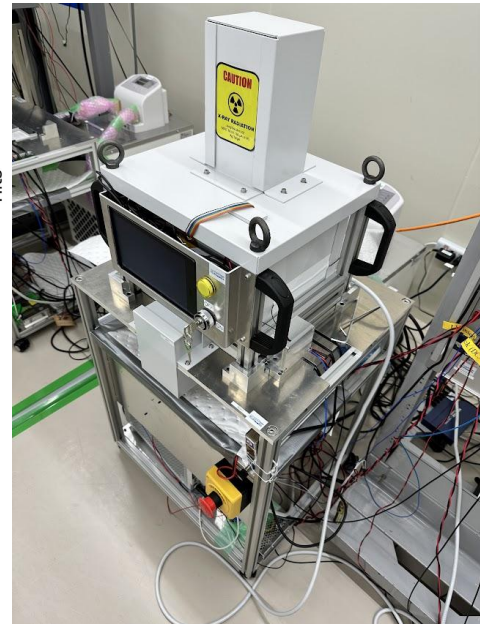
X-ray scan

- Need enough irradiation on the HV capacitor
 - If the X-ray box is slightly tilted (upwards on these figures), then irradiation to the bottom part of the module may be slightly sparse

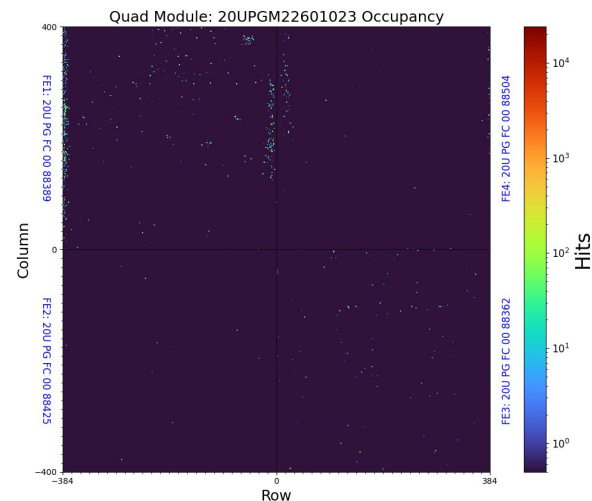
Noise around WB pads (chip bottom)

- Some modules show high noise near the chip bottom
 - They are concentrated on around rows 0-14
- This feature may be correlated to mis-measurements in disconnected bump scan?
- Investigated effects of enabling LCC

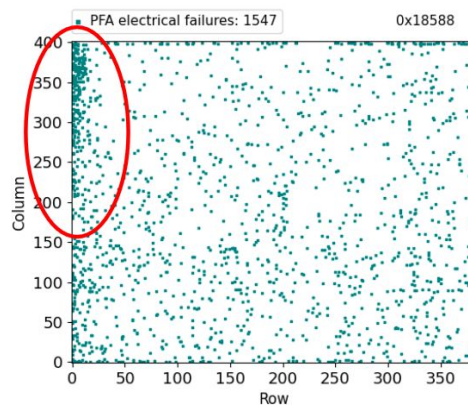
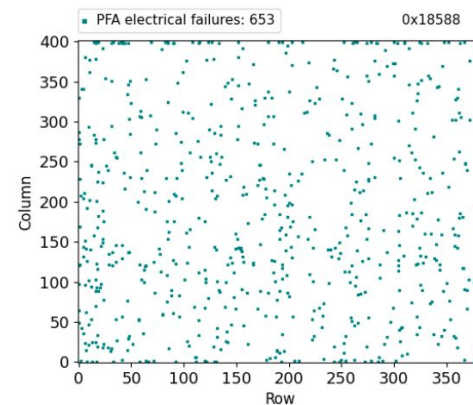
(INITIAL_WARM)	LCC off	LCC on
Num. of chips tested	310	60
Num. of noisy chips	17	0
Fraction	5.5%	0.0%

- So far we observed no 'noisy' module after enabling LCC by default
 - Good indication of effectiveness of the LCC
- Will check also results from the cold tests too

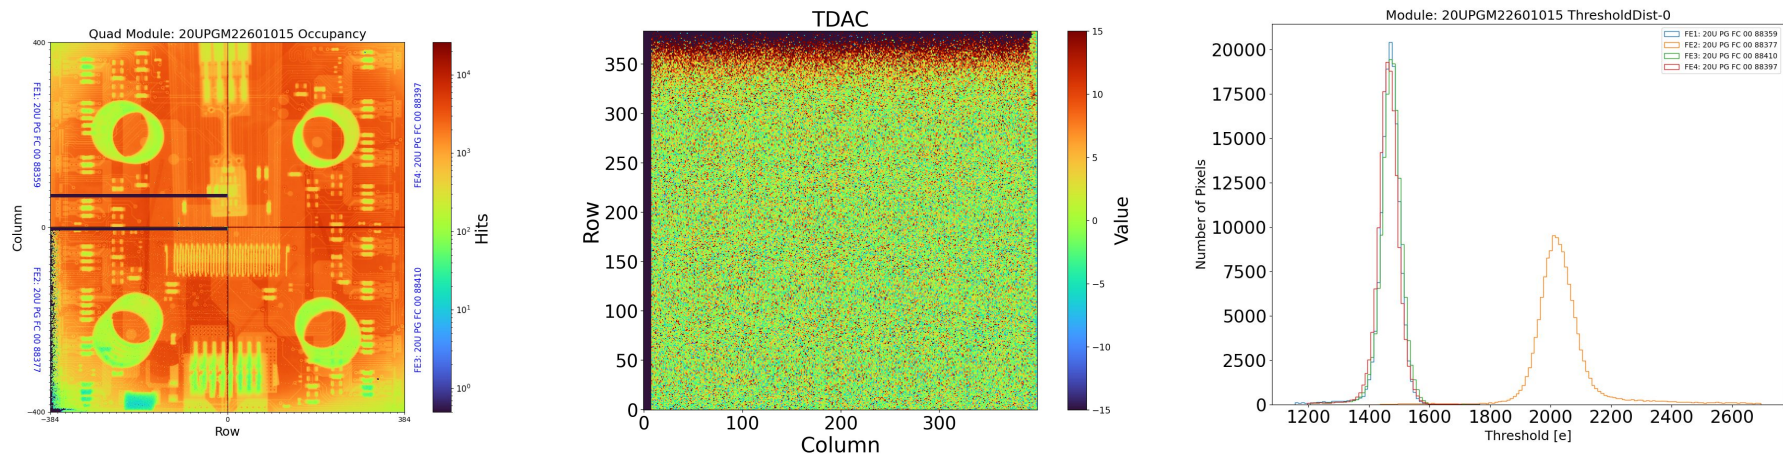
20UPGM22601015

Failed tuning at FE2

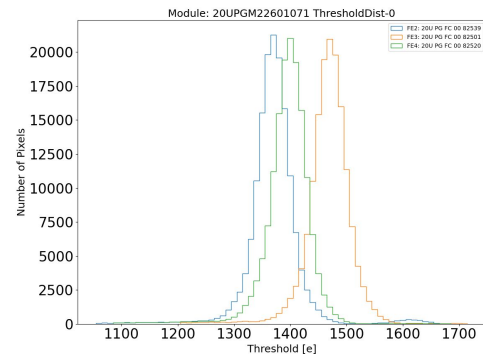
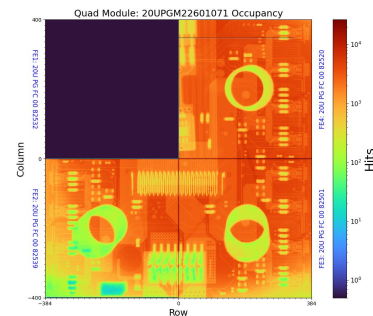
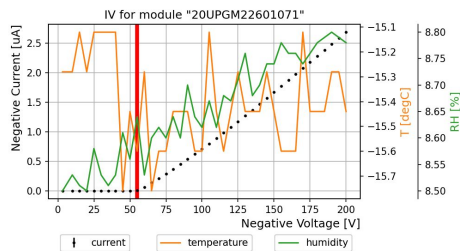
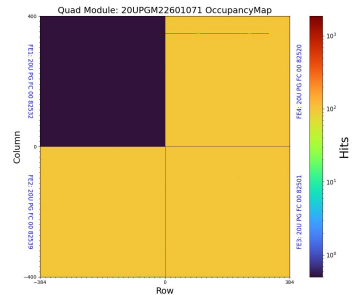
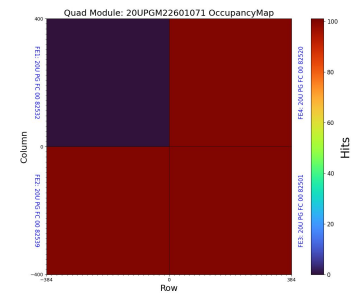
20UPGM22601071

chip 1 disable → コミュニケーションとれず

- INITIAL_WARMではEnCoreCol2: 0011 1111 1111 1111
- INITIAL_COLDでchip 1がdisableされている

chip 3のthreshold高め

Chip 4: analogが一部読めてない

IV break at ~60 V

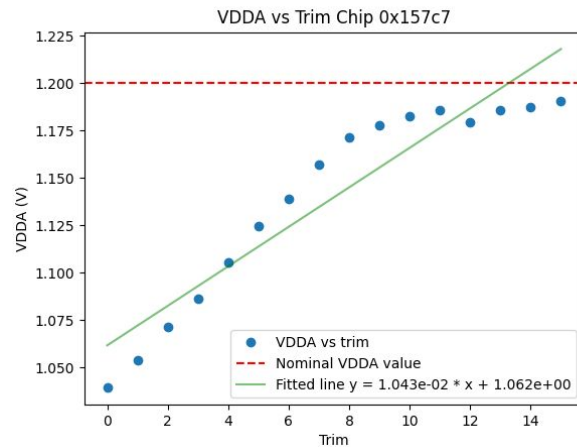
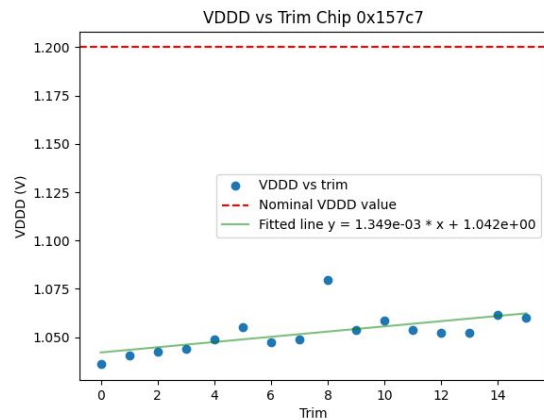
20UPGM22601094

Chip 4 EnCoreColumn2: 1111 1110 0111 1111

Chip 4のVDDA/Dの出力が1.2 Vに達しない

→ failの理由

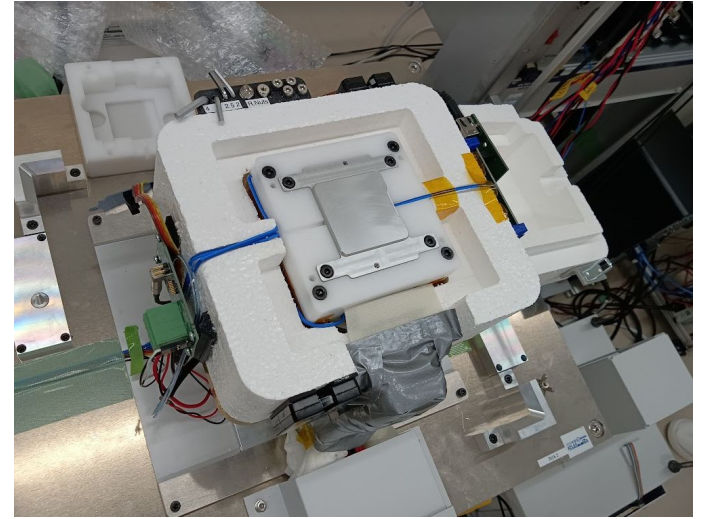
Cooling box

- For OE modules, thermal contact is not very robust
 - Cooling head directly contacts the ASIC side
 - Try to push the module with springs
