Debugging a module with bad columns

Francesco Crescioli

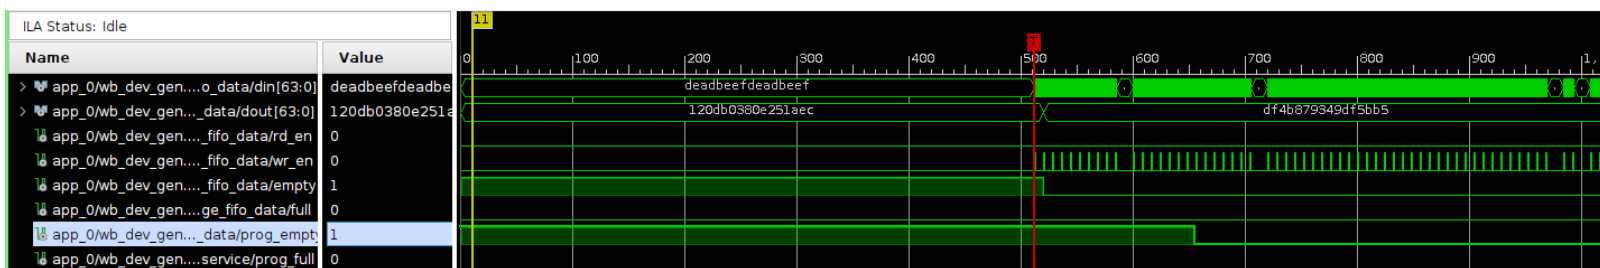
- This is a snapshot of a continuous stream of data
- NS = 0 and ChipID = 0 consistently for all packets
 - The problematic FE is indeed ChipID 0
- Data is super hard to decode but has some patterns

- At least for this chip the bad core column issue seems to be related to an unexpected behaviour of the internal hit data flow
 - It is NOT a case of link instability
 - The bad columns induce the chip to send out a never ending flow of hit data
 - Everything else in the chip seems functional
- This is NOT the expected behaviour
 - No trigger were issued
 - no trigger command were sent and this is confirmed by a reading of TrigCnt = 0
- This is just one quad, I have others with less severe behaviour I will look into very soon
