# VELO revalidation and intensity ramp-up

**Victor Coco** (CERN) for the LHCb Velo group

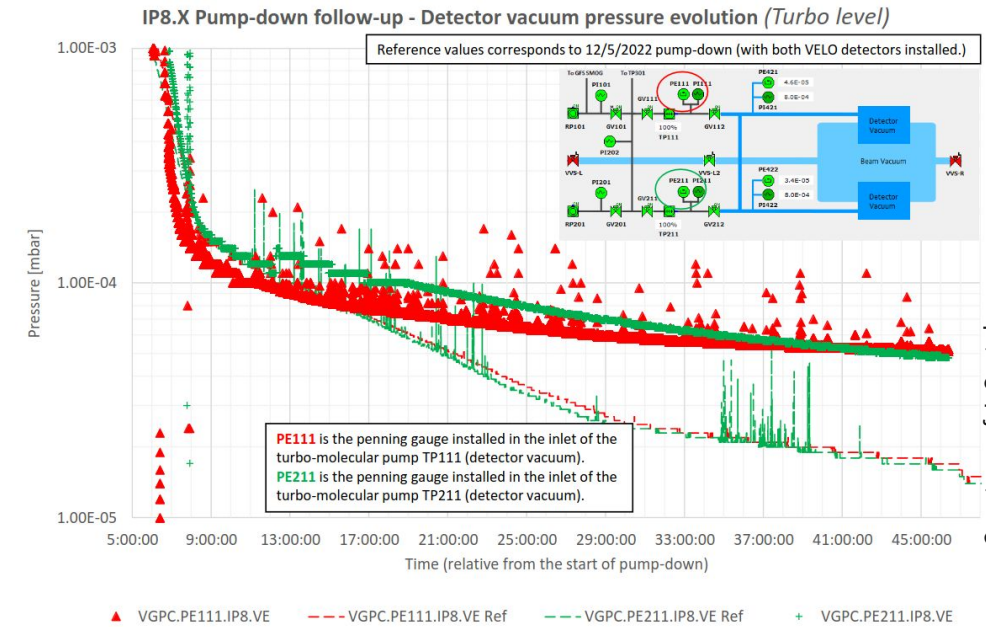
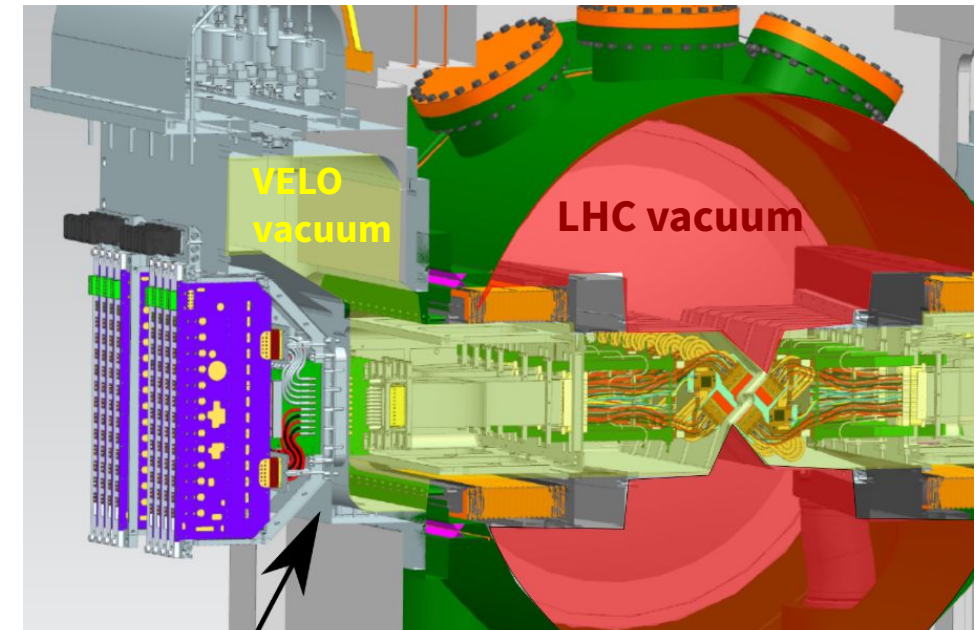
- **Pressure evolution within the detector vacuum volume was different from the 2022:**
  - DSO test on 15th, retightened flange on 16th, checked impact of tertiary vacuum on 19th followed by He-leak test.

- Stabilised around  $3\text{-}4 \cdot 10^{-5}$  mbar
- **He leak check by TE-VSC**
  - Identified the possible region at the top corner of A-side detector flange.

- Measurement at  $10^{-5}$  mbar.l/s but likely an underestimation because of the complex mechanical interface.
  - Max leak rate from pressure readout and pump speed is  $10^{-2}$  mbar.l/s

- **Intervention to fix requires O(10 days)**
  - Discussion with TE-VSC, LHCb TC and VELO groups to evaluate the options on Feb. 23<sup>th</sup>, could have started on 26<sup>th</sup> Feb.

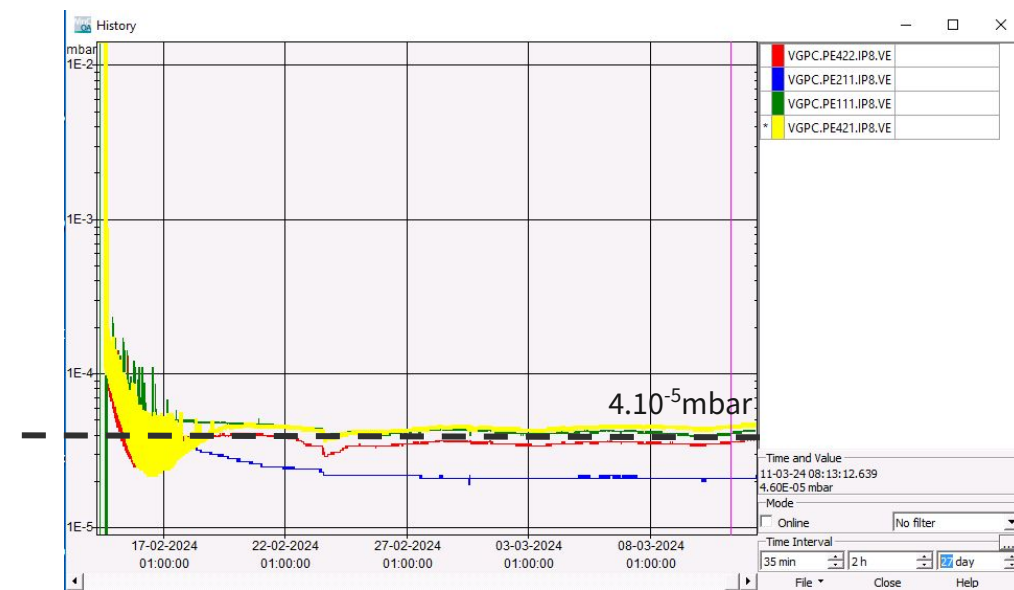
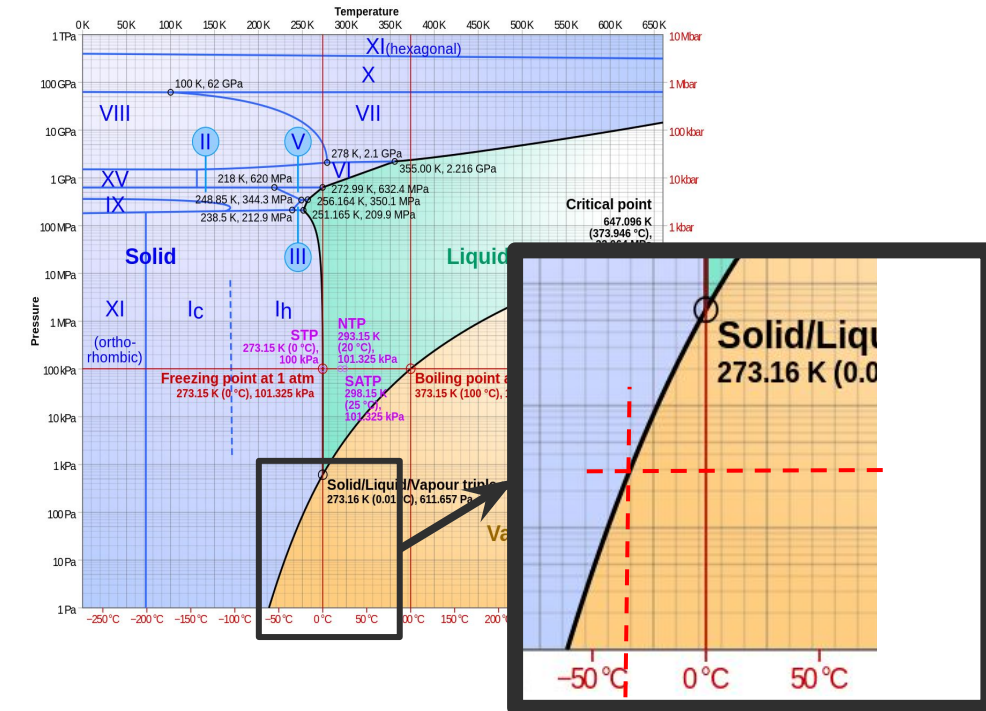
- 3-4.10<sup>-5</sup>mbar instead of 10<sup>-6</sup>-10<sup>-7</sup> mbar
- Expected not to degrades under steady load

- presence of water from air humidity in the detector
- when the pump are running:
  - saturated water vapor at -35°C is at 0.22mbar
  - Partial pressure of water in air 0.028, ie needs to reach about 7.8mbar to form ice
- If pumps stops:
  - Would take about 5 days to reach
  - But at 10<sup>-3</sup>mbar (about 1 min): hw safety system triggers turning OFF HV and LV, warming up the detector (~1h), and close the CO<sub>2</sub> safety valve.

- reaching the 10 mbar limit of the vacuum safety system (ie connecting LHC and detector vacuum) if the pump stops
  - about 7 days to reach 10 mbar
  - leave enough time to fix the source of the stop

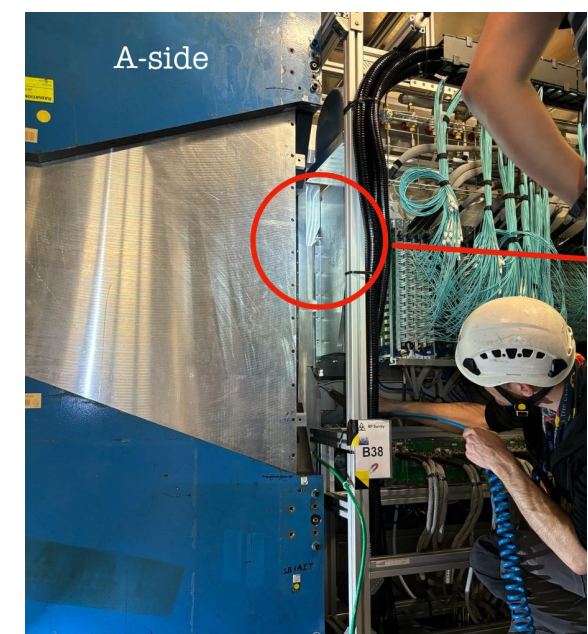
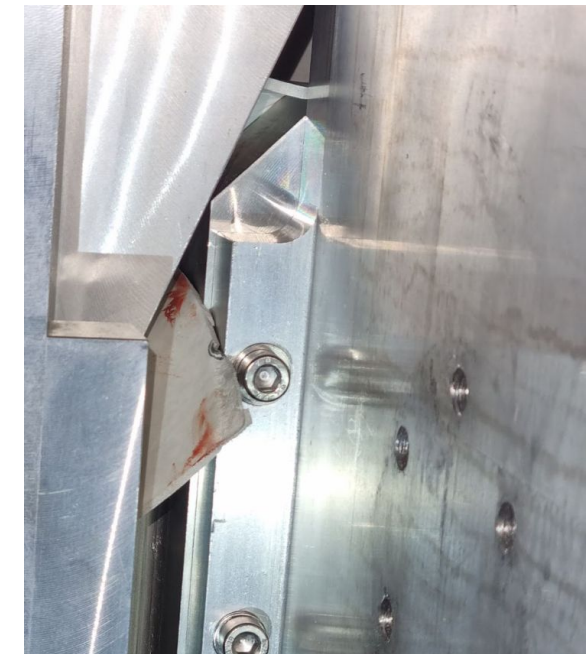
- **Source of the leak is not completely identified**
  - Could be parts of the heat mat stuck, or dust on the O-ring.
- **J. Sestak (TE-VSC) kindly providing an design for isolation vacuum around the leak**
  - If 1 mbar can be reached, better detector vacuum could be reached
  - To be produced and tested in the coming days
- **Fixing the leak**
  - Intervention itself should take about 10 days and requires:
    - Uncabling (2-4 days depending how much we uncable)
    - Venting (2 days)
    - Opening detector, de-engaging from RF box, cleaning interface / changing O-ring, re-engaging and closing (1-2 days)
    - Pump down (2 days)
    - Recabling (2-4 days depending how much we uncable)
    - Recommissioning without beam (2-3 days)
  - Come with some risk for the detector equipment

Region spotted by He leak check

⇒ probably not before YETS 2024/2025
