PRE-RUN PREPARATIONS 2024

S.HAIDER

-
- Upgrades and repairs
 - Cooling down
 - First observations

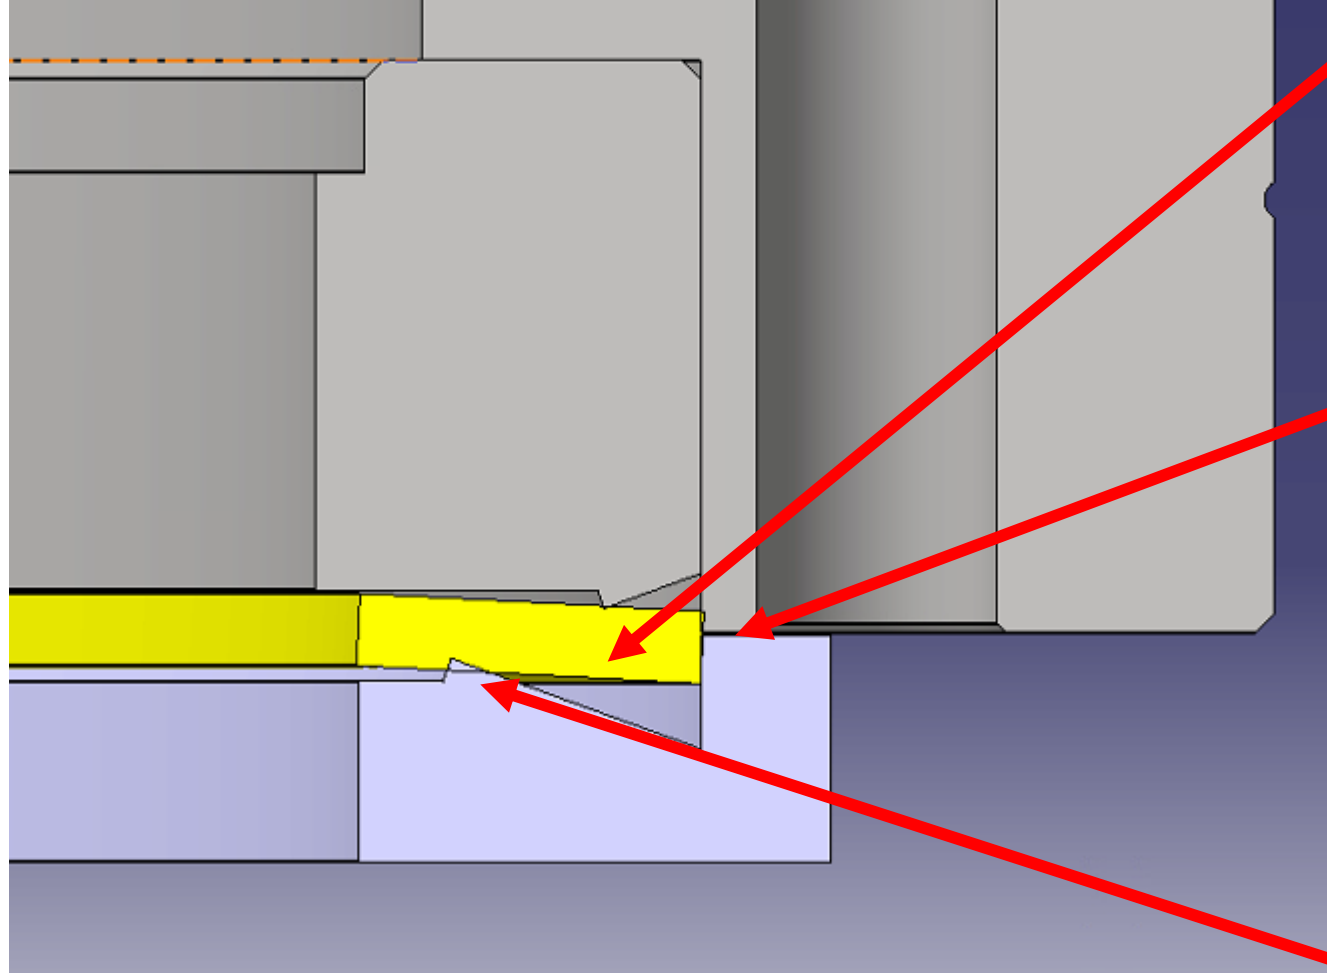
The knife-edges of the two flanges are not on top of each other!!!!

The gasket was distorted because the knife-edge on the SUN did not have anything to press against.

Both flanges were “steel-on-steel” due to the enormous pressure of the screws

Only the lower knife edge was pressed into the gasket

We fill the gap between flange and copper gasket, in order to keep the form of the gasket intact.
Such both knife-edges can cut into the copper.

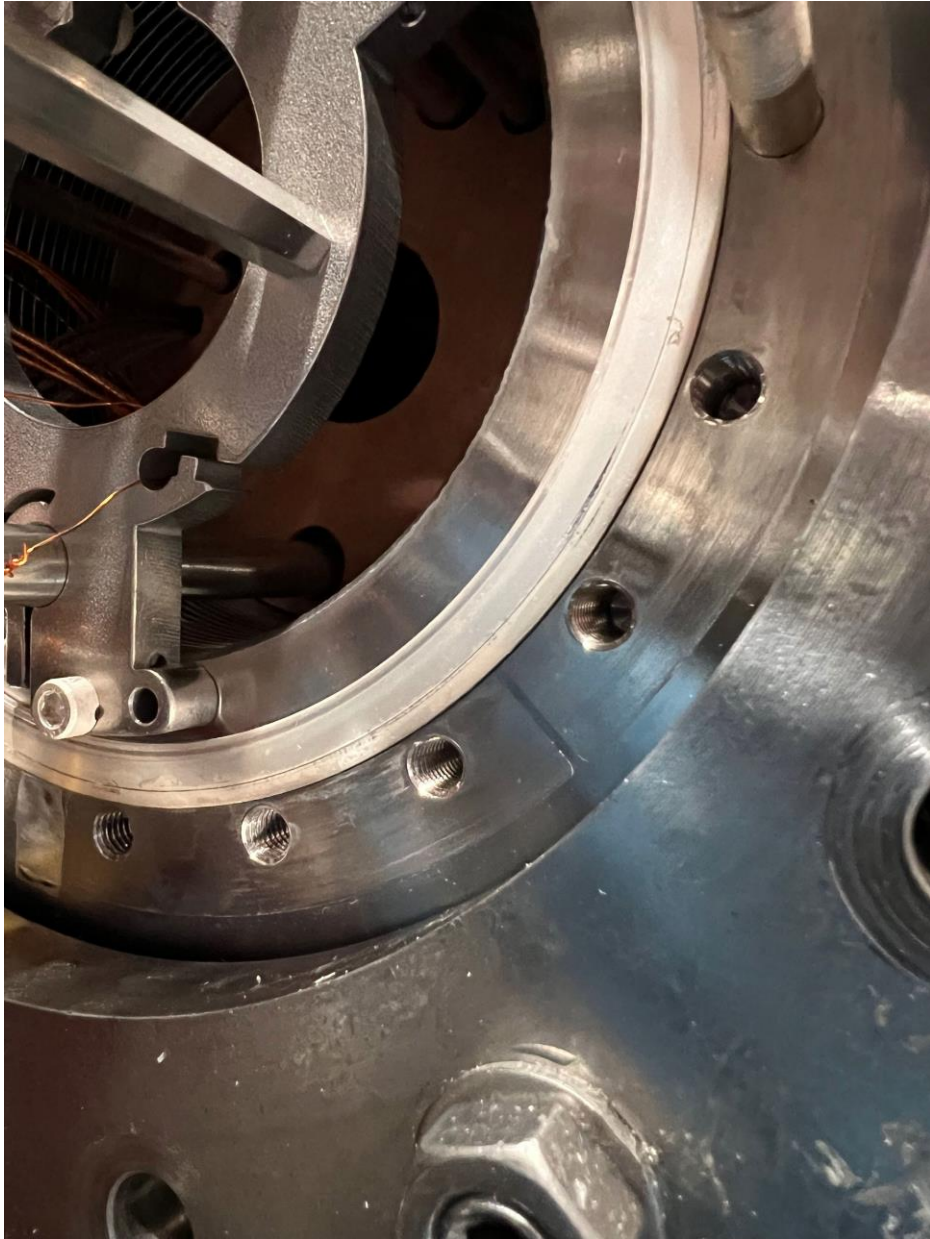
The copper gasket
was deformed into a
“Cone” !

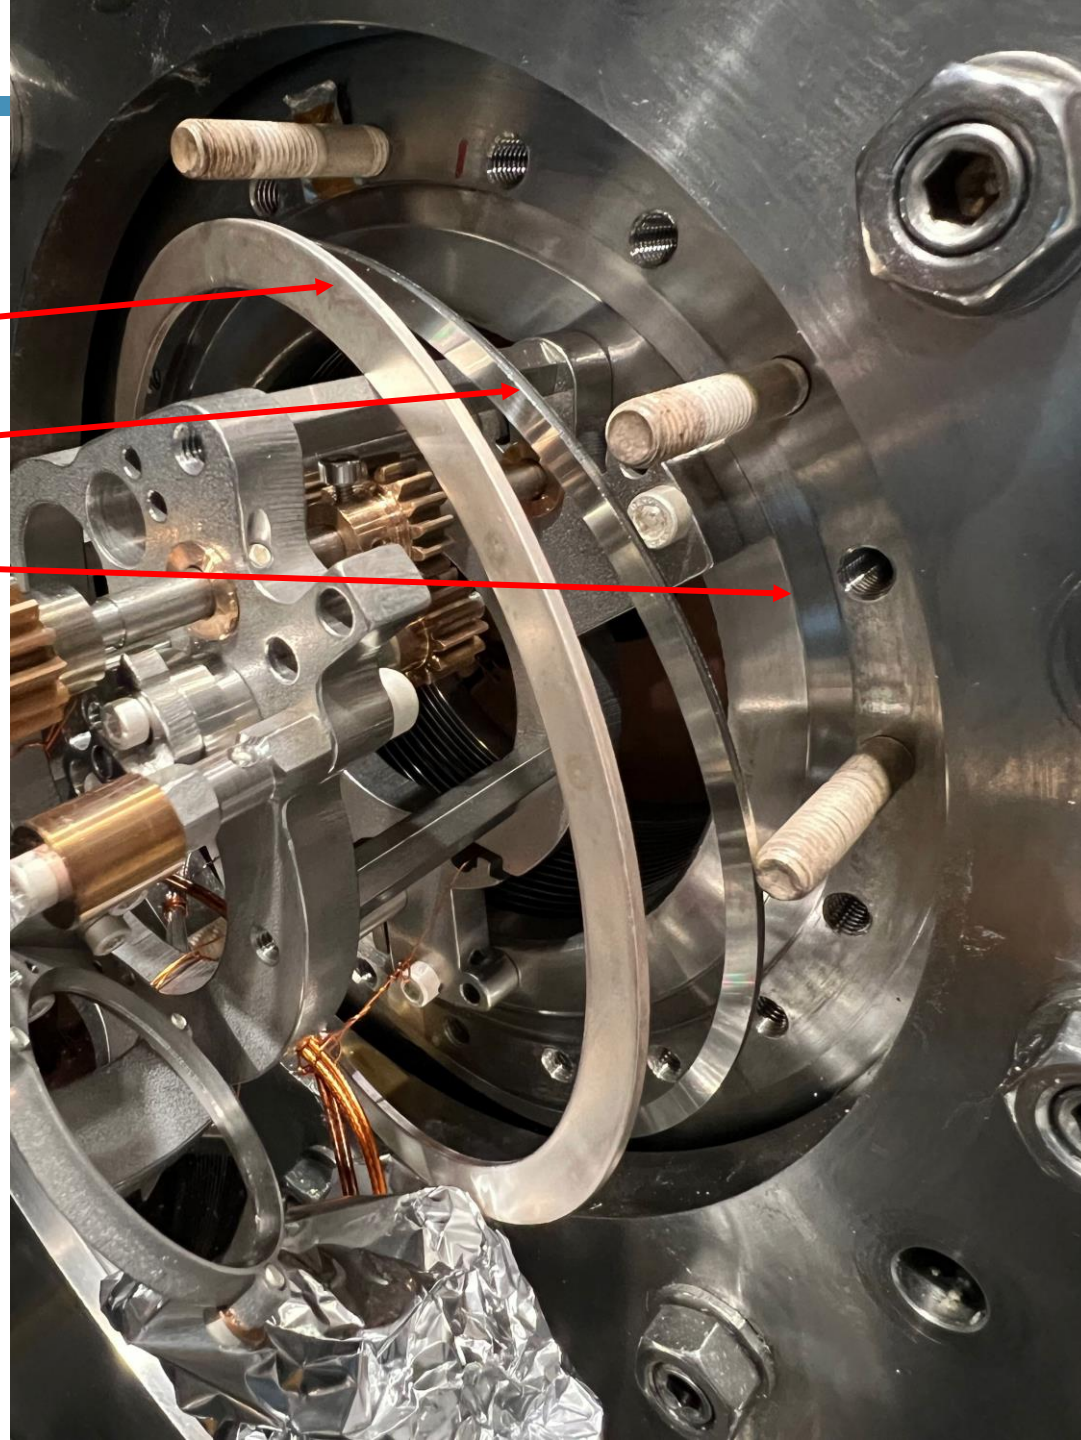
End January vacuum test with the new SUN in place. All actuators Adjusted and verified.

No leaks found with the Helium leak detector

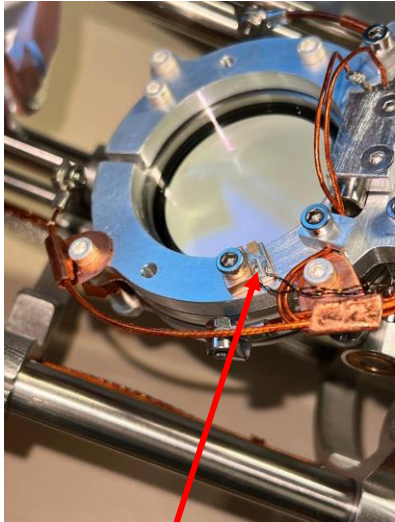
5T MCP temperature Sensor was repaired

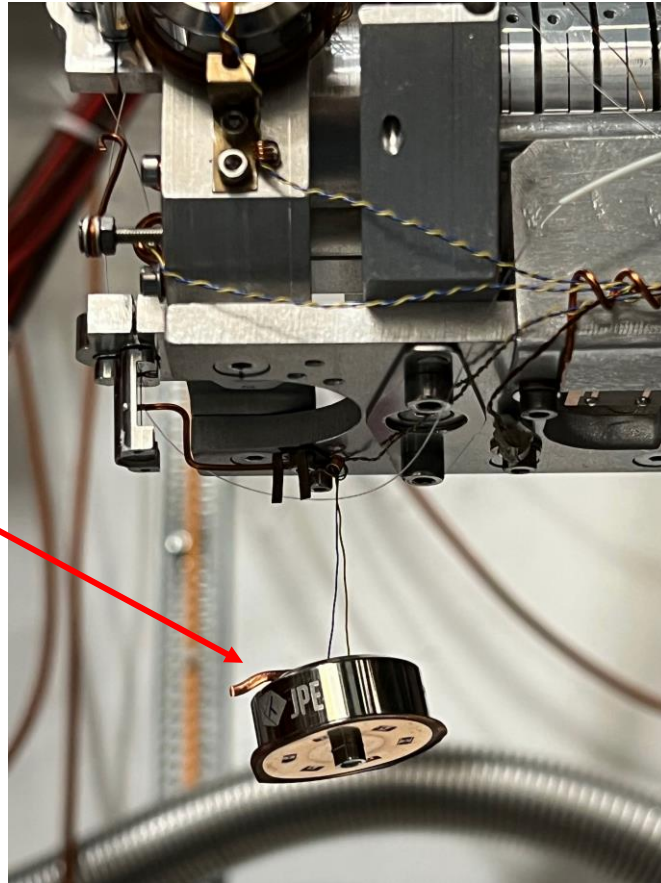
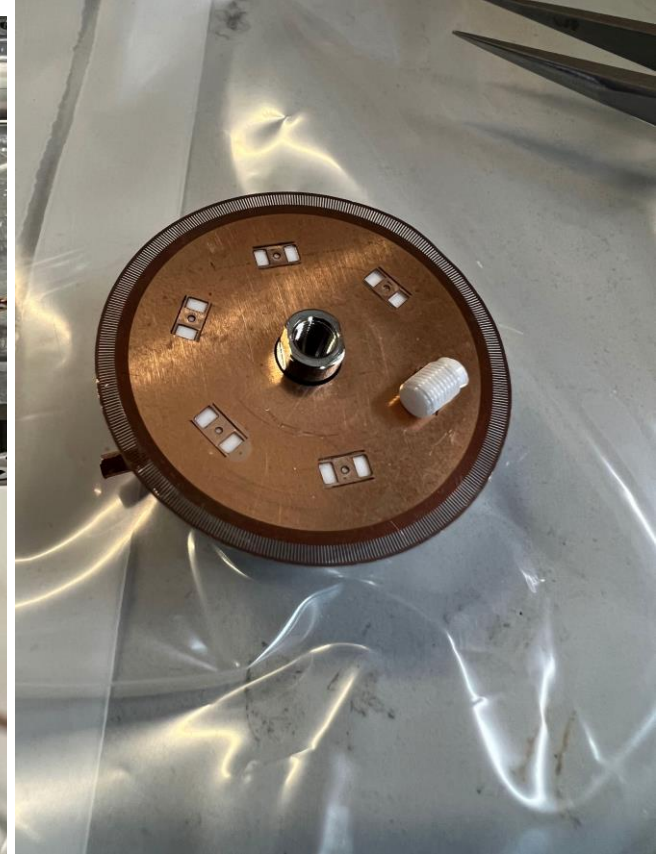
One of the IT opening sequences, a cable got tangled-up on the Y-axis alignment motor of the IT trap, and snapped its ceramic axis.

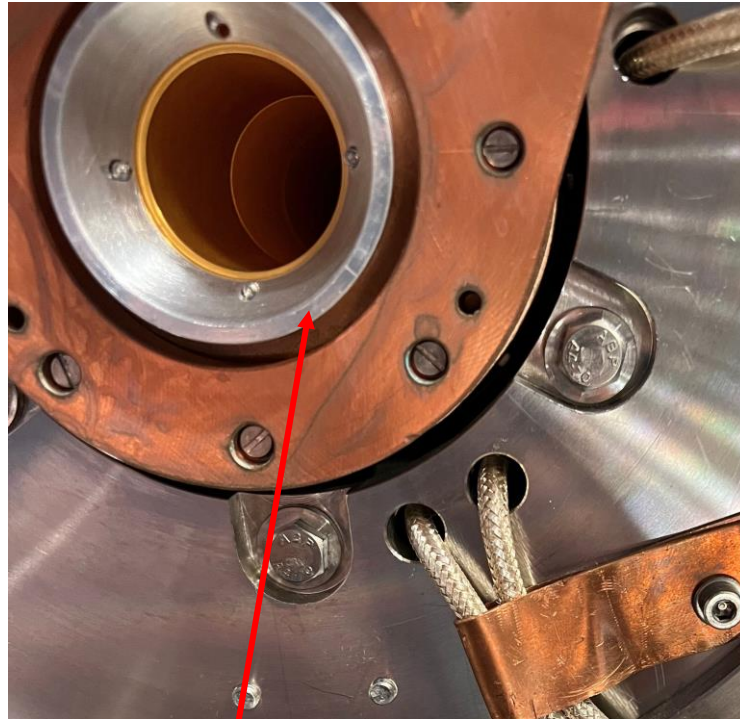
The end of the 5T trap has a cone attached to trap electrode T6. (which is on no 3D drawing!!)

These two electrodes were colliding by $\sim 1.5\text{mm}$ when the experiment was fully assembled. We never realized this because also the cable to T6 was broken. Only electron test showed that something was wrong in this area.

The “coned” electrode of the 5T trap was shorted by a few mm and the cable to T6 was repaired.

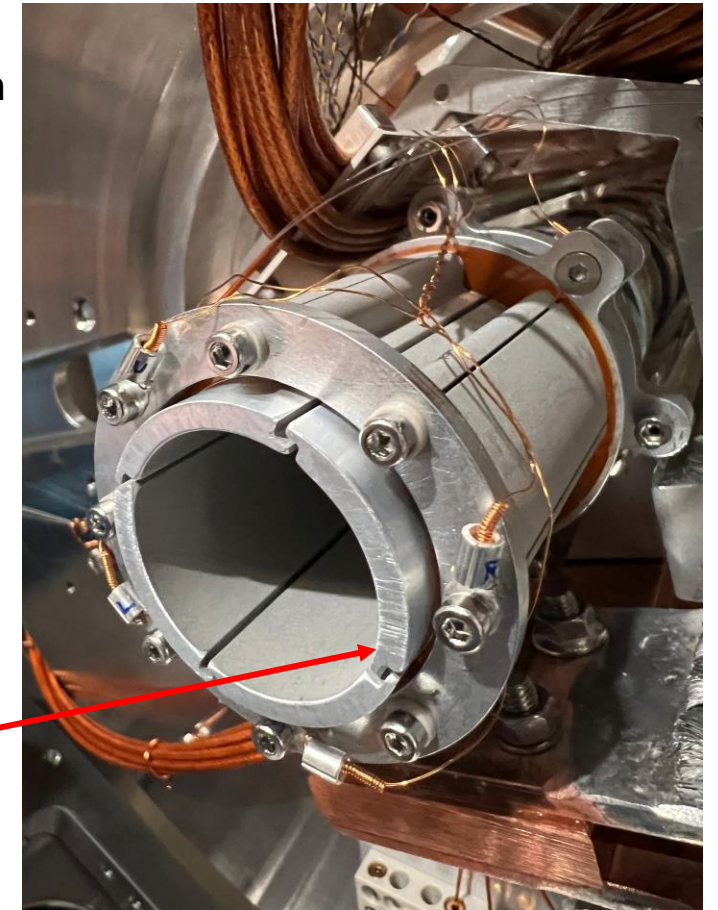
Split electrode of the IT trap in the CR. I.e. the first electrode on the IT trap

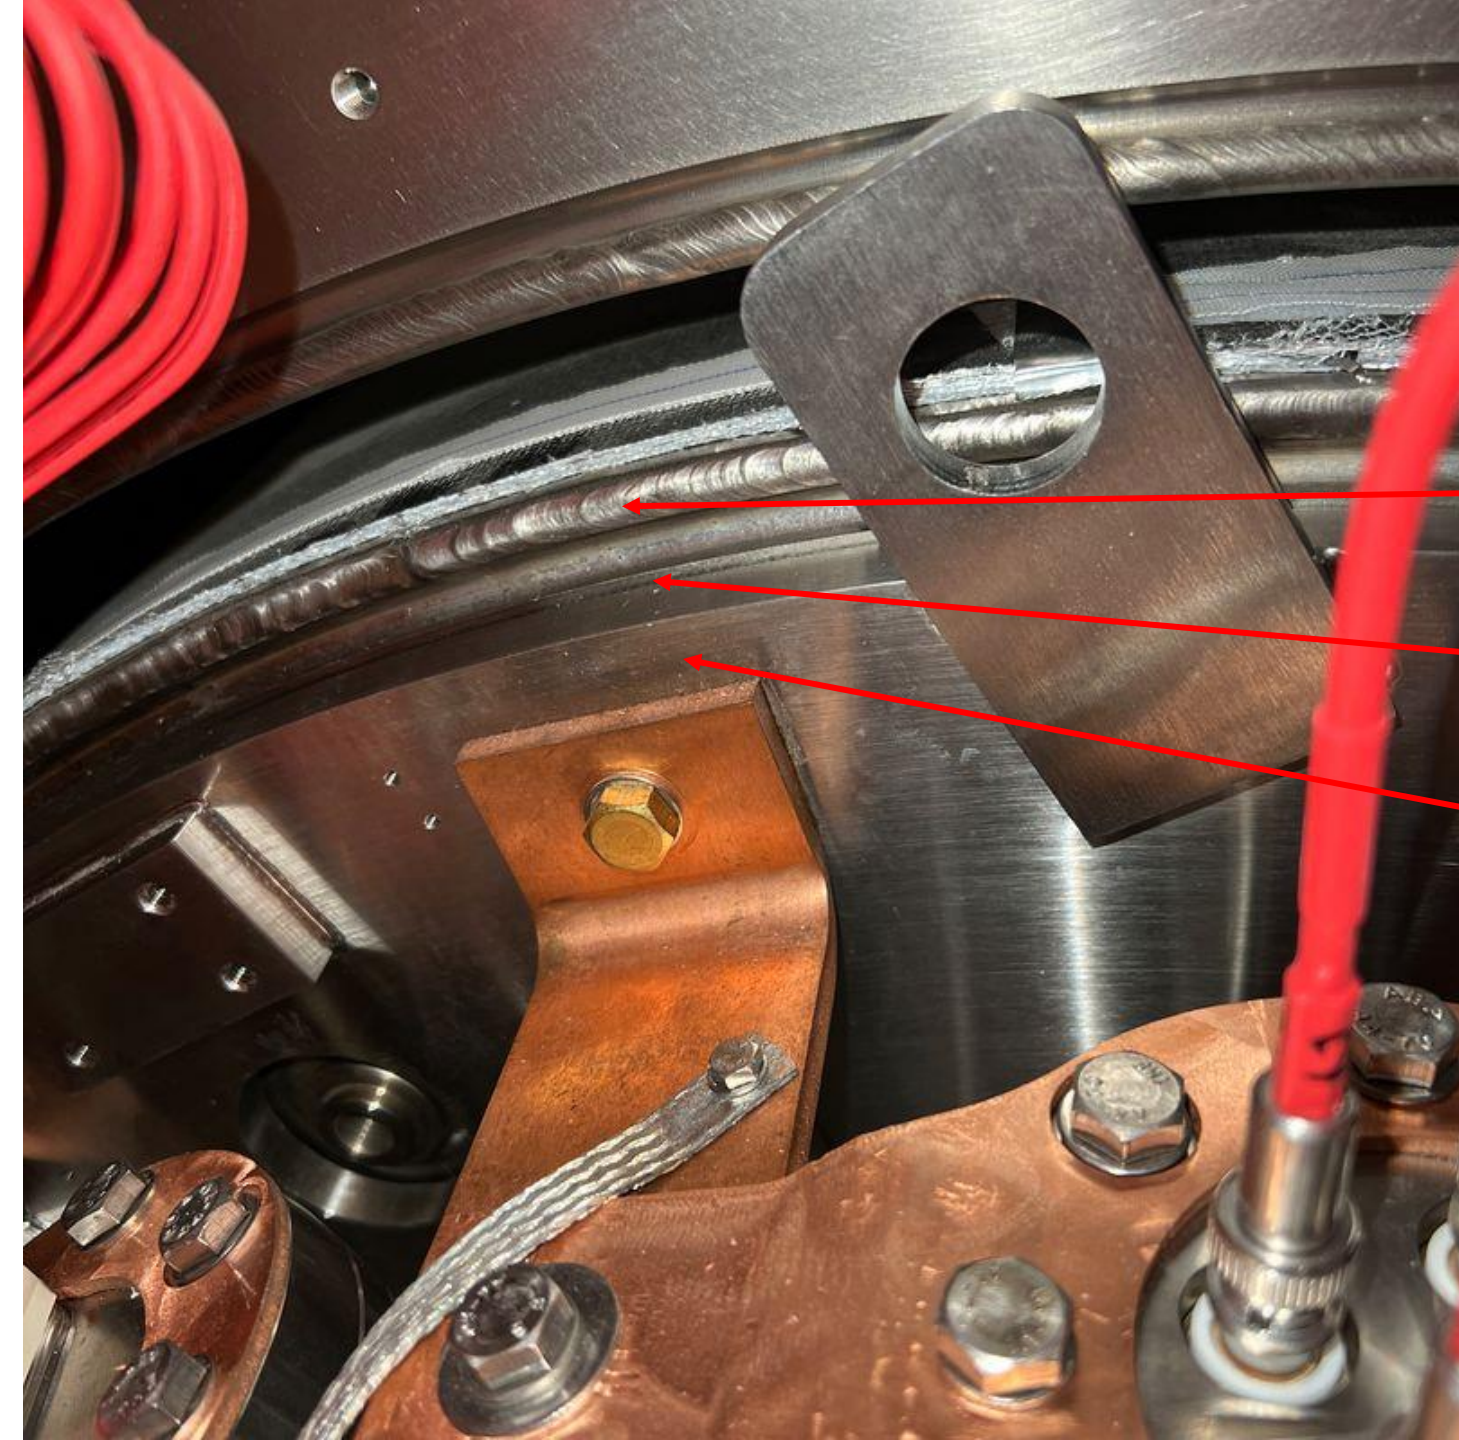
View from the open 5T-CR-part

Zero gap between the flanges!!!!
