Beamline Status

05.2024

Starship Chamber repairs

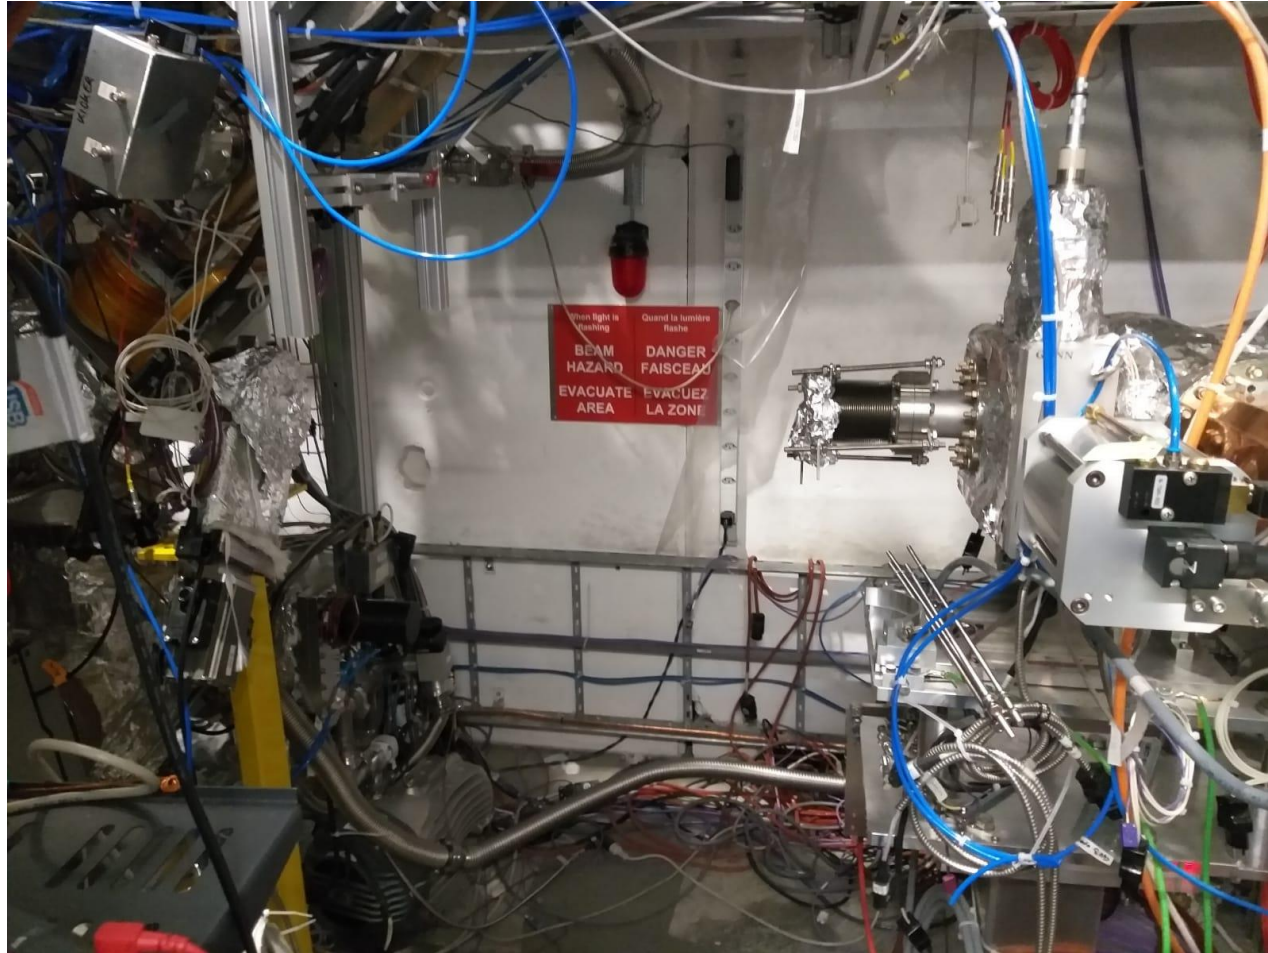
The chamber had to be removed from the beamline for re-cabling
