Experience with 175MHz, 200kW, CW couplers for LIPAc's RFQ

DE FRANCO Andrea, CISMONDI Fabio
on behalf of the IFMIF/EVEDA Integrated Project Team
6th WWFPC; 2nd - 3rd July 2024 - CERN

Linear IFMIF Prototype Accelerator (LIPAc)
Rokkasho Fusion Institute (BA Site)

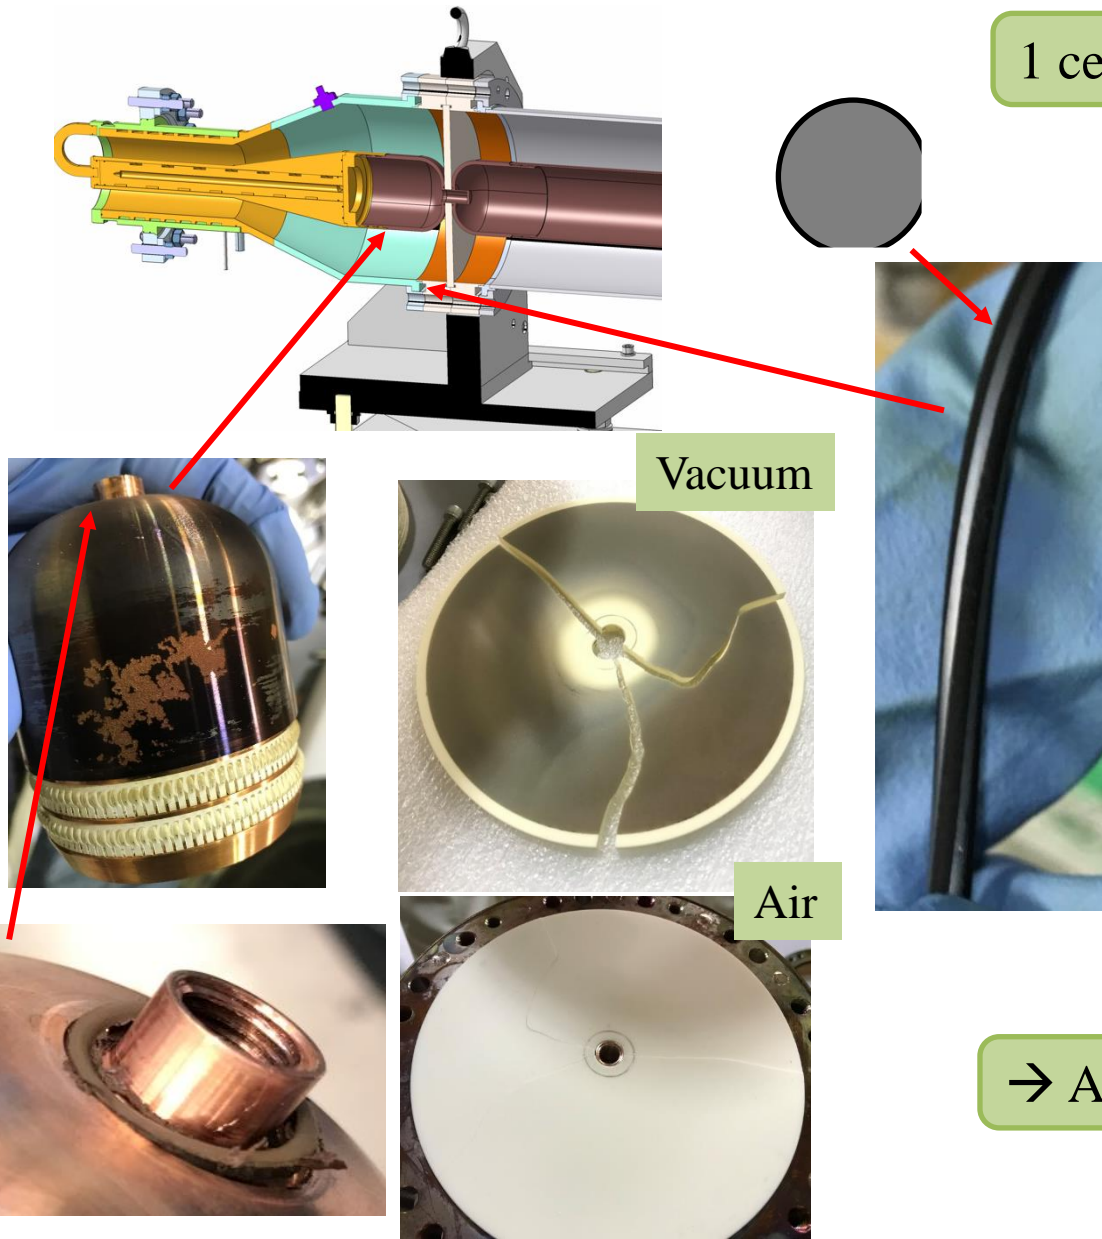
1 ceramic broke during test while interlock were disabled

1: Al, O
2&3: Al, O,
Cu

→ Additional surface temperature sensors attached to coupler.

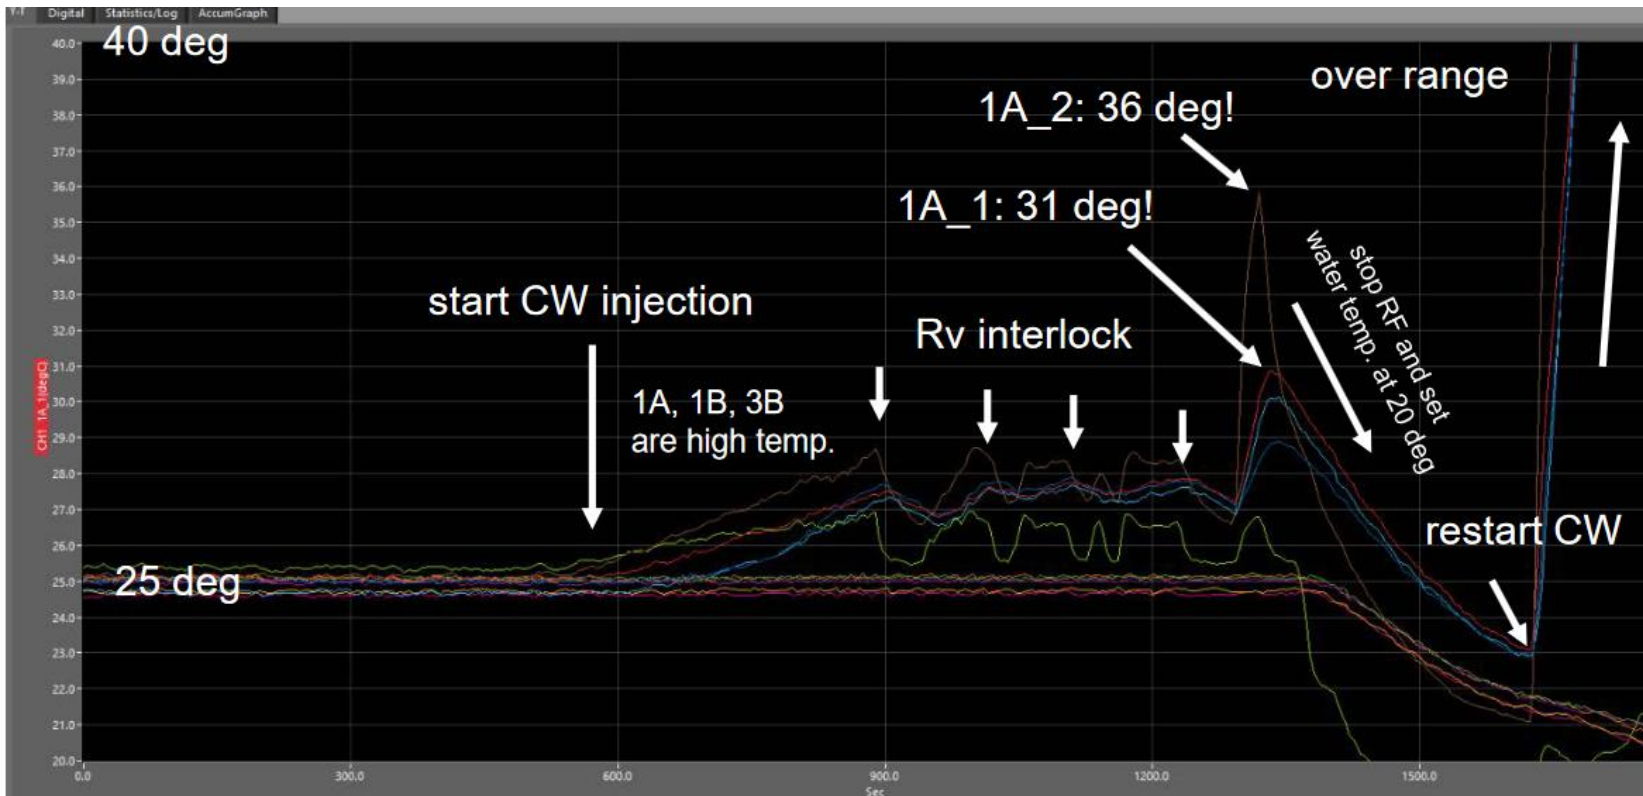
CW conditioning with ~7kW Fwd in each coupler.
3 couplers are hot.

CH(ALL)	Level	Unit
CH1 1A_1	+76.64	degC
CH2 1B	+82.28	degC
CH3 2A	+20.80	degC
CH4 2B	+20.71	degC
CH5 3A	+20.71	degC
CH6 3B	+83.05	degC
CH7 4A	+20.32	degC
CH8 4B	+20.30	degC

→ Install water cooling external jacket & interlock from T sensors

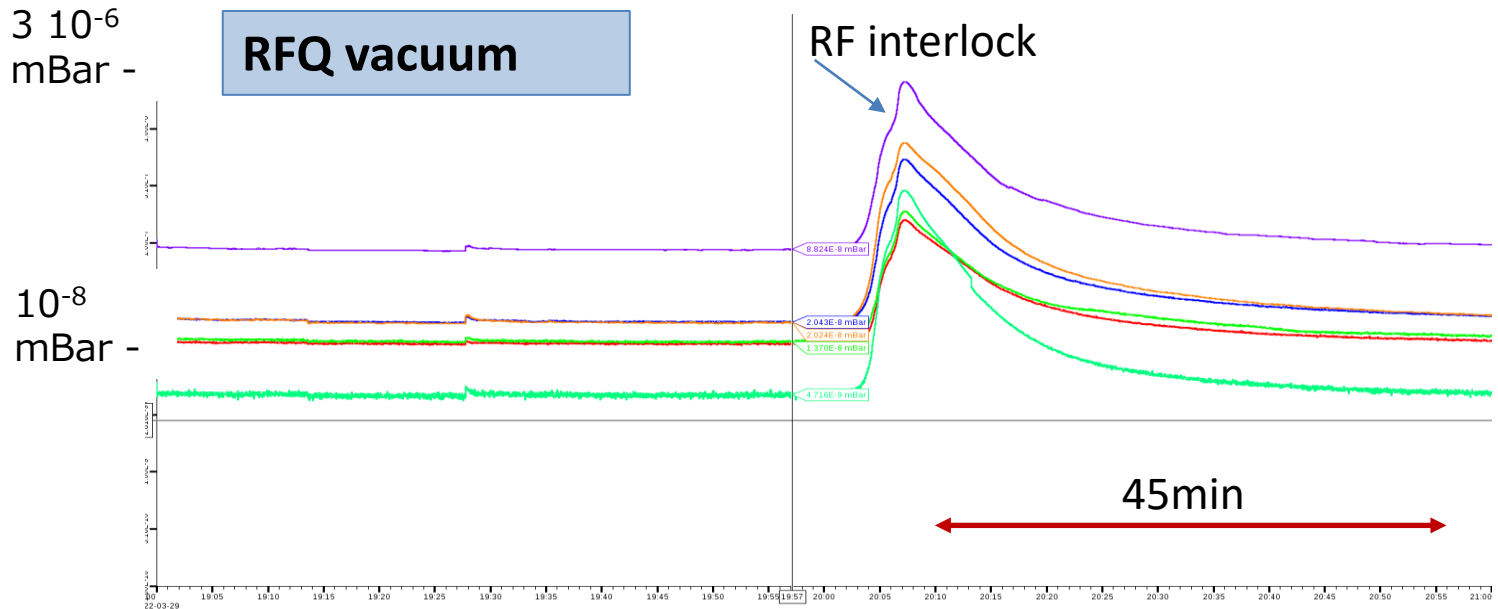
Vacuum leak time constant very slow & correlated with couplers temperature.
 → Suspect o-ring melt in RF window

Could not clearly identify which coupler
 → Dismount all 8 for inspection

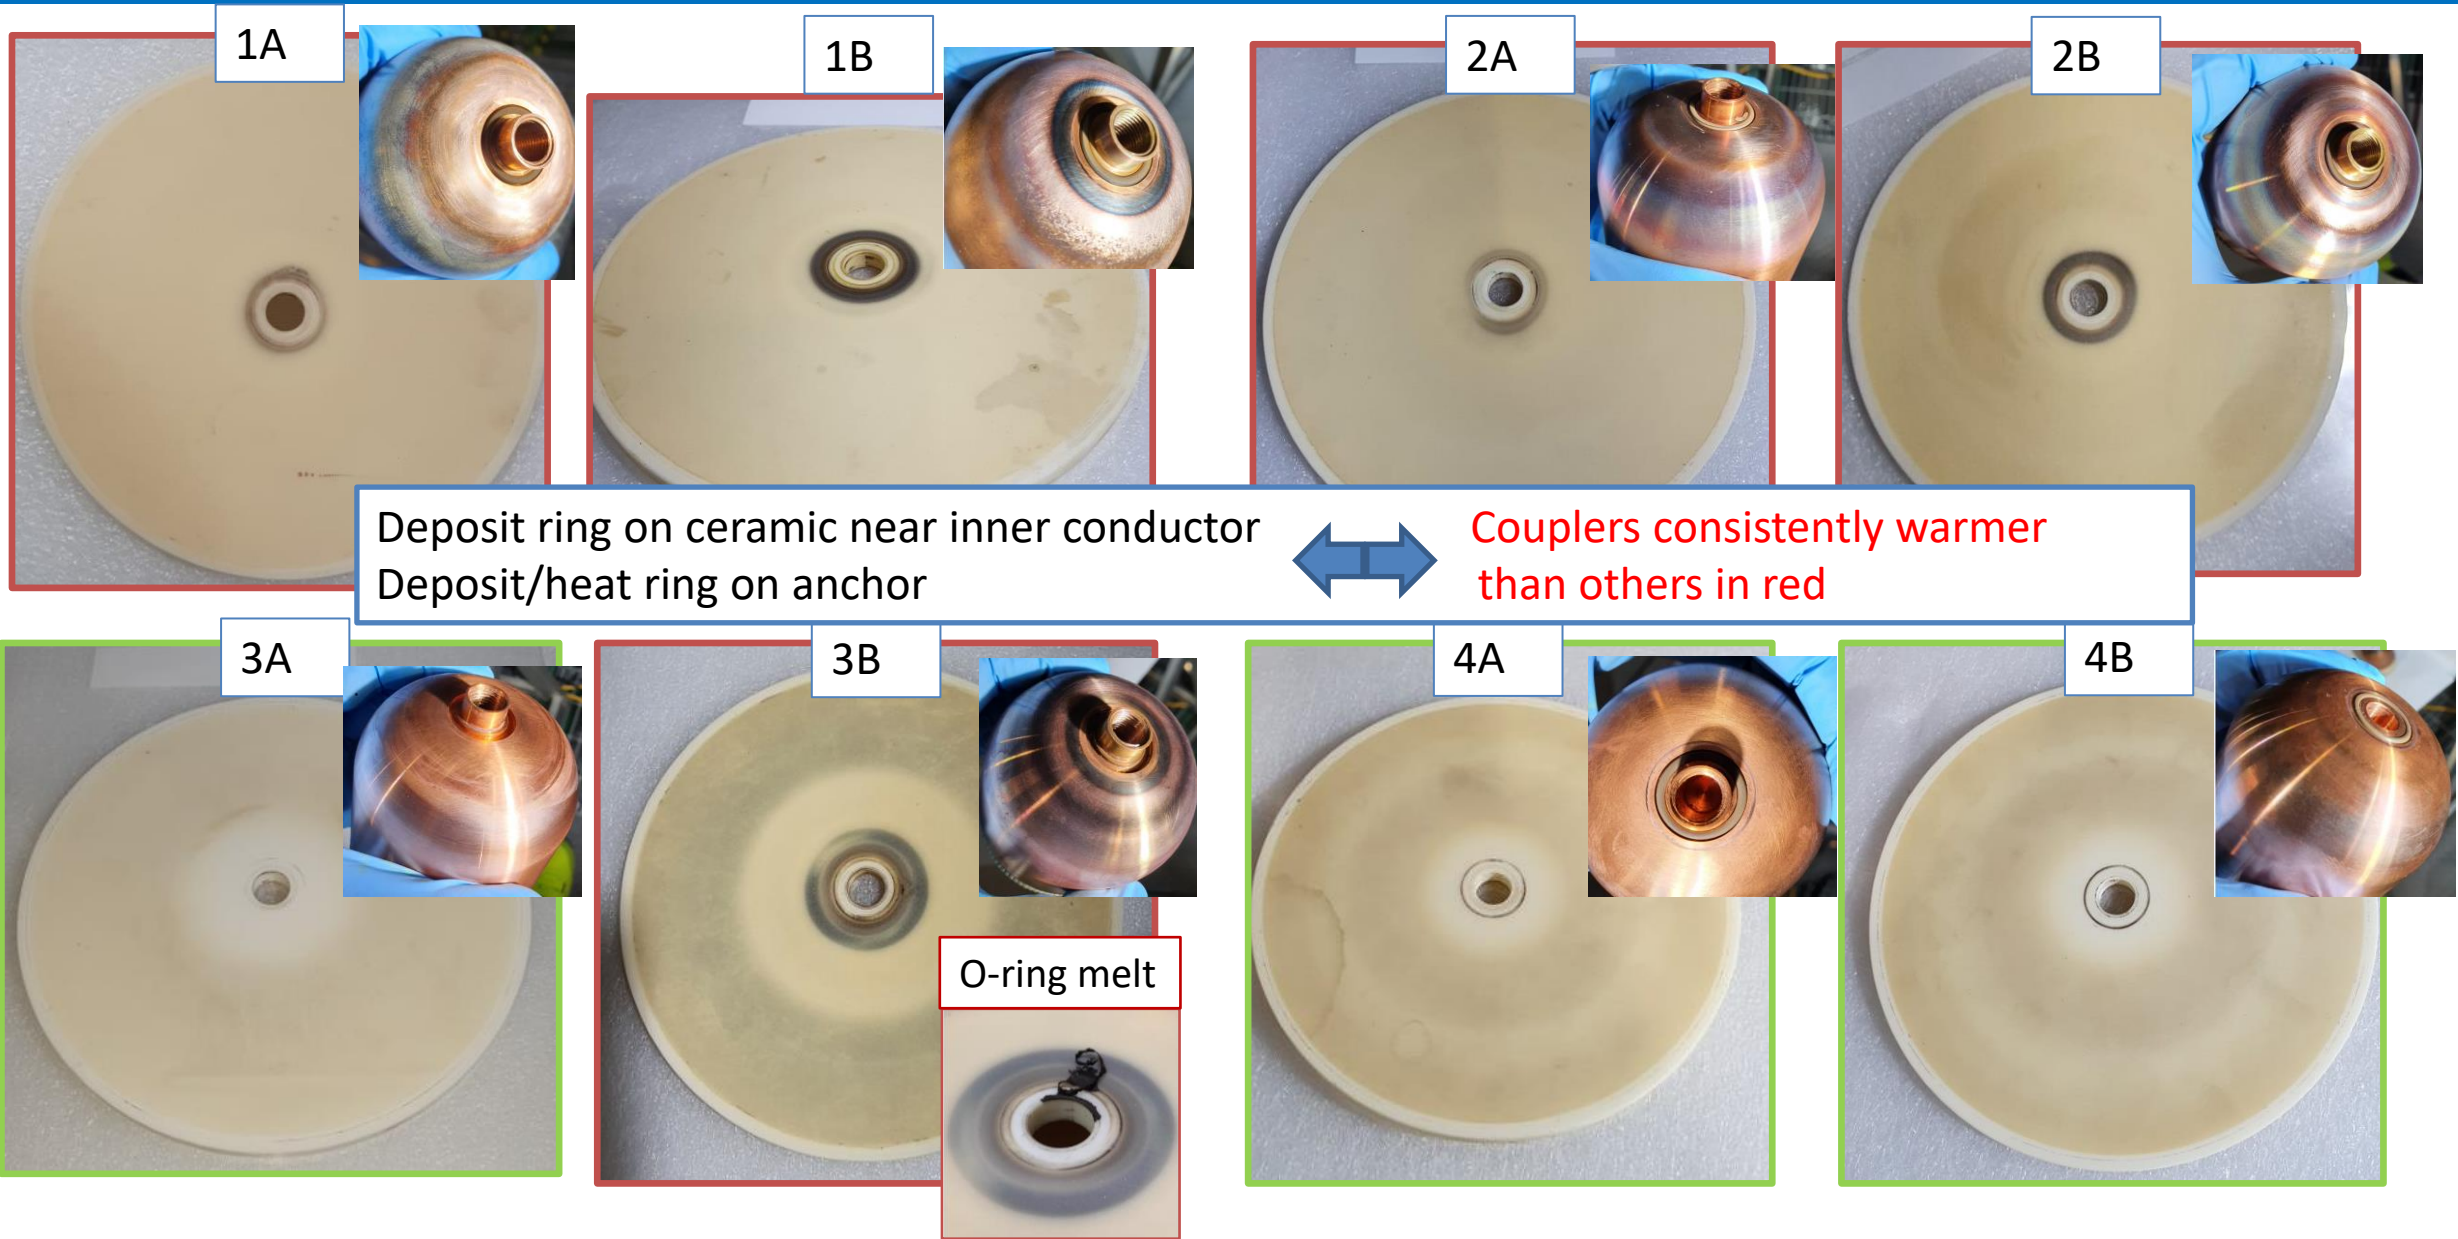
Inspection of the couplers after the leak

Deposit ring on ceramic near inner conductor
Deposit/heat ring on anchor

↔ Couplers consistently warmer than others in red

O-ring melt

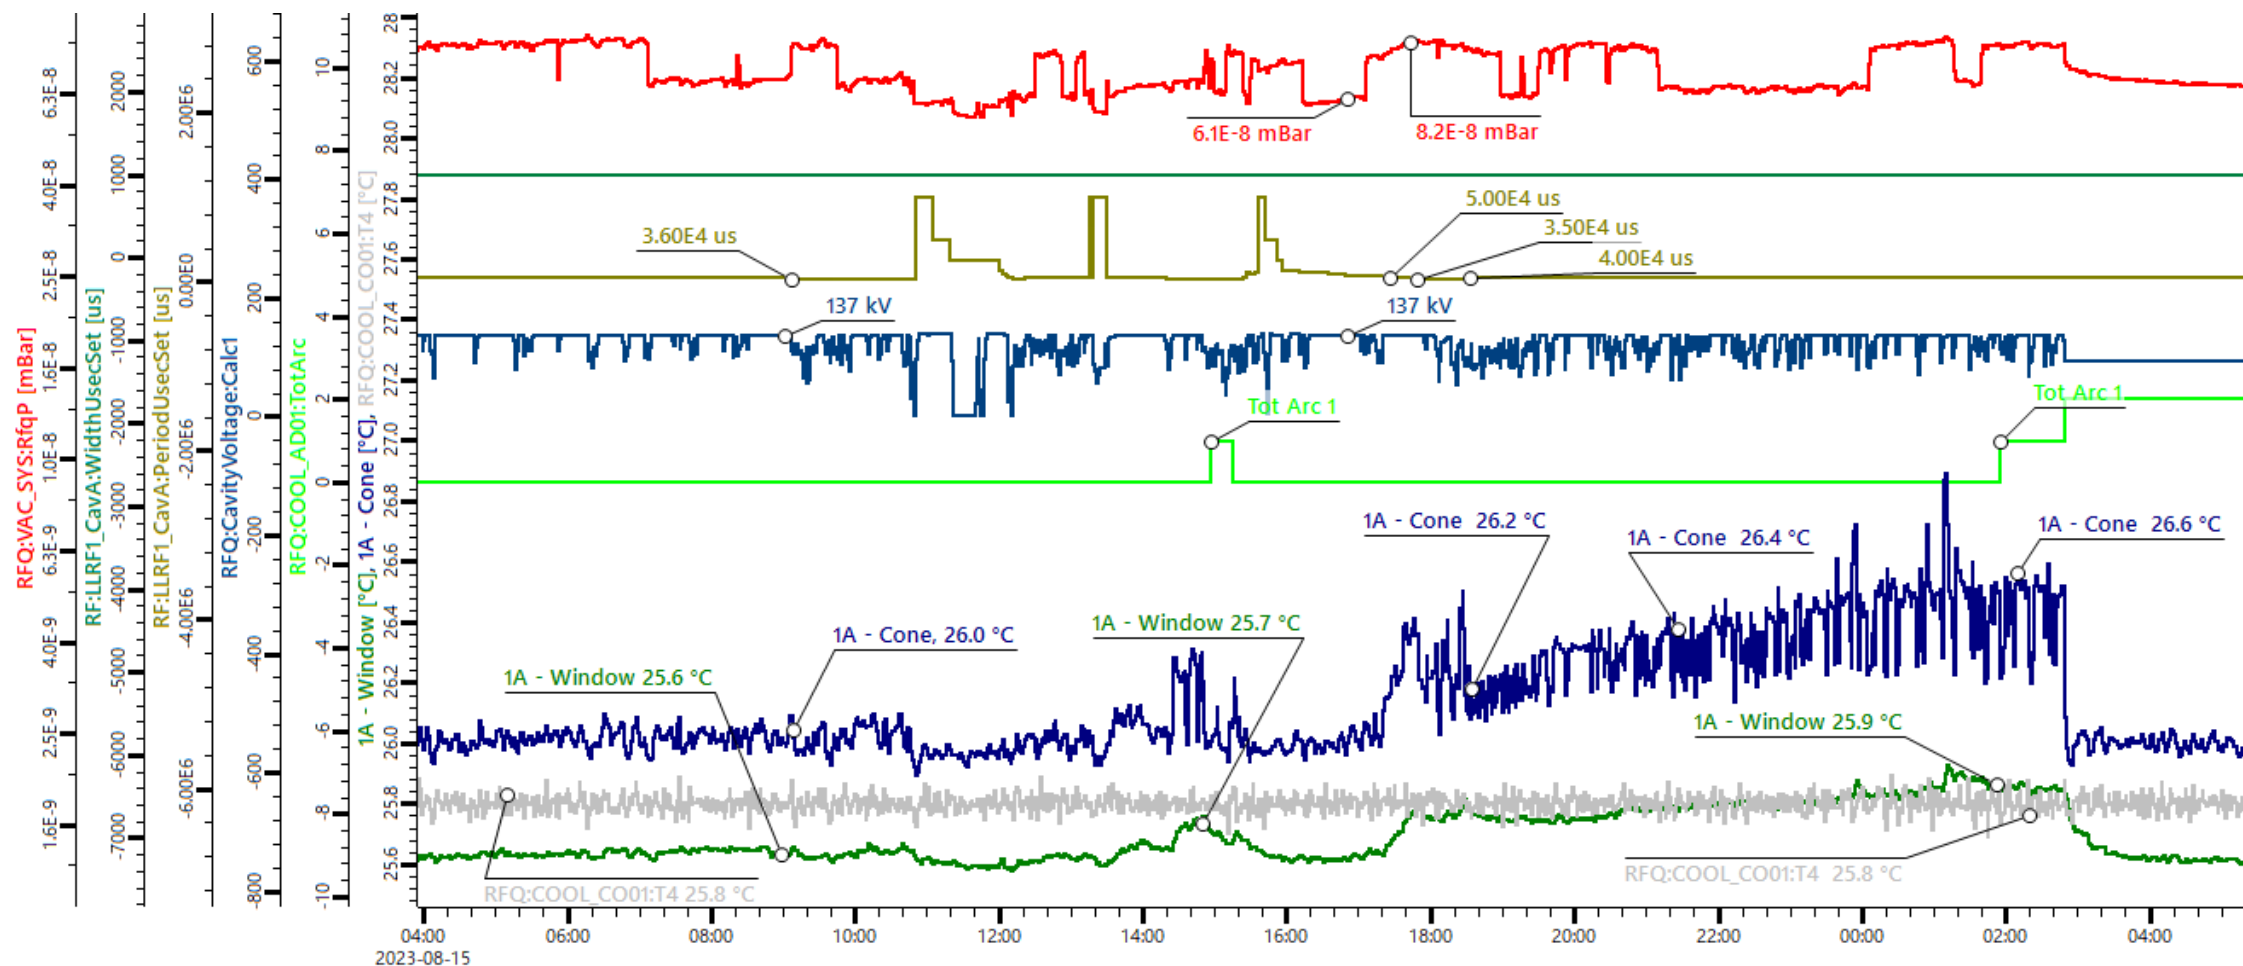
Example of 1A

Same ceramics are installed, but vacuum/air surface is flipped. The ceramics of couplers 1A(hot) and 4A(cold) are swapped. Initially all couplers are cold, one by one the same 5 units start to become warm.

Coupler external surface temperature increase per unit d.c. is comparable to previous campaigns.

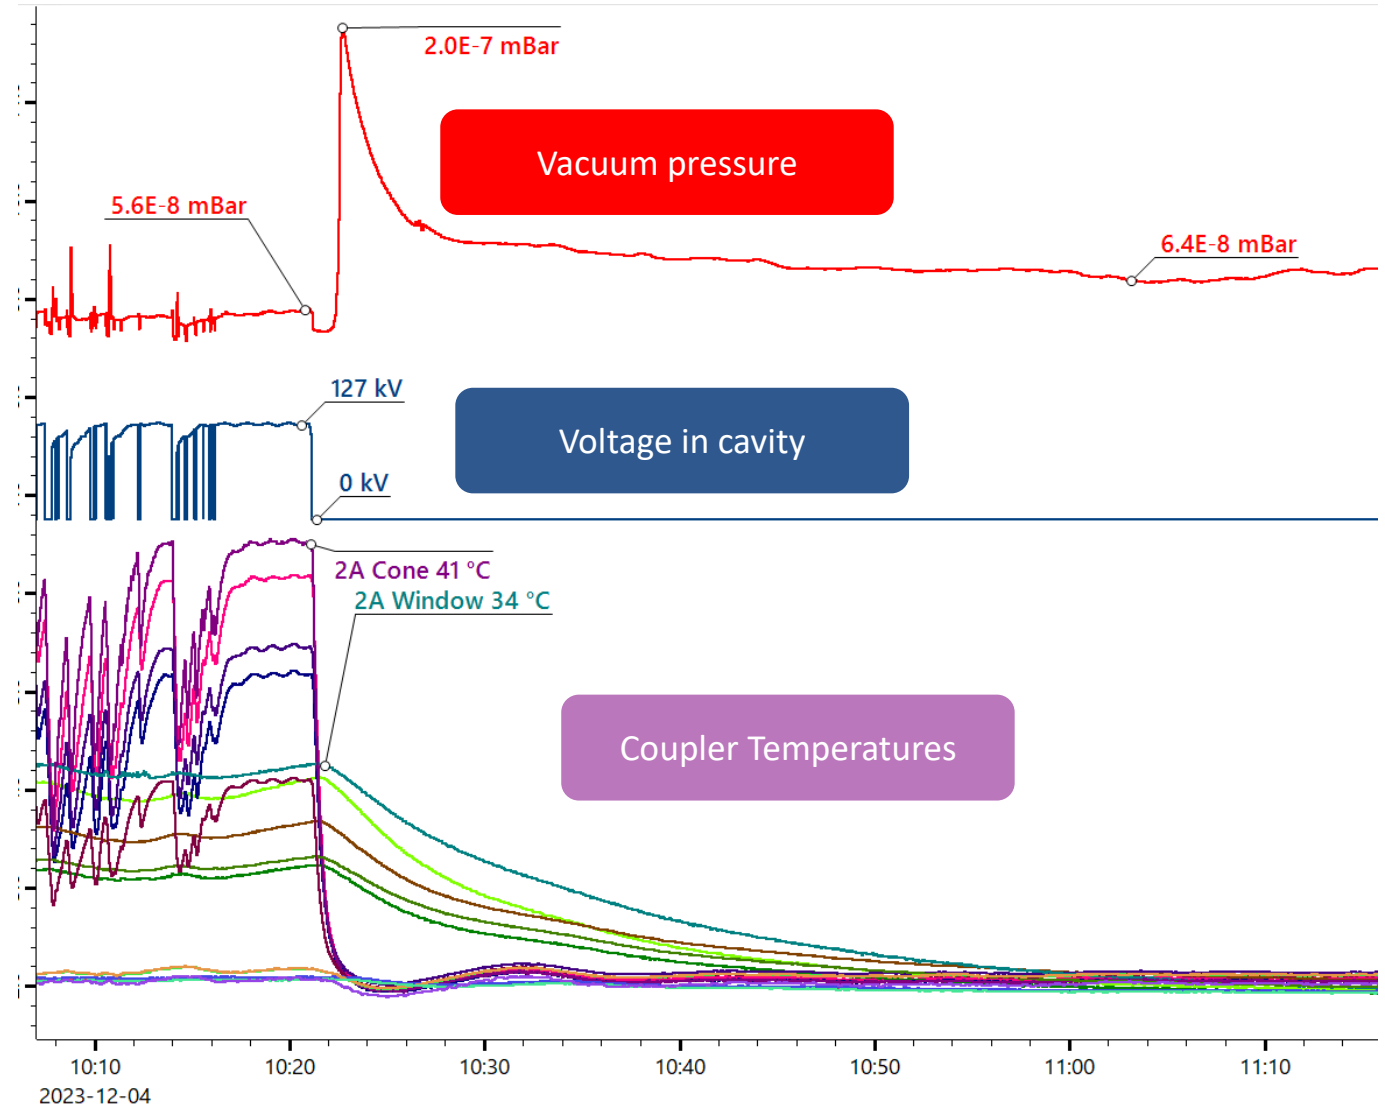
Reached 26% d.c. and small vacuum leaks are detected.
Behaviour suggests damage to O-rings.

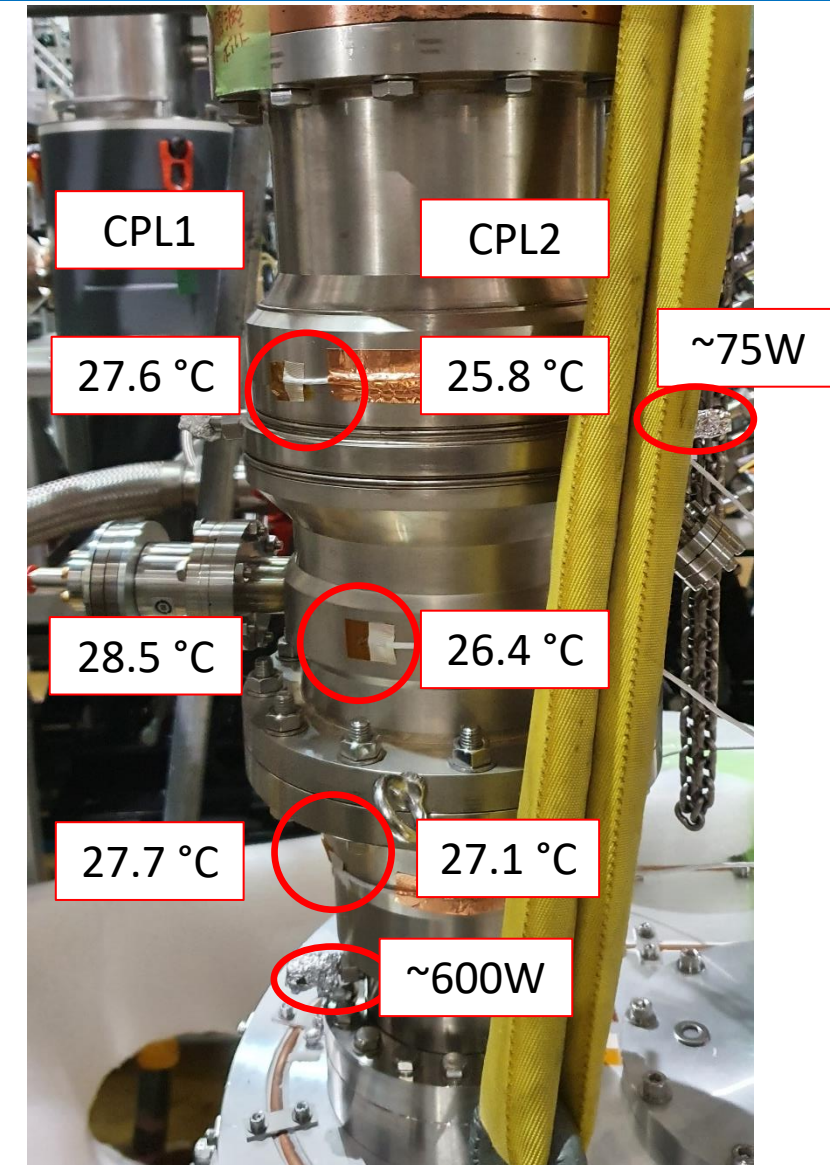
Couplers not hot at duty cycle = 96%. Heat measured with calorimetry not sufficient to explain MP in CPL1.

Cavity visual inspection after test

Cu layer not well attached - melted

Cu layer on SUS input flange not well attached, RF enter gap and create loop, which further melt and deform. Heat marks on the nearby coupler are visible.

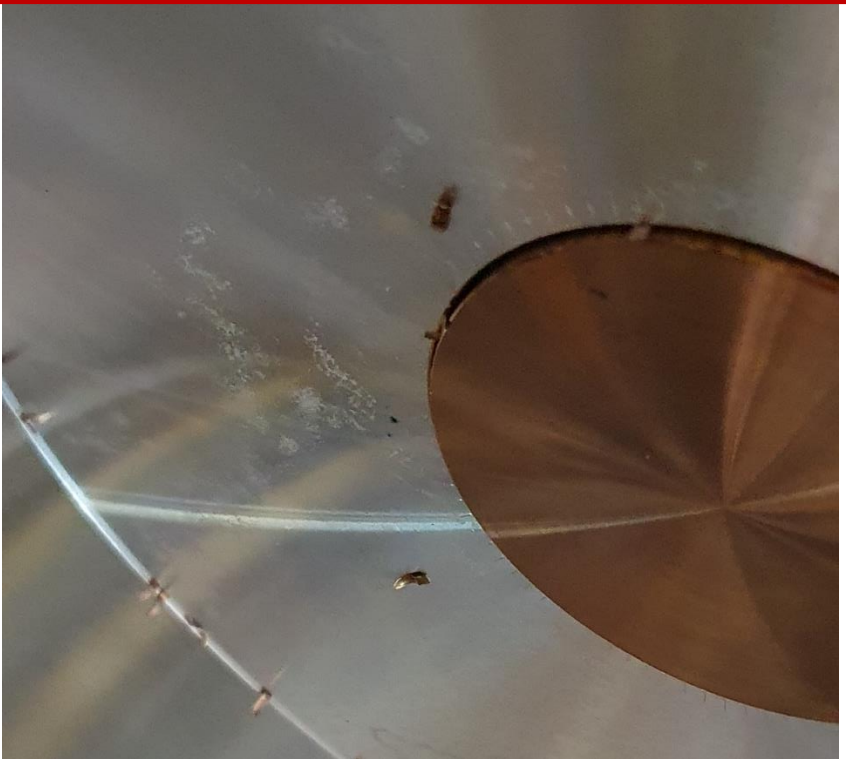
MP / Arcs , protruded and melted RF fingers

Traces of MP on cavity surface near tuner. Also, visible deformed and melted RF fingers.

MP/Arcs on the tuner, fingers easy to break → Change tuner concept
 Push/Pull from outside to slightly deform the lid and change the capacitive gap.

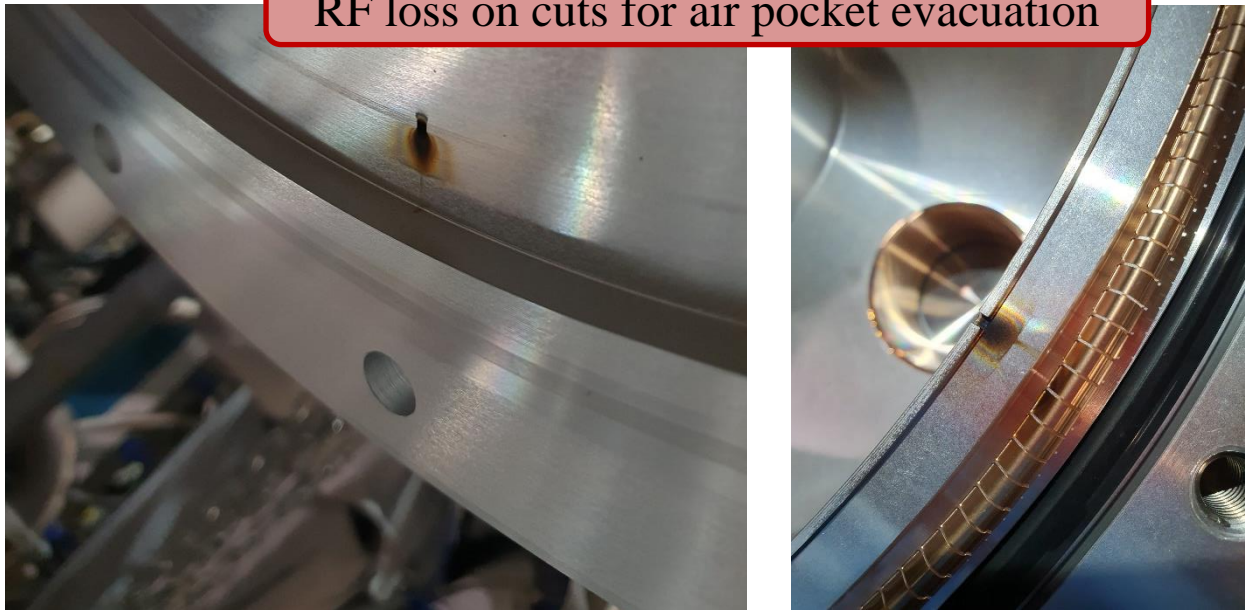
RF loss on cuts for air pocket evacuation

RF loss induced heat in the cuts used for evacuation of air pocket near O-ring.

Vacuum was not great (10^{-7} - 10^{-6} mBar).
 → Change vacuum port flange
 → Introduce 2 vacuum ports
 → Cu plating

Slits machined directly into the lid.
 Follow current direction & larger aperture.
Vacuum pumps:
 Add port for
 1 NEG (200 L/s SAES CapaciTorr HV200)

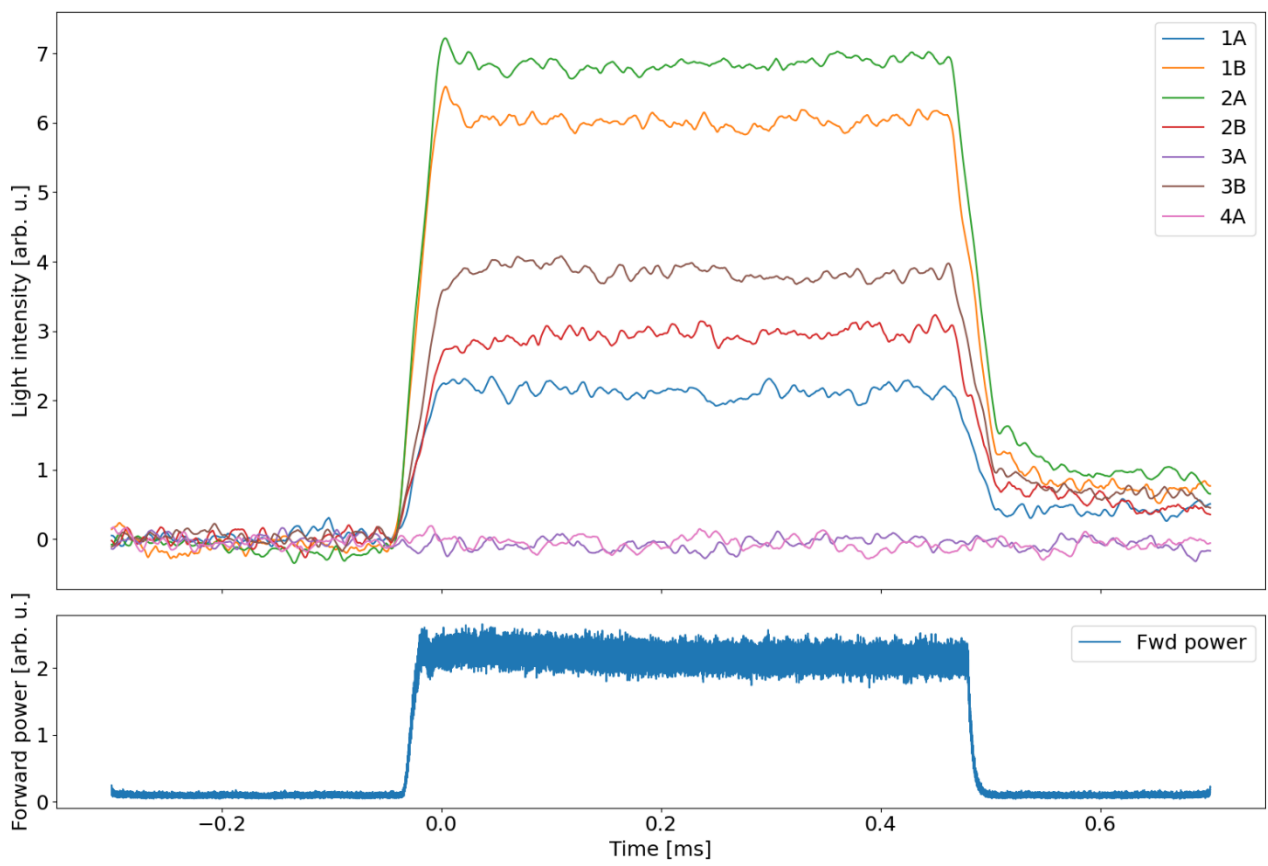
Swapped 1B(hot) and 4B(cold) coupler and tuned both to ideal beta coupling. The same coupler (in different position) are hot/cold.

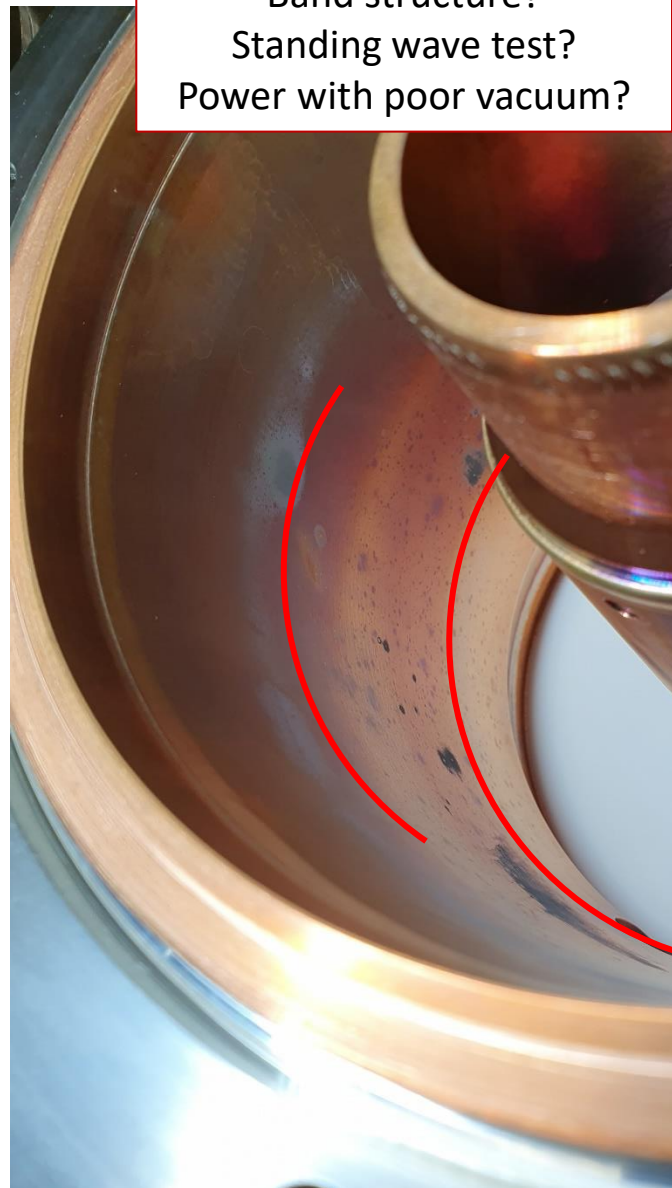
Ceramic (air) looks good
minor arcs on outer cond.

Antenna looks good

Marks on outer cond. – heat inside inner cond.

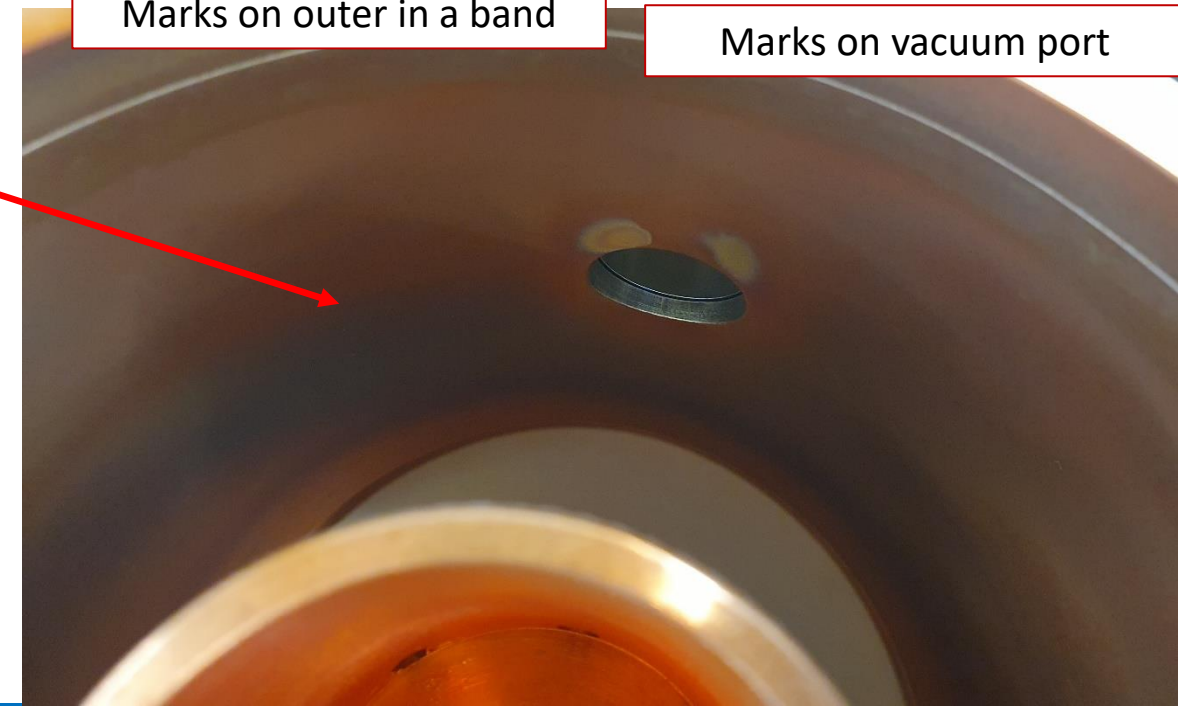
Marks on vacuum port
