Recent Experience with Testing and Operating RF Couplers at SNS

John Mammosser

July 2nd, 2024

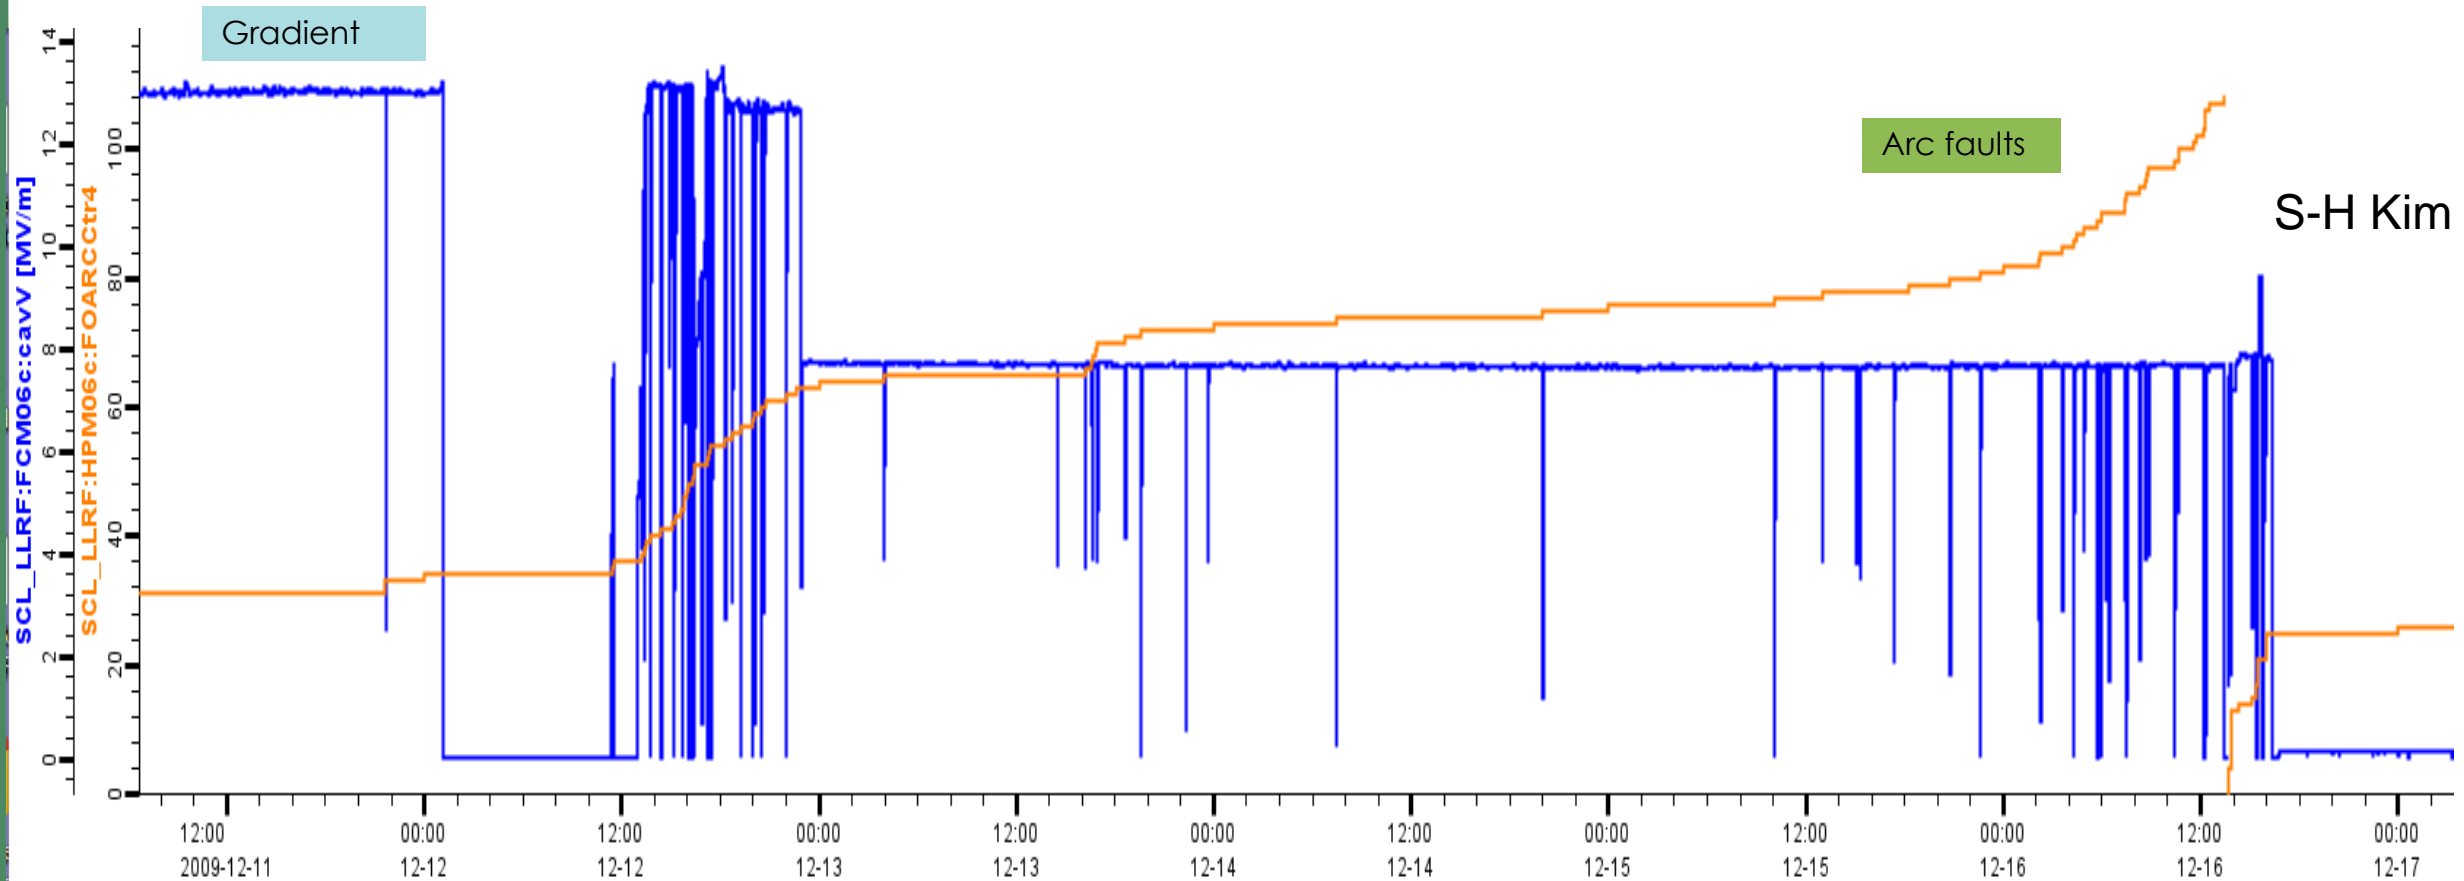
It all started in 2009 with 06c performance degrading

- 06c showed clear signs of Window vacuum arcs
- Gradient was significantly lowered but arcing continued

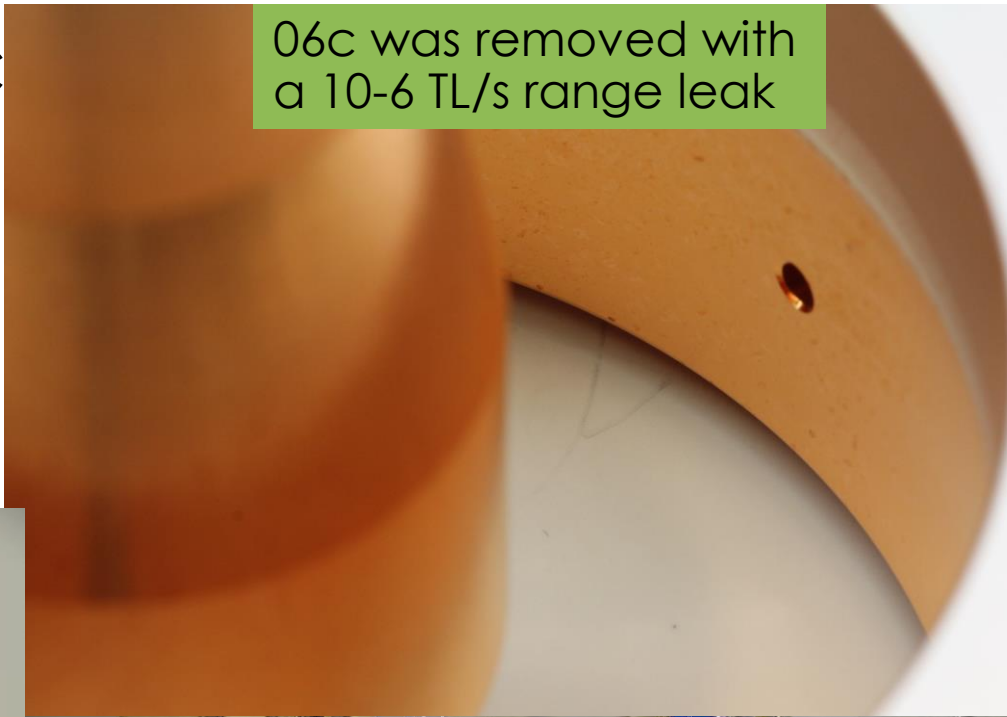
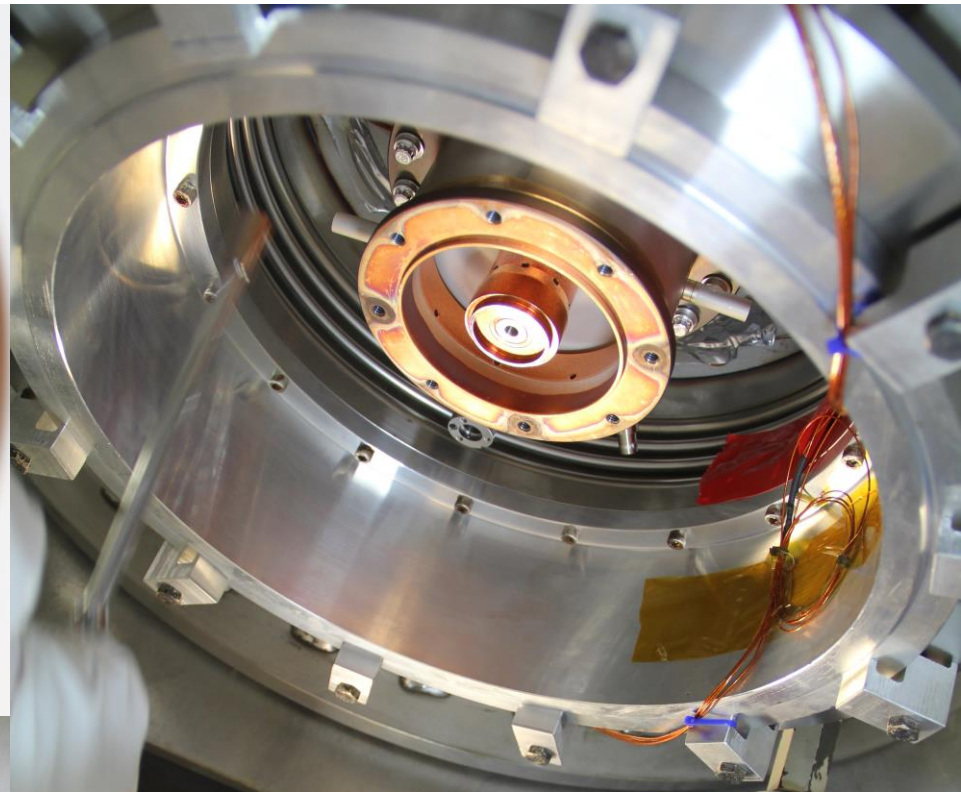
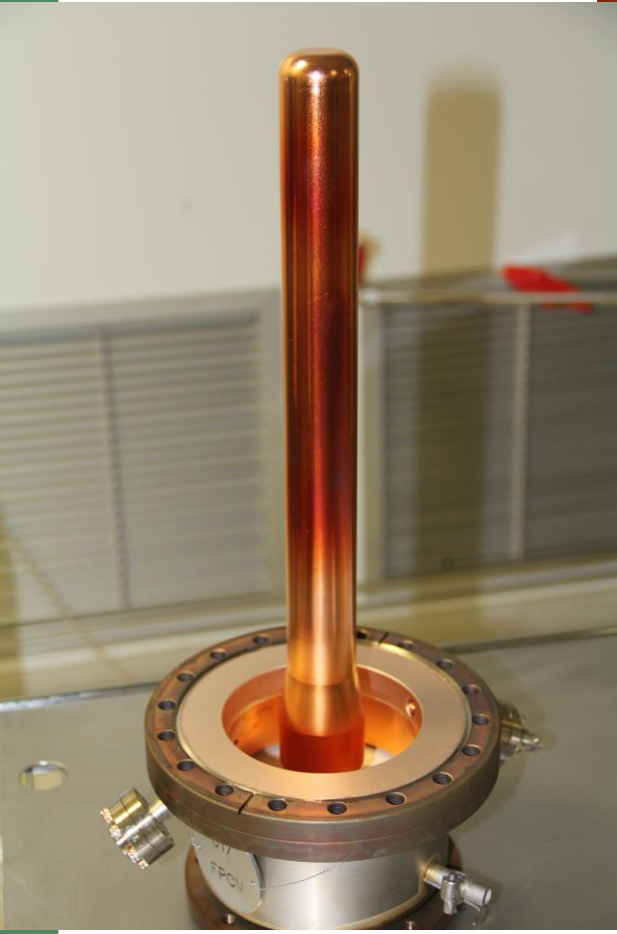
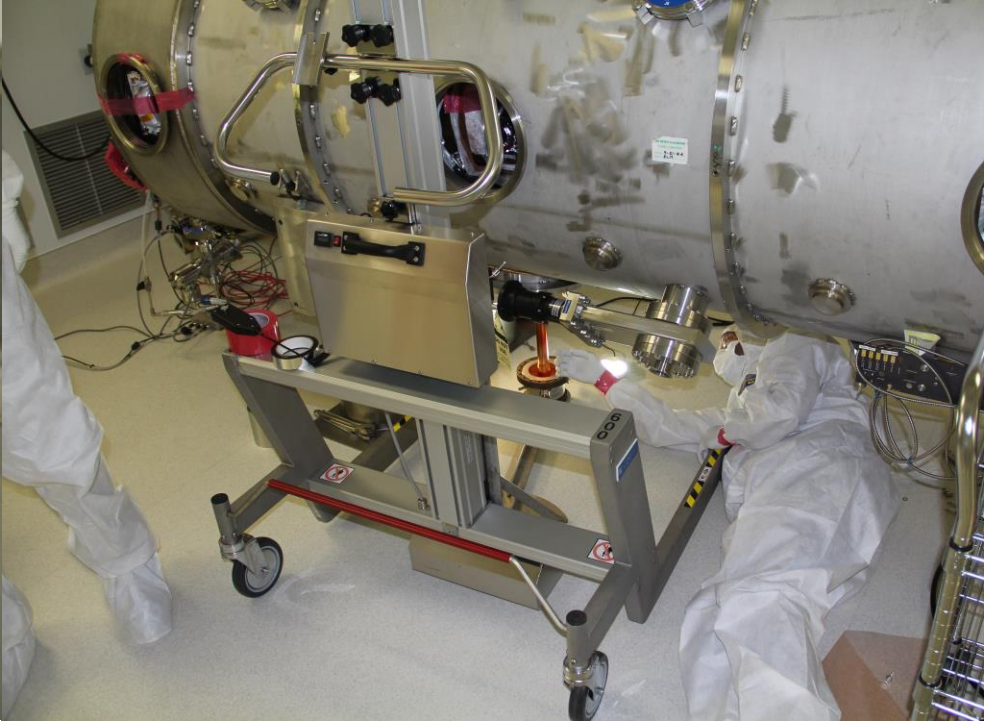
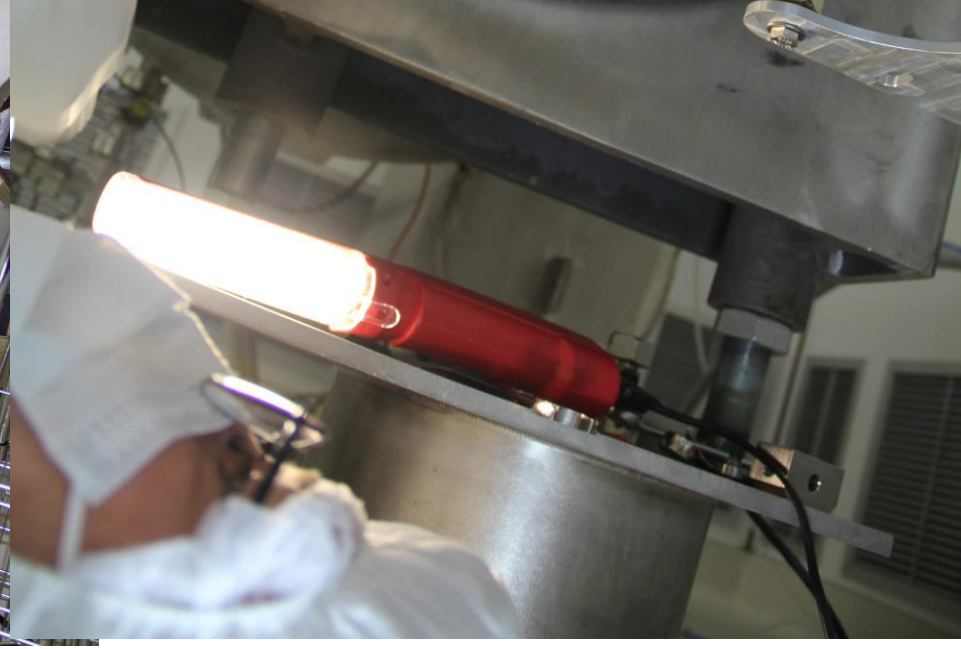
06c ceramic failure

06c was removed with a 10-6 TL/s range leak

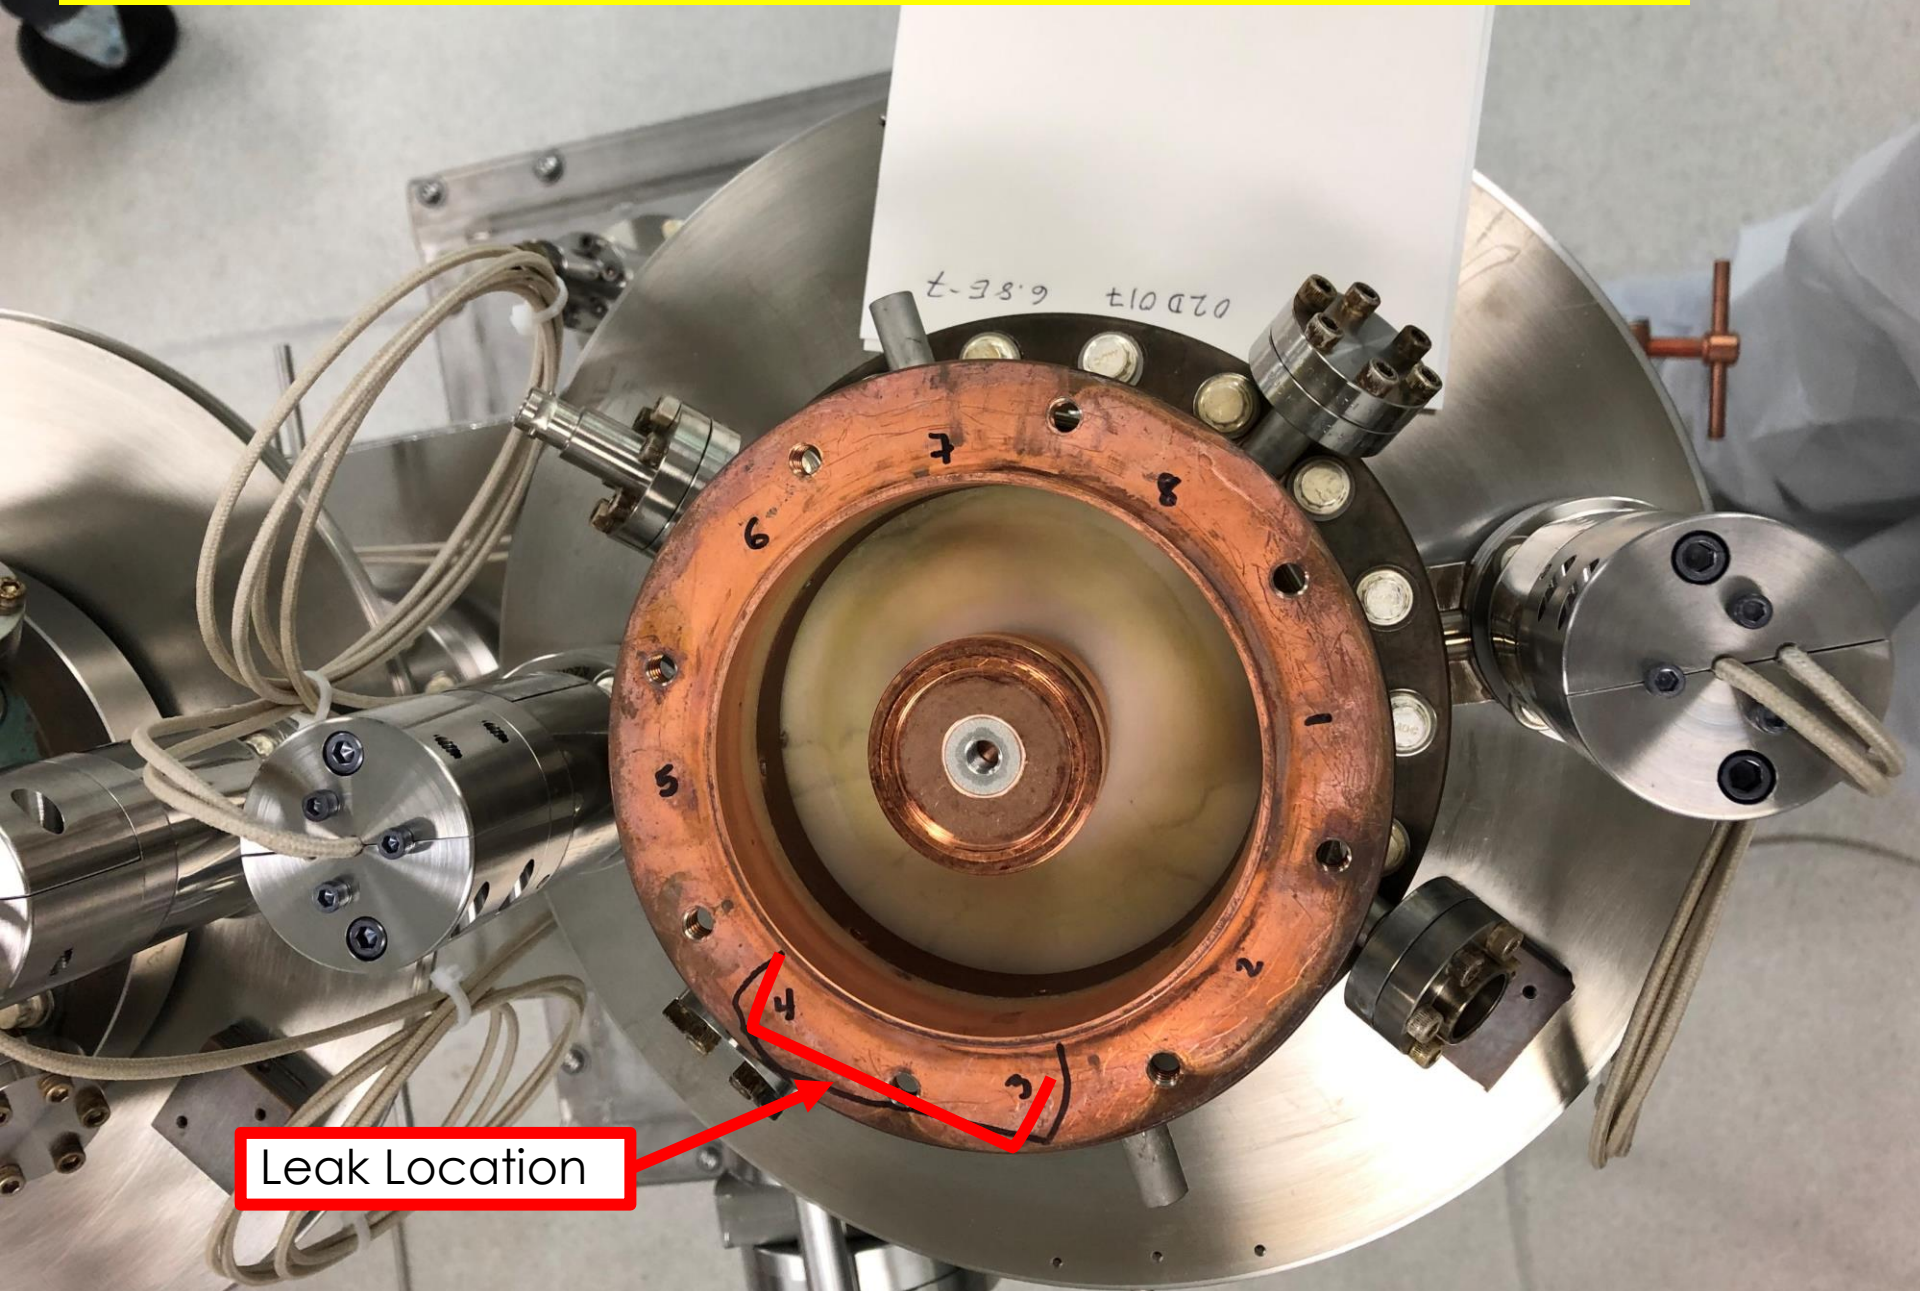
Leak Location

CM01 Cav-A, CM00002, Coupler 02D017, leak rate $6.8e-7$ TL/s location
outer conductor

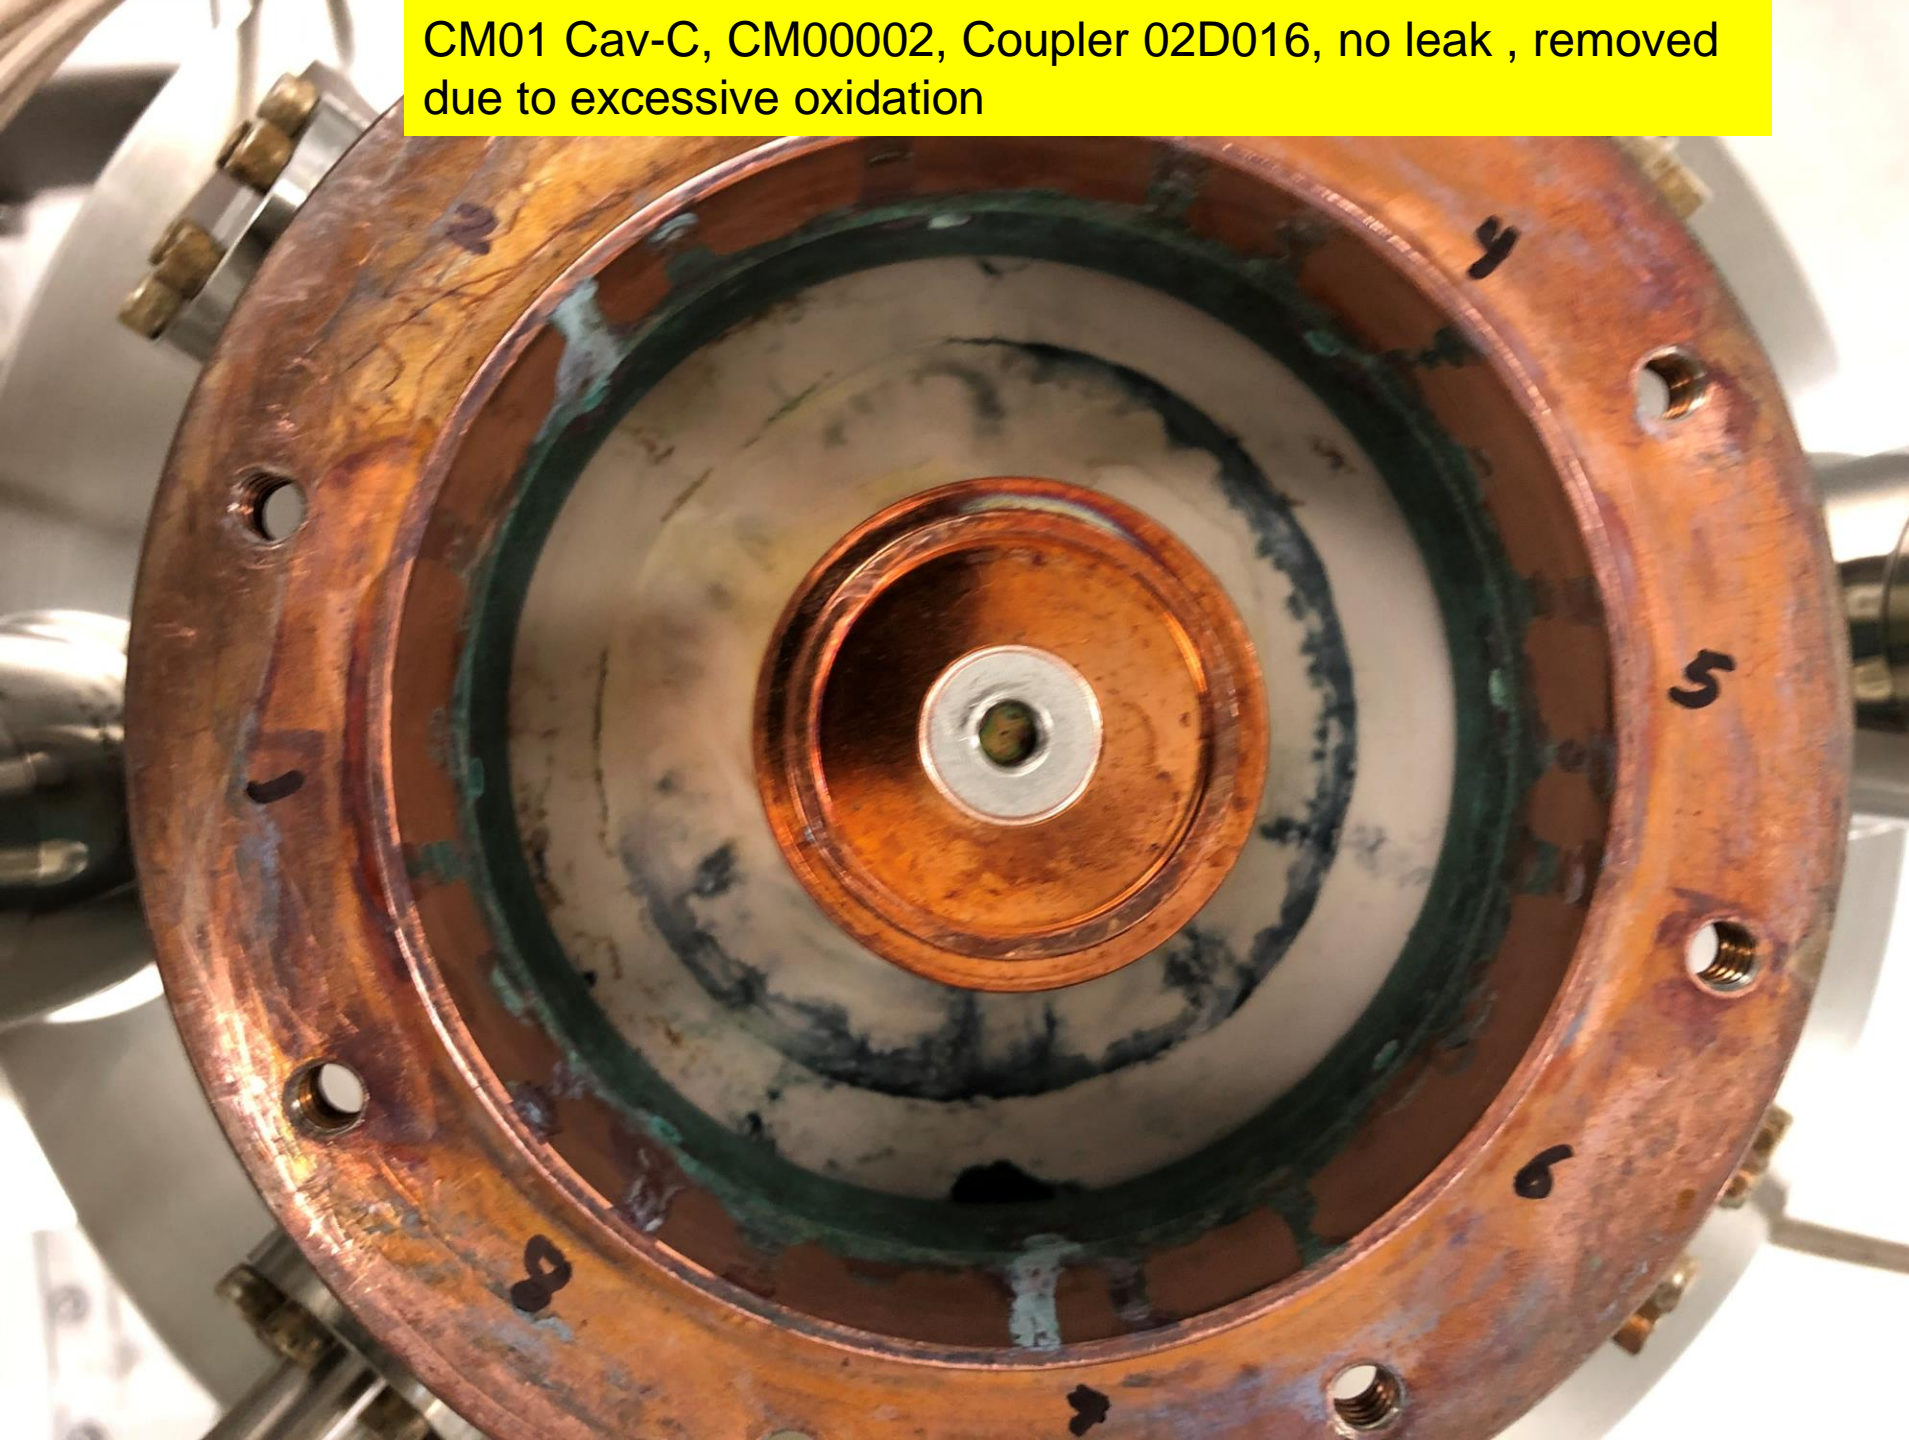
CM01 Cav-C, CM00002, Coupler 02D016, no leak , removed due to excessive oxidation

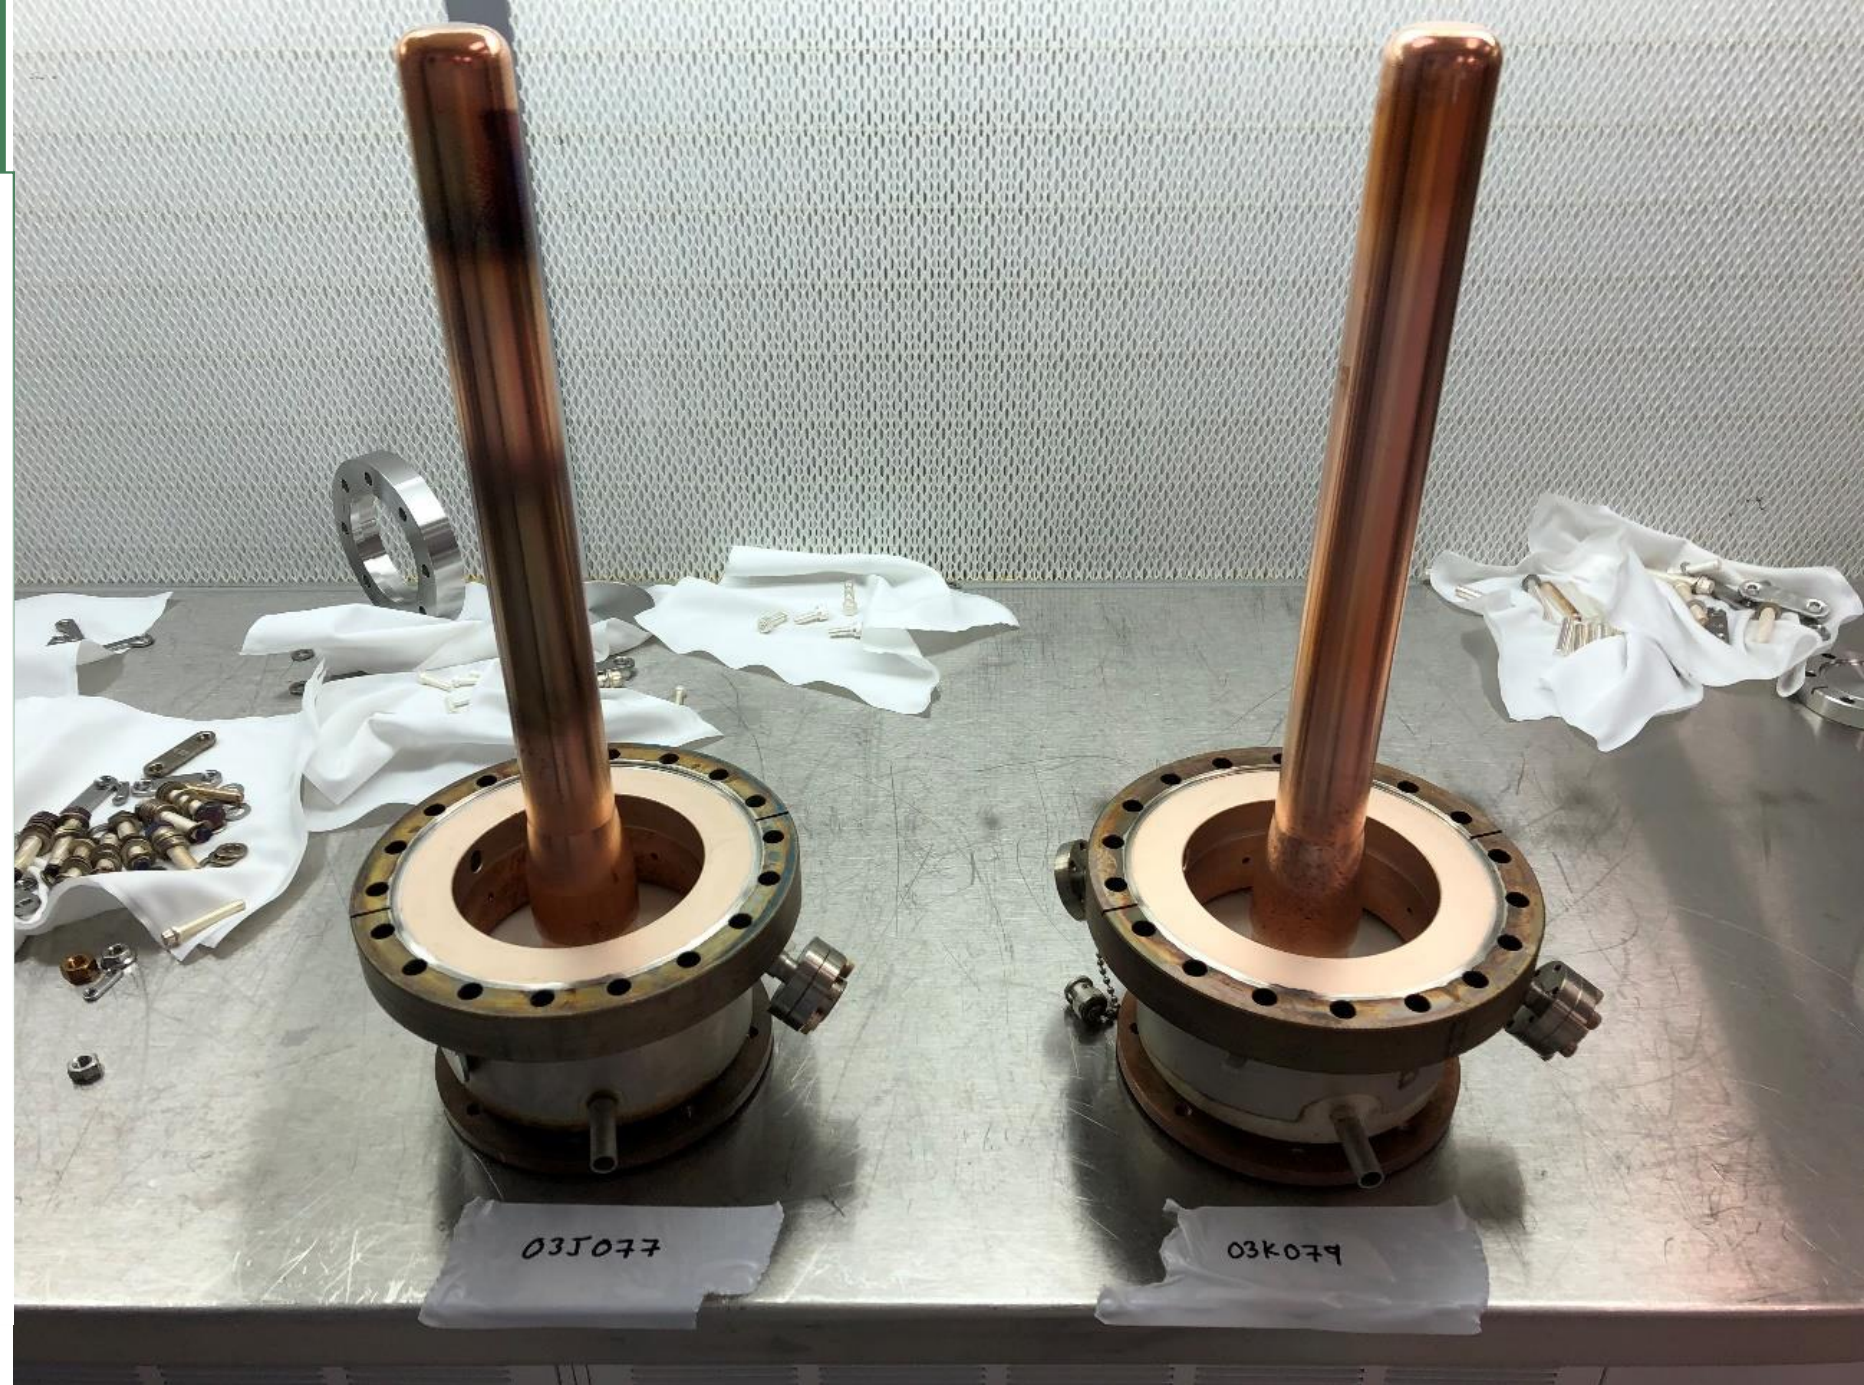
- CM17 removed from linac
1/18/2018
- Cleanroom repairs
 - 20b leak rate
 $1.7e-7$ TL/s
 - 20d leak rate
 $2.2e-7$ TL/s
- Removed couplers in cleanroom from 20d (left) and 20b (right)

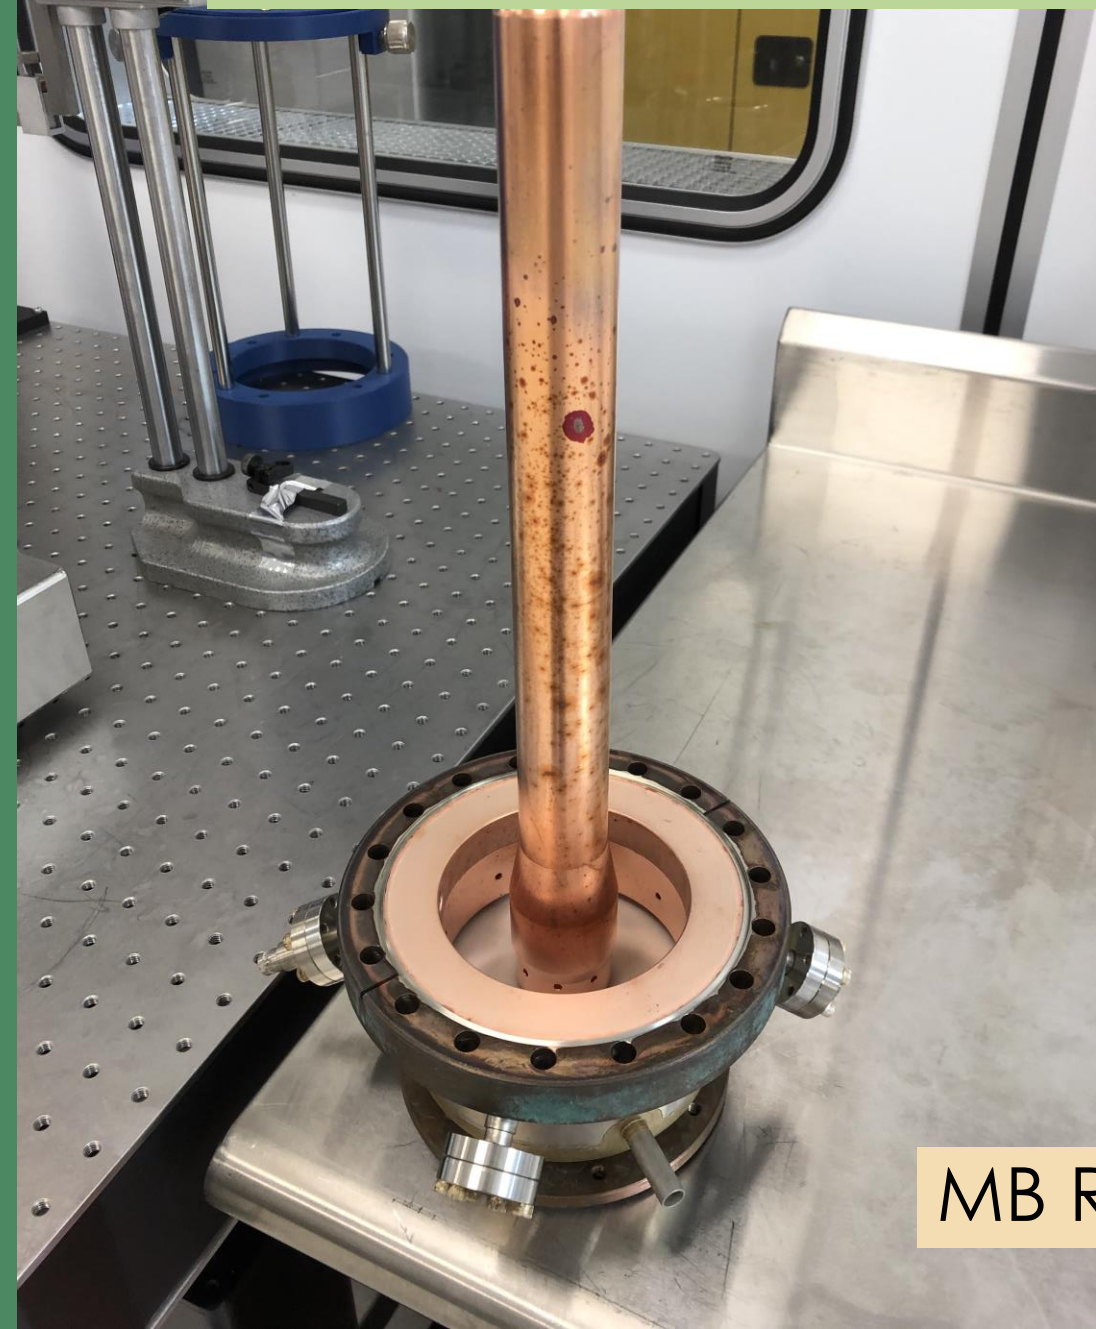
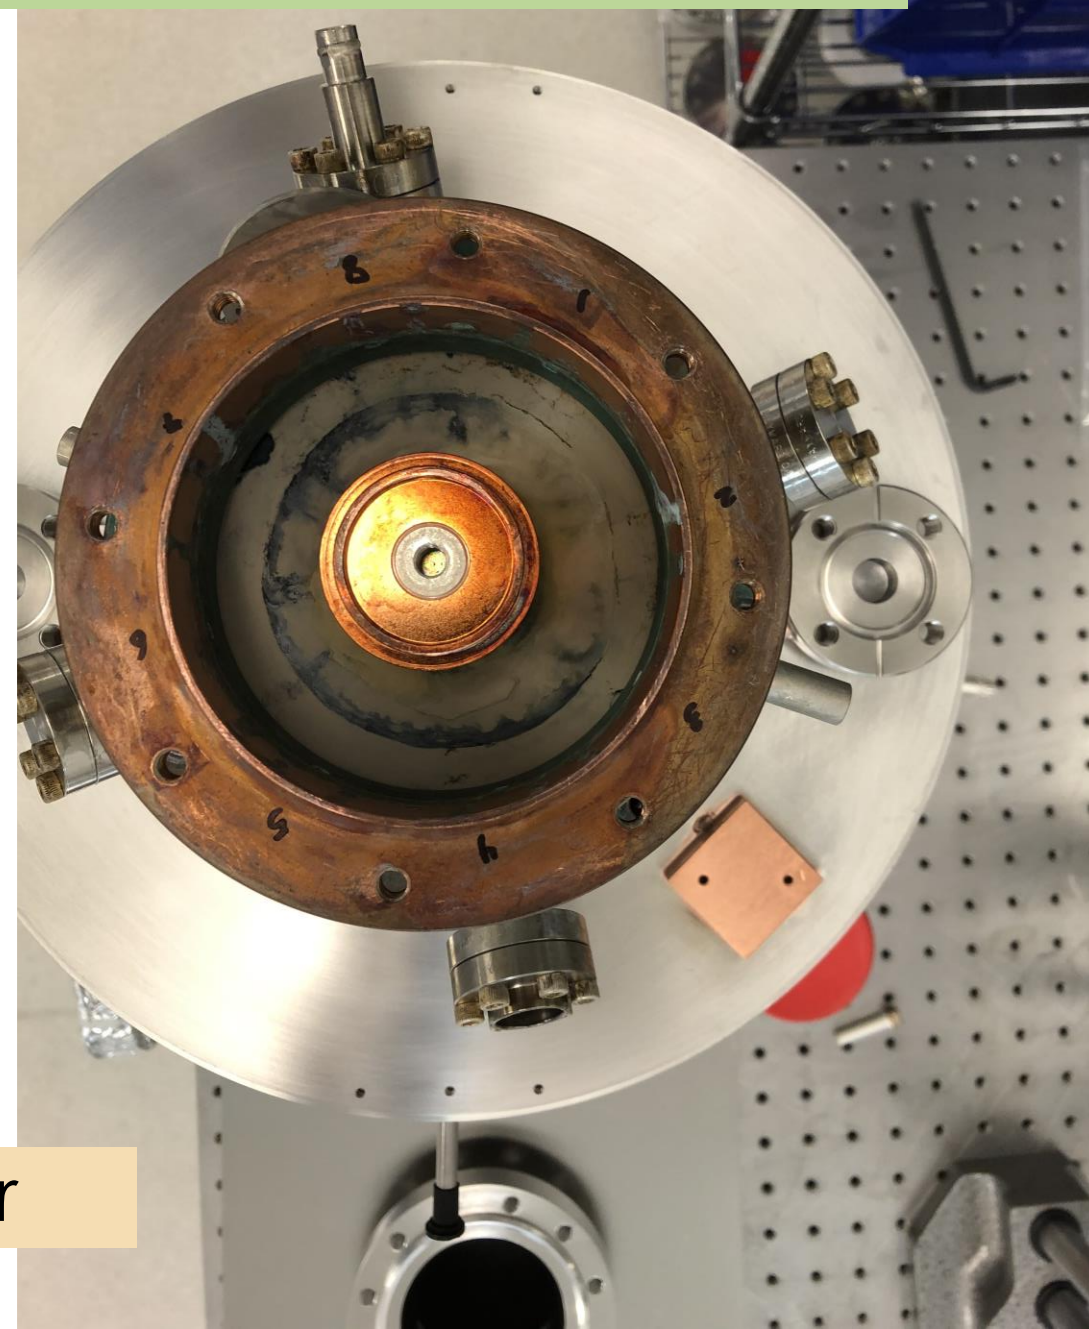
Evidence of Arcing and Condensation Corrosion

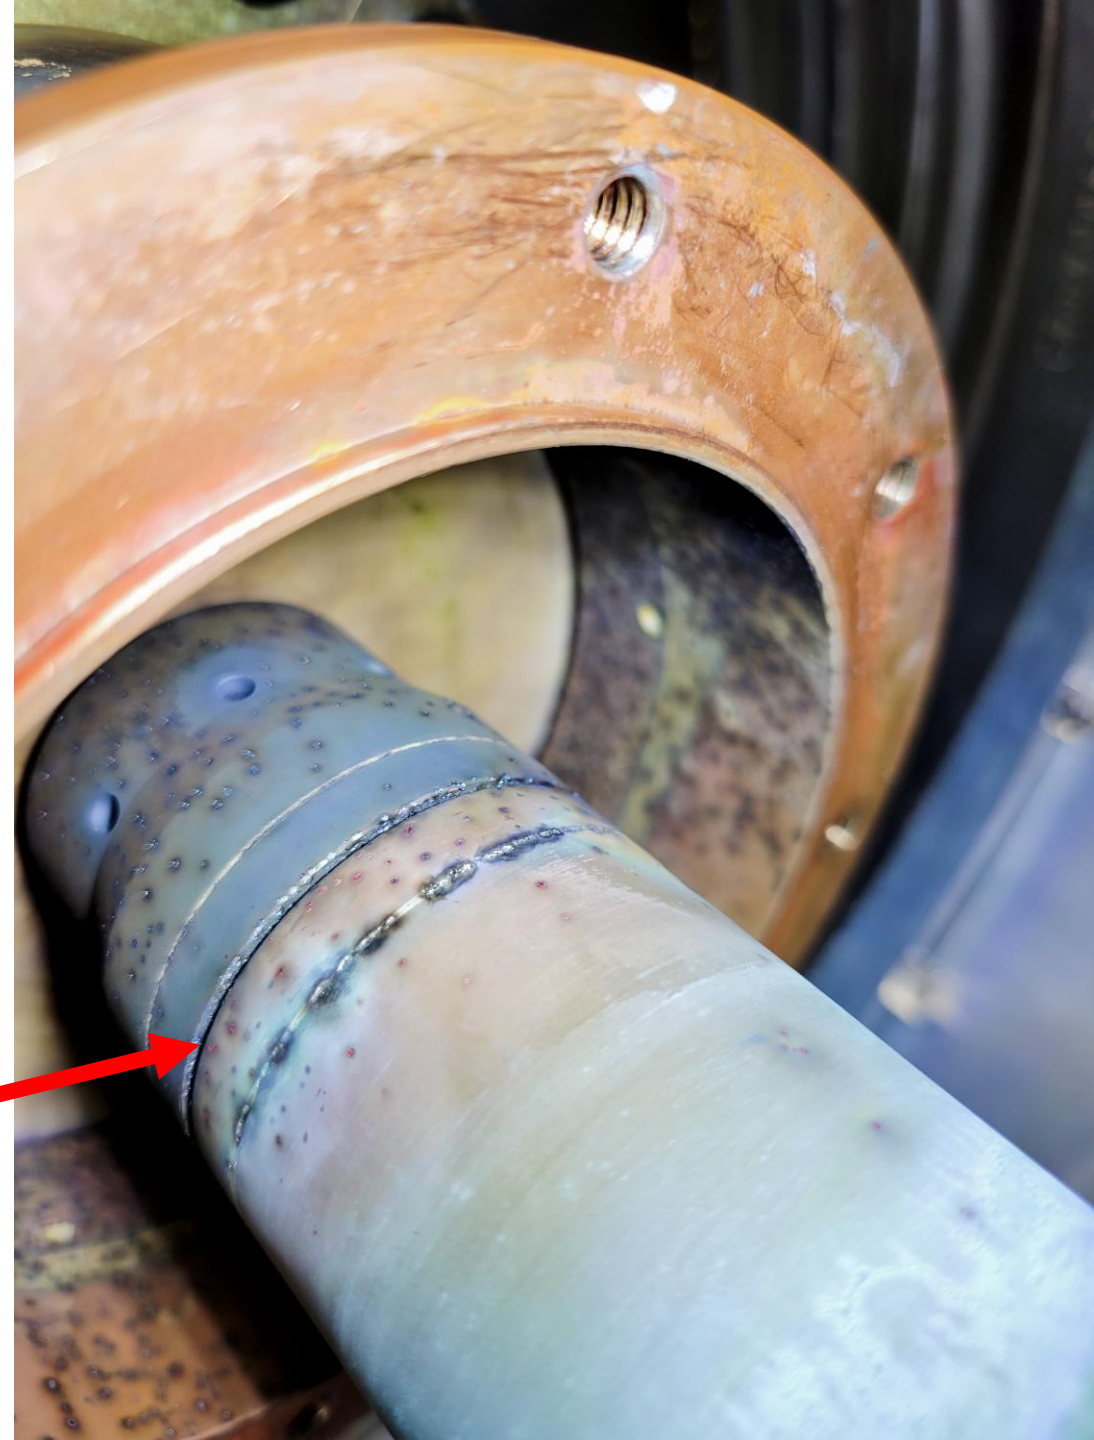
- On 11/2021 we decided to investigate 05a airside and replace it
- What we found was the inner conductor extension was arc welded to the RF coupler
- This had been running like this for a long time

Airside inner conductor extension connection showing severe arc damage

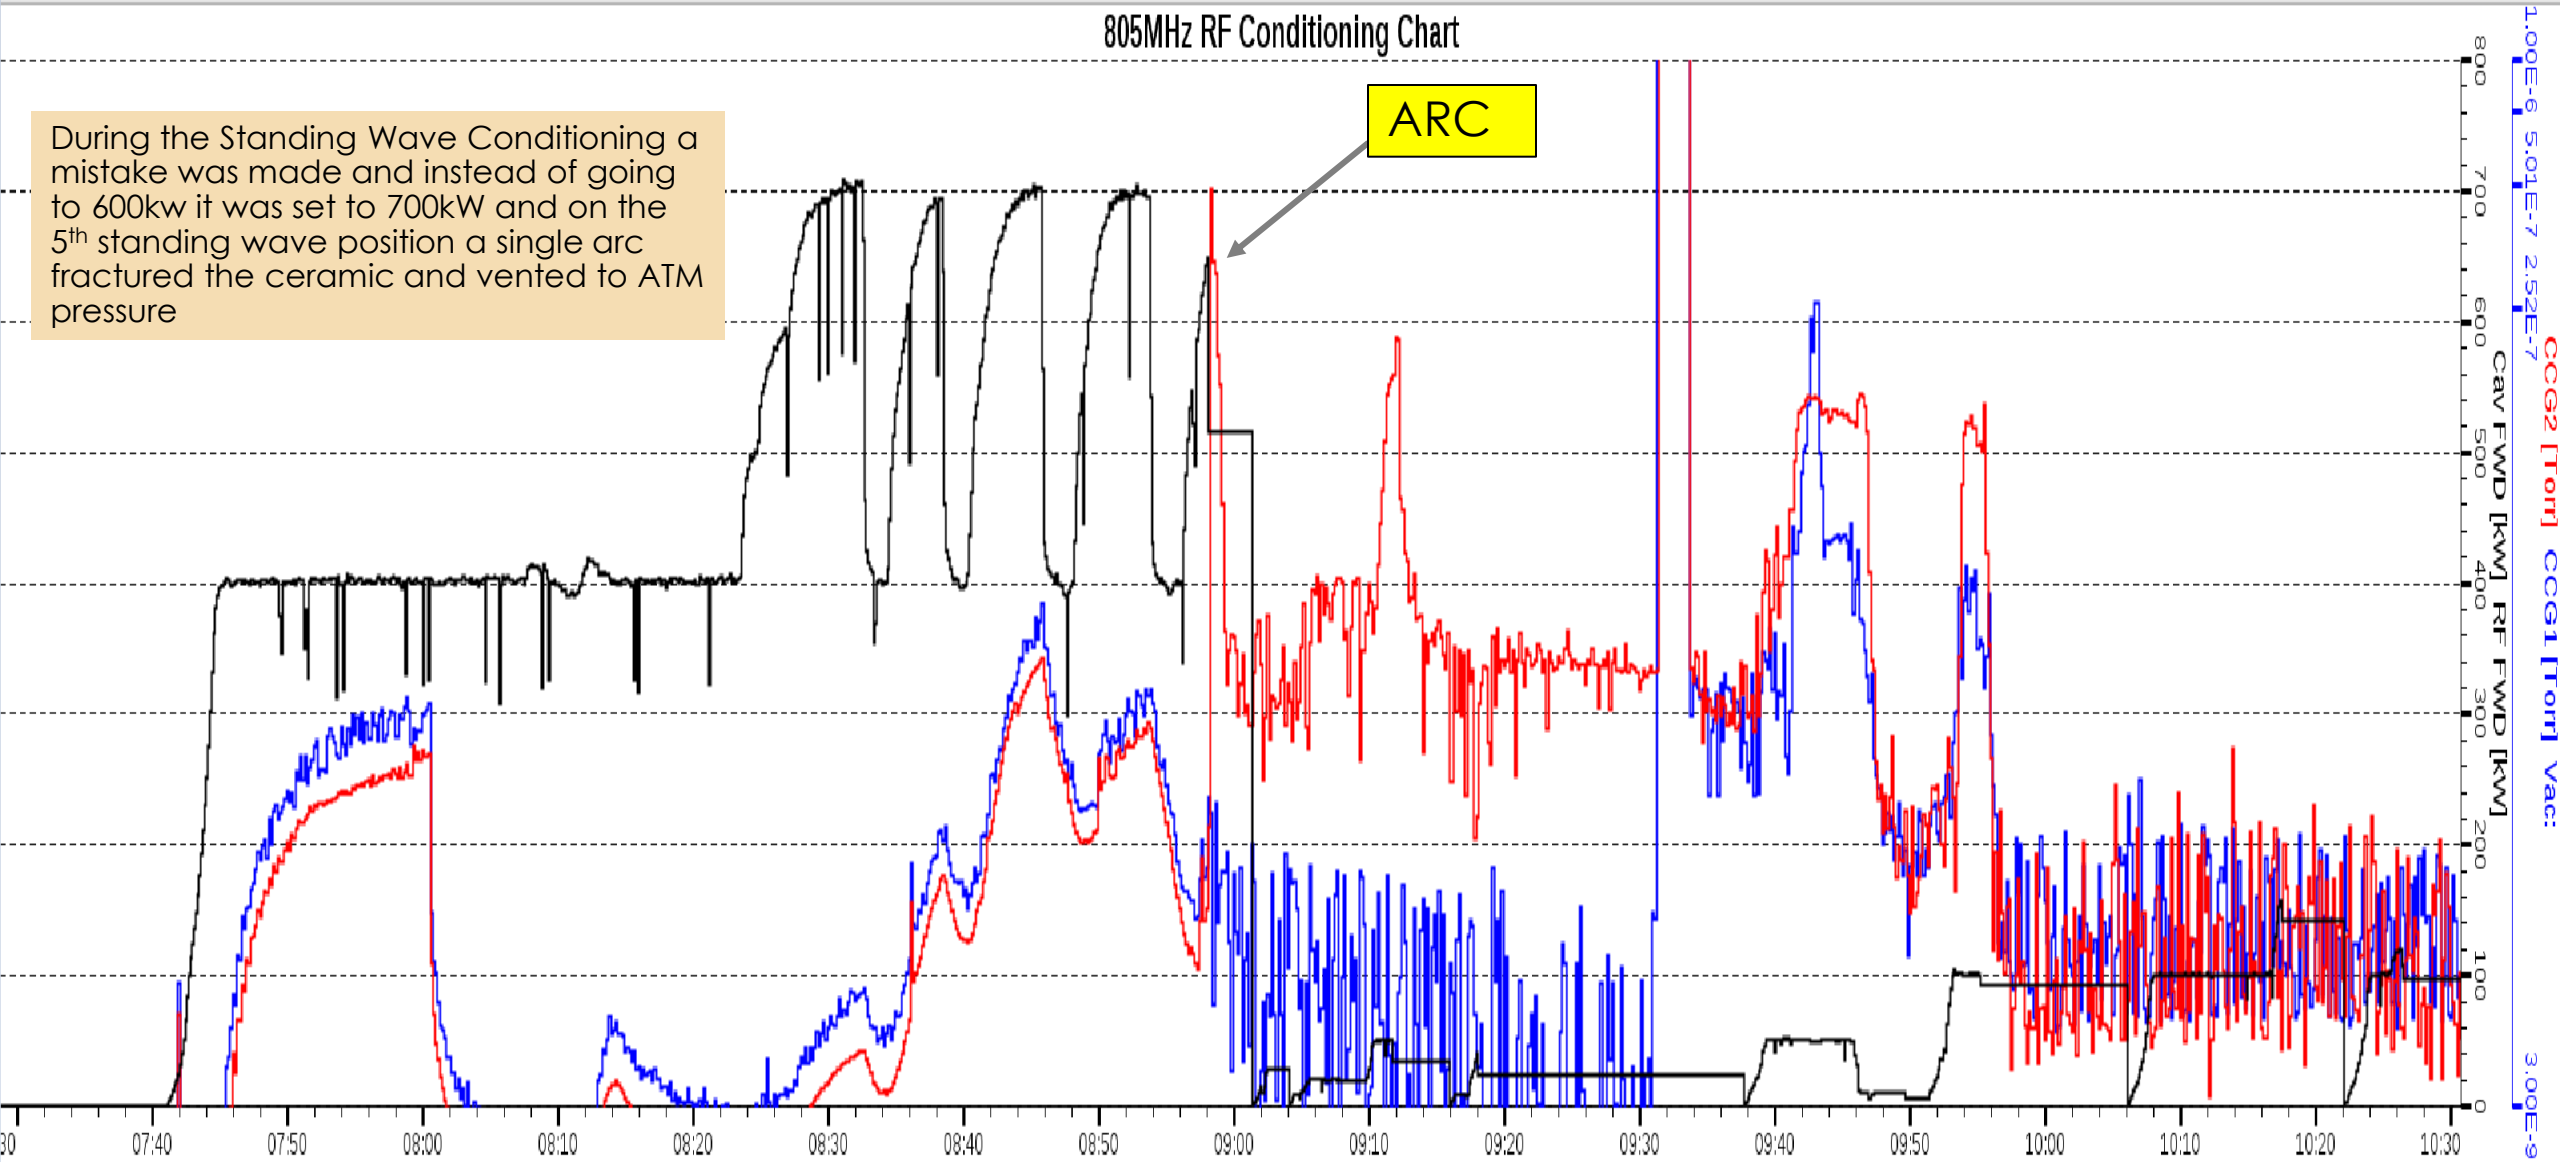
During the Standing Wave Conditioning a mistake was made and instead of going to 600kw it was set to 700kw and on the 5th standing wave position a single arc fractured the ceramic and vented to ATM pressure

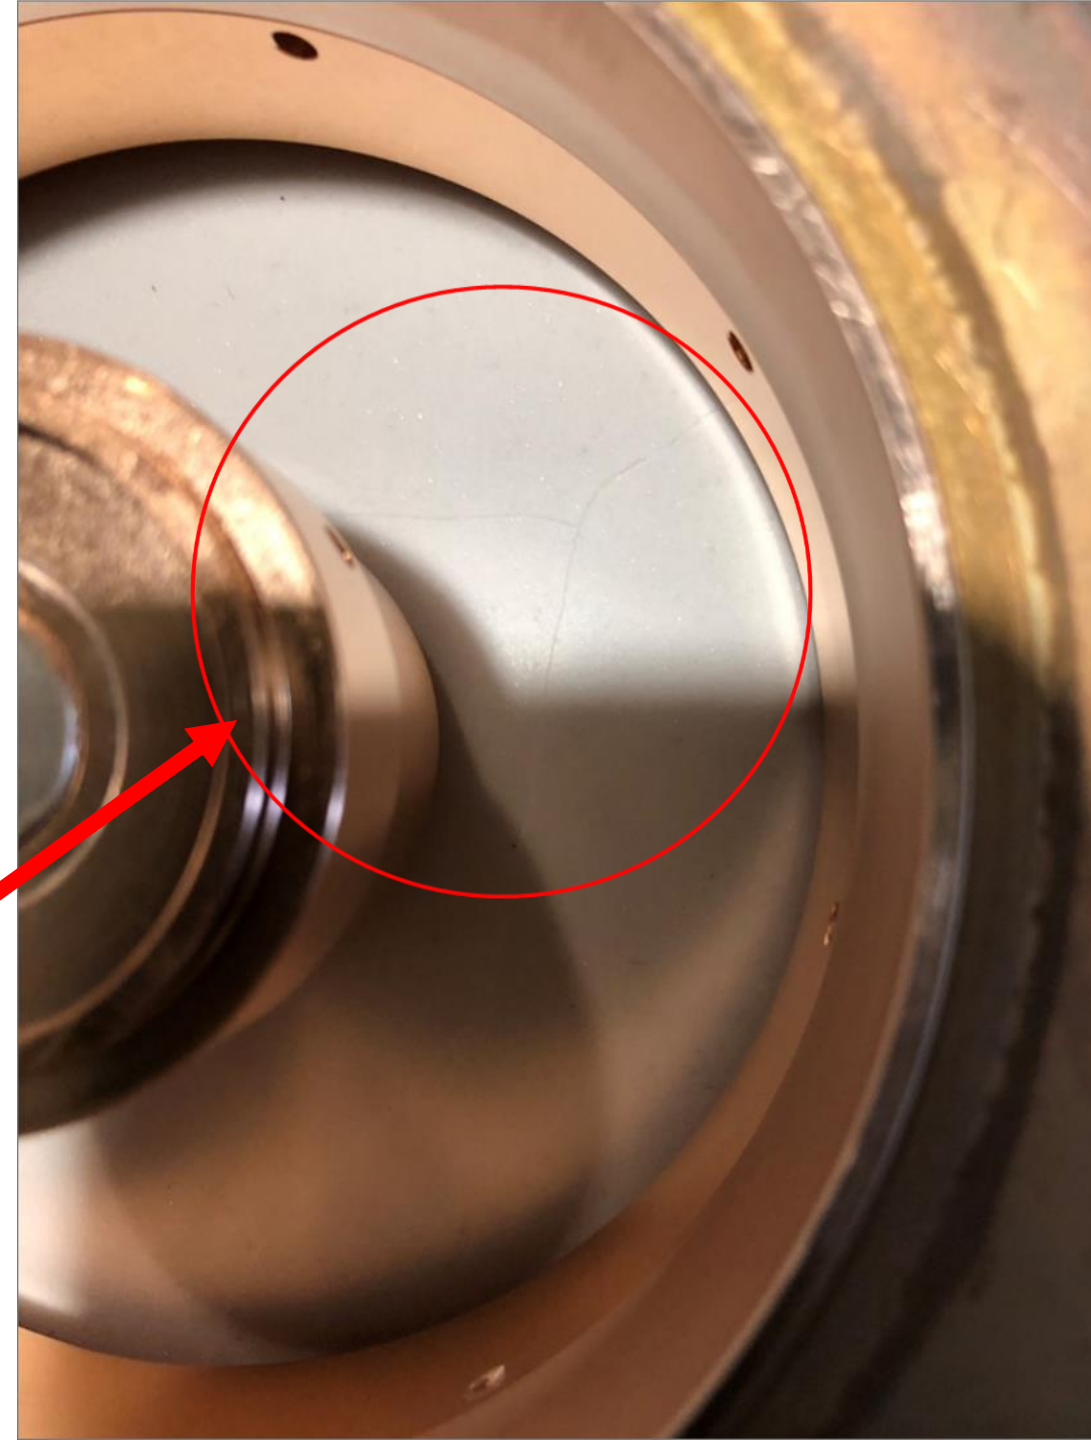
- During testing one ceramic broke by a single arc event during standing wave testing
 - Venting the waveguide, $>10^{-4}$ range leak
 - This type failure only happened once 06c in operations
 - Most likely failed due to thermal shock

Complete fracture of the ceramic from inner to outer conductor
