Recent Experience with Testing and Operating RF Couplers at SNS

John Mammosser

July 2nd, 2024

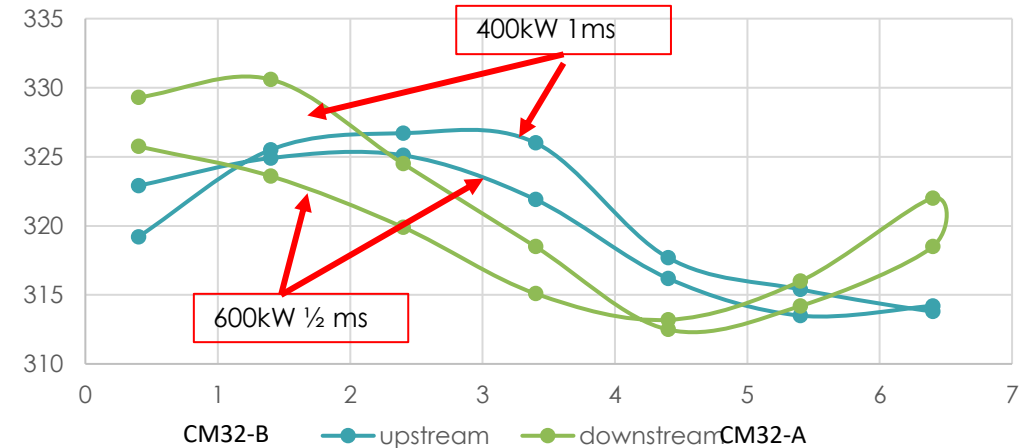
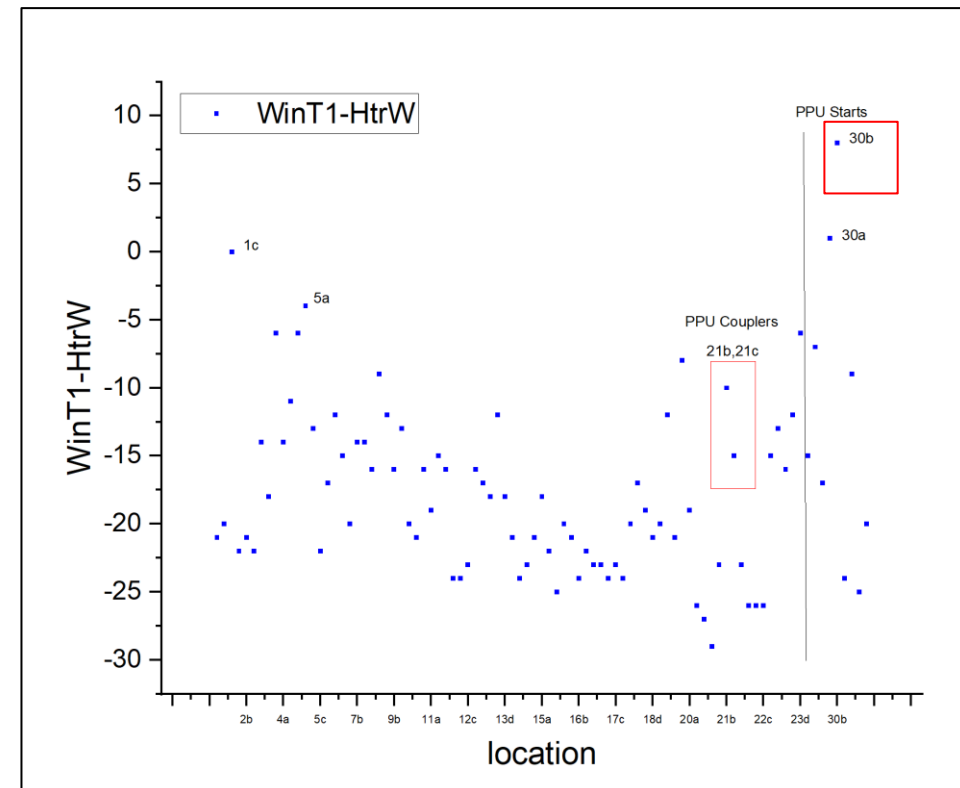
CM32-B CM32-A

- During RF Conditioning of the RF couplers ceramic temperatures would depend on the position standing wave
- Once installed in the tunnel several cavities became limited by the RF coupler ceramic temperature 30b and 32b were the highest
- Since installation and two run periods CM32 was warmed up to repair a tuner and after that the RF coupler temperature has seemed to recover to a much lower value
