RFD CM- M7 testing- Vacuum

N. Valverde, K. Turaj on behalf of HL-LHC WP4, SY-RF-SRF and AL/40-30

18.06.2024

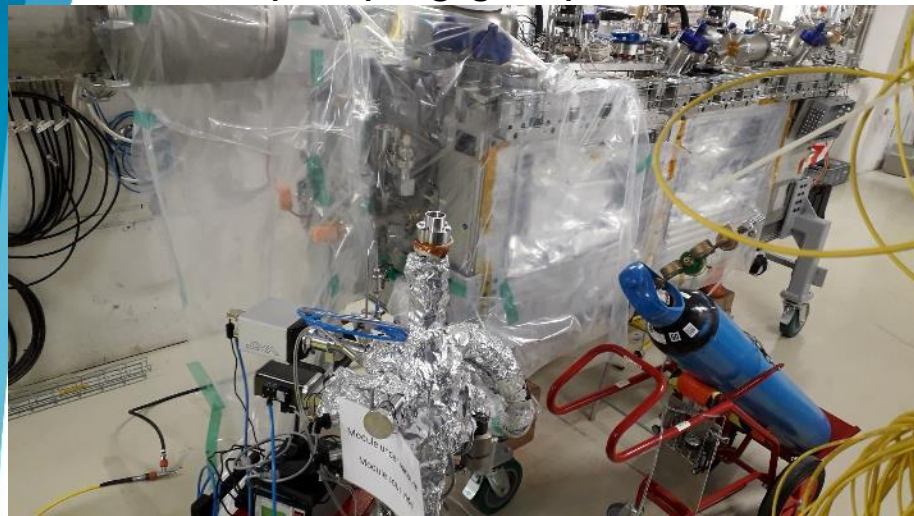
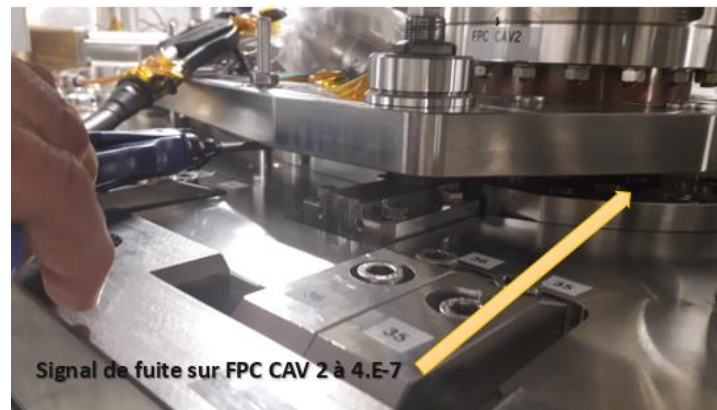
Non-acceptable leak found on the FPC2
Leak rate : 3×10^{-7} mbar.l/s
(Report EDMS2978057, NCR EDMS2995891)

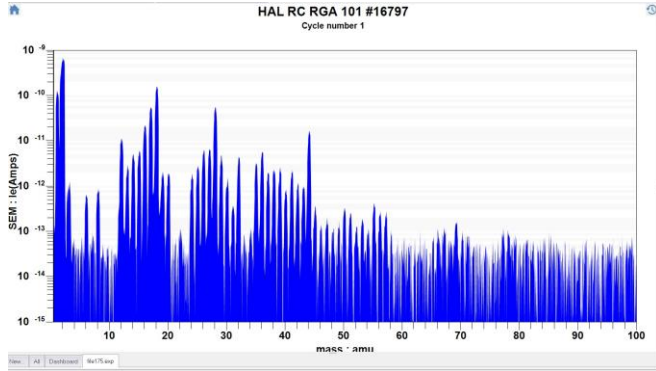
RGA of the pumping group alone

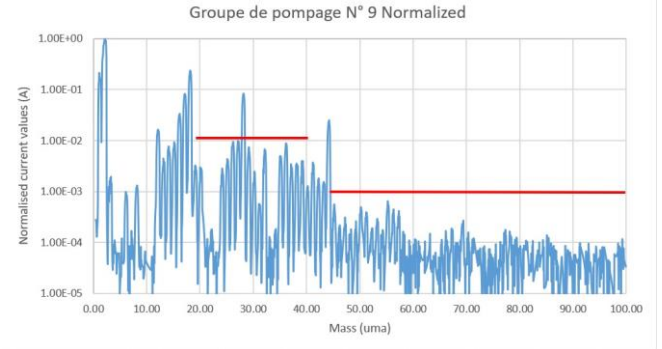
5 RGA of the pumping group connected to beam vacuum

Leak confirmed with the RGA

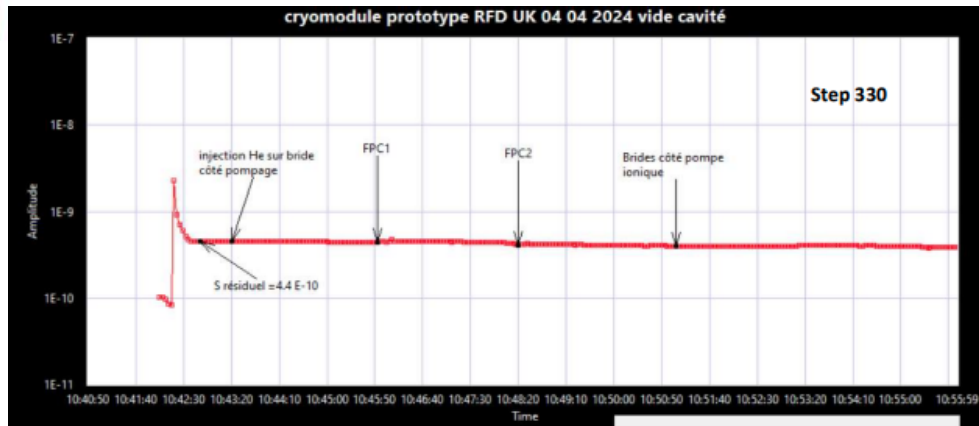
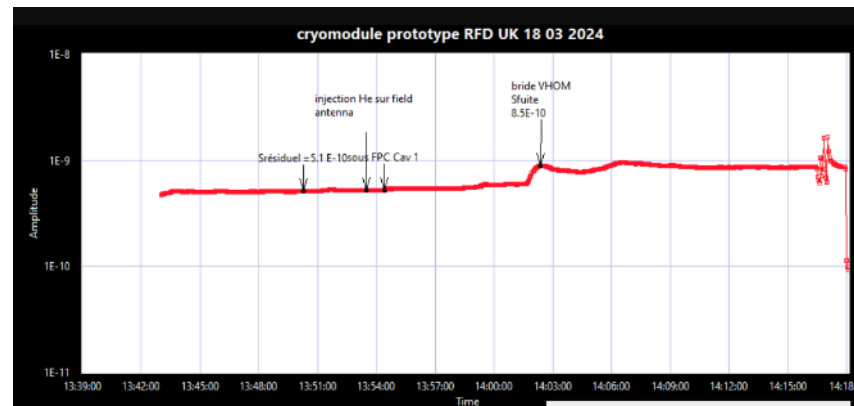
No leak in FPC2 after the repair

However, leak found on VHOM2, leak rate 2.33×10^{-10} mbar.l/s → Accept as it is; it's too risky to try to repair it.

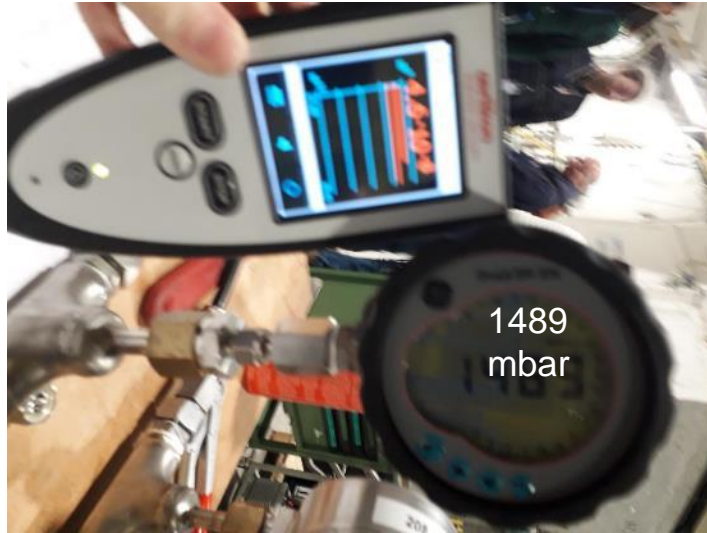
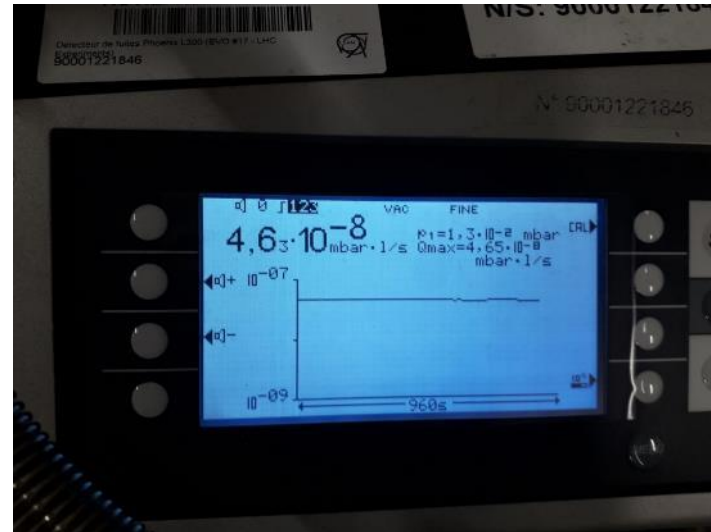
During pressure test of the Cryo Lines, the pressure of the insulation vacuum and the beam vacuum was stable

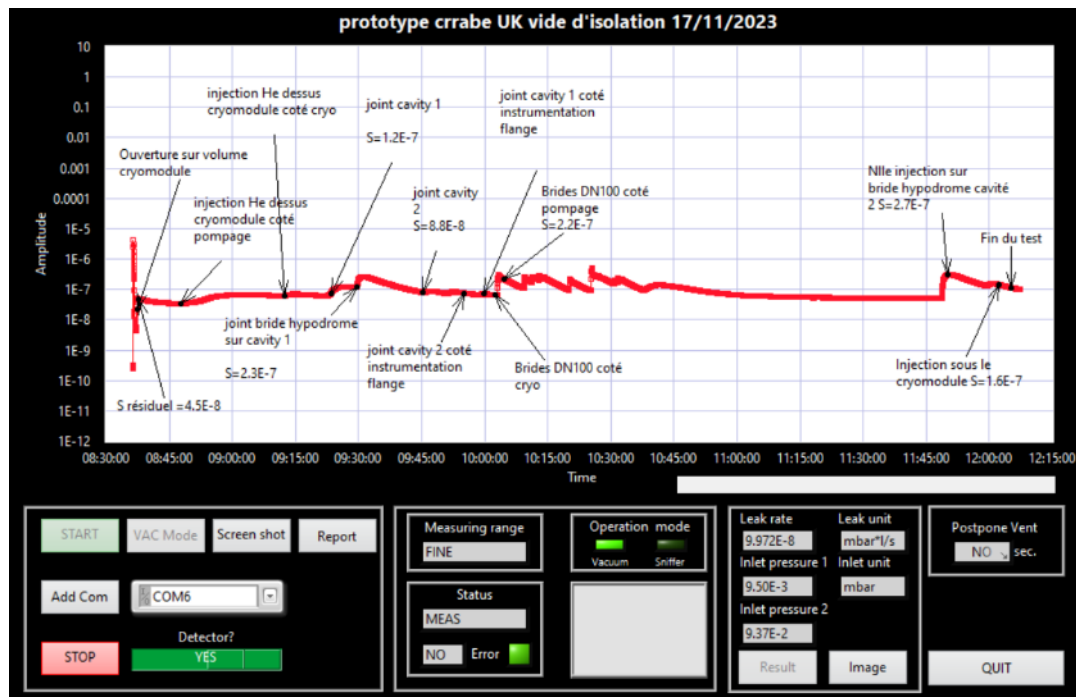
Leak test insulation (spraying helium around the VV) :

Two leaks at 10^{-7} mbar range detected (connection to pumping group, small window of the VV).

Both leaks repaired after the RF test.
