WP4-RFD/SPS– NCR and repair action for FPC 1 & FPC 2

18th of June 2024

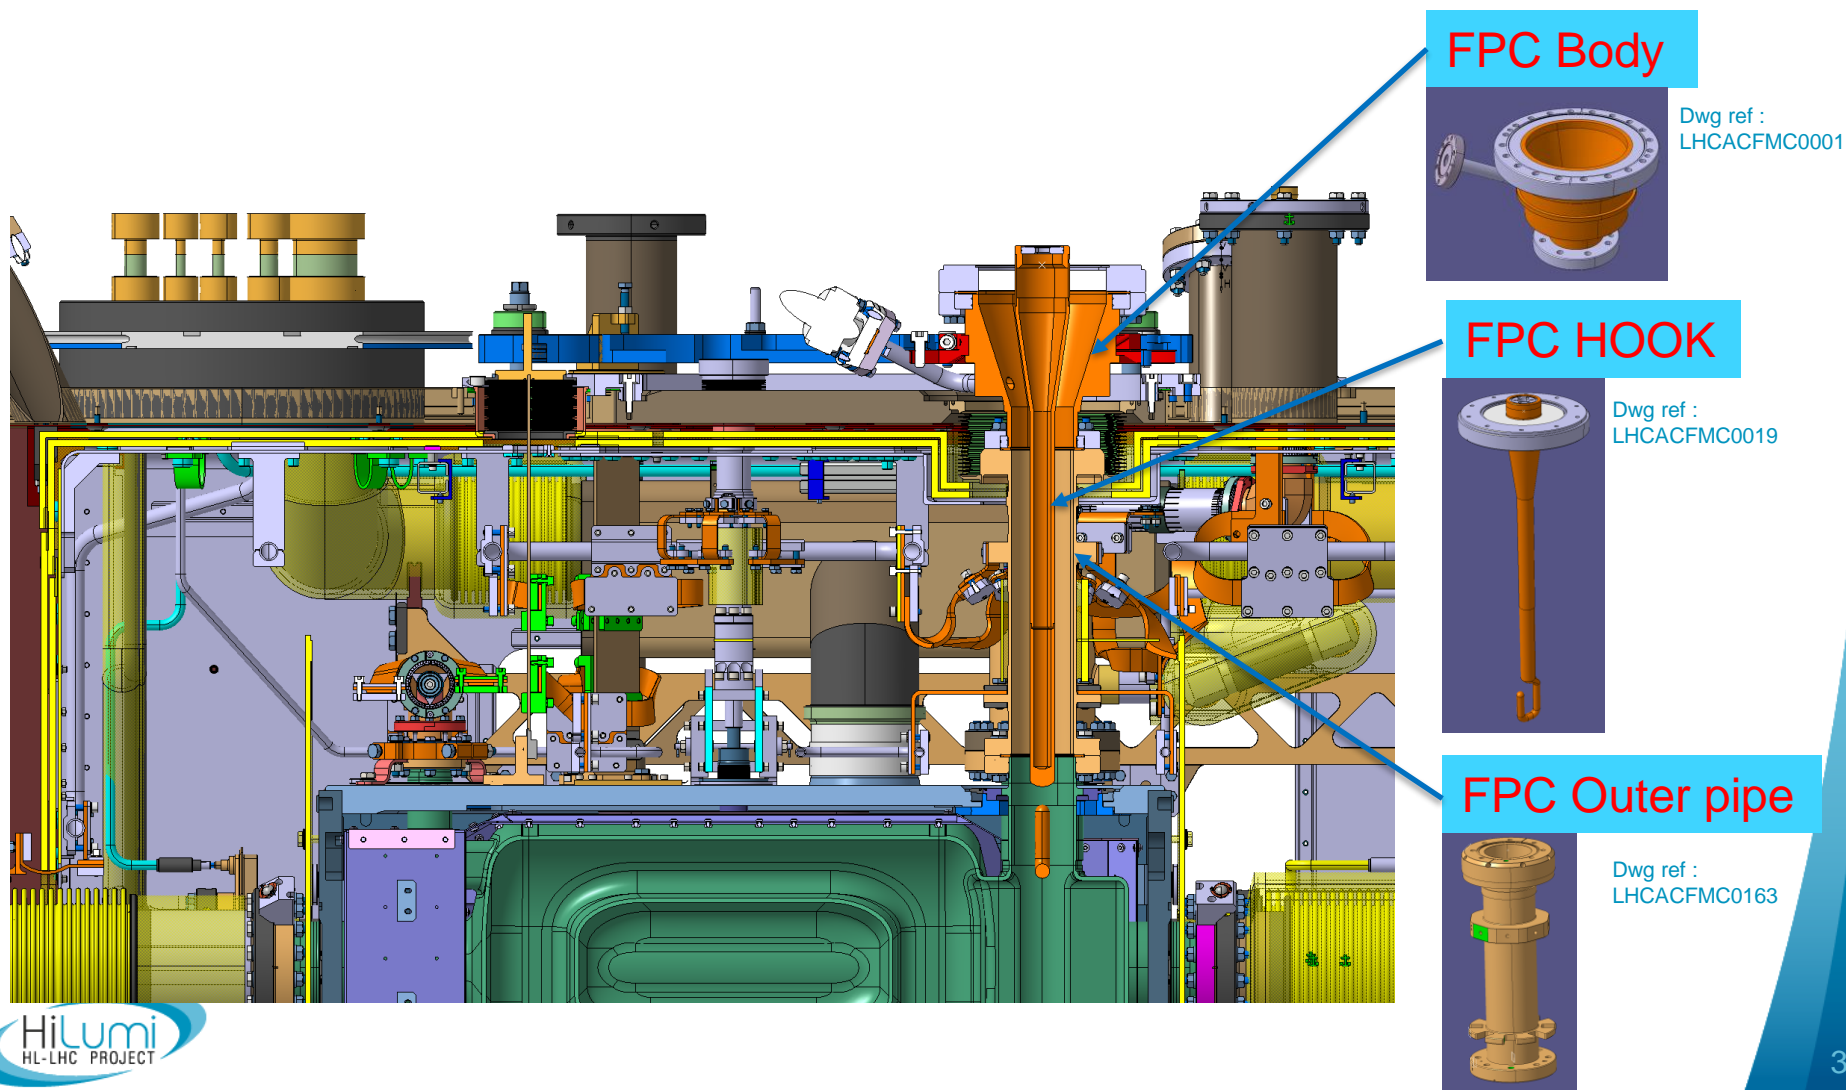
FPC cavity 1

- Non-conformity identified during SM18 tests : [NCR: EDMS 2995980](#)
 - Tilt of the FPC on Cav 1 – short circuit

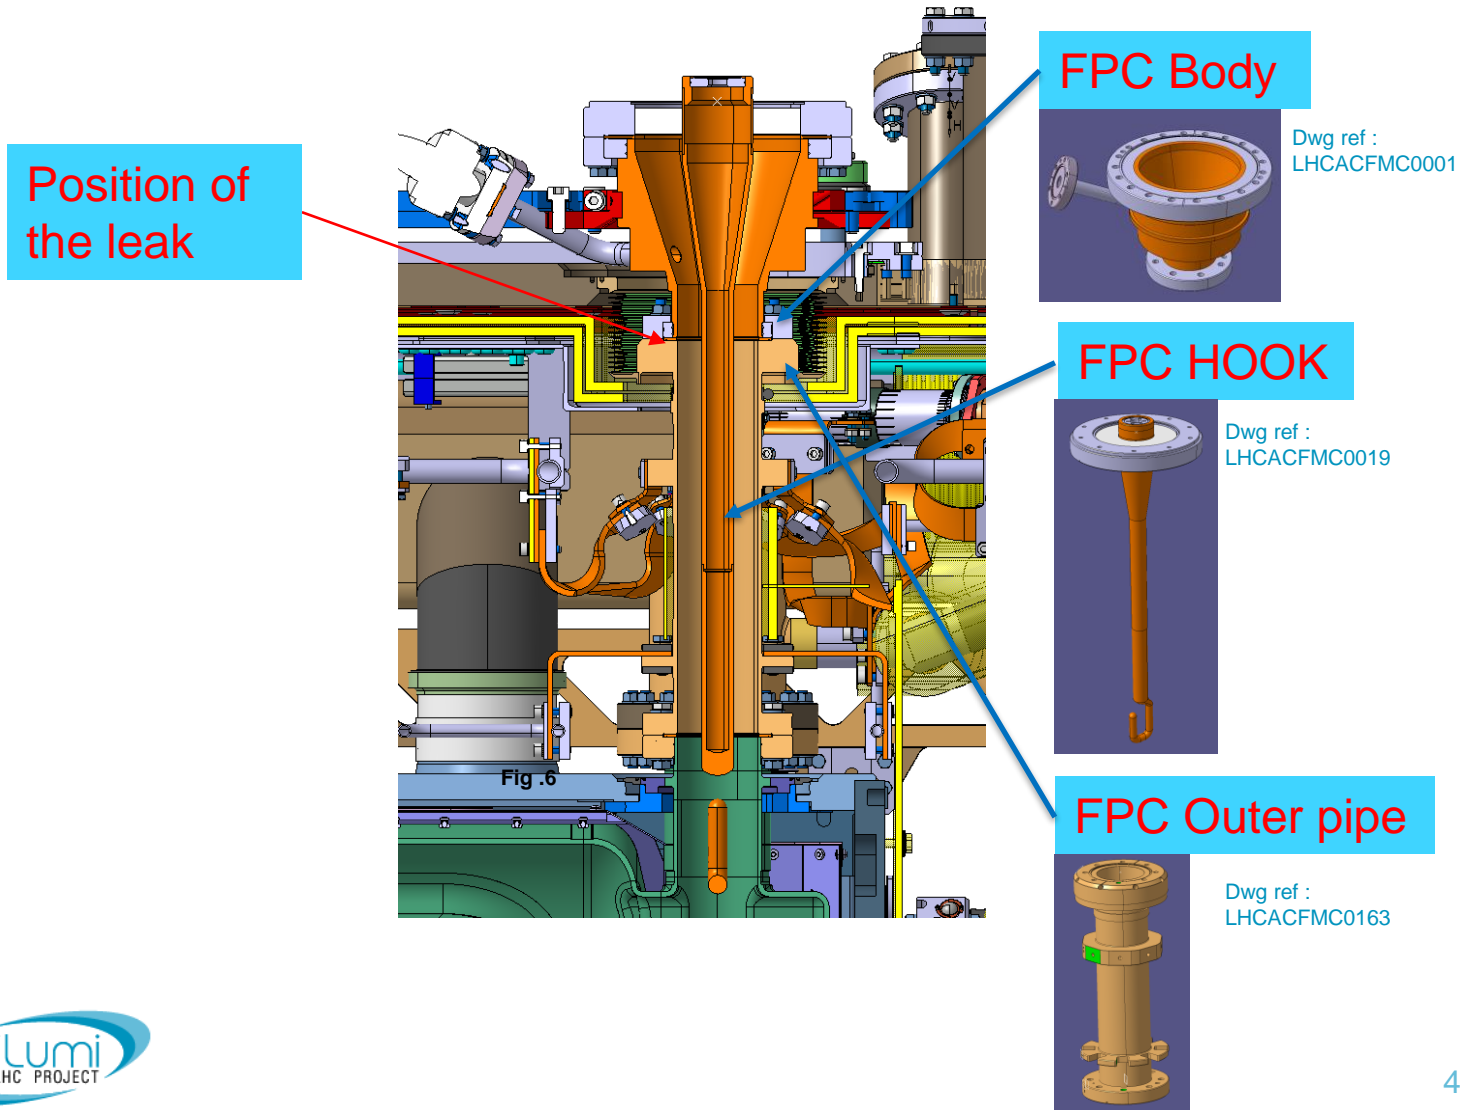
FPC cavity 2

- Non-conformity identified during SM18 tests : [NCR: EDMS 2995891](#)
 - Tilt & Vacuum leak on the FPC of Cav 2

- A similar but smaller deformation is also visible on FPC cavity #2 but without electrical short and no undesired behaviour noticed during RF checks. This bending is very likely to have caused the vacuum leak.

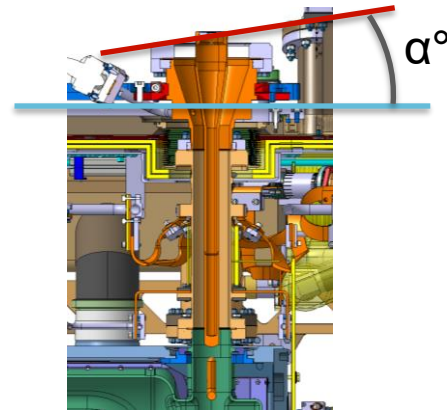
- Preliminary RF checks performed by E.Montesinos and his team showed a problem on FPC of cavity #1
 - A measure of electrical continuity between inner and outer conductor of the FPC showed a contact between the conductors
 - Visually, the top flange FPC look tilted
- WRT the surrounding elements

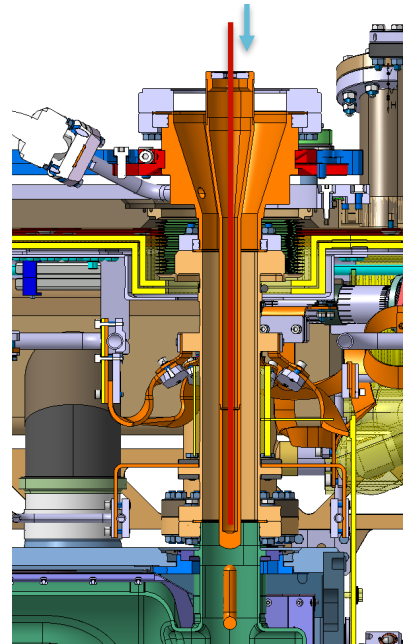
- Both FPCs Cavity #1 and #2 are equipped with optical fibers (see talk of M.Guinchard)
 - The optical fiber sensor installed on both FPCs show no significant strain, excluding a permanent deformation of the FPC outer pipe
 - A $\text{Ø}15.5\text{mm}$ rod has been fitted inside the cooling channel of the hook to exclude a large bending of the hook
- (a large deformation of the hook would have prevented us from fitting this rod)*

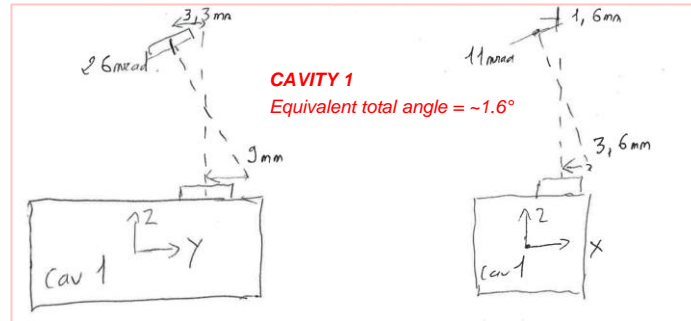
Fig .5 Measured using laser tracker – V.Rude

- A measure of both the top FPC flange and the lower FPC outer pipe flange (Plane + axis for both) show a deviation as described on the sketches below :

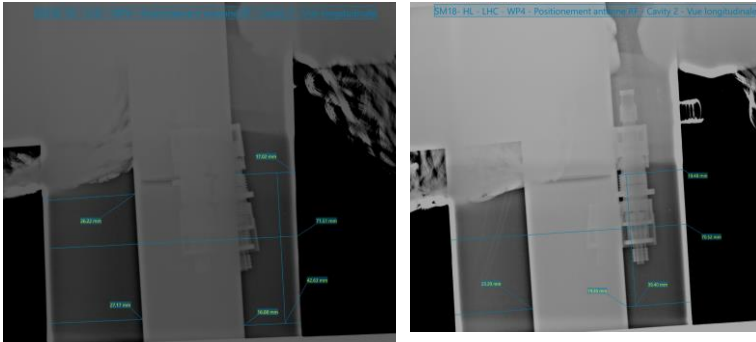
Result of radiographic measure (see full results in EDMS 2995980)- courtesy A.Porret

- X-ray confirms our preliminary observations :
 - The hook isn't bended
 - The deviation starts from the top

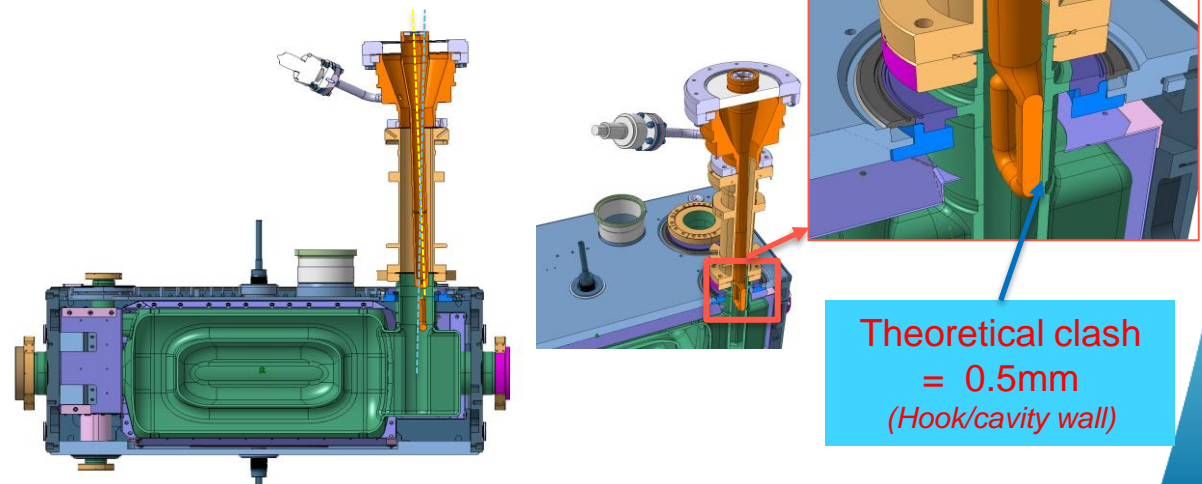
3D modelling of the deviation

Theoretical clash
= 0.5mm
(Hook/cavity wall)

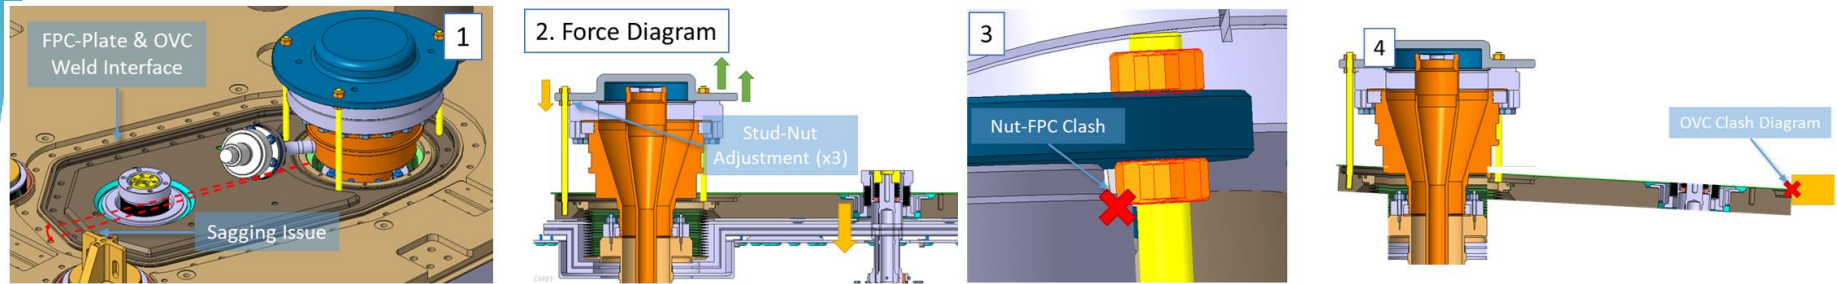
Draft document from N. Templeton (STFC)

The root cause was determined to be same for both FPCs; a multi-problem case during step5.8:

- *The FPC-Plate to OVC interface could not be welded due to cantilever sagging.*
- *Correcting the plate pitch was challenging with the FPC-Plate tooling.*
- *A clash between tooling nuts and the FPC caused nuts to round when adjusting and loss of torque feel.*

However, these 3 problems alone can not cause damage since a bellows decouples the FPC and FPC-Plate.

- *As the weld interface correction was attempted, it's suspected an unknown clash between the FPC-Plate and OVC created the force path through the FPC.*

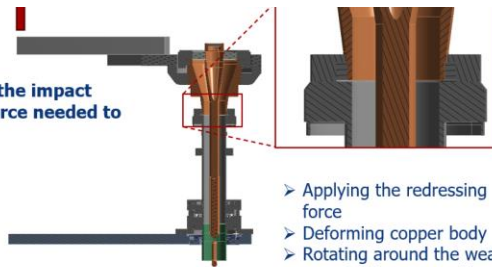
- Applying the redressing force
- Deforming copper body
- Rotating around the weakest point leading to rigid body motion of the antenna

- Mechanical simulation : [EDMS 2977959](#) - JOANNA SYLWIA SWIESZEK
 - The estimated force for the bending of the body of FPC cavity #1 is ~4.2KN
(force applied ~530mm away for FPC axis)
 - The estimated force it to recover its nominal position is ~6KN

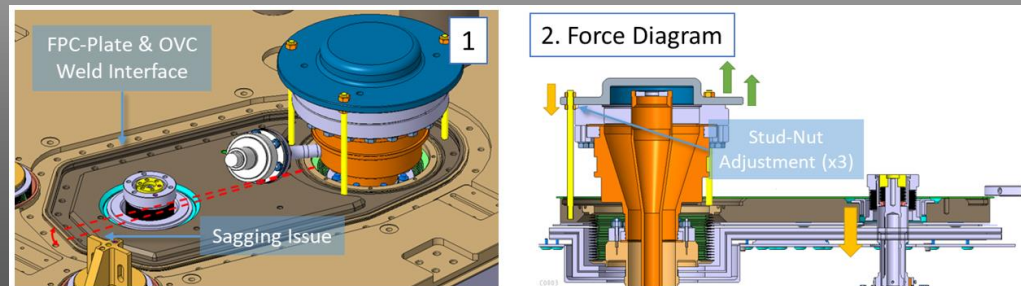
- The force needed on the M8 rods to bend the FPC body would have been ~28KN
(force applied ~75mm away for FPC axis)
- The load to tighten the M8 nuts added to the axial load would have exceeded the maximum allowed stress of the M8 rods.

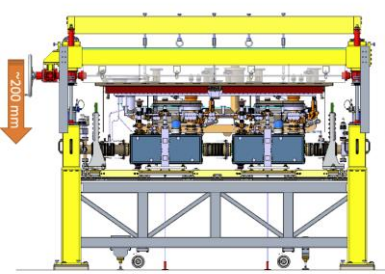
5-6-5 Lower Gantry using Top Kinematics to align

- A misalignment of the top plate WRT cavity string was measured before the top plate has been lowered but noticed only after the top plate has been lowered in position

- The misalignment on Y axis (-7.95mm min) is larger than the FPC aperture margining ($\pm 2.5\text{mm}$)
- There is a possibility that the top plate misalignment lead to a collision on the FPC plate

- Because of the tight environment it is really hard to properly look at the FPC plate passing through the aperture of the top plate. Nevertheless it is of crucial importance that this happens without collision.
- A specific tooling to better adjust the position of the FPC plates need to be designed
- Use the optical fiber installed on the FPC outer pipe to better monitor potential issue.
