Status of MBRD series production

S. Farinon INFN - Genova

Zoom Meeting – May 22nd, 2024

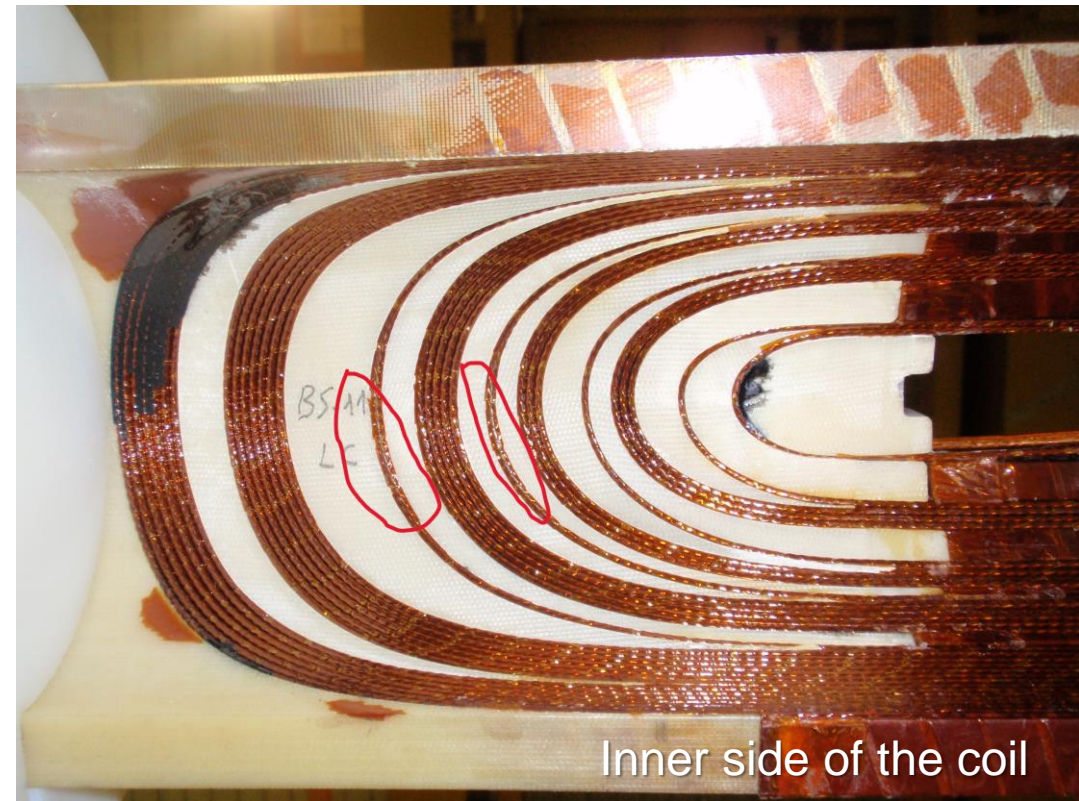
- The winding and curing of all the 24 coils has been completed.
- There are 2 issues:
 - Insulation damage at the coil ends
 - During curing, the coil is pressed against the mandrel at 90 MPa, which can damage the turn insulation in some areas.
 - ASG developed a process to restore the insulation in both collared and single coils (approved by CERN/INFN).
 - The repair has already been performed on MBRD2 at CERN, but still needs to be applied to MBRD1 and to the coils that have not yet been collared.

(https://edms.cern.ch/ui/file/3088308/1.0/28837_1_MBRD_TURN_INSULATION_RESTORING.pdf)

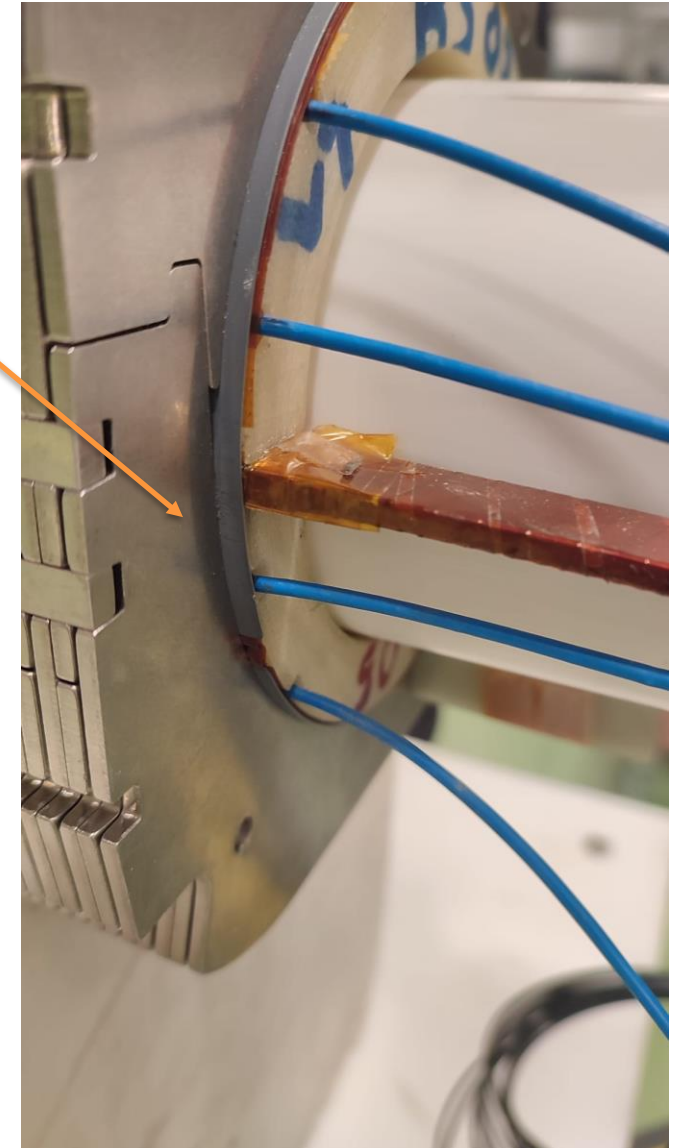
Protruding SS protection sheets

- This issue, which has affected all collared apertures, was initially detected on MBRD1.
- The root cause consists in the fact that, according to the drawings, the SS protection sheets are as long as the coils.
- Due to the inherent difficulty of precisely controlling their position, this protrusion occurs in almost all apertures, leading to the encountered problems.

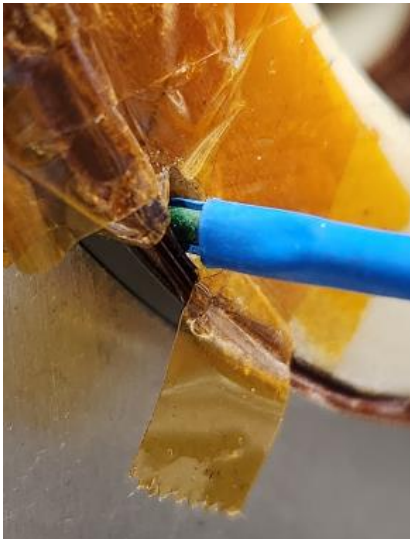
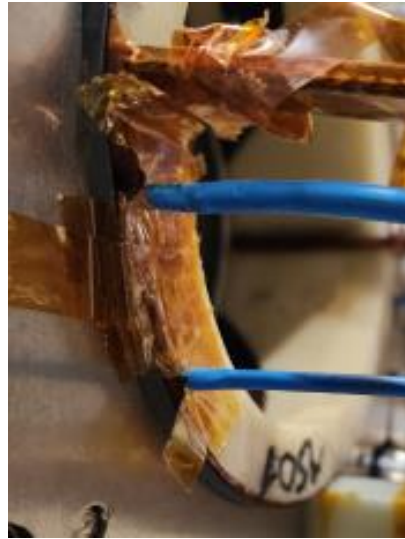
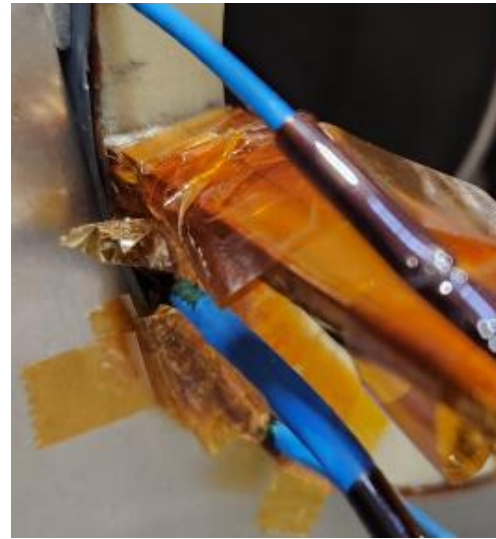
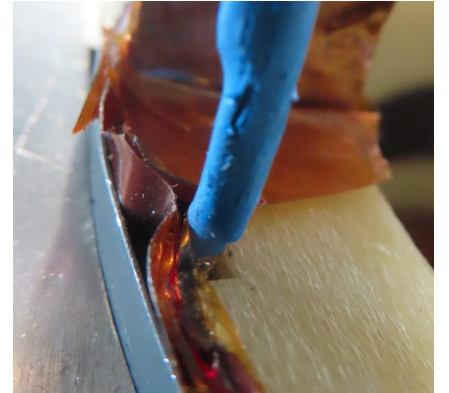
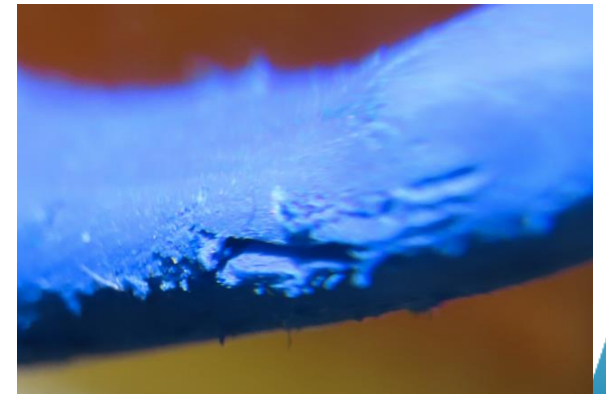
MBRD1 status

- MBRD1 arrived at CERN in October 2023 (with partial loading of the longitudinal tie rods).
- In December 2023, with INFN staff, the tie rods were successfully loaded to their nominal load.
- Subsequent electrical tests at high voltage (3.1 kV) revealed a short circuit to ground in QH Y112.
 - Since no electrical tests were planned upon receipt, it's impossible to determine whether the short occurred during transportation or during the loading of the tie rods.
 - The revised acceptance procedure now includes high-voltage electrical tests upon receipt.
- CERN technicians attempted to locate the source of the issue using endoscopy but, in the end, it was decided to disassemble the end plate.

- The anomaly at QH Y112 wasn't traced by ASG, and we're still waiting for an explanation from them.
- A local electrical test at 3.1 kV was performed between YT112 and an aluminum sheet enclosing the wire. The investigation precisely identified the defect's location at the repaired section with the polyimide tape.

- Corrective actions:
 - MBRD1 has been temporarily reassembled for transportation back to ASG, a decision made by ASG.
 - However, this transportation process experienced some delays due to customs documentation, and it is now scheduled for next week, specifically May 28th, 2024.
 - MBRD1 will be repaired with the highest priority.
 - The repair process will involve several steps, including bending of the SS protection sheets, reassembling of the end plate, repairing of the stabilizer brazing, splicing, and attaching VTs according to CERN's procedural guidance.
 - According to the current schedule, its delivery to CERN is expected in June 2024.

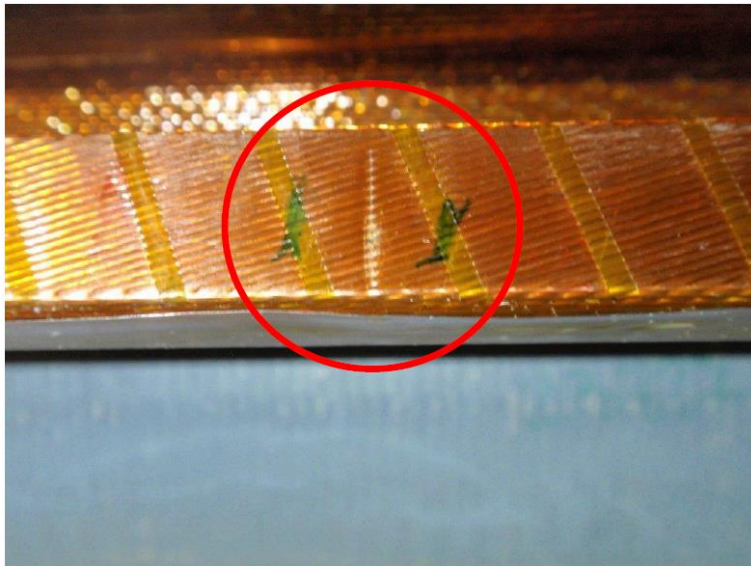
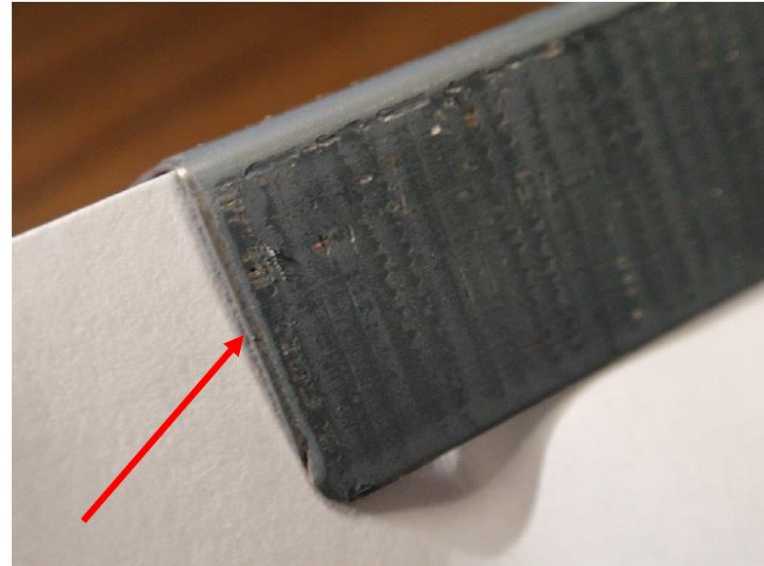
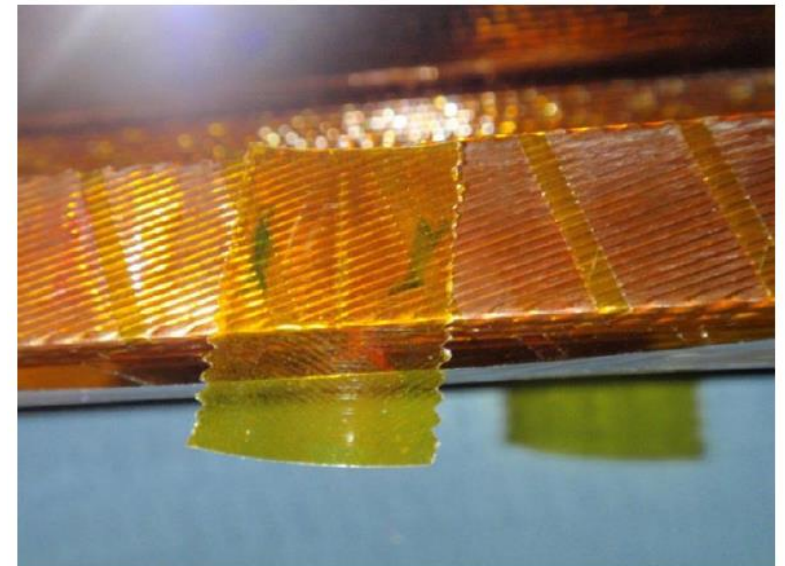
Short coil BS-08 vs ground

- The cause of this issue was the unforeseen overlapping of two adjacent coil protection sheets side by side.
- This overlapping resulted in an increase in thickness, which under pressure led to damage to all the ground insulation layers (no damage to the conductor strands).
- Accepted repair proposal includes the replacement of damaged GI and QH and the local application of a single layer of polyimide adhesive tape (20 mm in width and 0.05 mm in thickness).
