BHZ61 – 50+ years of service, (PXMBHGC4WP-01000011)

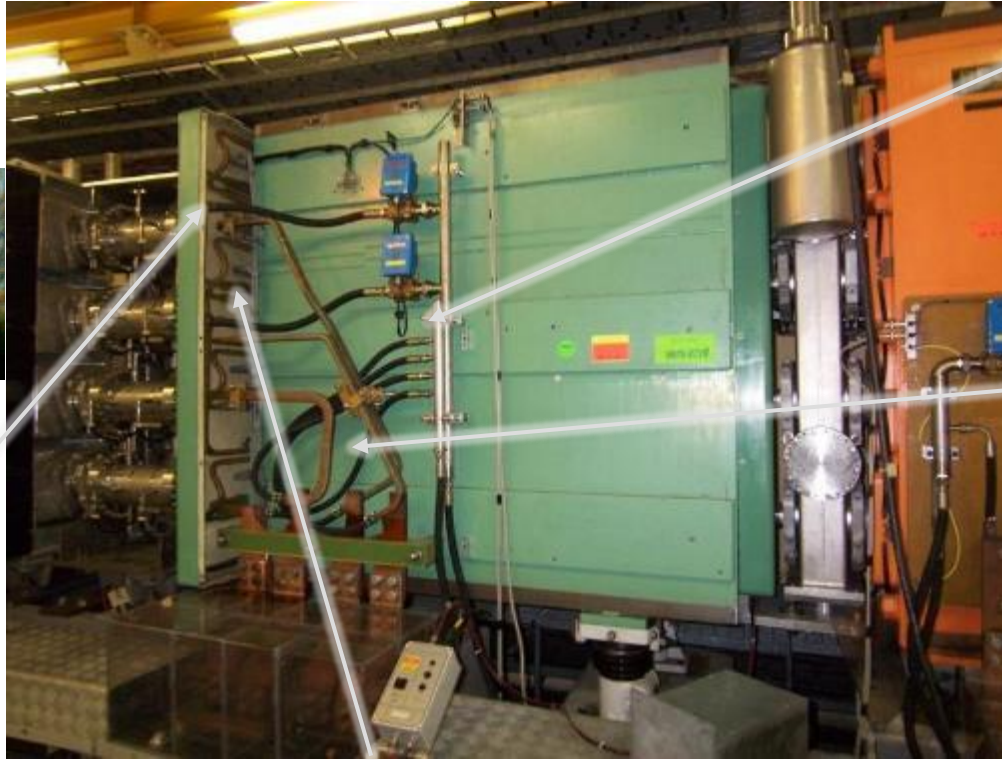
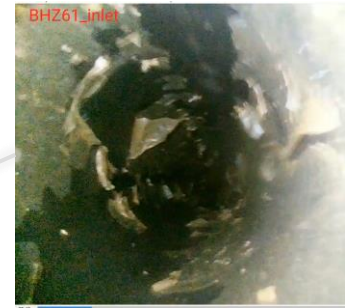
Brazed Insert (sil-fos)

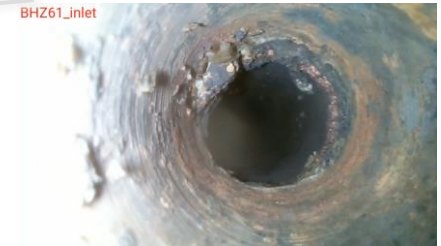
Inside cooling hose.
Analysis:
(<https://edms.cern.ch/document/3064730>)

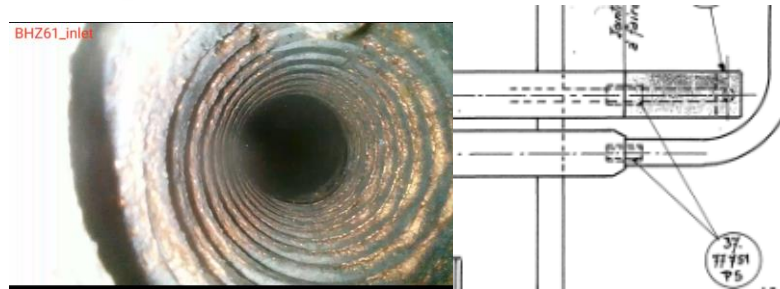
Brazing of ss hose fitting
(method tbc)

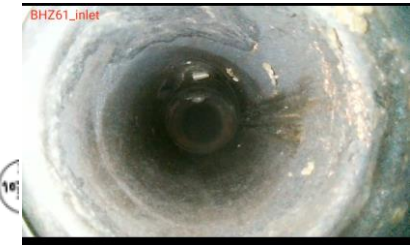
Brazed insert between busbar and coil (Sil-fos)

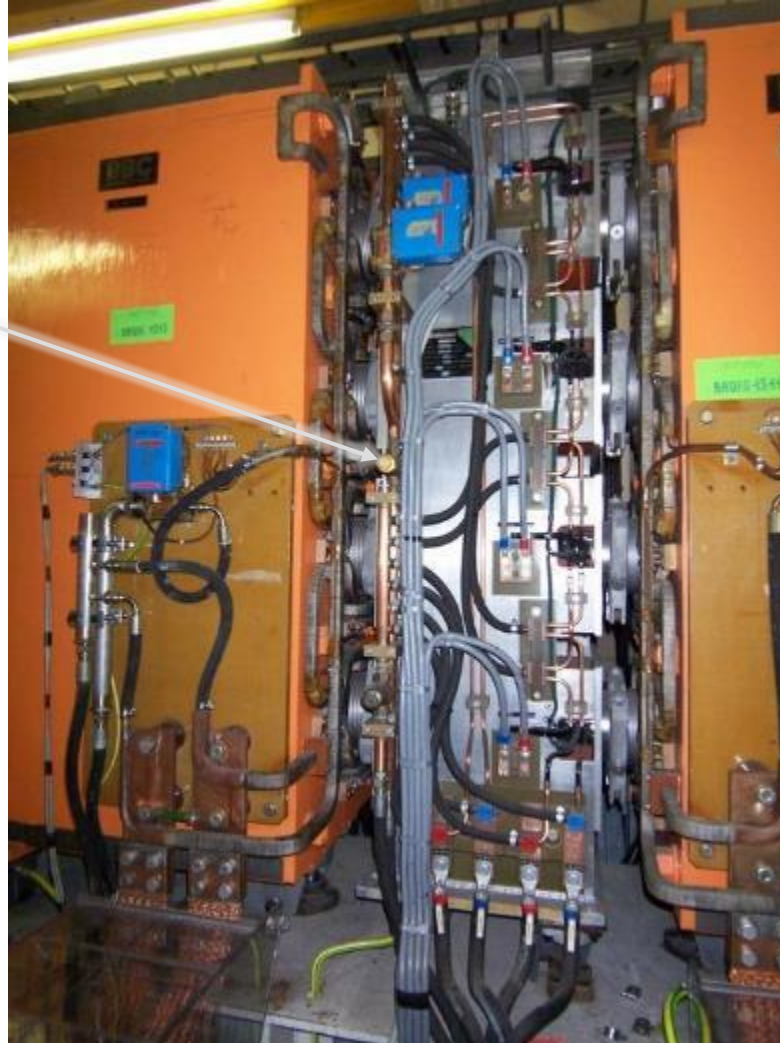
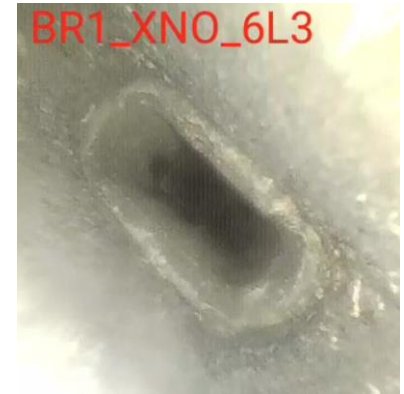
Demin Resin in the inlet
manifold

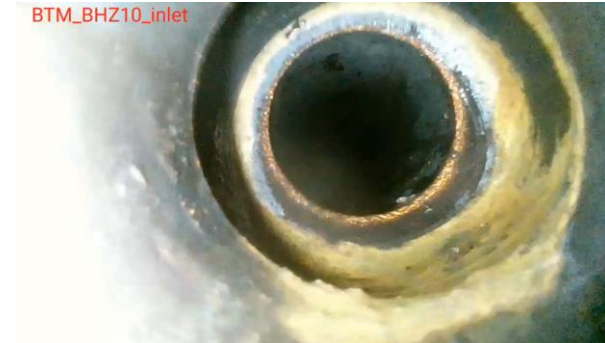
Cu – Cu Sil-fos brazing

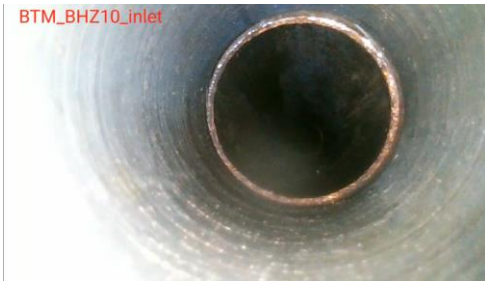
Cu – SS vacuum brazing

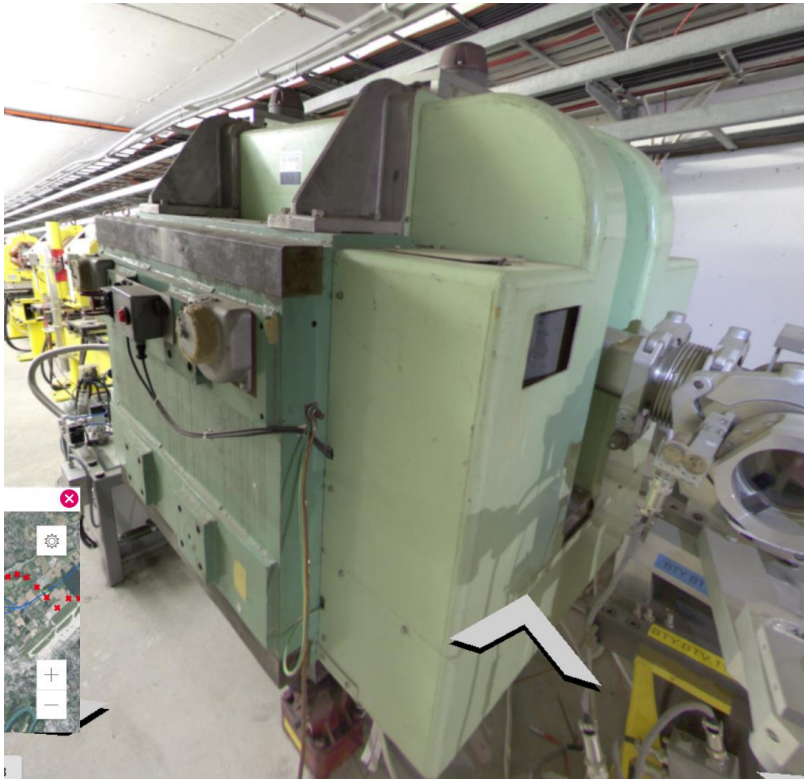
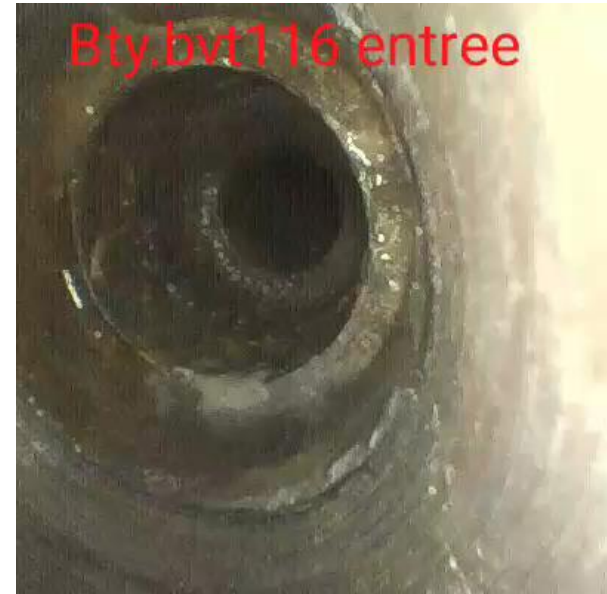
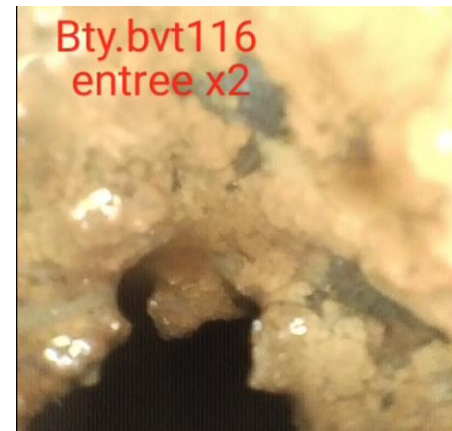
Pollution (Video)

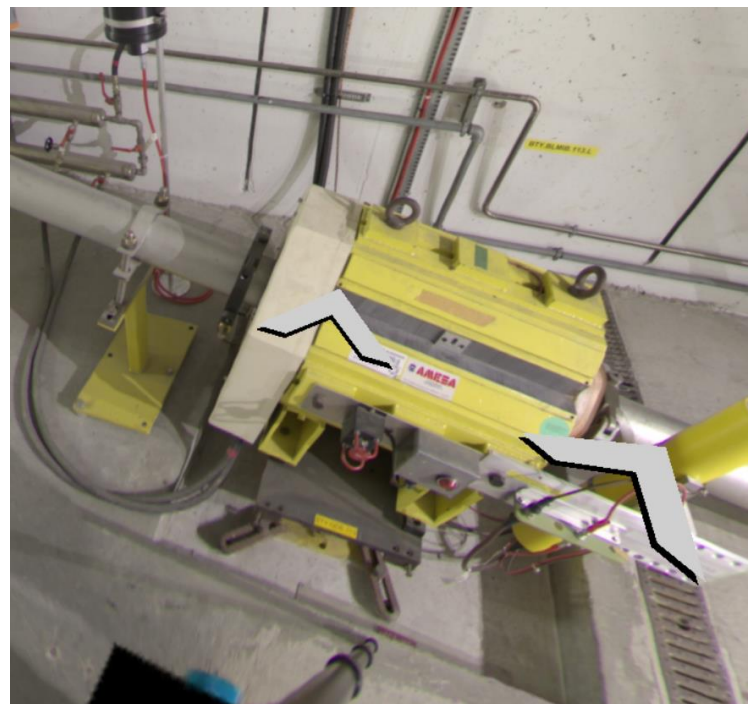
Pollution (Video)

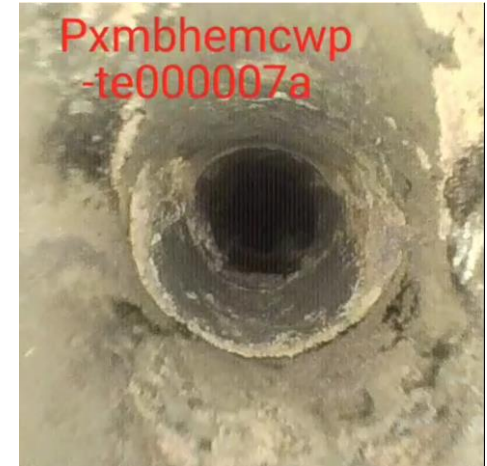
Cu – CCZ Sil-fos brazing

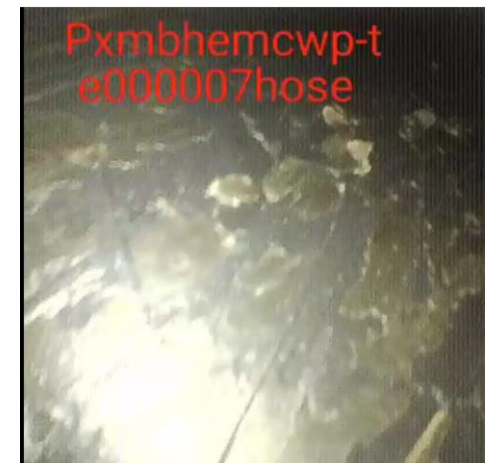
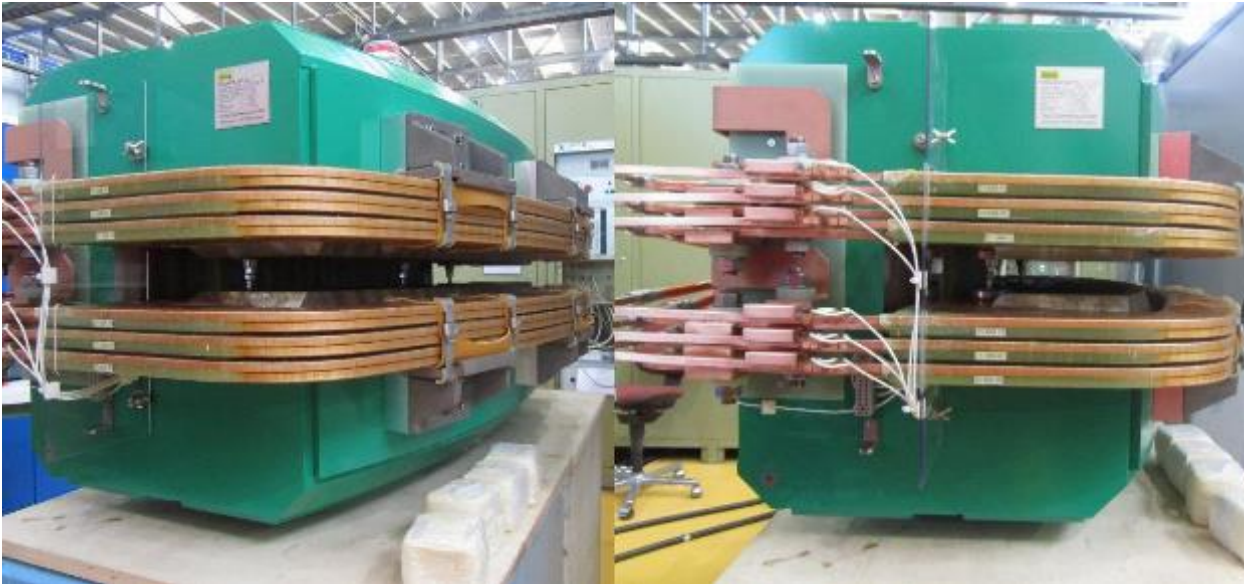
Deposits in hose

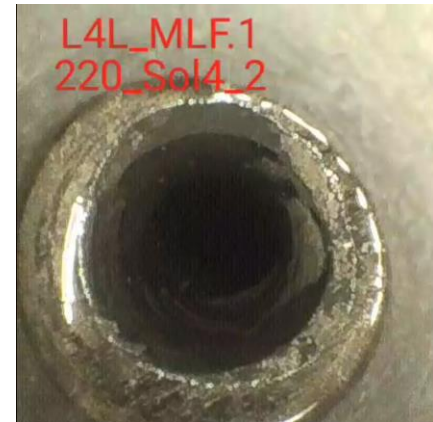
Cu – Cu brazing?

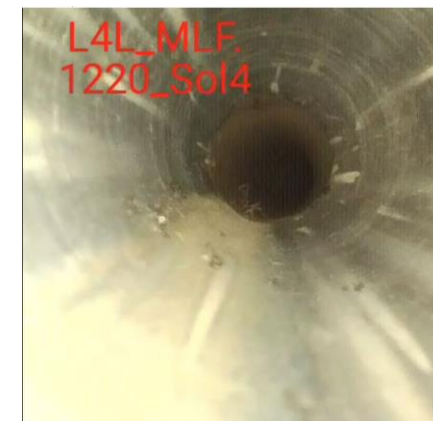
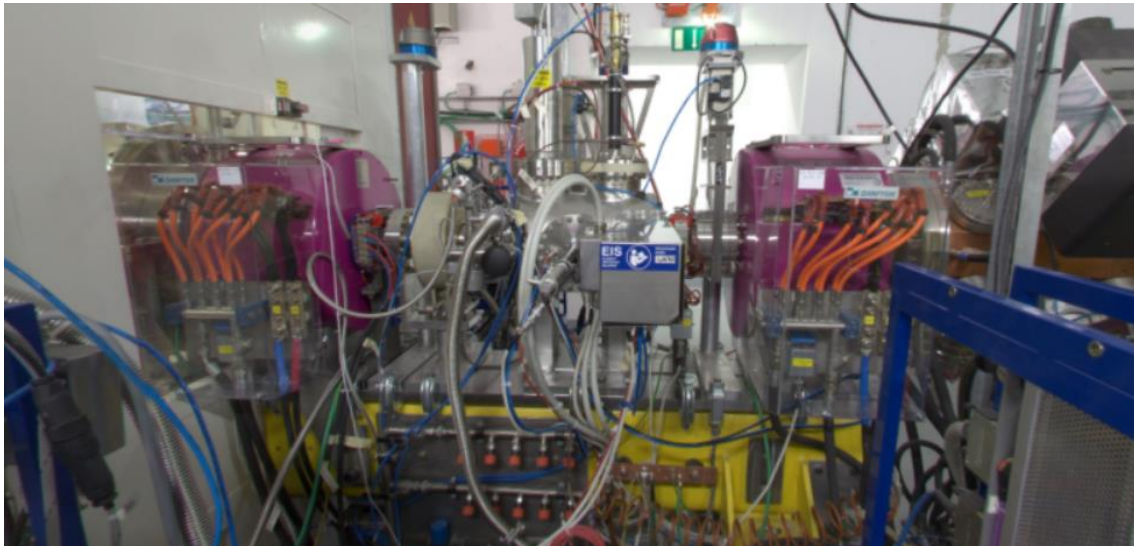
Deposits in hose

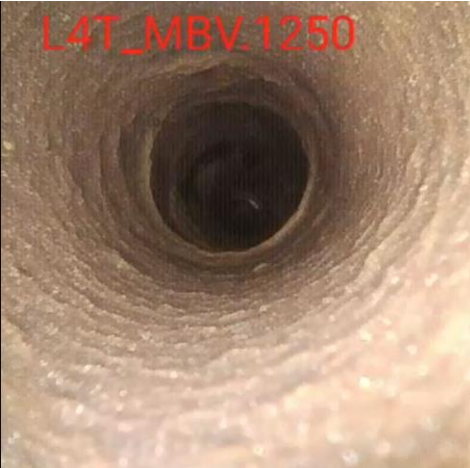
Cu – Cu brazing??

Cu erosion?

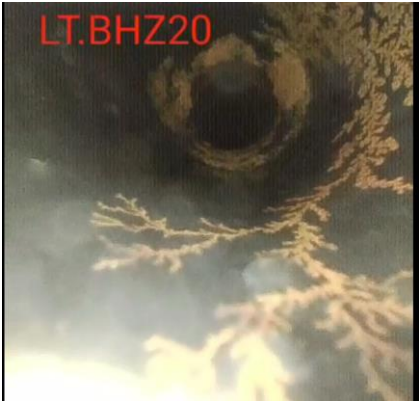
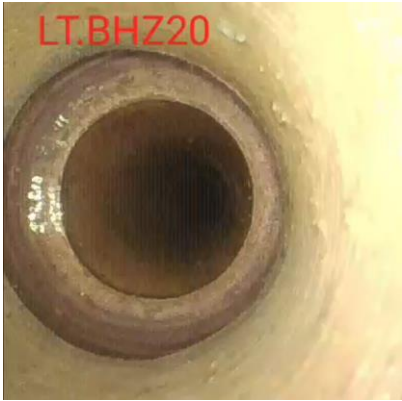
Cu – SS vacuum brazing

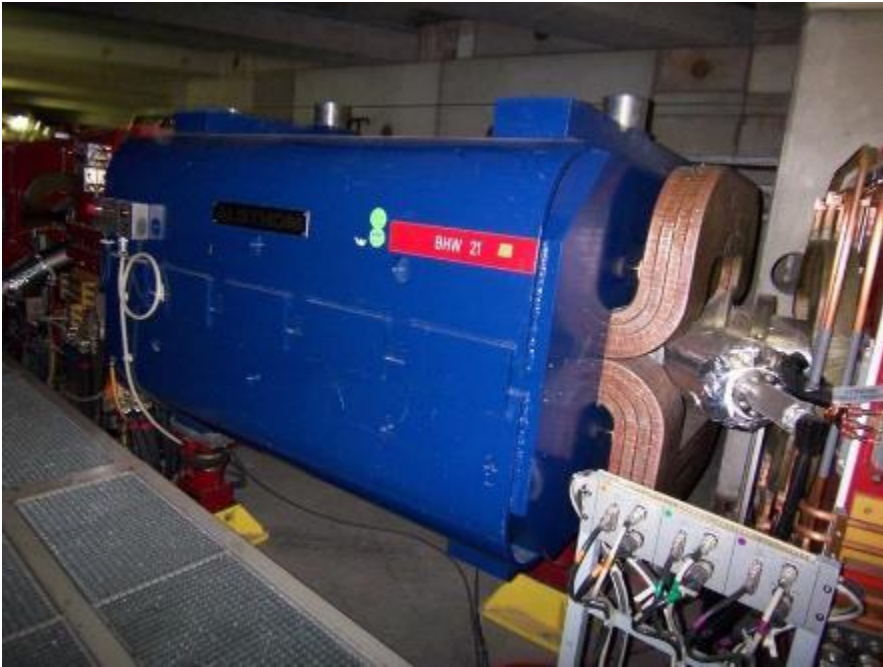
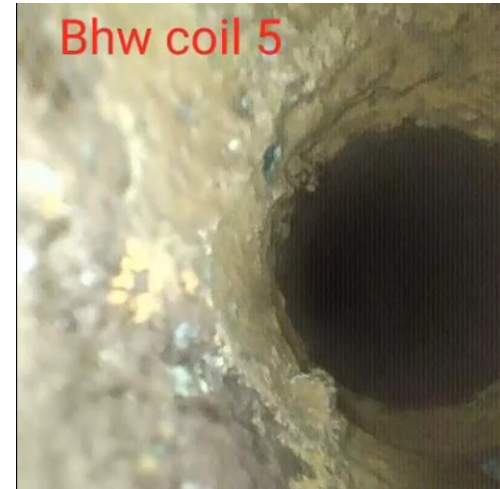
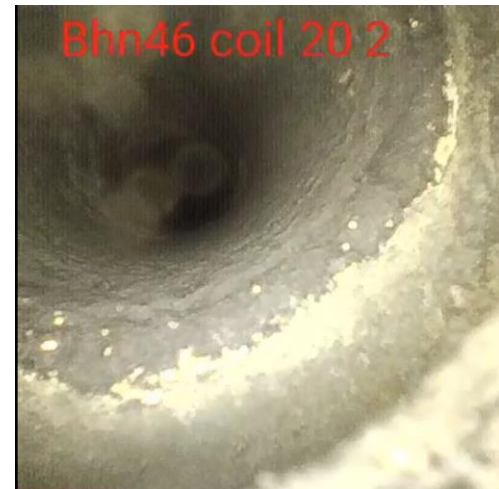
AD BHW Coil (workshop) (PXMBHHFC01-00000005) Installed 1986, Failed at brazed joint 2020?

Cu – Cu Sil-Fos brazing

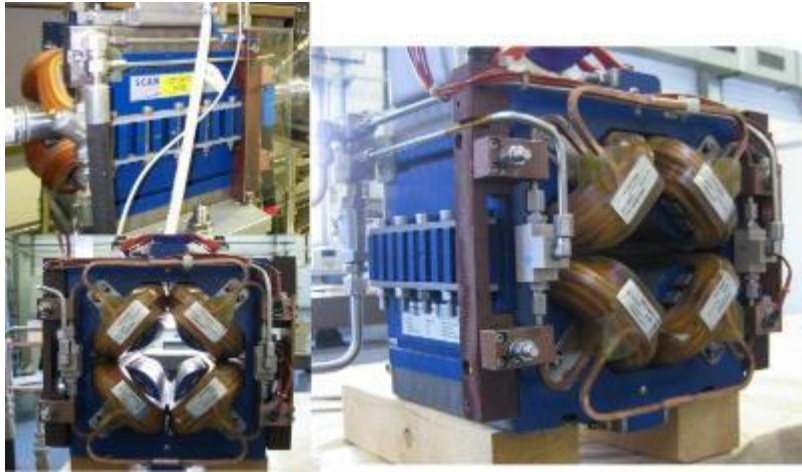
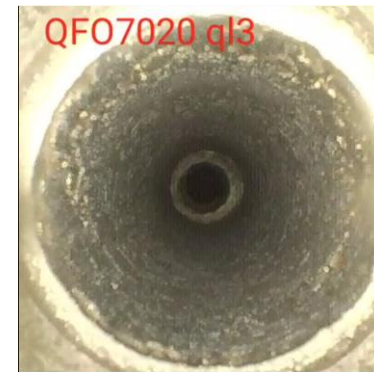
Cu – SS vacuum brazing

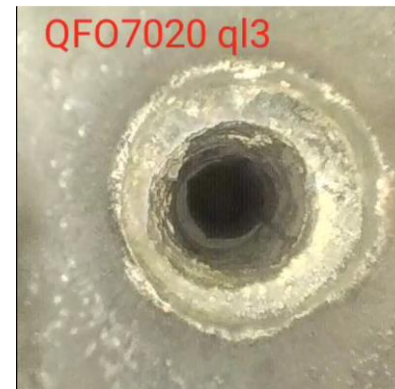
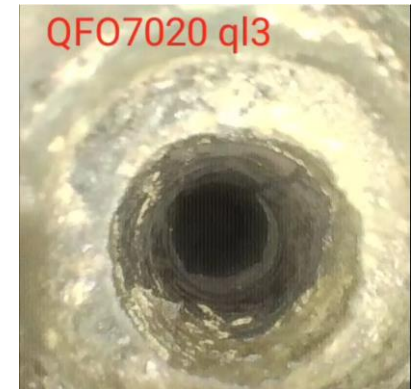
Cu – Cu Sil-Fos brazing

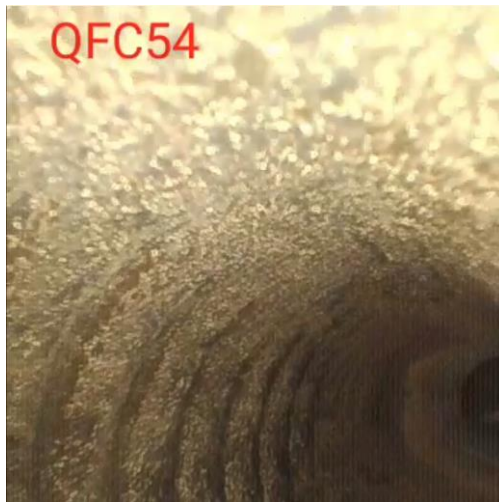
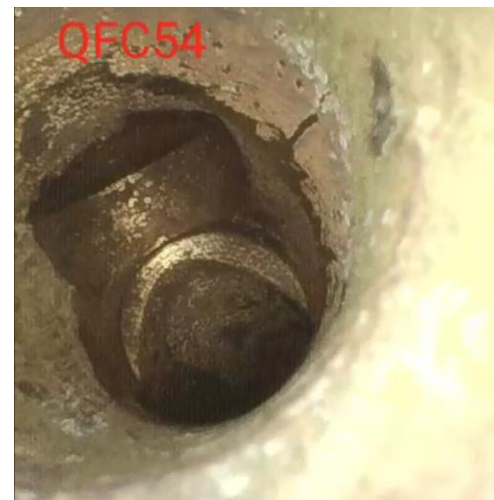
Cu erosion due to high water speed (8 to 14 m/s)
