MQXFB coil fabrication

for the MQXFB coil production & QA team

14th HL-LHC Collaboration Meeting
07 - 10 October 2024

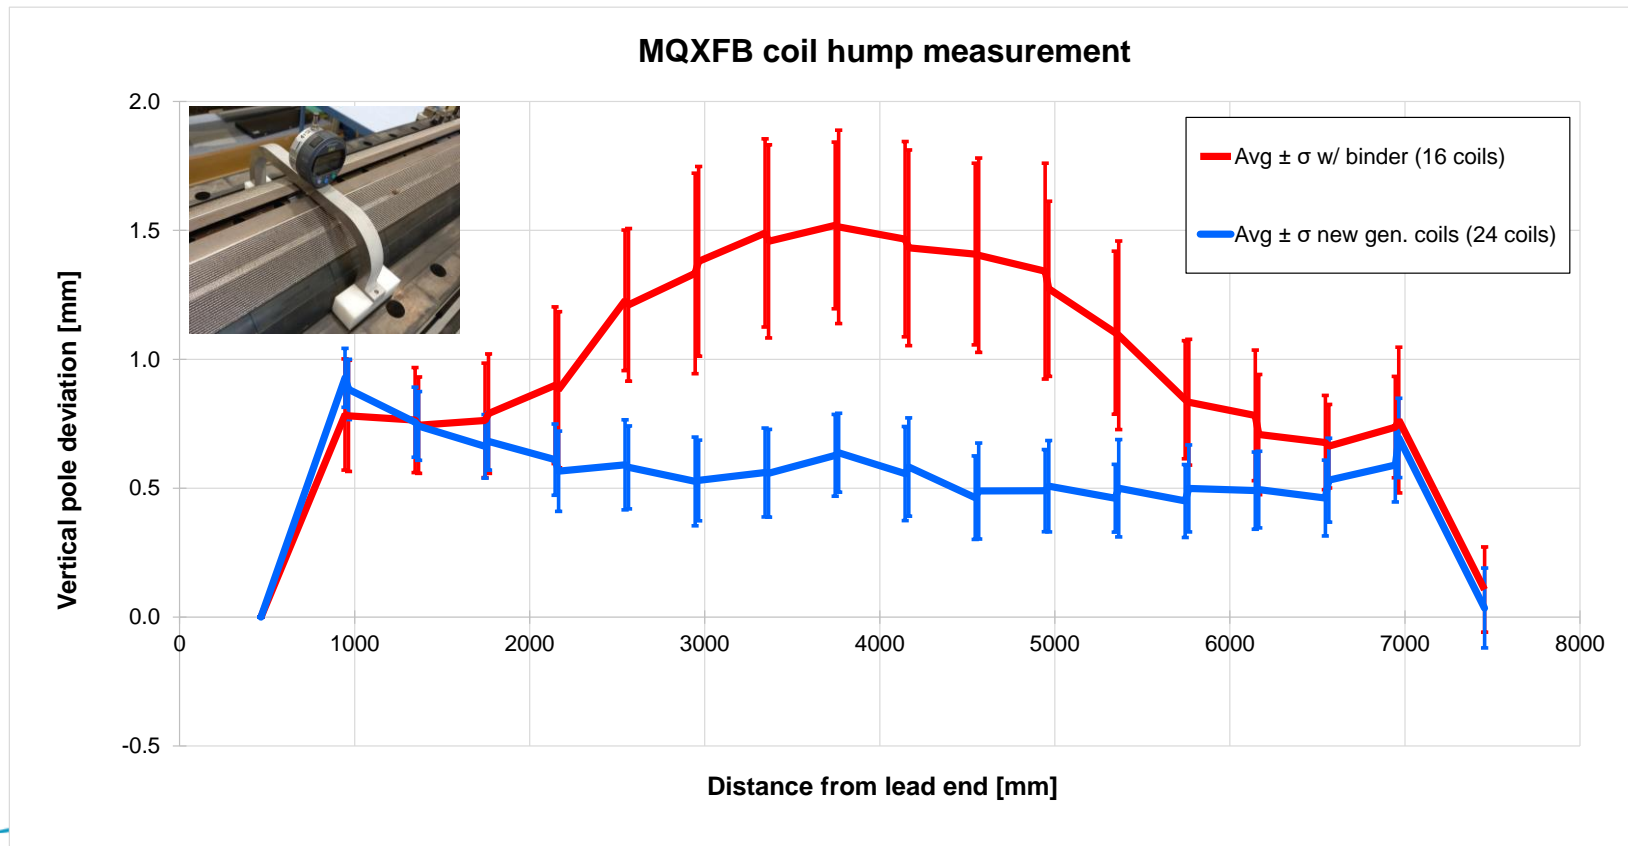
Measurables: coil hump

- New generation coils do not show any 'hump' after reaction heat treatment
 - Significant difference w.r.t. coils cured with binder on both layers
 - Behavior similar to MQXFA coils

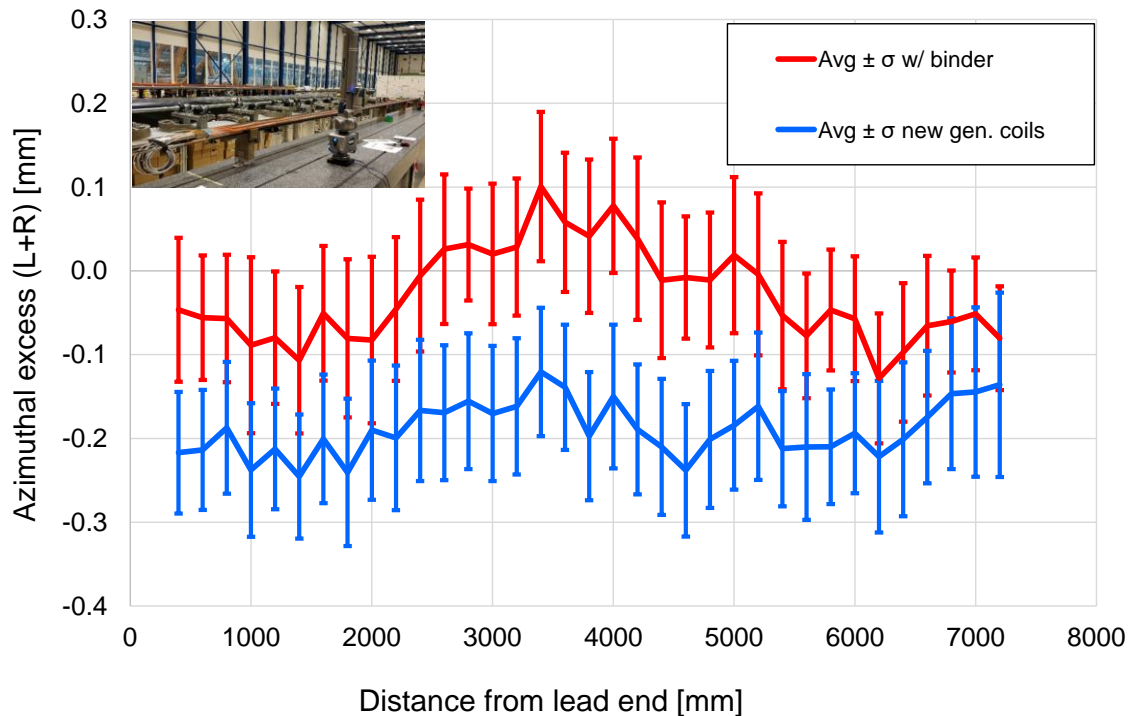
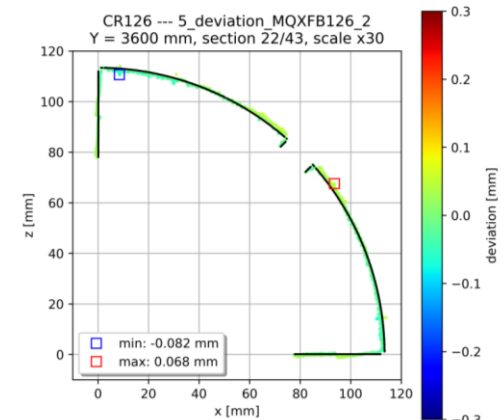
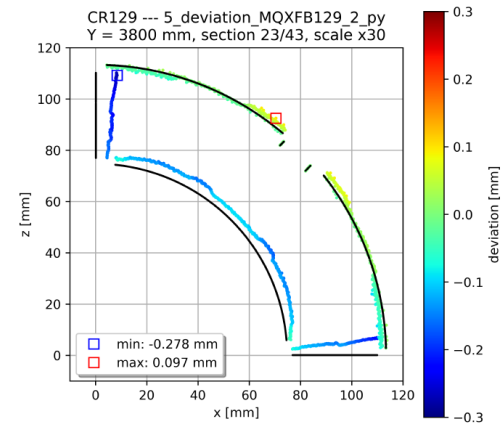
Measurables: coil size

- New generation coils size
 - More uniform along the length
 - Azimuthally smaller and do not present any sign of a 'fatter' coil towards the longitudinal center
 - Small wedge in the midplane of the coil of about 89.6° (mock-up test to assess stress [indico 1260584](https://indico.cern.ch/event/1260584))

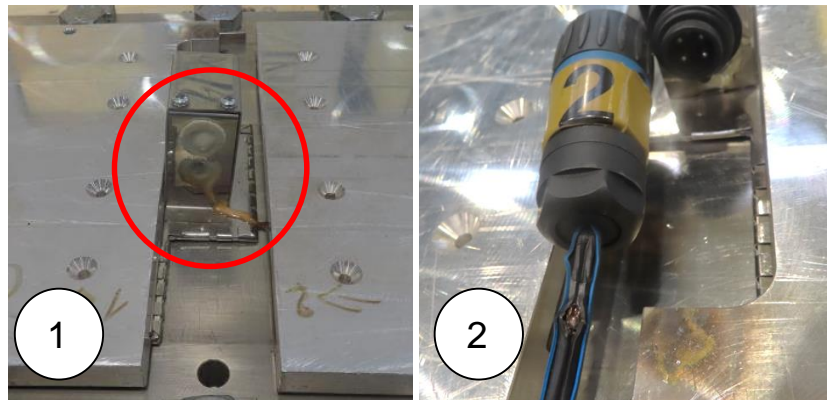
CR138 (NCR 2974448) → Over heating during impregnation cycle

- Instead of degassing at 110°C, the mold was heated up to 250/300°C for 24 hours (best guess based on findings)
 - Stop of the process and investigation of the root causes
 - Opening of the mold to check the reacted, not yet impregnated, coil
- Root cause pointed to human errors
 - The correct TCs were installed in the mold but the wrong connector was plugged in the impregnation machine (11T connector)
 - Short circuit between power connector and heating plate #2 appeared, causing tripping of the circuit breaker and stop of all heaters

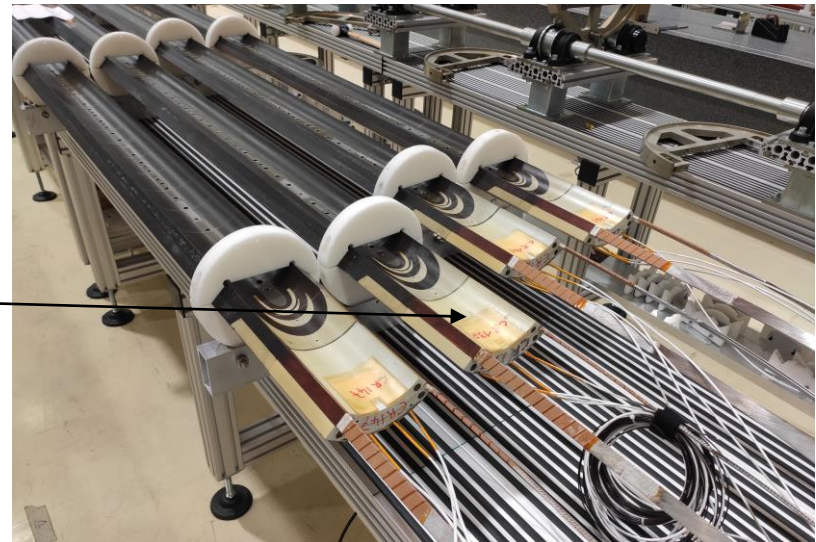
- CR138 was accepted and assembled in MQXFB07

Coil CR138 in the storage bench prior to start the assembly

- Replace of all damaged parts (splice insulation and QH) and installation of fresh S2 glass
- Consolidation of the impregnation machine

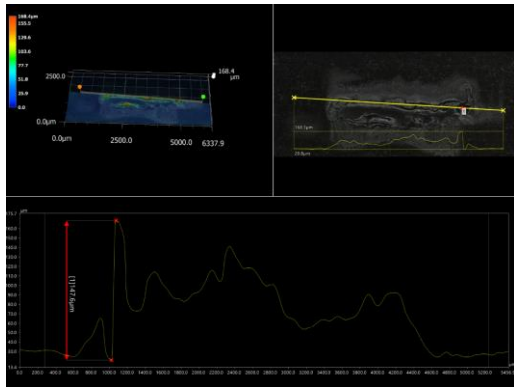
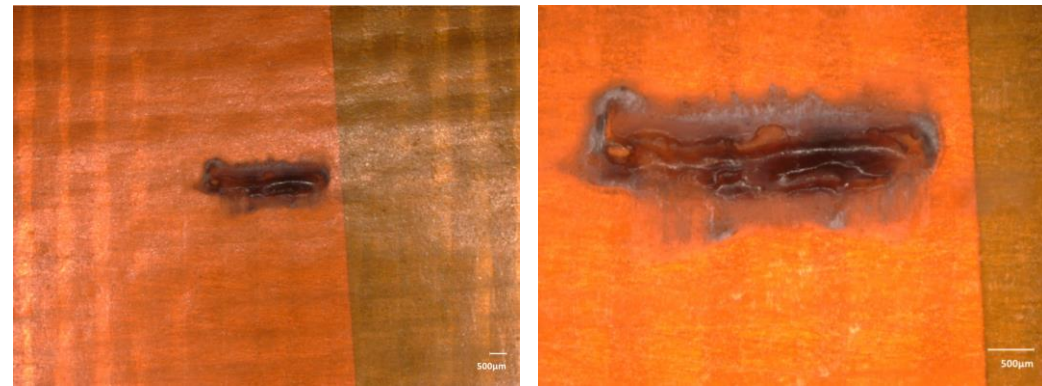
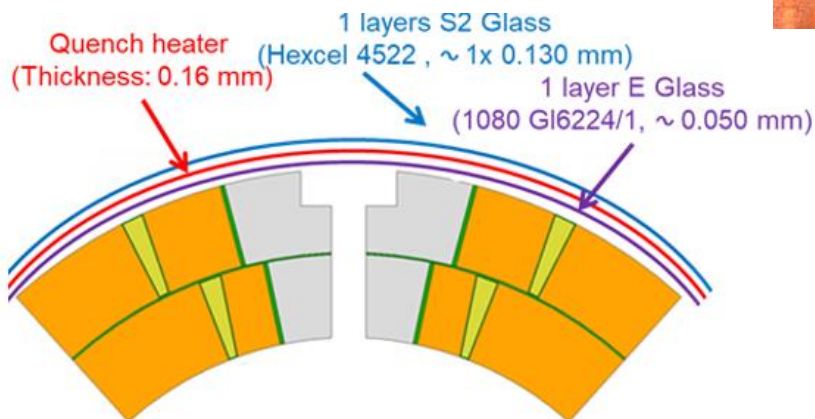
Results and proposed repair solution

1. Based on the analysis of the replica the maximum depth of the defect is 150 μm (in principle above the QH)
2. Inspection of the surface showed a shallow cavity with a burnt aspect and no metallic particle was observed
3. The electrical test passed successfully up to nominal (3.7 kV for 120 s)

- Slightly superficially scrap the OL of the impregnated coil in correspondence of the defect
- Based on findings, reinforce the insulation QH to coil by adding a polyimide patch underneath the heater strip
- Restore the OD of the coil with a local impregnation
 - Trials ongoing on cut MQXFB coil segment

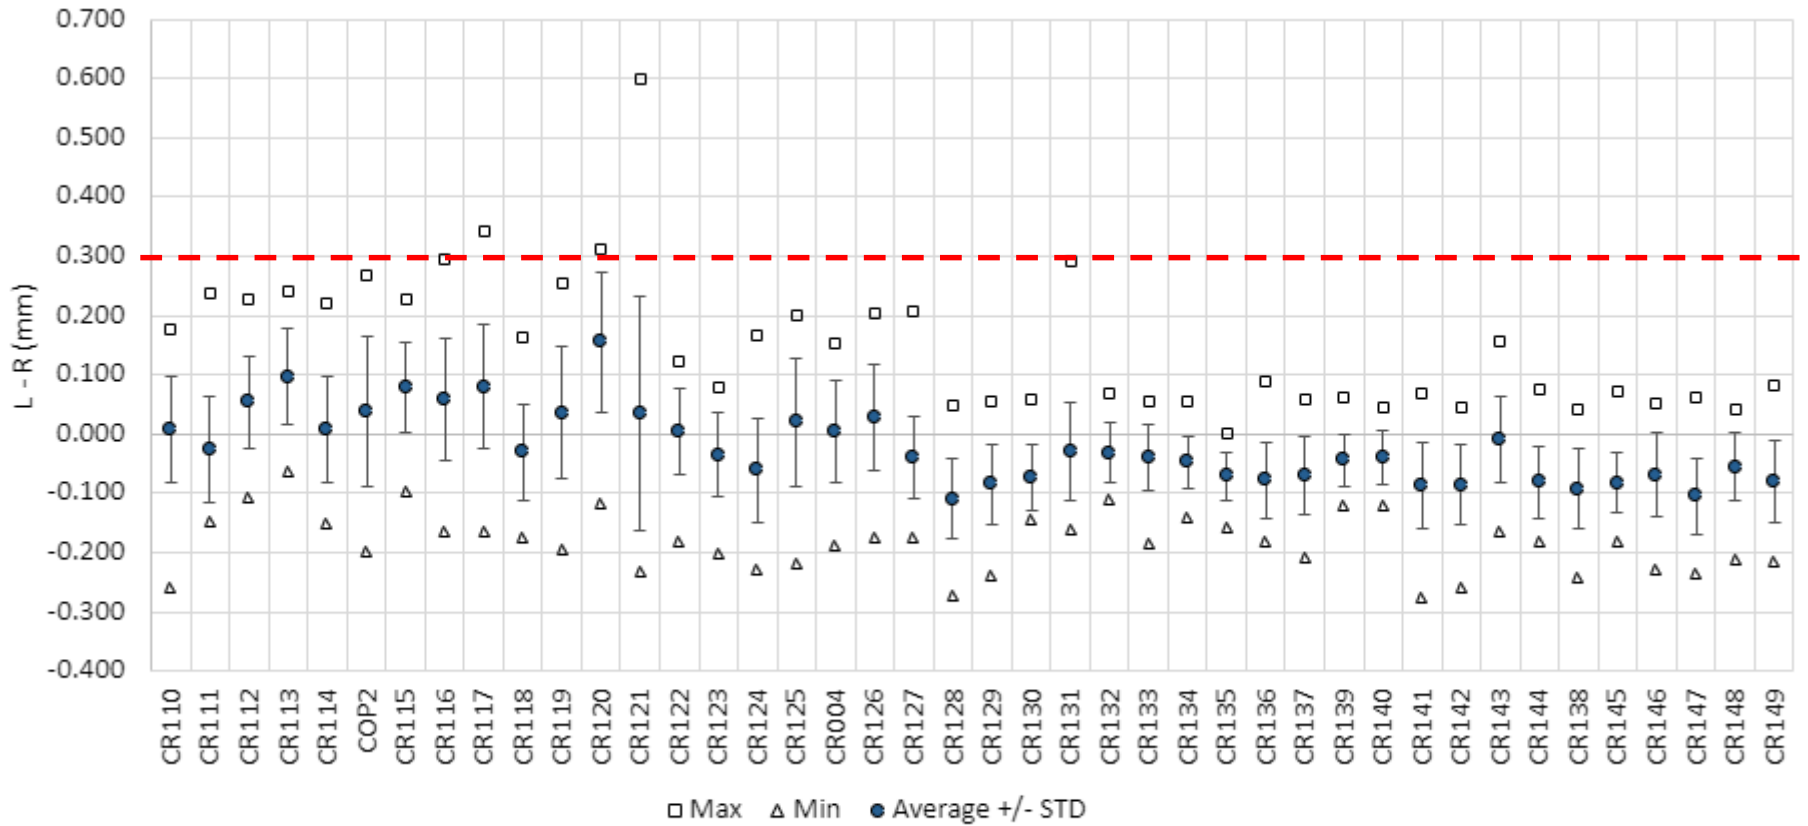
Coil size: asymmetry L-R

- In terms of asymmetry, within specification (<0.3 mm) → no need of pole key machining
