RFD-SPS UK Assembly Lessons learnt & improvements

UK Contribution to WP4

*14th HL-LHC Collaboration Meeting
8th October 2024
Genoa*

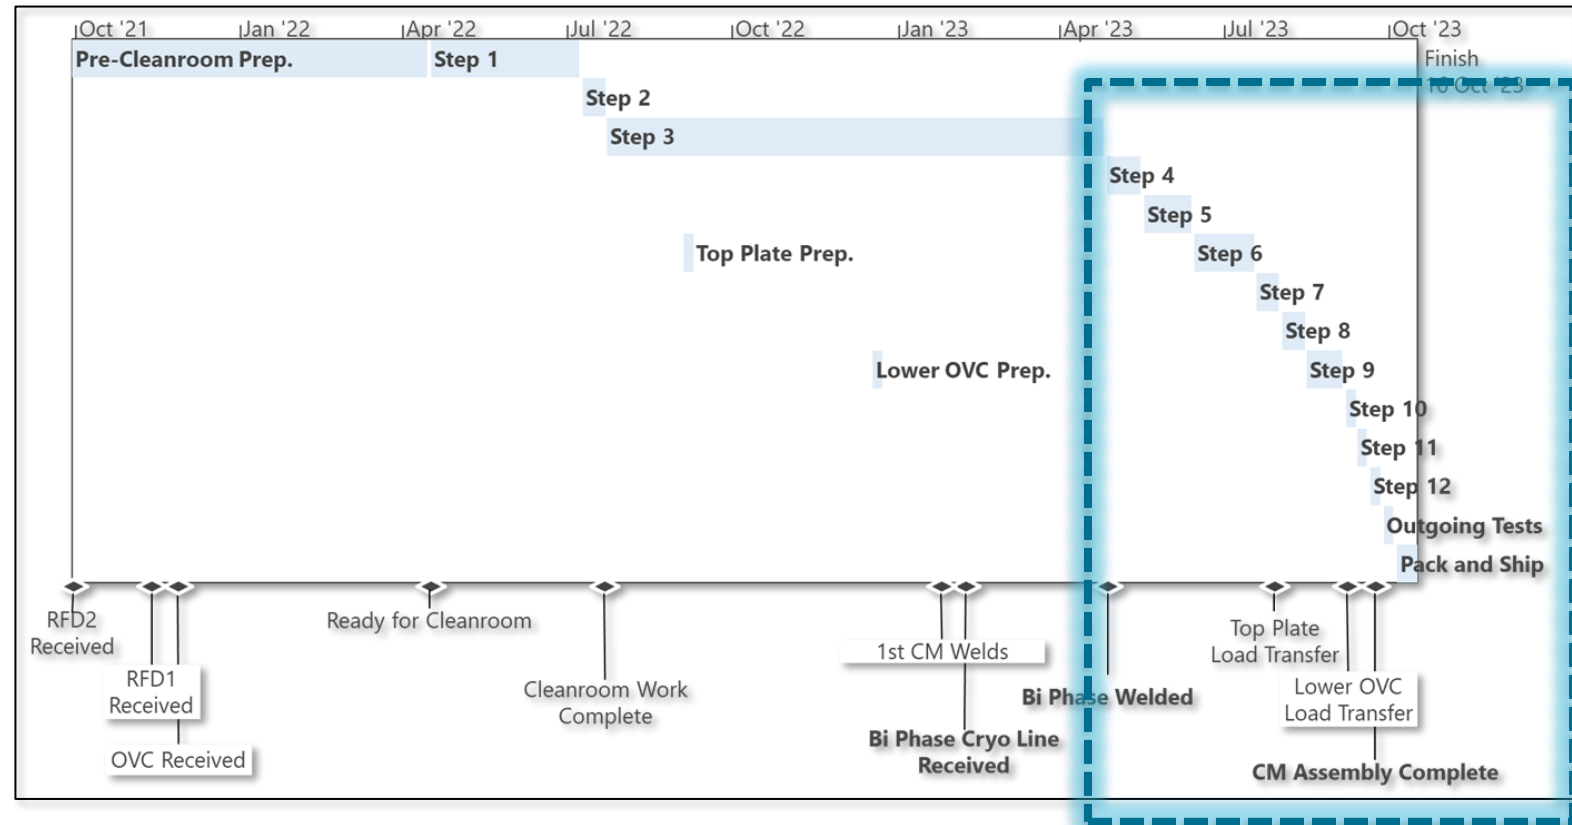
Co-axials (Step 5) installed before 50k line (Step 4) – had to be removed and reinstalled

- Back Loaded and compressed schedule – less buffer time to reflect and review
- Not following procedure led to steps backwards
- Hard Deadline for RFD-SPS to reach SM18 before Nov 2023

- DQW Series scheduled adequately for tasks to be performed

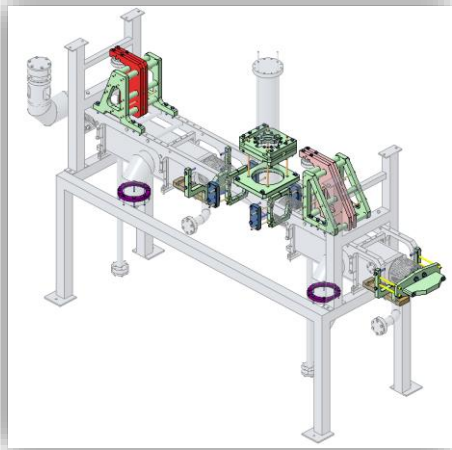
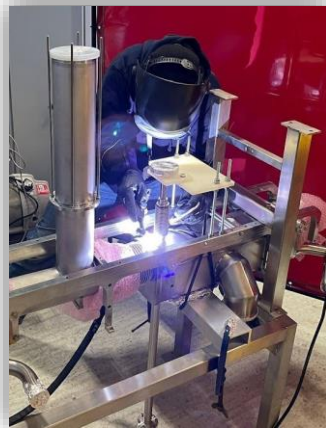
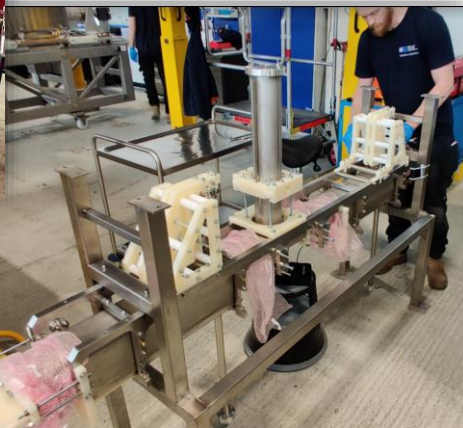
- Handling errors experienced during RFD SPS build
- Some imperfections are the result of not following procedure correctly, some from suppliers, others unknown.
- Difficult to categorically conclude when damages occurred as travellers were quite lightweight

- Bespoke covers design for DQW build for various processing and assembly steps with bellow components

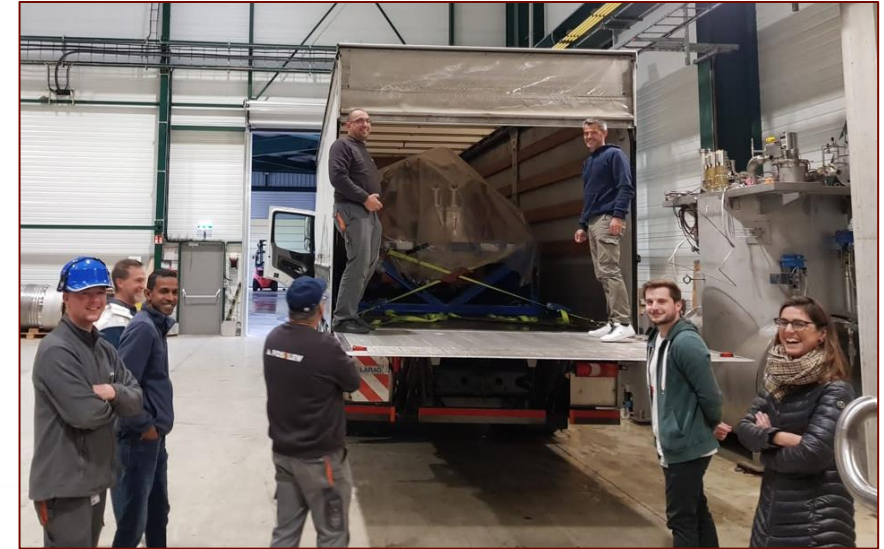
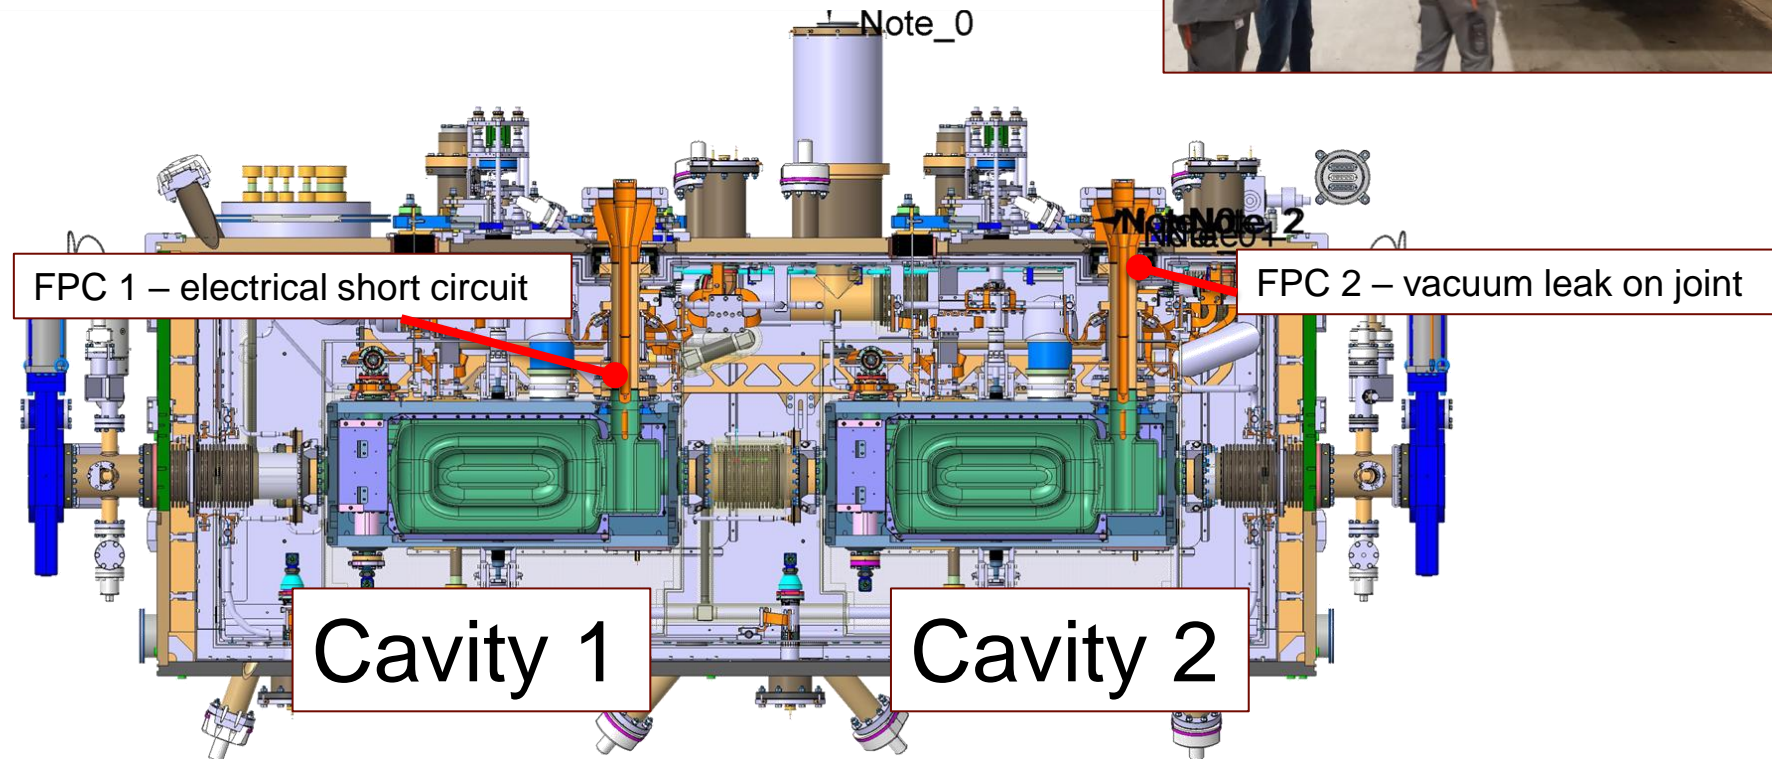
- On arrival of RFD – SPS at CERN
- Electrical Short Circuit on FPC on cavity 1
- Vacuum Leak on FPC hook joint on cavity 2
- X-ray studies undertaken to establish exact hook position.

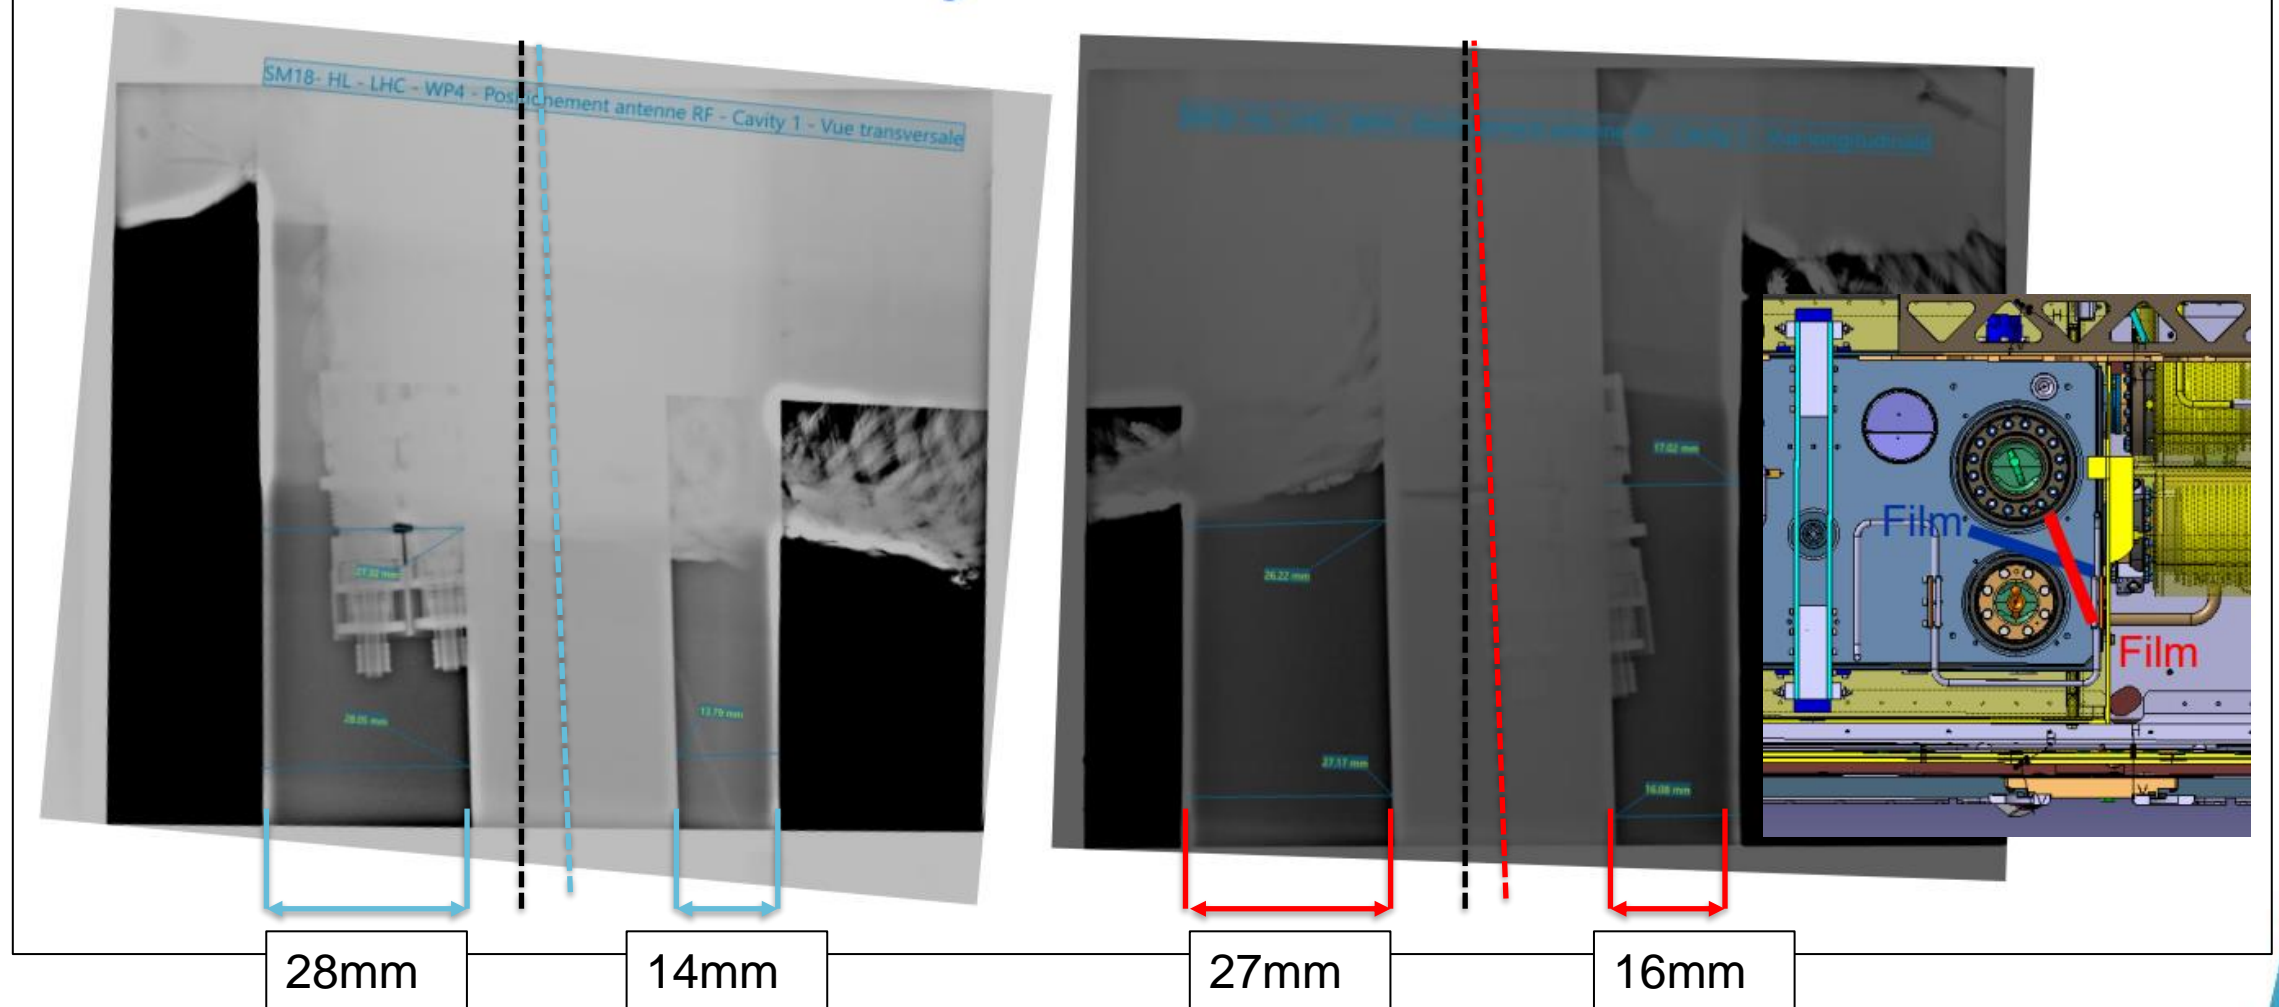
Results on FPC Cavity #1

- Clearance should be equal on both sides – indicating an angular offset between hook and tube (Confirmed by short circuit)

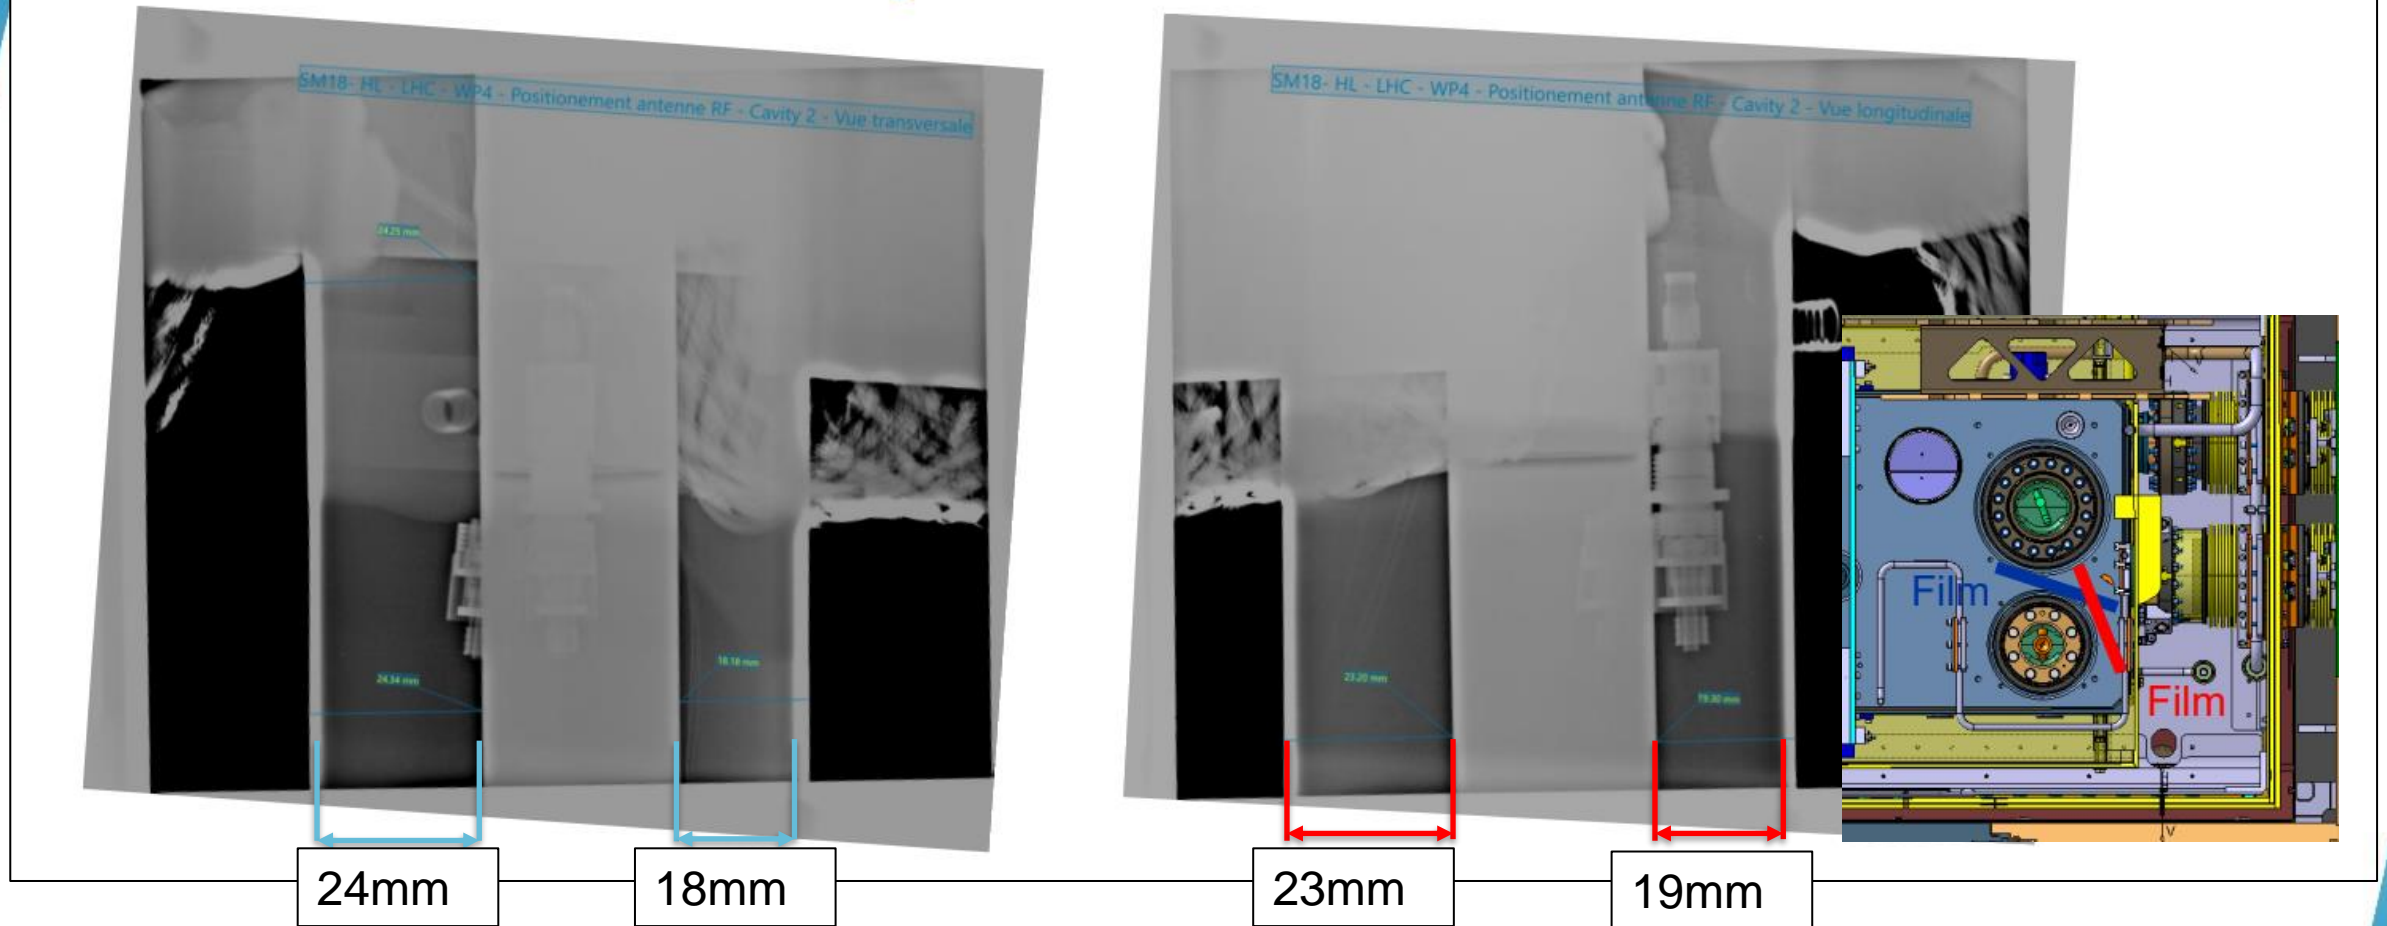
Results on FPC Cavity #2

- Again, clearance should be equal on both sides – indicating an angular offset between hook and tube (Confirmed by leak on gasket)

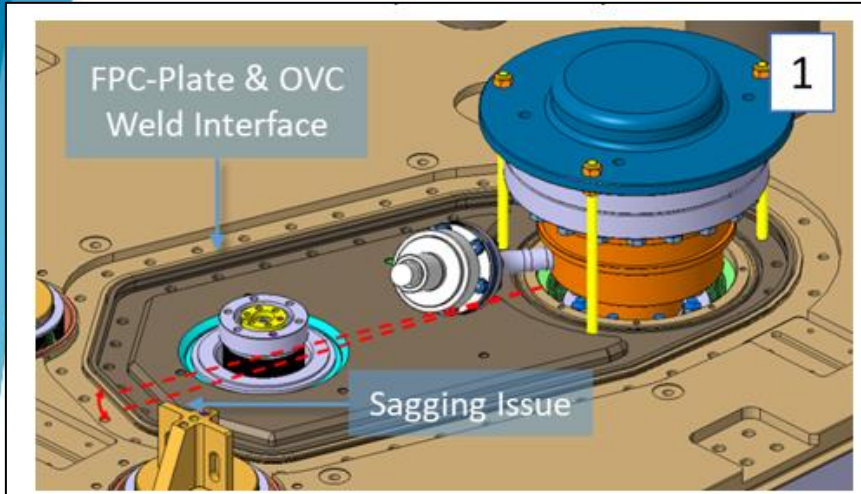
1. The FPC-Plate to OVC interface could not be welded due to cantilever sagging
2. As the weld interface correction was attempted, it's suspected an unknown clash between the FPC-Plate and OVC created the force path through the FPC

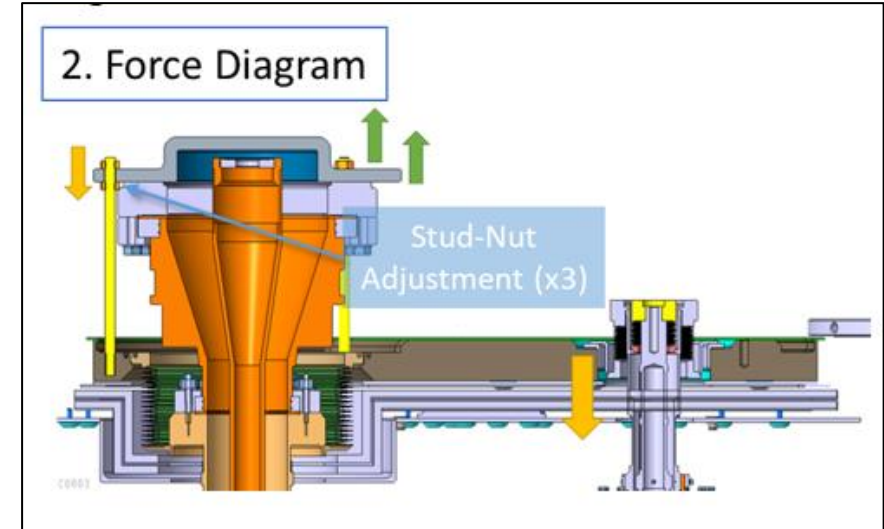
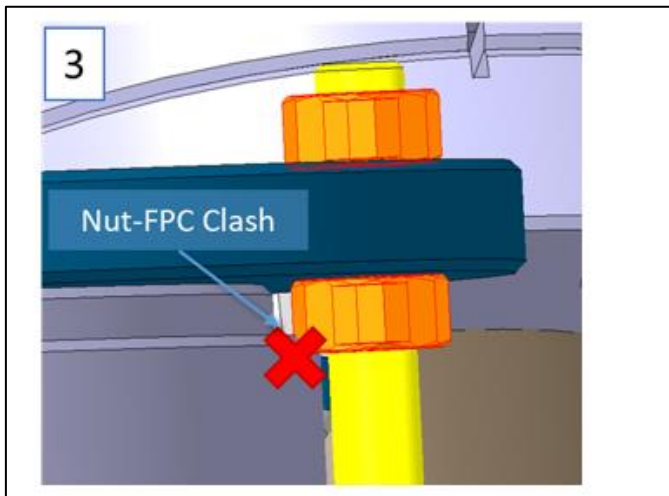
3. Correcting the plate pitch was challenging with the FPC-Plate tooling. Due to nut clash on tooling
4. Suspected OVC clash location
