AUP Cold Mass & Cryostat Assembly Production Challenges

HL-LHC AUP Cold Mass & Cryostat Assembly, L3/CAM

14th HL-LHC Collaboration Meeting

Genoa, Italy, October 7-10, 2024

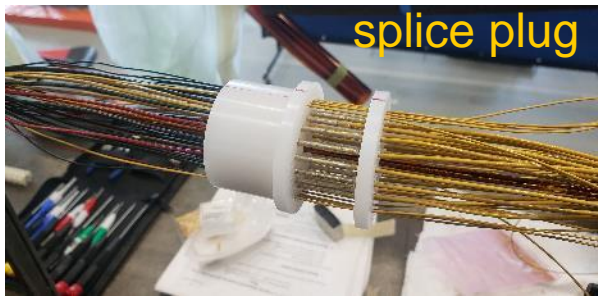
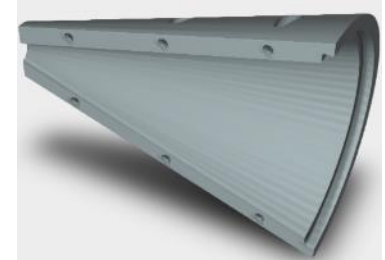
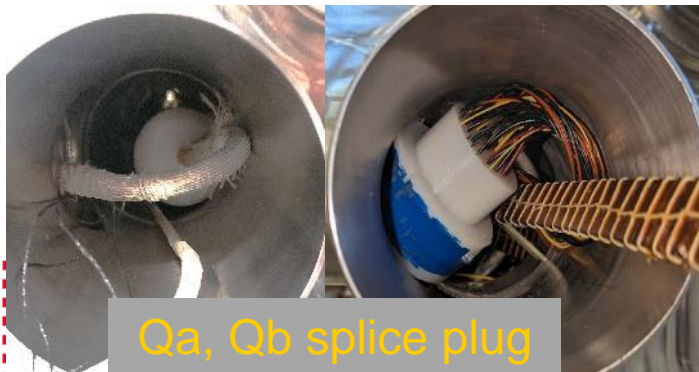
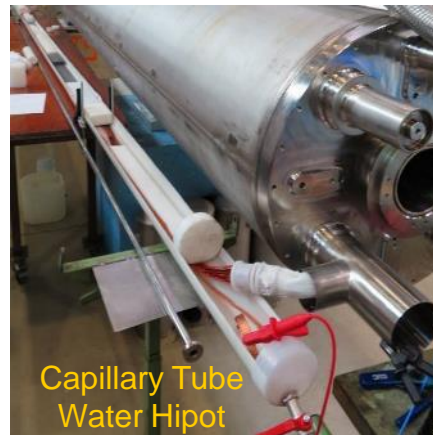
CM02 Lessons Learned

- Capillary tube – too many wires for tube diameter made it difficult to pull the wires through the 4 m long capillary causing the splice plug to be out of position in the cold mass tee.
 - Re-routed RTD instrumentation wires to reduce wire count in capillary tube.
 - Developed 3D printed tools to aid in wire alignment and wire pulling through the capillary tube.
 - Improved the wire splice robustness using barrel splice design, DocDb-4974.
 - Adopted CERN's water hipot procedure to test wire insulation integrity.

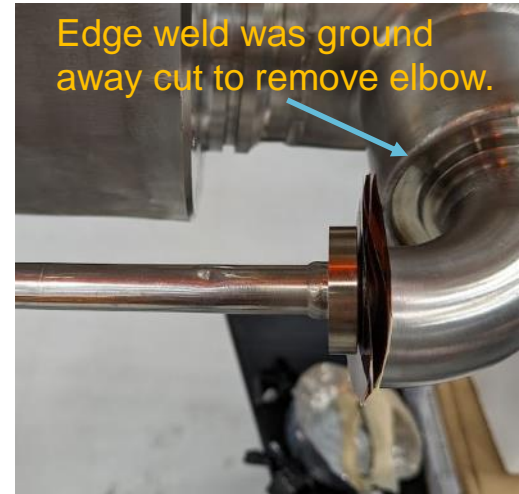
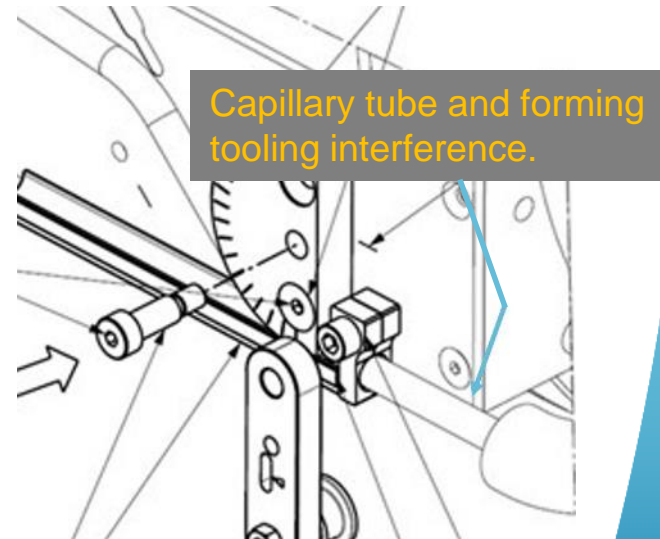
Dinged Capillary Tube, Lessons Learned DR13499

- Root cause: During the capillary bending of Qa bend #1, the tubing pressed into the edge of the bending tooling mounted to the cold mass slightly deforming the capillary tubing 0.5 mm. The edge weld of the elbow/tee was ground away to rework the wire bundle thereby making the nominal tee length slightly shorter. The effect of the shorter tee is misalignment of the capillary tube with the forming tooling.
- Corrective action: Replace the capillary tube. Add relief to the tube forming tooling in the contact area.

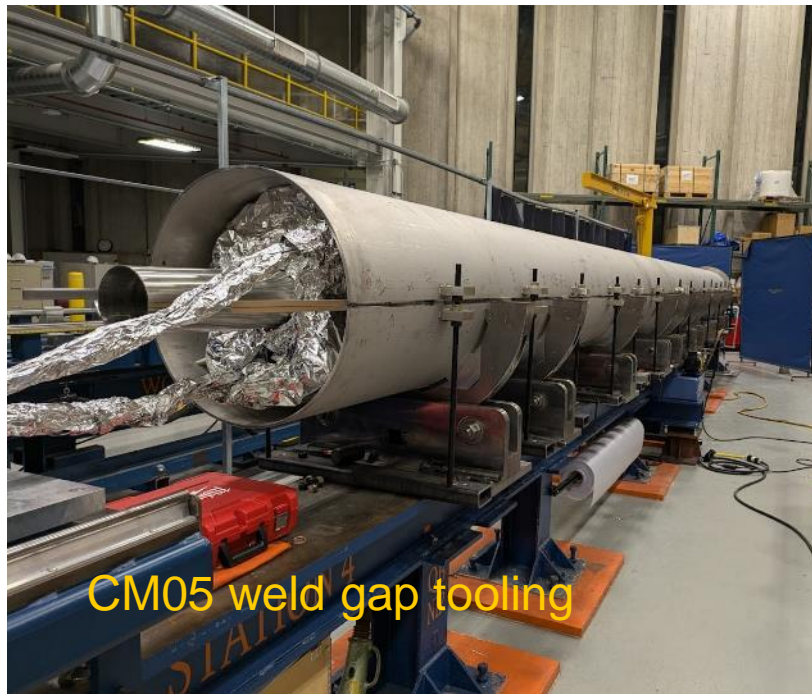
Upper/Lower Shell Twist, CM04

- Shell twist in free state caused at shell forming. Shells machined in constrained condition.
- Impact → extra weeks for setting weld gap in CM04
- Process and tooling change in CM05 implemented.

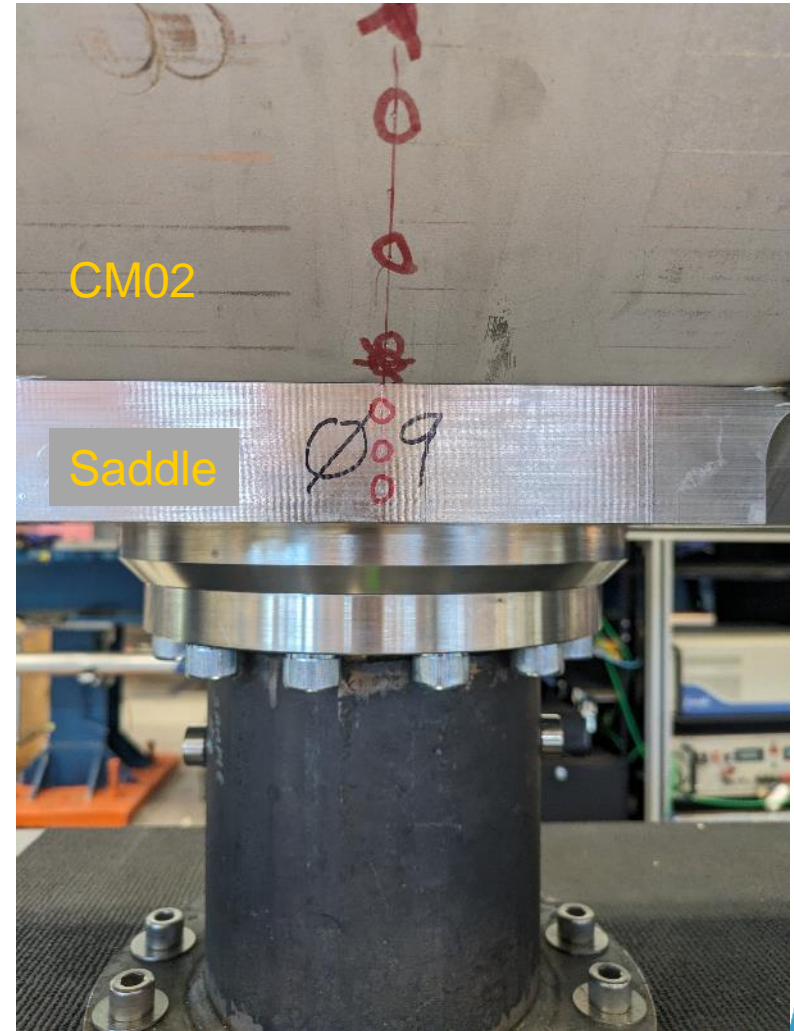
Alignment of Cold Mass to Saddle Lessons Learned, DR13565

- Root cause: Saddle missing metrology punch marks. Red line was used for alignment instead.
- Corrective action: Revise cold mass traveler to verify the saddle has 3 punch marks and a scribe line prior to tack welding.

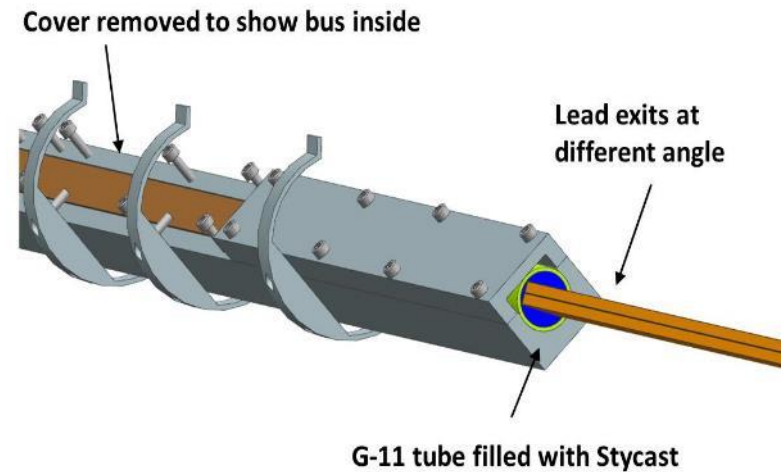
Bus Housing Assembled Upside Down DR13115

- Bus and housing assembled upside down and inserted into CM02.
- Corrective action: Removed bus with housing from cold mass, removed bus from housing, bus flipped over into the correct configuration, reassembled, and reinserted into CM02.

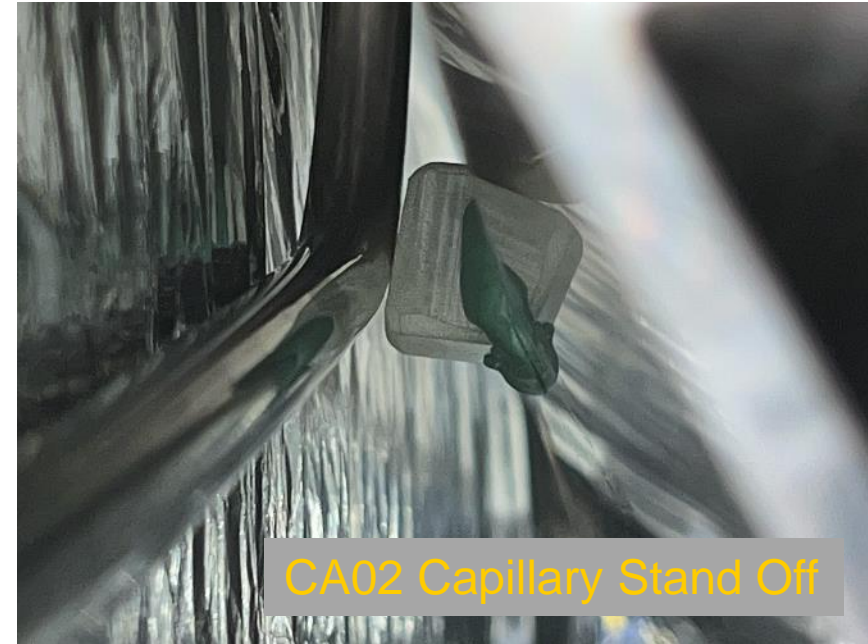
CA02 Capillary Stand Off

- The capillary tube flange was reworked on both ends, shortening the T, creating an interference with the capillary tube forming tooling, resulting in the capillary tube contacting the thermal shield.
- Used Araldite1580 (green putty) to attach G-11 stand off from the thermal shield.

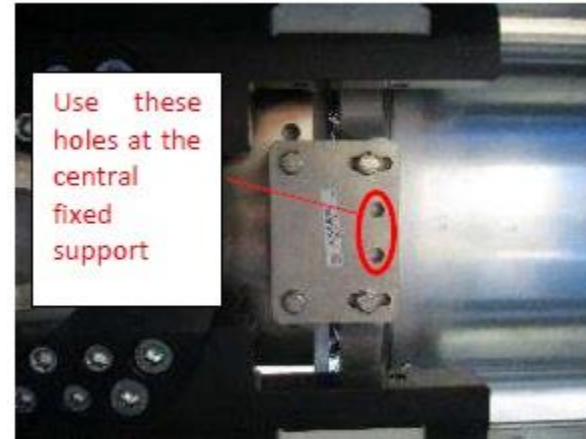
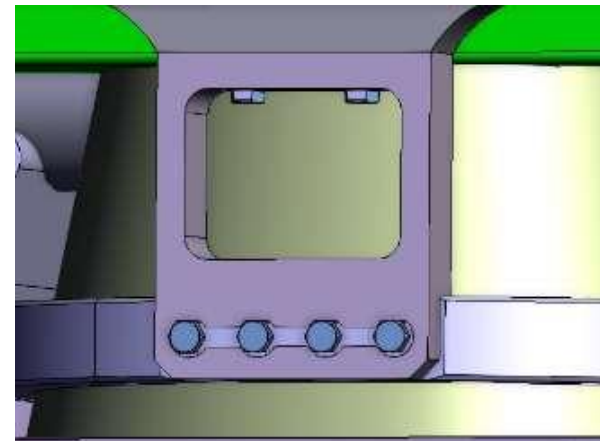
CA02 Thermal Shield Out of Position Lessons Learned, DR13552

- Thermal shield is located 4.5-5 mm too far towards the Non-IP end such that the thermal shield support pieces cannot be installed at the fixed support post.
- Root cause: During setup, incorrect holes used on bracket to locate thermal shield.
- New support piece fabricated.

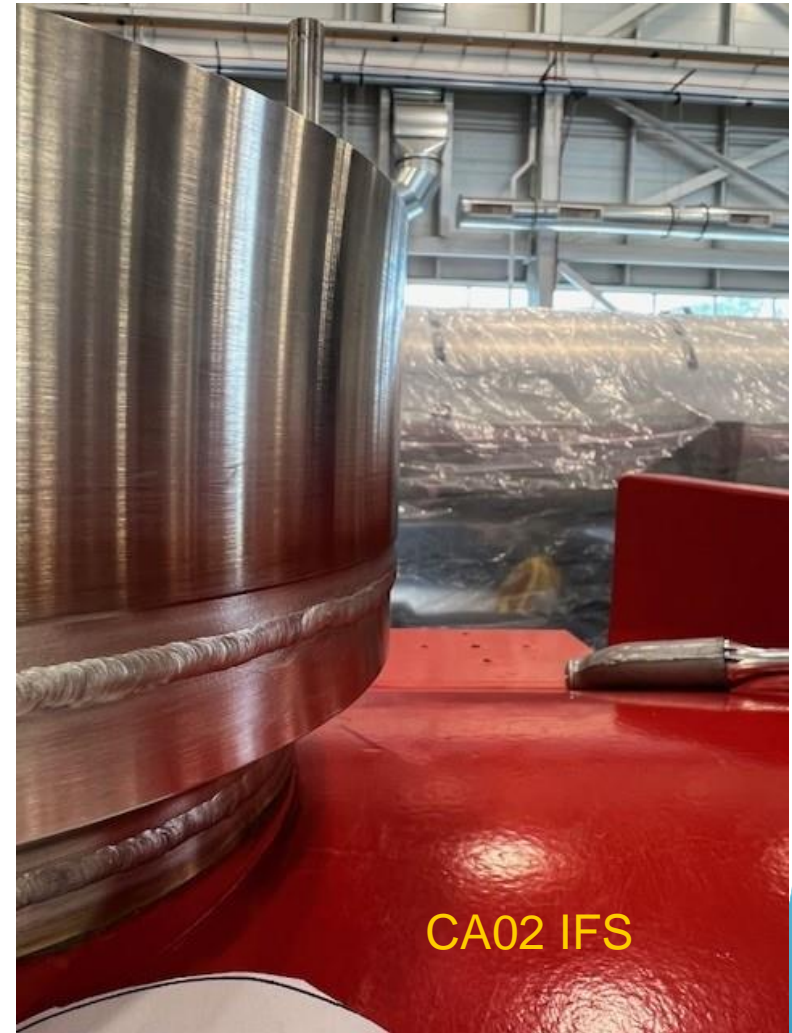
CA02 IFS Head to Flange Misalignment DR13575, DR 13584

- Root cause: IFS Assembly was cut at weld due to incorrect wiring.
- Corrective action: Wiring schematics were adjusted to correctly illustrate the orientation of the wiring.
- Made wire solder connections using new IFS head and welded in place.
- After welding there was a misalignment of the new IFS and the existing lower flange that was slightly distorted from the original weld.
- The issue meets requirements of ASME B&PV Code Sect. VIII div.2 and can be operational at FNAL, however, it does not meet ISO requirements and escalated to an NCR (LHC-QQXFA-QN-0012 (ver.1)).
