# Conductor and Cable Summary and Comparison of MQXFB07 Witness Sample Results

S. C. Hopkins, J. Fleiter, T. Boutboul (TE-MS-C-LSC)

Technical Meeting to Review Coils for MQXFB07, 11 July 2024

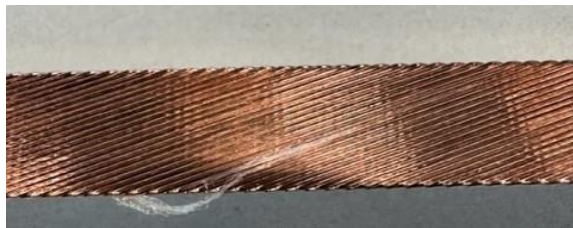
# NCR: Plastic Entrapped in Cabling

- During production of cable **H16OC0452A** for **CR147**, the inspection system identified fragments of material at positions 686, 746 and 755 m:
  - Identified as polyethylene film (23  $\mu\text{m}$  thick) used to wrap wire spools
  - Similar film applied by the manufacturer is removed for inspection and sampling, and replaced by CERN for storage
- The cable was thoroughly inspected and all plastic removed
- All standard tests were performed, and the cable geometry and extracted strand  $I_c$  and RRR were in specification: no impact on this cable expected
- Respooling procedures were revised to prevent recurrence:
  - Reduced speed and tension for removing plastic wrap
  - Heightened vigilance during unwrapping and respooling, with inspection by a second operator
- A blue coloured wrap will be used when wrapping future stock for storage, to increase visibility of any fragments

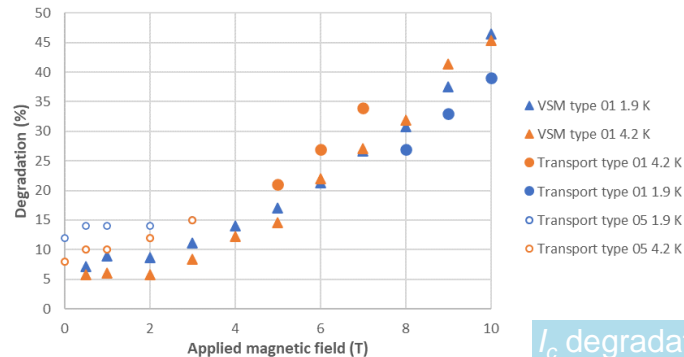
- During impregnation of reacted coil **CR138**, thermocouples were not connected and an uncontrolled temperature increase potentially up to 300 °C for 24 h occurred
- Transport  $I_c$  and VSM tests (see [EDMS 3007813](#)) following application of a simulated heat treatment to reacted samples suggested negligible impact on both Nb-Ti and Nb<sub>3</sub>Sn performance
  - For Nb-Ti leads,  $I_c$  degradation increases with applied field, but is modest (~10 %) in operating conditions, and RRR increases
  - For Nb<sub>3</sub>Sn, VSM data suggest no degradation of  $I_c$

$I_c$  degradation of Nb-Ti samples

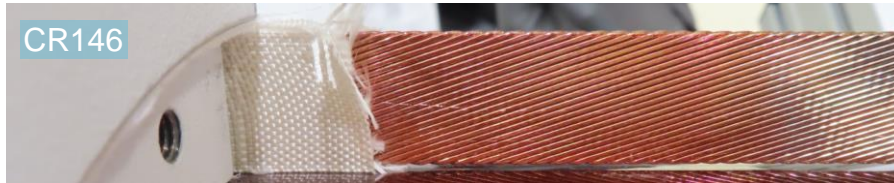
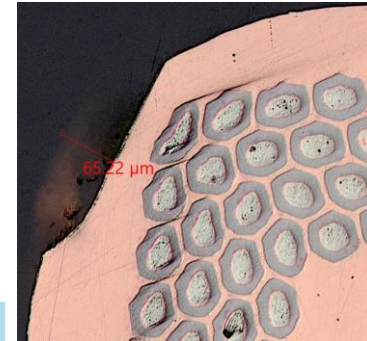
- For **CR146**, the cable of the inner connection was lightly scratched with tooling during the removal of cable insulation
- The scratch does not appear to penetrate beyond the copper, with estimated depth 22  $\mu\text{m}$
- Not specifically evaluated at cable level, but a study is ongoing to simulate the effects of mechanical damage following a more severe case for coil CR141 (MQXFB06)
  - Initial findings showed no degradation of RRR even for severe simulated defects:
    - ~60  $\mu\text{m}$  depth, applied compressively by a straight edge or rolling (indenting) with a 60  $\mu\text{m}$  wire
  - $I_c$  samples recently reacted: due for measurement in ~2 weeks

More severe simulated defect not causing RRR degradation

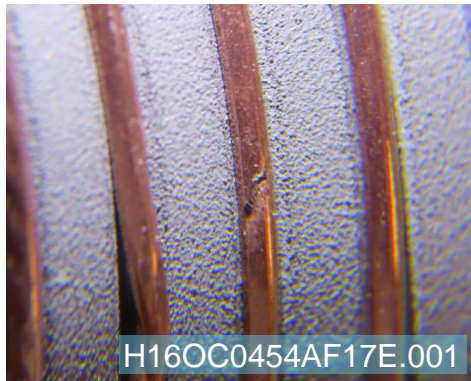
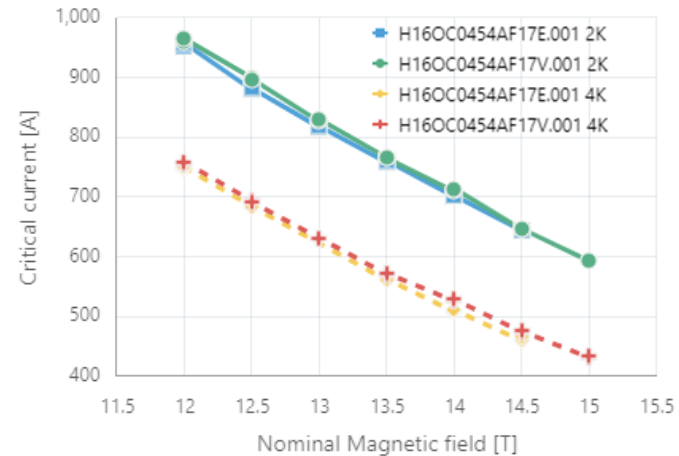
- Recap from MQXFB06:
  - For CR141, two virgin witness samples were found to be damaged after heat treatment
  - Modifications were made to the mica sheet in the mould assembly for CR144 onwards
- For **CR145**, an extracted witness sample from strand 17 appeared to be damaged
  - Not the same form as previous defects, and no apparent contact with mica sheet
- On testing, no degradation of  $I_c$  was found
  - No indication that further changes to reaction tooling are required

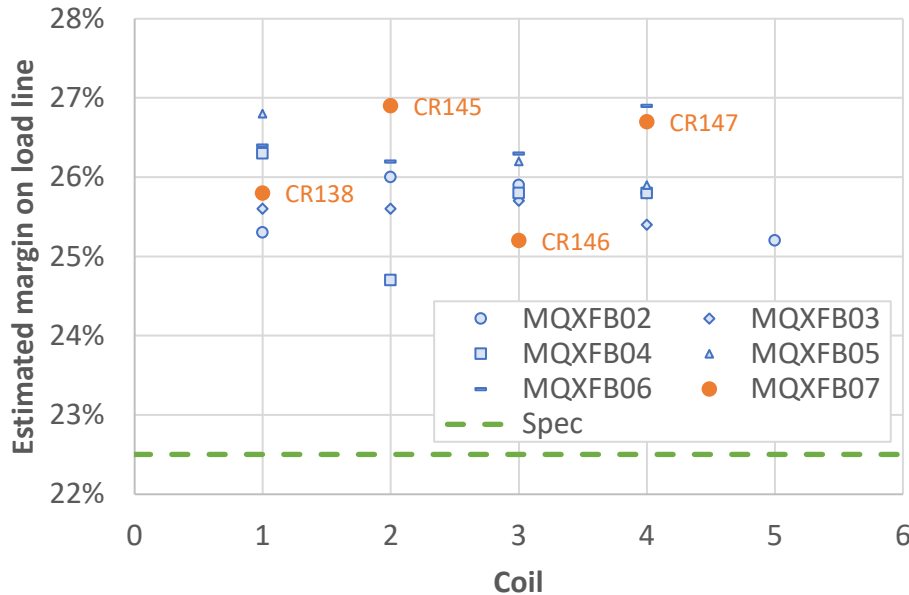
- Large margin on load line of  $\sim 26.2\%$
- Consistent in mean and spread with recent coils

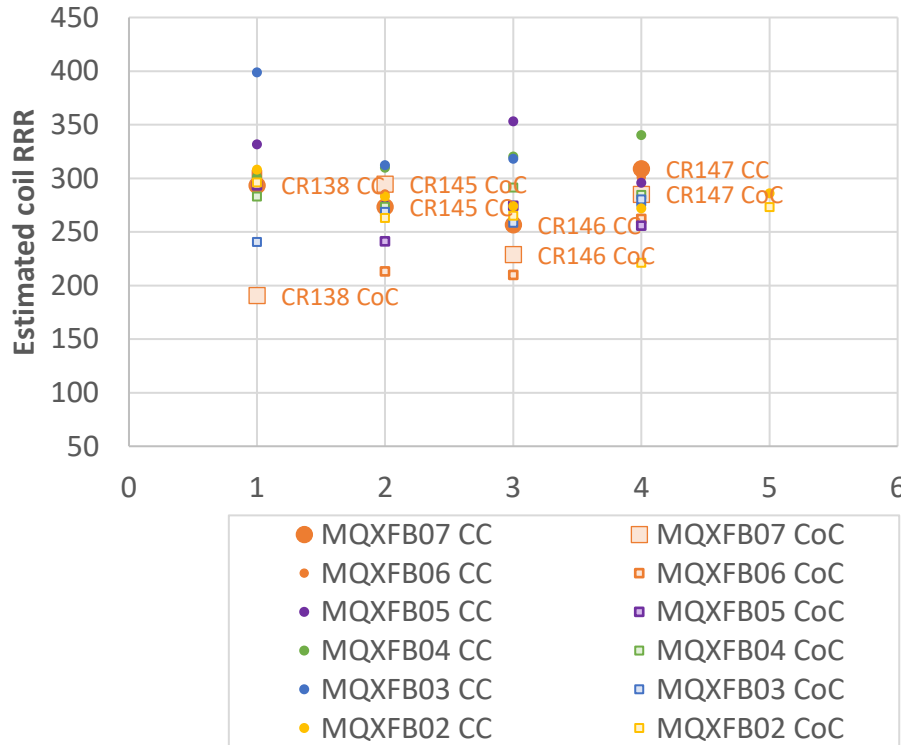
- Large RRR margin
- Connection side (CC) generally has higher RRR
- Low RRR of CR138 CoC due to HT NCR, but still well above specification limit
- All other values within the range of other recent coils

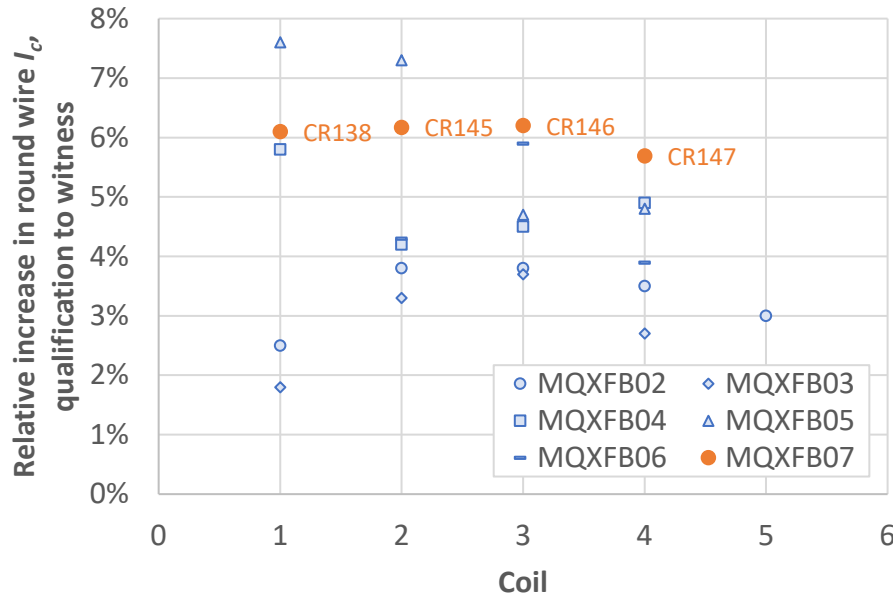
- $I_c$  consistently slightly higher for witness samples (HT in building 180) than qualification samples (HT in building 163)
- Very consistent for recent coils (despite HT NCRs)

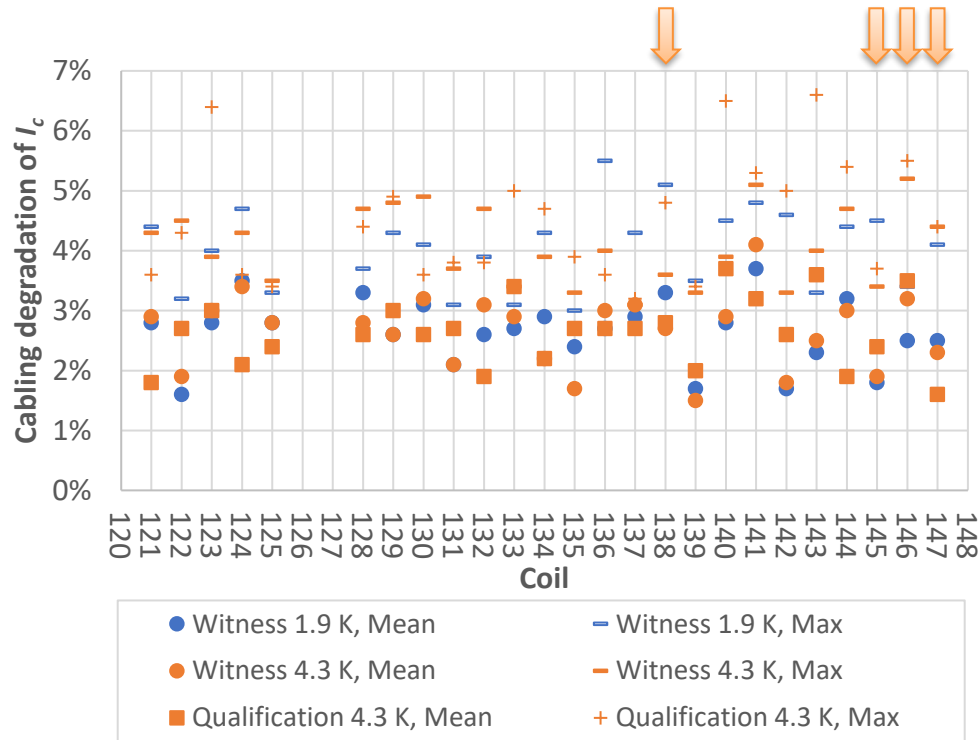
- Cabling degradation of  $I_c$  is within the 5 % specification for all coils
- Consistent and conforming degradation as assessed from witness samples across all recent production, both at 1.9 K and 4.3 K
- Mean cabling degradation ~3 %
