MQXFB07 Coils: Coil fabrication, manufacturing data and NC

N. Lusa, S. Izquierdo Bermudez, L. Baudin, A. Vieitez Suarez, J. Axensalva,
P. M. Quassolo, L. Grand-Clement, R. Berthet, O. Housiaux,

11/07/2024

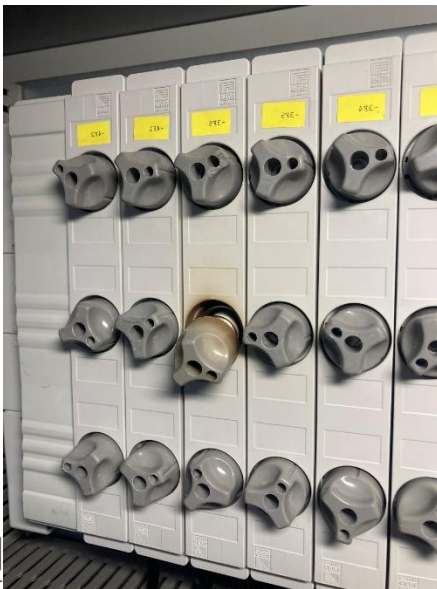
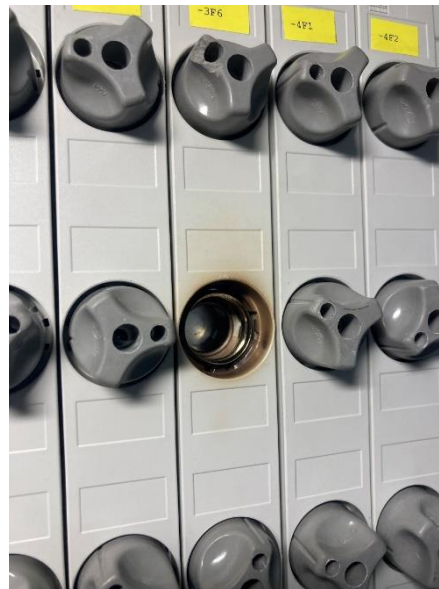
CR138 (NCR 2962606) → Furnace intervention

- During the 3rd plateau, issue in B7 zone which was not regulating correctly the temperature
 - Adjacent heating zones B6 and B8 provide more heat flow so the temperature increased above the target
- Root cause analysis showed a B7 zone fuse heavily damaged which was then replaced
 - Electrical check of the heating resistances of the furnace and of the electrical circuit → ok

Preventive action:

- Check of the fuses every 3 months in the preventive maintenance planning
- Implementation of phase controller on each of the static relays to monitor any missing phase

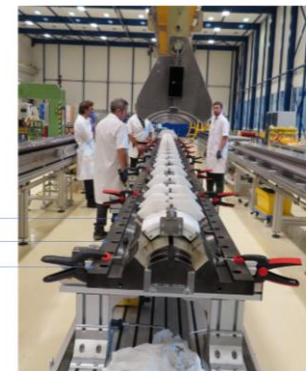
- Anomalous heating in the rear part of the oven (TCs17, 19, 37) located in block #75 reached the higher temperature, i.e. 675°C
 - Assess the impact of the over temperature on I_c and RRR in that location

Start of the straight section – Block 75

Start of the coil – Block 78

VAMAS – Block 80

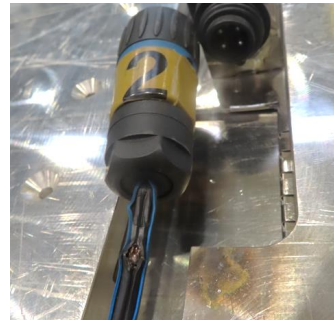
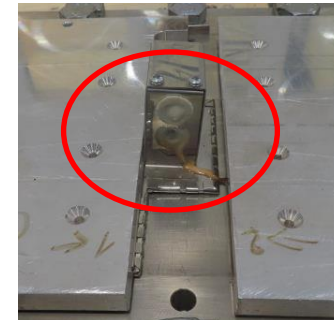
- NCR deeply discussed during CW group meeting on December the 6th ([indico 1355007](#))
- During the tests performed prior to inject the epoxy resin into the mould, an issue caused the stop of the operations and the opening of the mould
- Instead of degassing at 110°C, the mould was heated up to 250/300°C for 24 hours (best guess based on findings)

- In the impregnation machine there are 2 sets of TCs (for MQXFB and 11T coils)
- The correct TCs were installed in the mould but the wrong connector was plugged in the impregnation machine (11T connector)
 - Monitoring of the 11T TCs which were in contact with the impregnation machine table so "in the air"
 - We were blind at the level of the mould temperature
- When 110°C were set for the degassing cycle, the heating plates ran at maximum power
 - Short circuit between power connector and heating plate #2 appeared, causing tripping of the circuit breaker and stop of all heaters
 - Investigation of the root causes

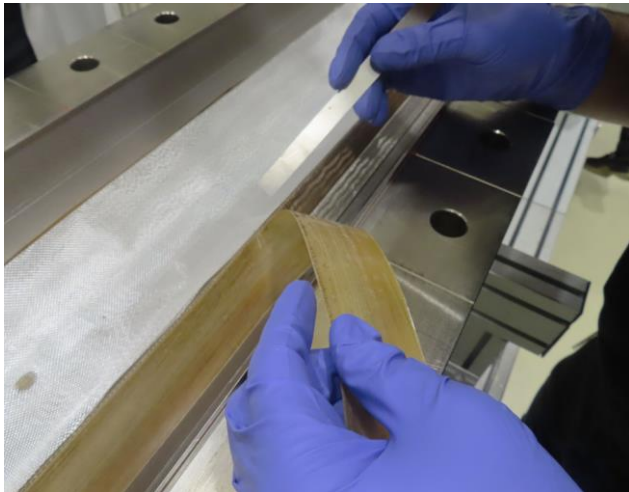
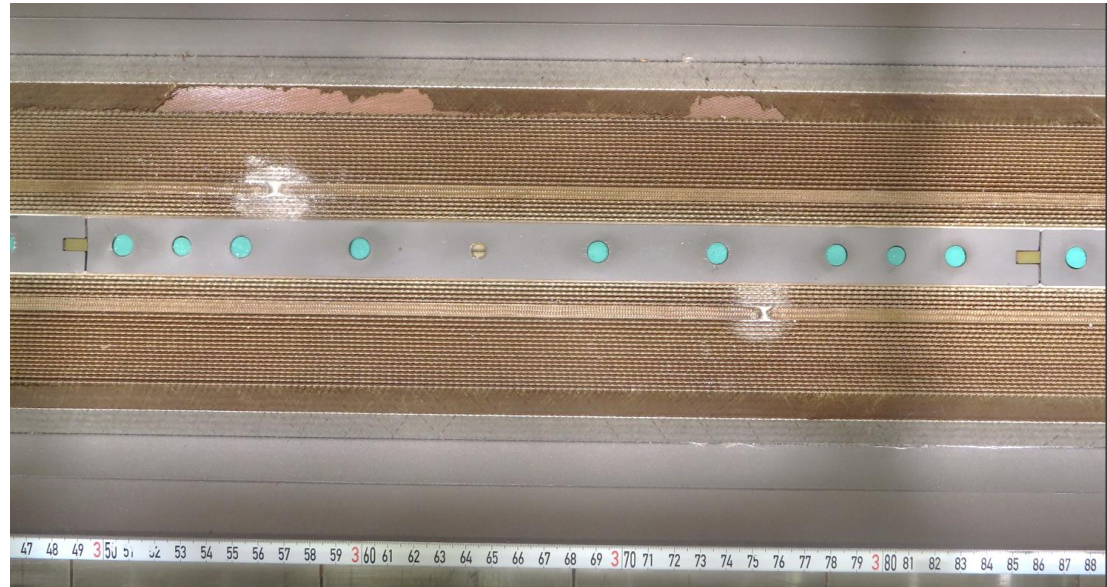
CR138 ([NCR 3128109](#)) → Cable insulation damaged

- After the [NCR 2974448](#) the mould was opened to inspect the coil and replace the damaged parts
- The G11 midplane shim was partially glued to the midplane of the coil (opposite layer jump)
 - During its removal, parts of the S2 glass insulation were stuck to the G11
 - Removal of the fragile S2 glass over about 200 mm
 - Local installation of fresh S2 glass to repair and new G11 shims

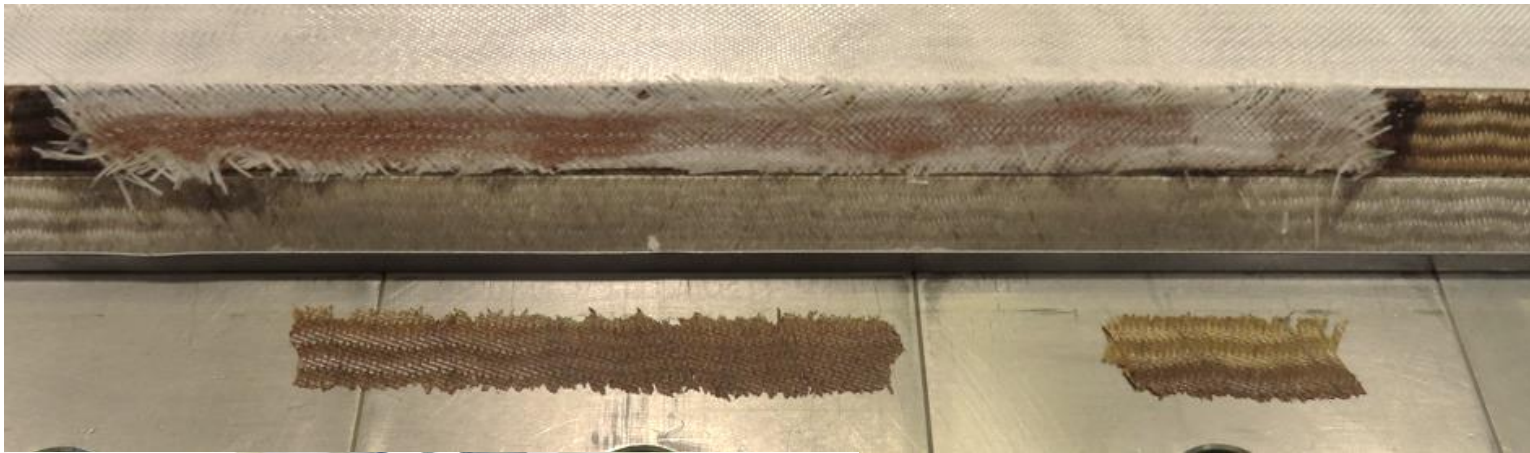
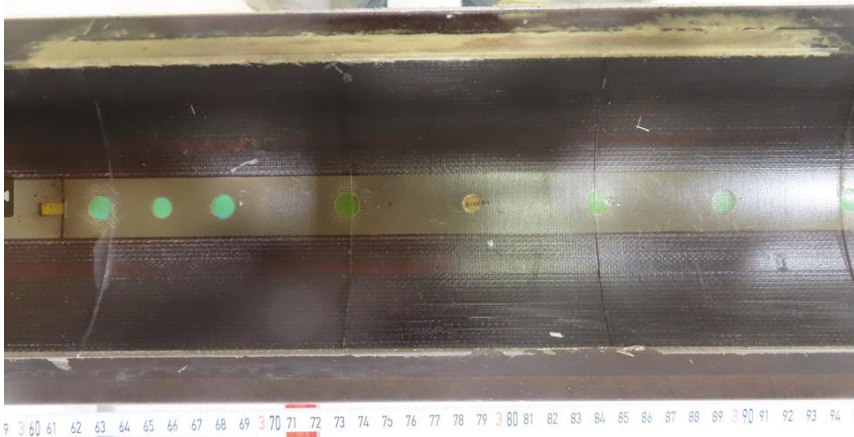
CR138 (NCR 3128109) → Cable insulation damaged

- The geometrical measurement showed no over thickness in the repair location [EDMS 3057190](#)

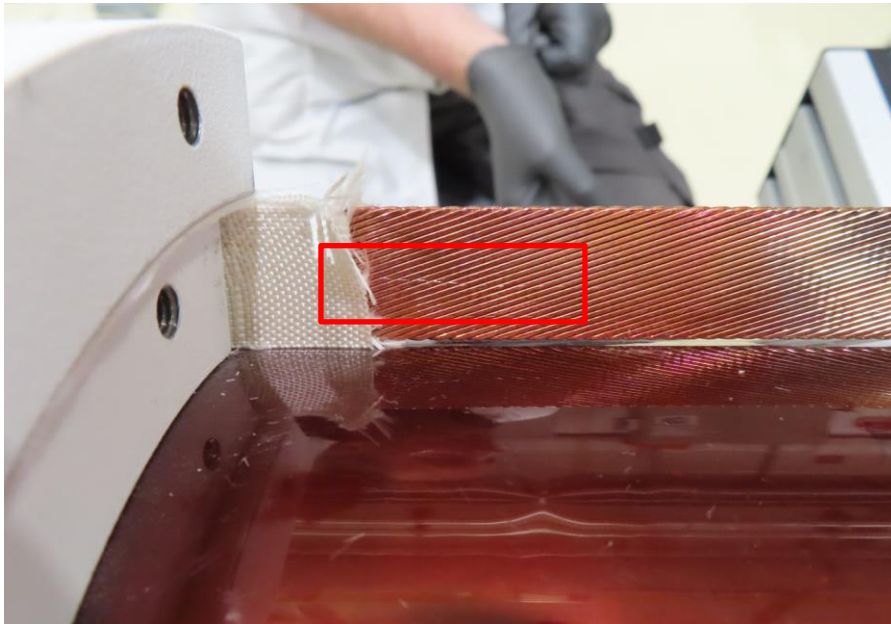
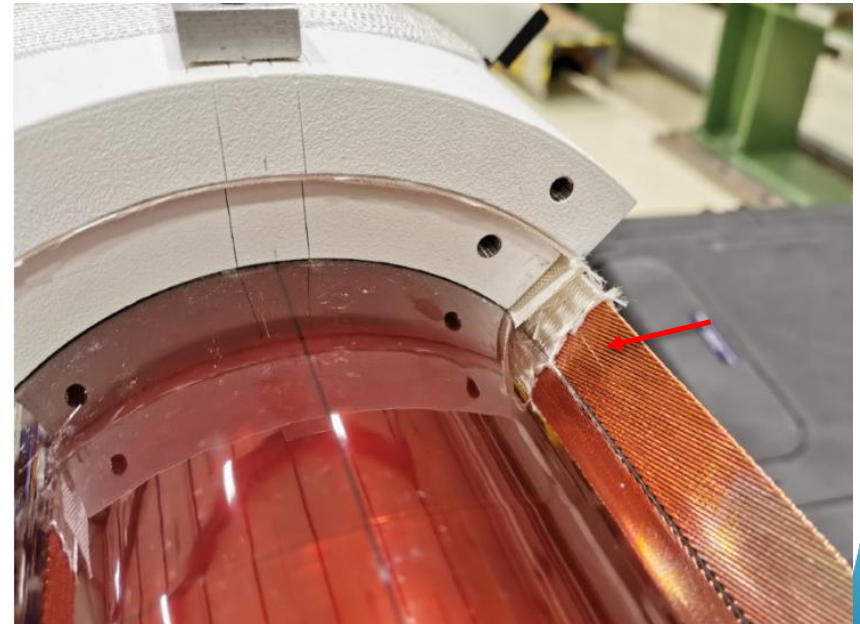
CR146 (NCR3083049) – Inner layer connection cable damaged

- The inner layer cable exiting from the coil was damaged during the removal of the S2 glass insulation, prior to remove the core
- Normally a 0.05 mm thick shim is inserted between the cable and the S2 glass then the fiberglass is cut
- During the cut of the S2 glass with a blade, the shim was not correctly kept by the operator, so it slipped away and the cable underneath was superficially damaged

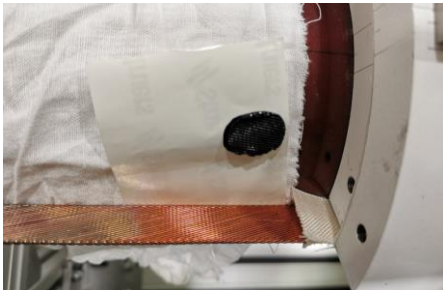
CR146 (NCR3083049) – Inner layer connection cable damaged

- The optical inspection showed that only the copper was affected by the scratch
- The measurement of the replica showed a maximum depth of the cut of 21.6 μm (more details in M. Crouvizier report [EDMS 3083153](#))
- The optical inspection of the cable after RHT did not reveal any tin leak

- Optical inspection of the cable before/after RHT
- Replica of the damage to measure the depth of the cut

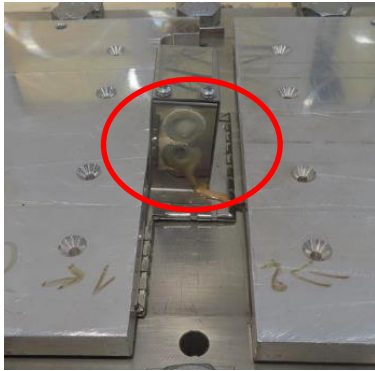
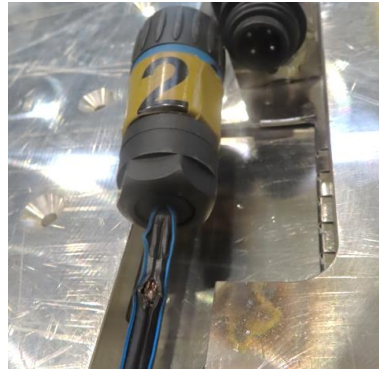
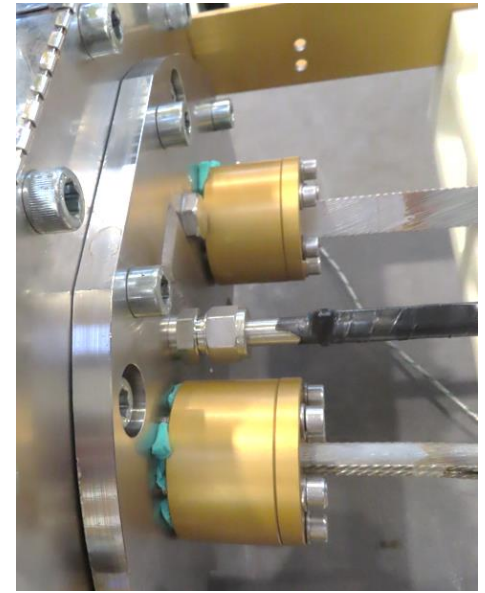
CR138 (NCR 2974448) → Over heating during impregnation cycle

- Some plastic parts were partially melted and damaged:
 - Plug covers 3D printed in TPU95 at around 245°C
 - Power cable sheaths damaged (melting temperature around 300°C)
 - Leads silicon joints damaged

- No tin-silver leakage have been observed at the level of the leads existing the mould ($T_m = 227^\circ\text{C}$)

Temperature estimation: 250/300°C

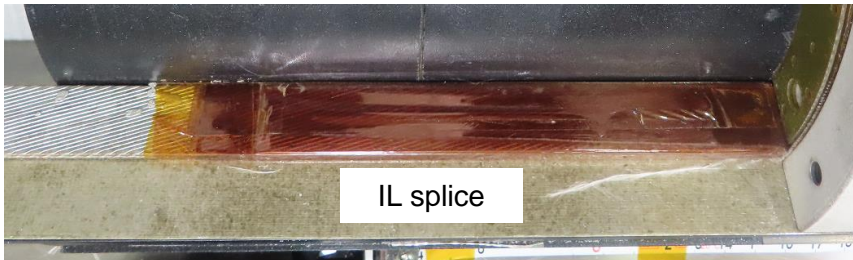
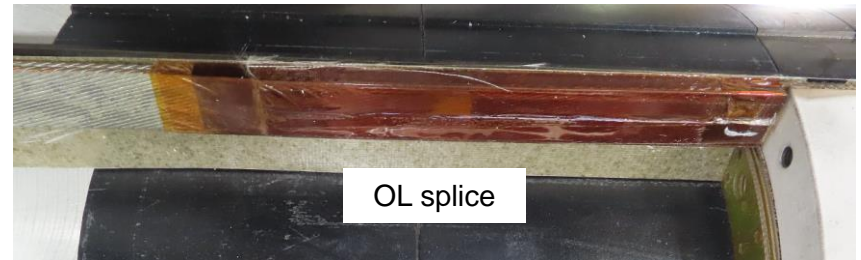
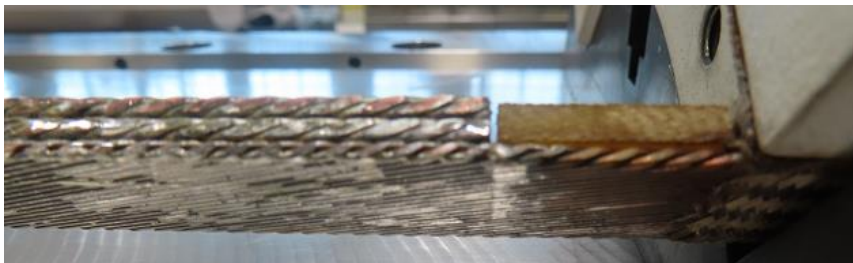
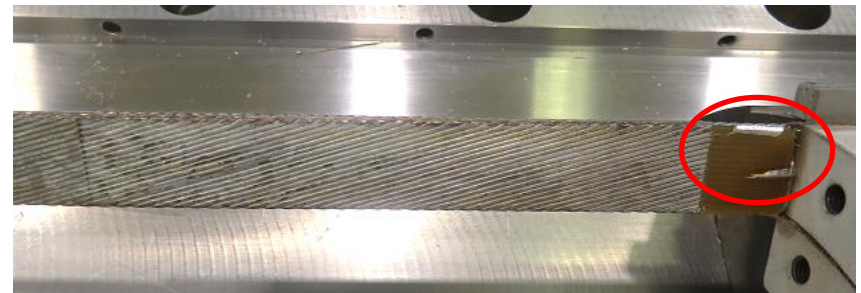
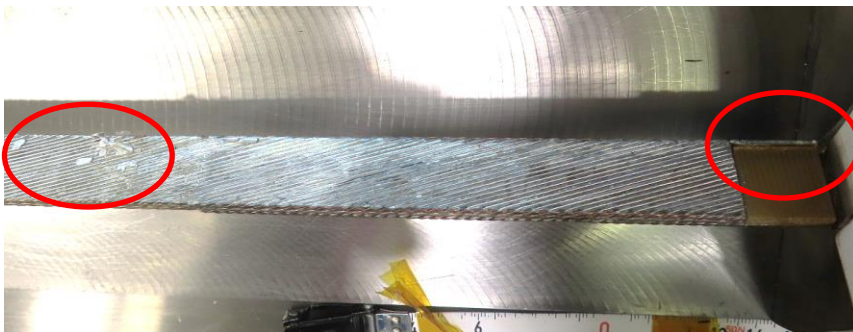
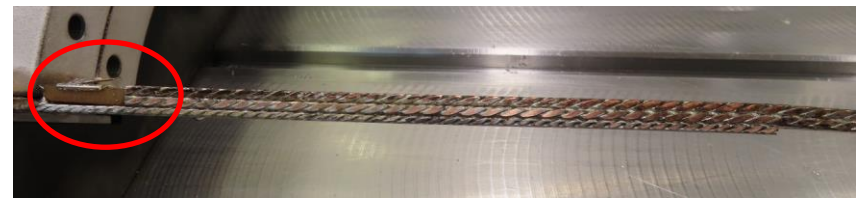
Splice analyses

- **Splice visual inspection** (all pictures available on [EDMS 2975146](#))
 - Tin-silver drops at the extremities of the splice insulation
 - Once the insulation removed, more SnAg was observed at the extremities of the splice region (towards the coil ends and towards mould end for the IL splice)
 - " Leopard skin" effect observed on both NbTi cables

The splices have been impacted by the impregnation mould overheating
