Experience with SPS RF and outlook

Sam Pitman, Eric Montesinos, Gino Cipolla, Sebastien Calvo, Flory Matthia Ten Broeke, Fred Killing, Christophe Renaud, Joan Revoltos, Calum Sharp, Christian Schachtner, Francesco Repola, Luciano Ciampo, Odin Ervik, Kim Wagener, Alessandro Cazzaniga, Giulia Papotti, Ivan Karpov, Bartek Bielawski, Rama Calaga 10/12/2024

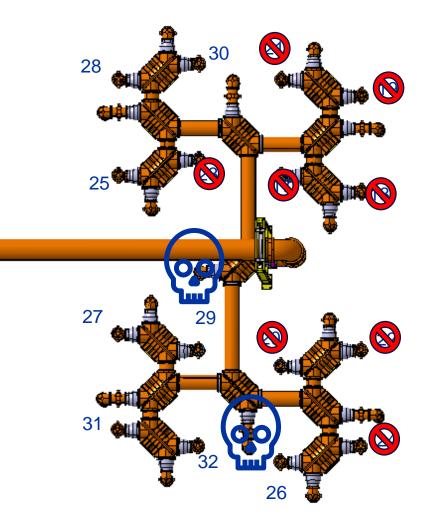
Technical stop event

- A connection error lead to the LLRF signal being missing on one half of system
- Some towers were full power and some zero
- This was very unbalanced due to the integration
- T26 first lost 13 modules
- Then the load broke
- Next the final load broke
- Finally the signal was re-established to the other towers
- Around 100 modules broken as a result of this event

Interlocks have since been connected to prevent this happening again

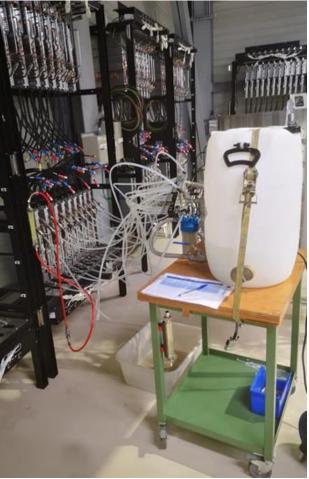
Thermal Paste

- Thermal paste was introduced to the cooling system
- This blocked the cooling channels of the transistors and caused overheating
- System was flushed of impurities
- Uncertain if there are still blockages causing problem
- We still see burned transistors
