ASG SUPERCONDUCTORS

MBRD1 REPAIR ACTIVITY AT ASG PREMISES

July 31, 2024

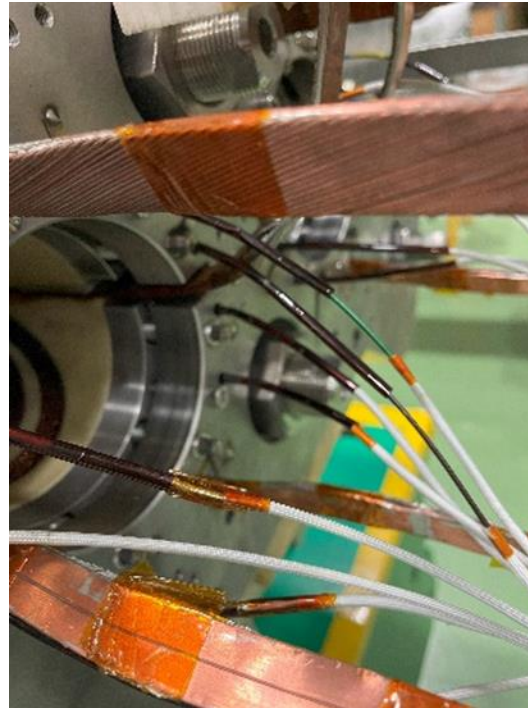
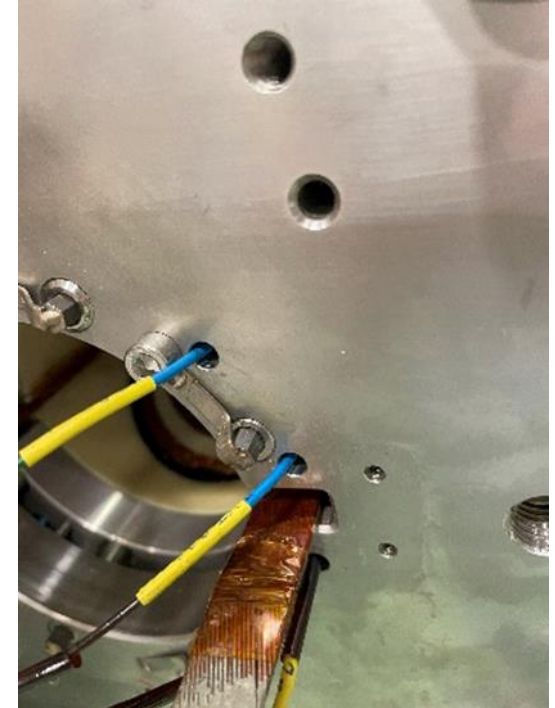
In the photos is shown the status on the MBRD1 at the arrival at ASG on July 2024

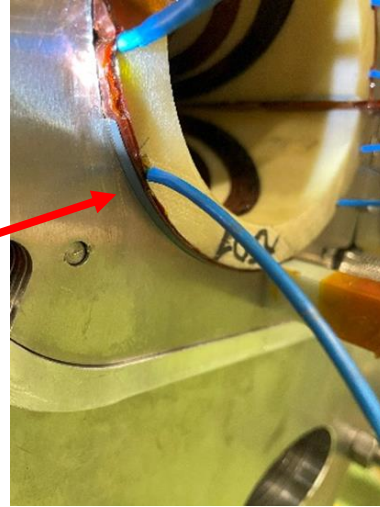
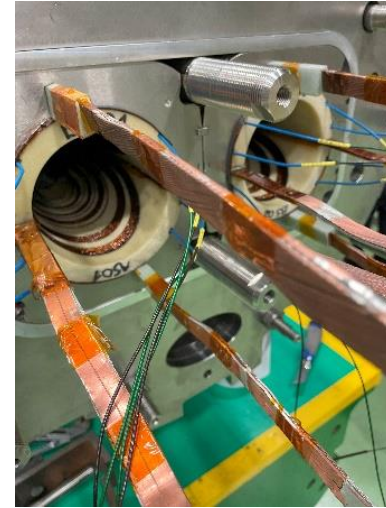
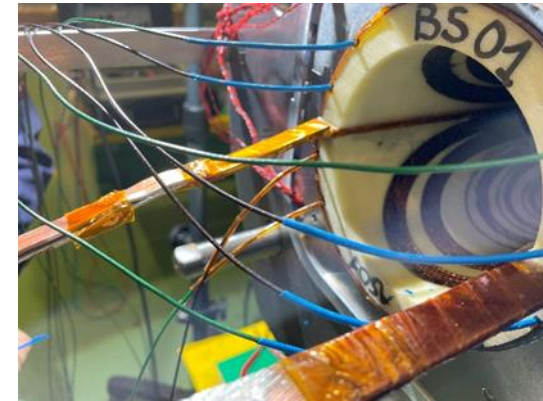
In these photos is shown the status on the MBRD1 Dipole. It is shown the detail of the YT112+ QH wire.

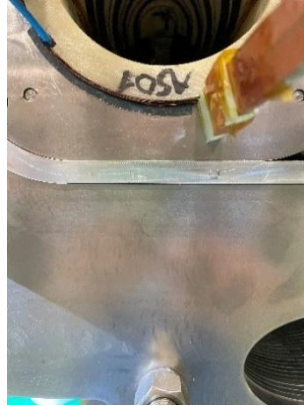
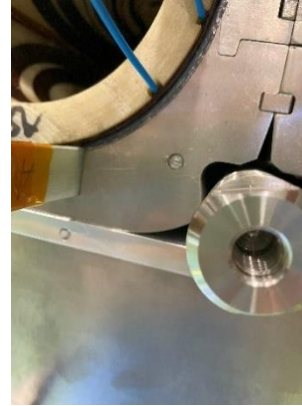
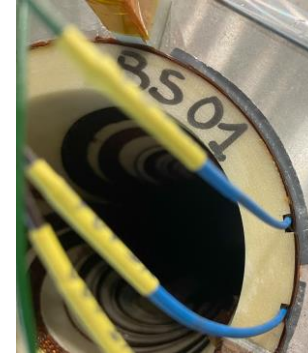
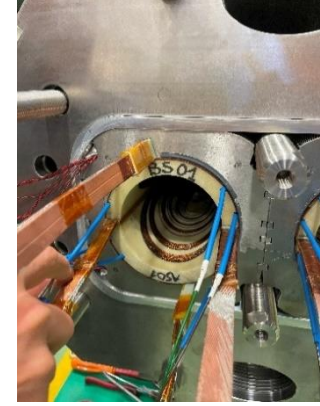
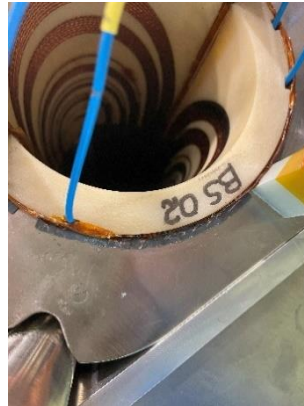
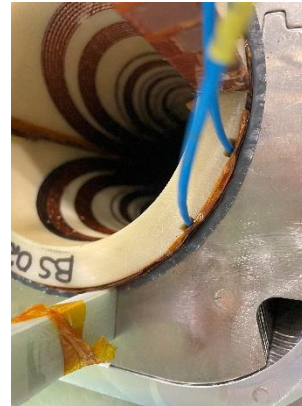
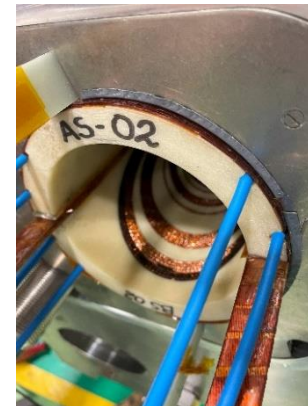
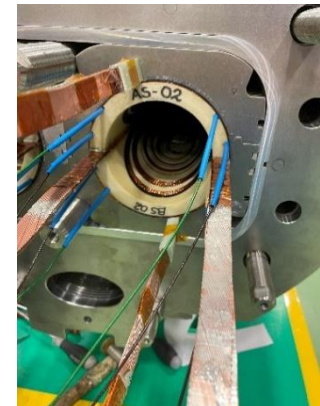
Coil by coil (on LC end) it is shown the coil protection foil edges bent against the adjacent collar

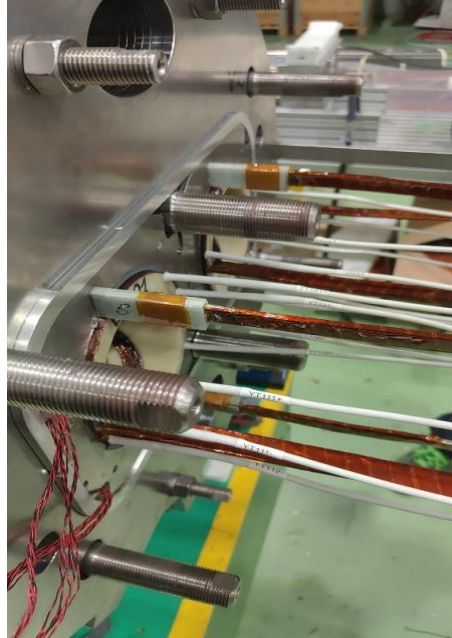
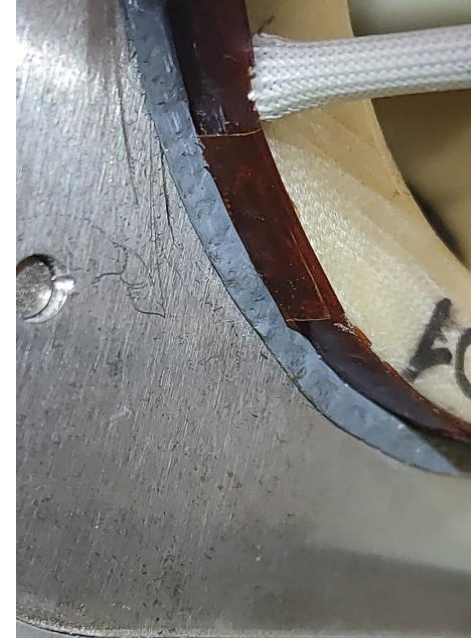
NOTE - The Y112+ wire (the one affected to short vs. ground during the test campaign after its arrival at CERN.

As shown in the pictures, the rupture appears to be due to fatigue stress.

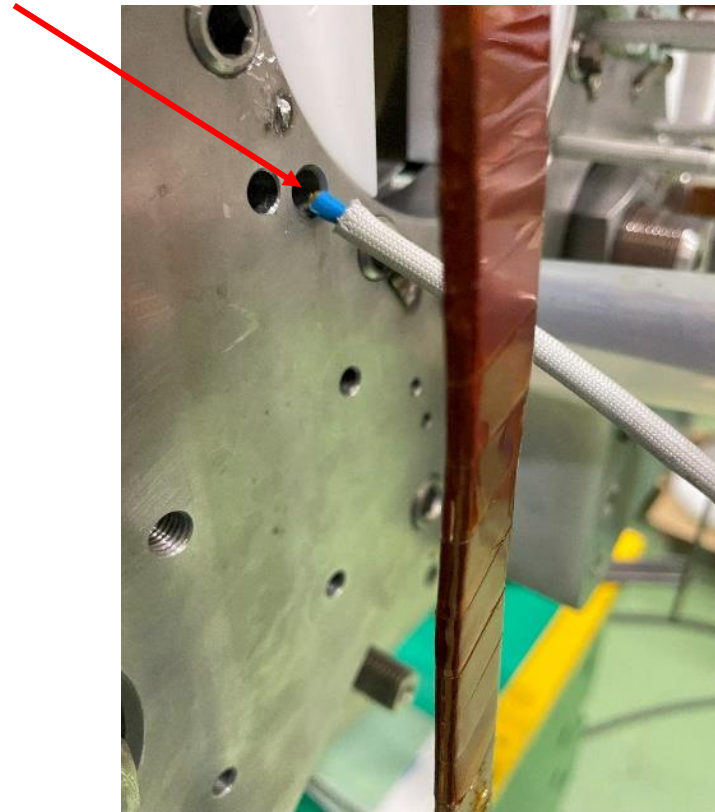
After having removed the LC head plate, it was found that the YT112+ wire is interrupted at approx. 5mm inwards measured from the outer surface from the G10 end-spacer.

It was agreed a repair solution that involves the milling of the end spacer with enough dimensions to allow a new QH wire soldering.
