ASG SUPERCONDUCTORS

MEETING INFN/CERN JULY, 31ST 2024

PROJECT: D2

VS-06 APERTURE COLLARING FAILURES ROOT CAUSE

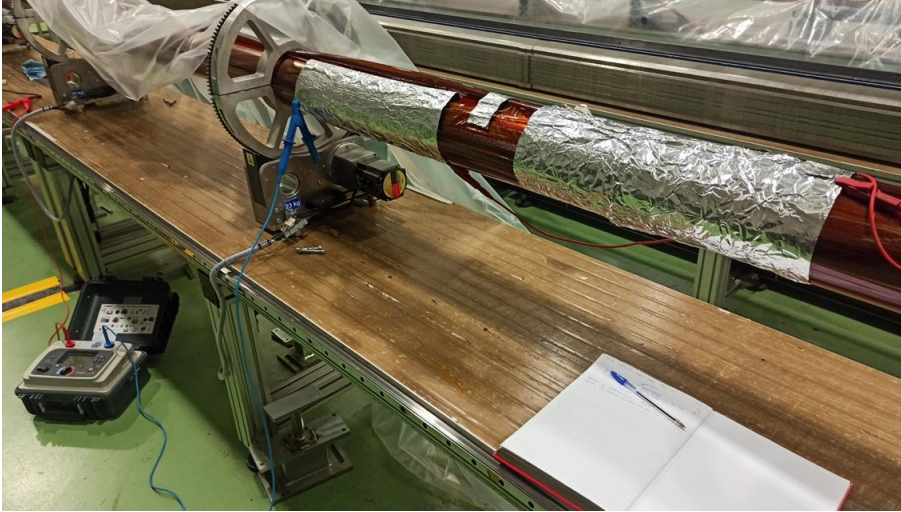
Fourth Attempt > (*) At first sight the short circuit has been localized in between the coil BS-08 and the QH left side but a capacity test performed in order to check if the insulation of the cable showed that the cable itself was not damaged.
 After further investigation it has been discovered that the origin was due to the coil protection foils that as they did not slide perfectly have damaged the Quench Heater by cutting its insulation in some locations.

Capacitance measurement carried out in between the Coil BS-08 and the adjcent wedge (2600 mm long) **5 nF** (vs calculation of 5,9 nF).

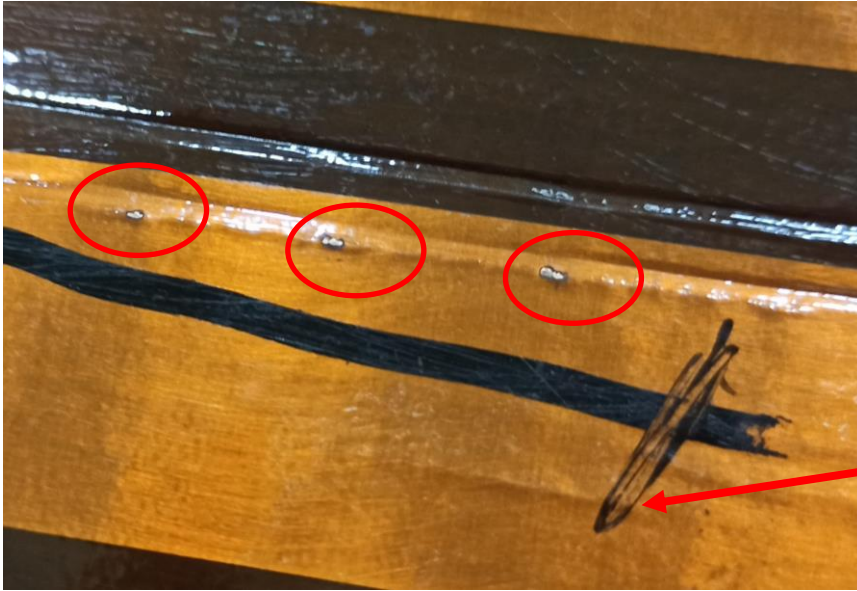
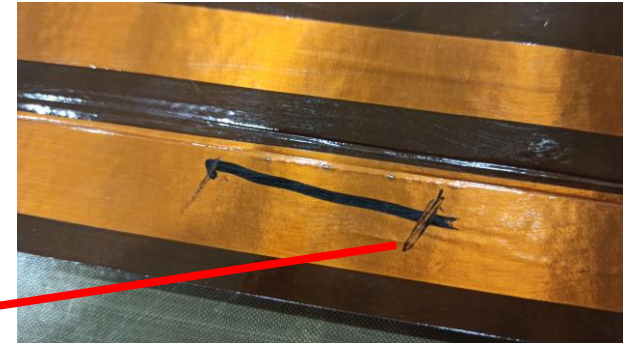
Circled in red are shown some location of defects detected onto the Quench Heater HCMBRDC006-CR000010 Insulation.

It happened as the adjacent coil protection foil edges damaged it.

About the location (at about 1640 mm from the LC side end) showed that the cross section into where the defect is mainly located is one used for carrying out the measurements of the elastic modulus.
