P42 XTAX Issue

Initial Assessment / Post-Mortem

EATM 13.08.2024

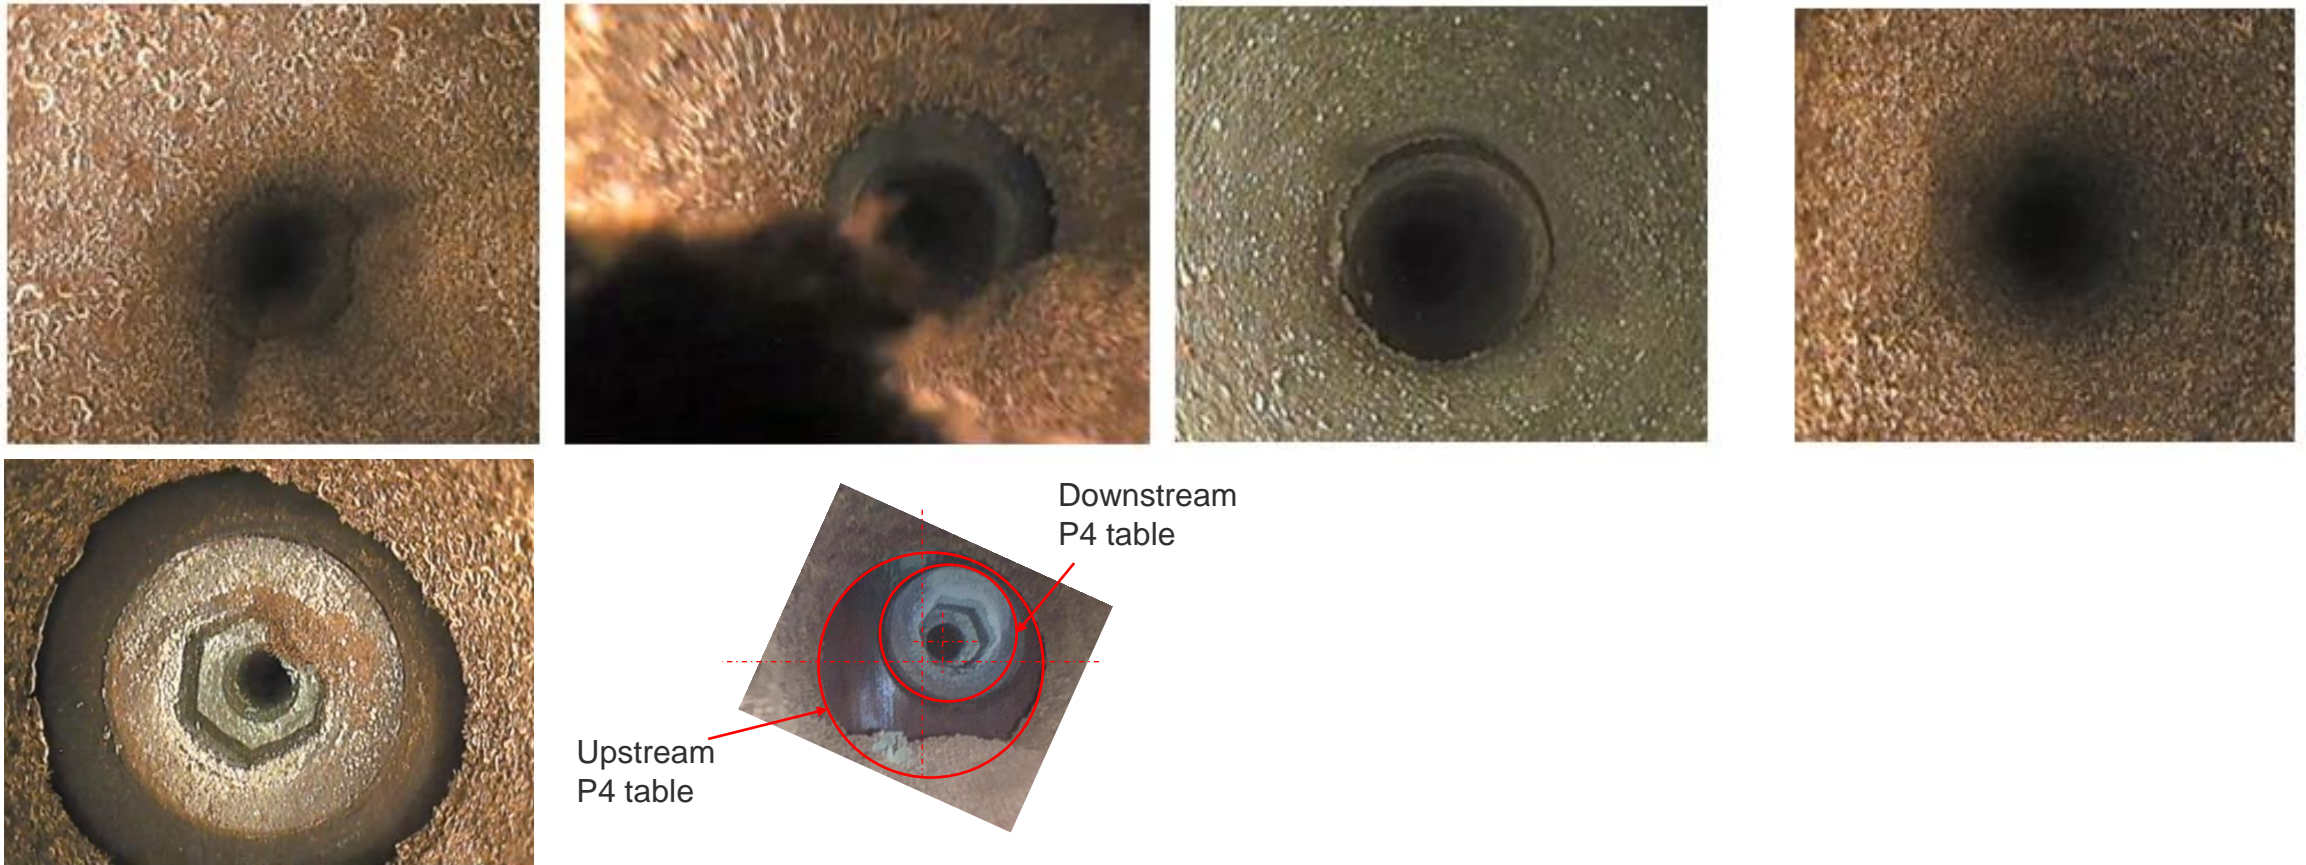
- Alignment and position measurement of the XTAXs is critical for operation. Suspecting at some point misalignment between the holes, several endoscopic checks were performed, showing no blocking material or melted material in the apertures, however some offsets, but nothing to fully explain the situation.

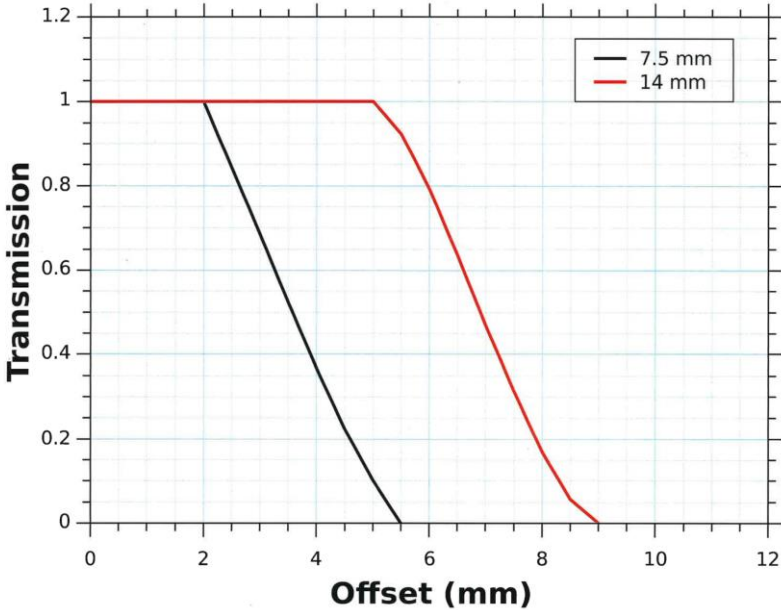
Expected transmission for a $\sigma = 3$ mm Gaussian beam on the 7.5 mm and 14 mm holes.

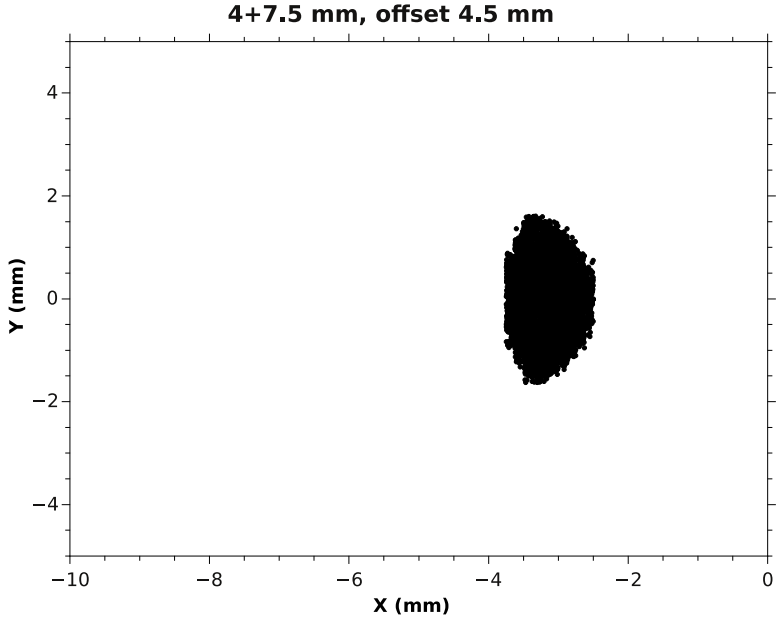
Observation of transmission through 7.5 mm hole hints to offset in the order of 4.5 mm or substantial material inside the aperture.

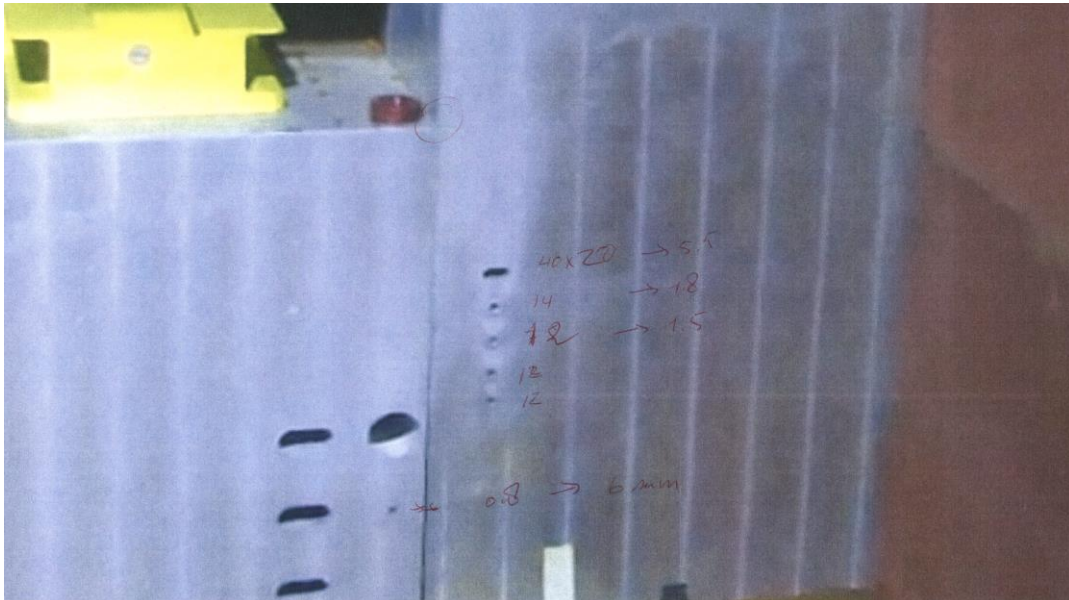
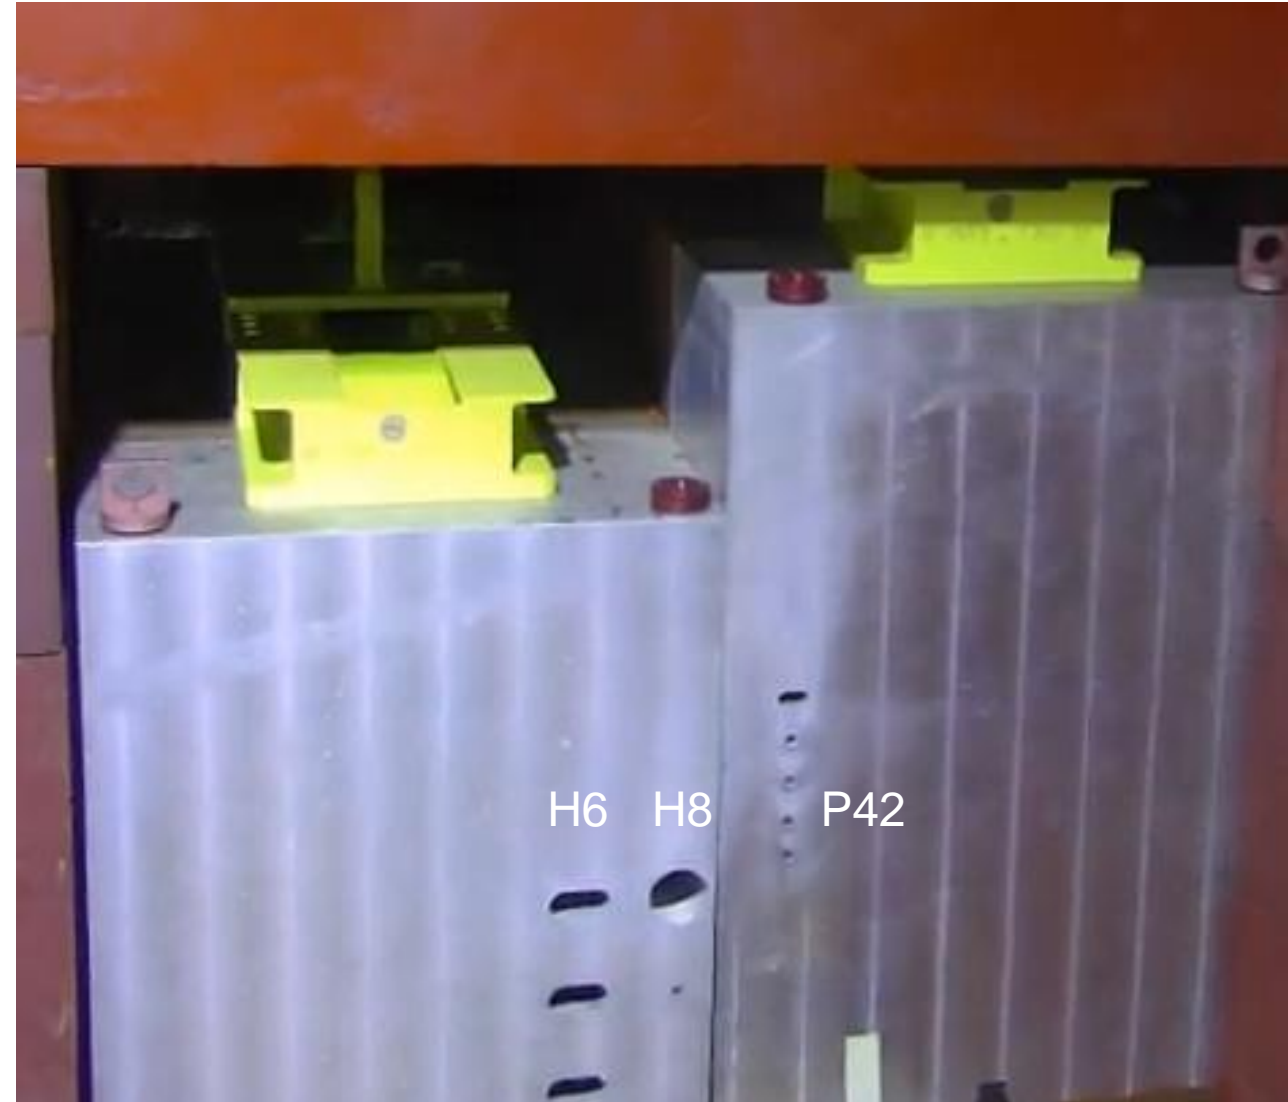
- During last YETS, several new pictures were taken, and with the recent stop for the H2 quadrupole exchange in TCC2, another visual inspection confirmed that the first XTAX of P42 is leaning on the first one of H8/H6.
- A physical intervention on the XTAXs in TCC2 is impossible without months of cooldown due to their high activation levels.

- H8: Decisions taken on 31.07. were (a) to block first H8 XTAX in 80 mm aperture position, (b) to change access system and CESAR as soon as possible to work with second XTAX (no safety implications).

- XTAX1 was locked out in the 14 mm aperture position.
- The overall downtime for NA62 was about 20 h.

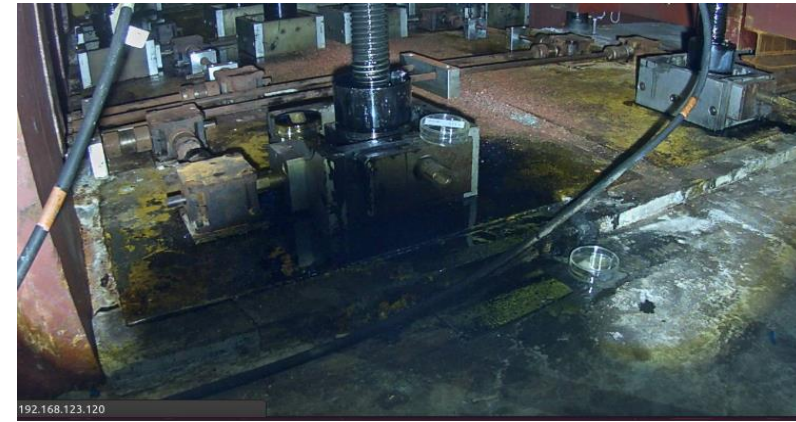
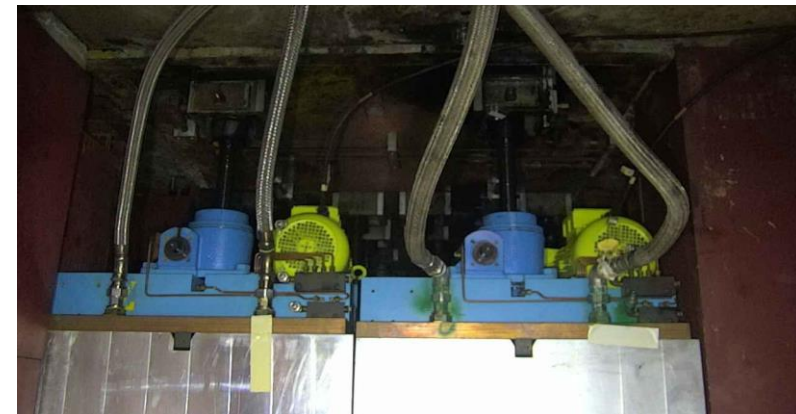
- The beam stop after H2 magnet exchanged was prolonged to understand the problem better and to allow for another access to TCC2, also to do additional inspections with robots on the other XTAX faces (H2, H4, M2) → access on 01.08. did not reveal any obvious issue for the other XTAXs but showed metallic debris between the H8 and P42 XTAXs. Also some grease was found on the floor (more than expected). The tables themselves did not look damaged.
