# **MBHHE.X0611085 incident and mitigation TE-MSC**

# Incident and mitigation timeline

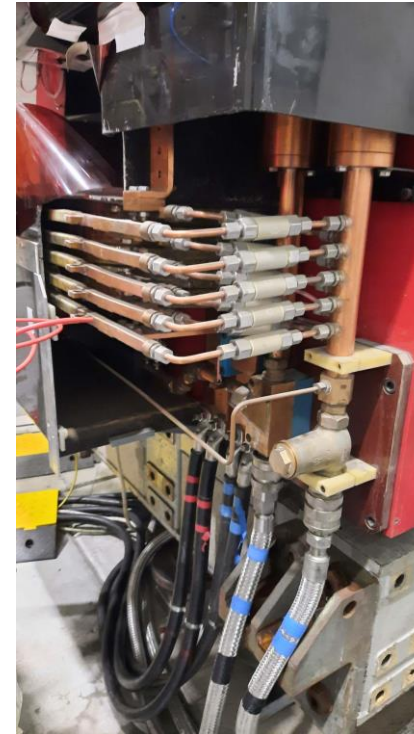
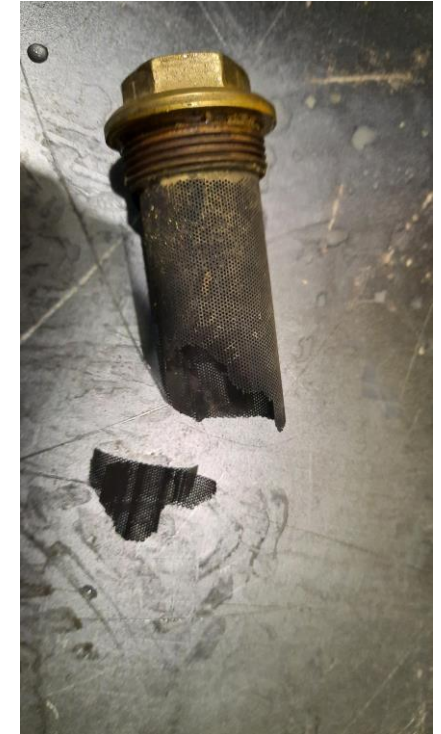
- **06.08.2024:**
  - CCC informed that “coil temp” fault was present
  - Thermal camera inspection showed too high temperature
  - After investigation, broken strainer was found (see picture)
  - Circuit was backflushed and operation resumed
- **11.08.2024:**
  - CCC informed that “coil temp” fault was again present
  - Expecting a blocked water circuit due to the broken strainer, a thermal camera inspection was repeated to find it
  - No clear difference in temperature between the circuits was found and after disassembly of the manifold, no signs of obstruction found
