Planned adjustment of the temperature interlock of the BBCW

Adriana Rossi @ 253rd MPP meeting – 13 Sept. 2024

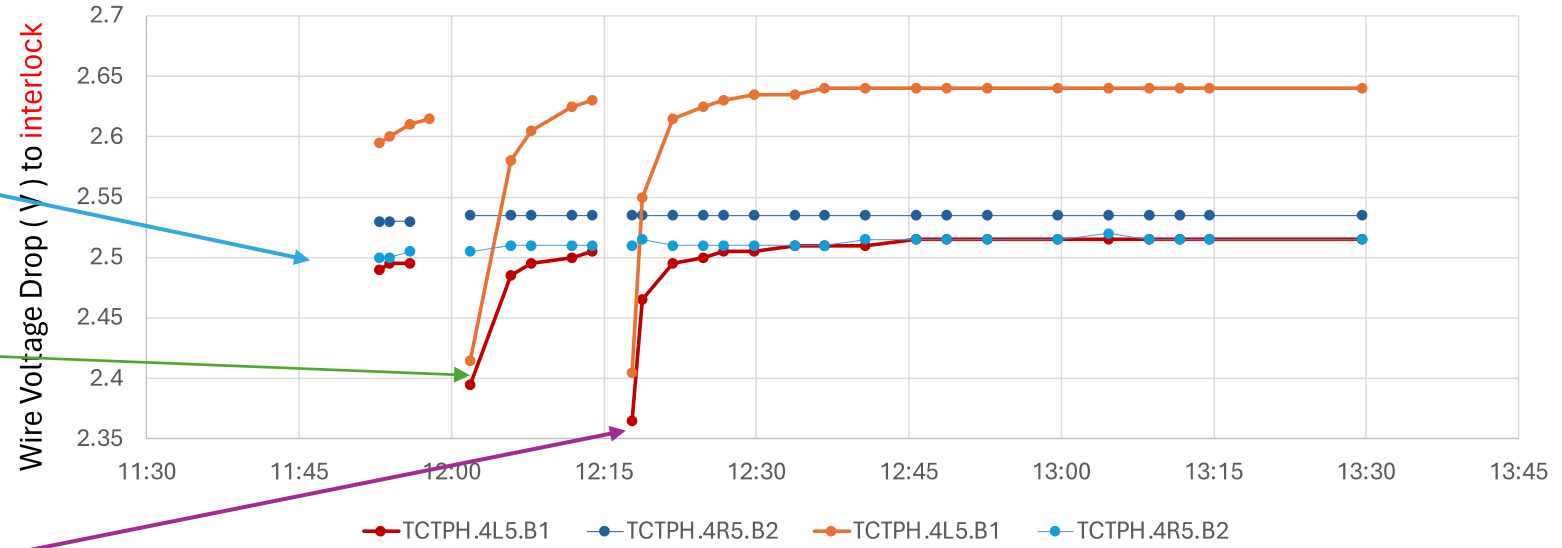
BBCW TESTS 24 April 2024

interlock triggered by moving cables

Interlock while modifying the threshold value

Interlock while just touching the voltmeter cable to thd lvl 1-1

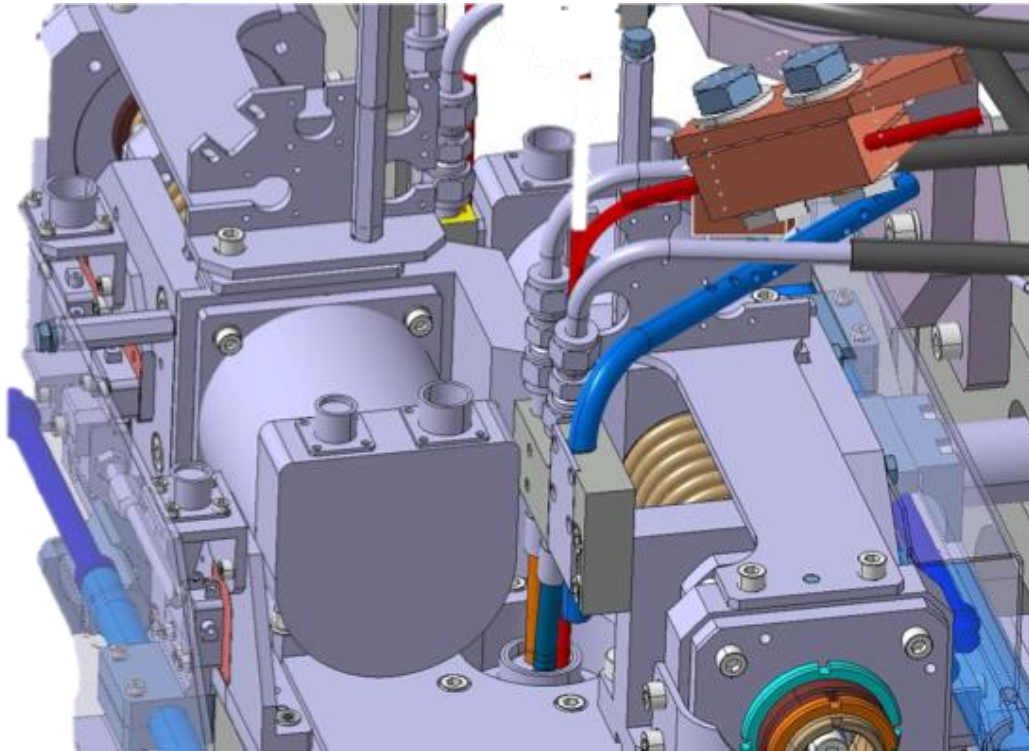
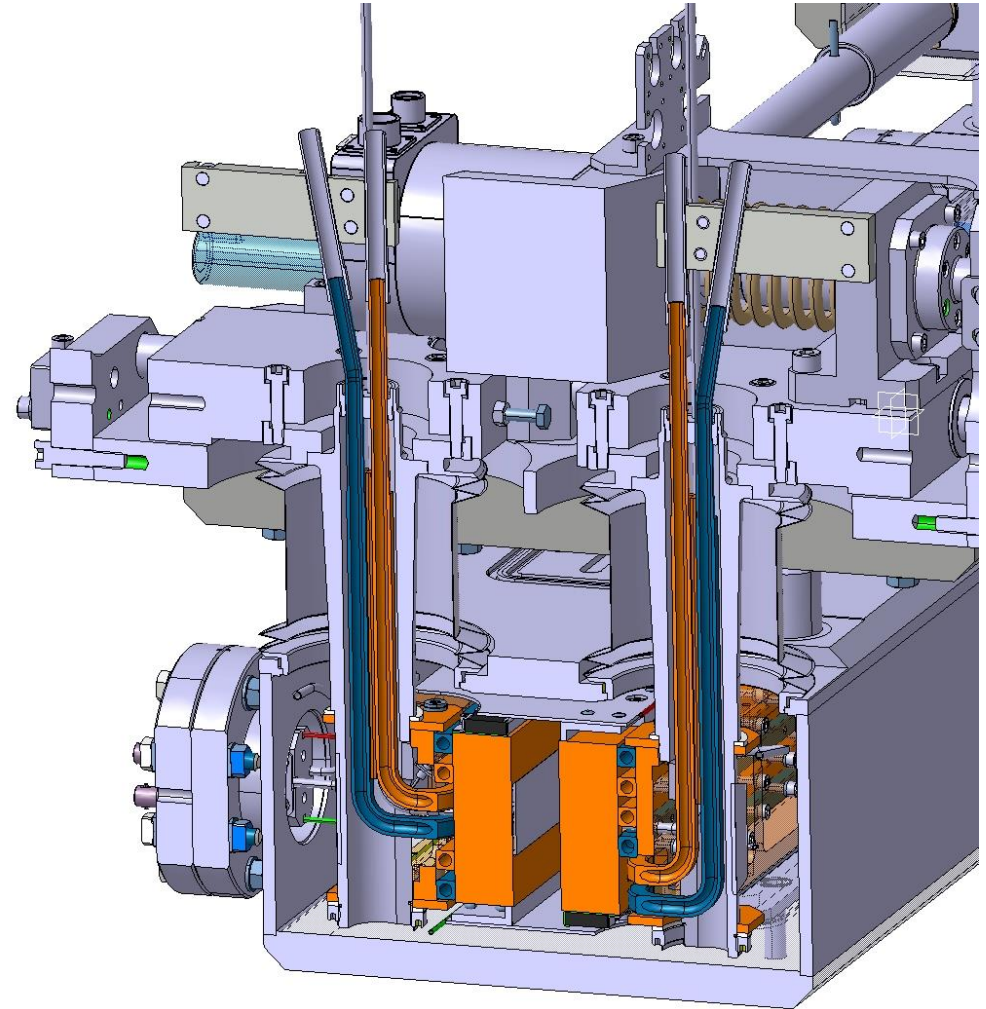
Wire after repair (courtesy of L. Gentini)

- We (Wilfried Devauchelle and myself) dismantled the connections to the flexible on both sides:
 - a. One side of the wire (corresponding to where the temperature is higher during operation) had a length of contact (length of the copper wire stripped from the sleeve and insulator, and in contact with the copper clamp) about 1/3 shorter than the others. This means that the surface to conduct the 350A was smaller, inducing larger local heat.

- b. The clamps were only half than in other locations (so the wire was squashed between the beak of the flexible cable – StSt – and 1 copper plate. Dispersion of heat was therefore lower.

- Solution: we replaced both sides clamps with double sided and thicker clamps.
- We then run tests at 350A, measuring the voltage drop on both wires (one per collimator jaw).

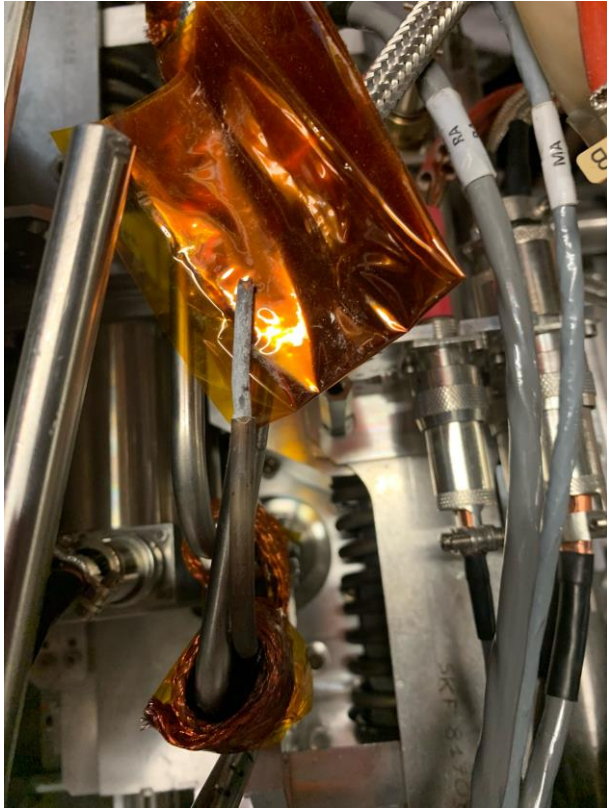
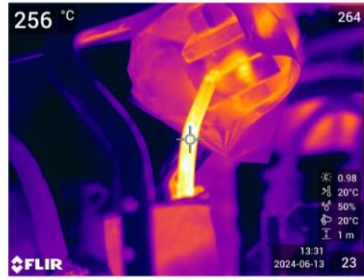
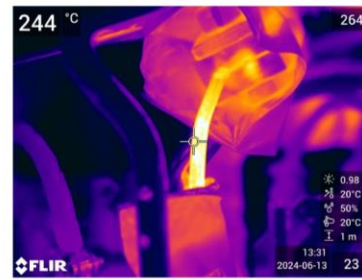
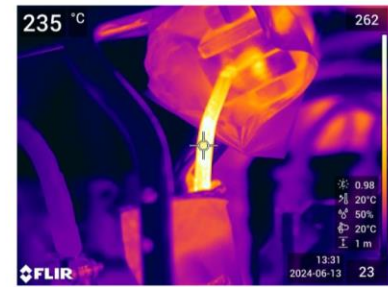
- a) The voltage stabilized after about 40 to 45 min, with values comparable (for both wires) to what was measured during tests on Apr 24.
 - b) The test could run for 1h45 min without triggering the interlock. (see picture annexed)

- c) The temperature of the wire (measured with a thermal camera) close to the clamp was $\sim 260^{\circ}\text{C}$ (highest 256°C , lowest 235°C) (see pictures annexed)

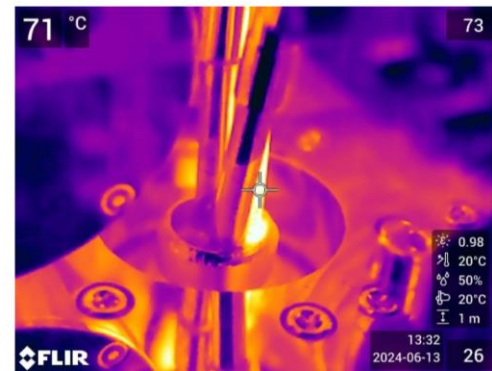
4) temperature measurement of “bague” cooling tubes and wire

- d) The temperature close to the 'bague' where the wire is brazed, to go from vacuum to air, was $\sim 70^{\circ}\text{C}$, and the bague itself cold. The temperature of the piece holding both the wire and the cooling tubes to the support in the same range.

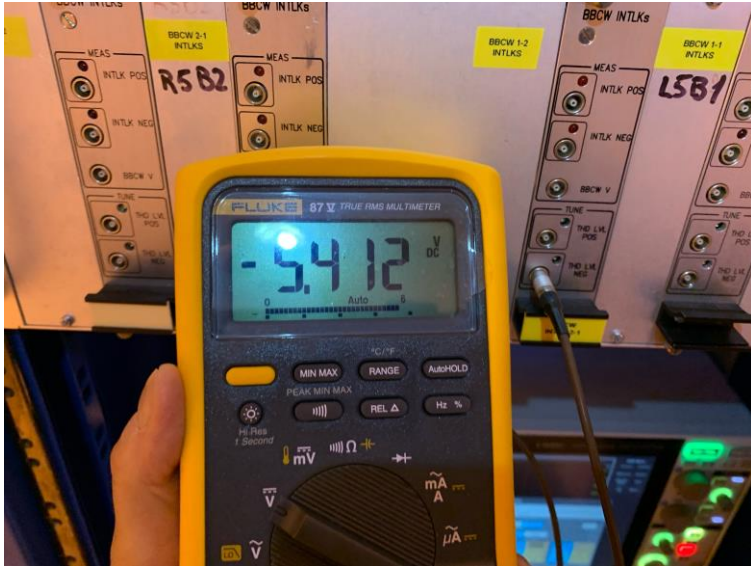
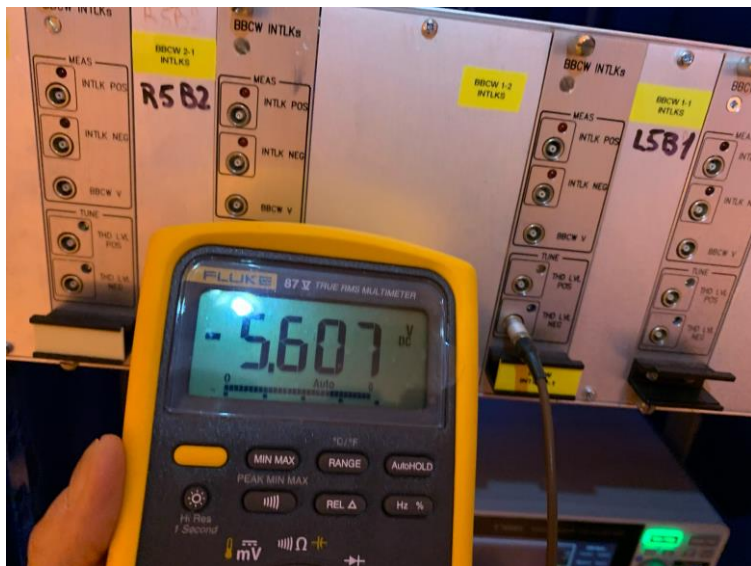
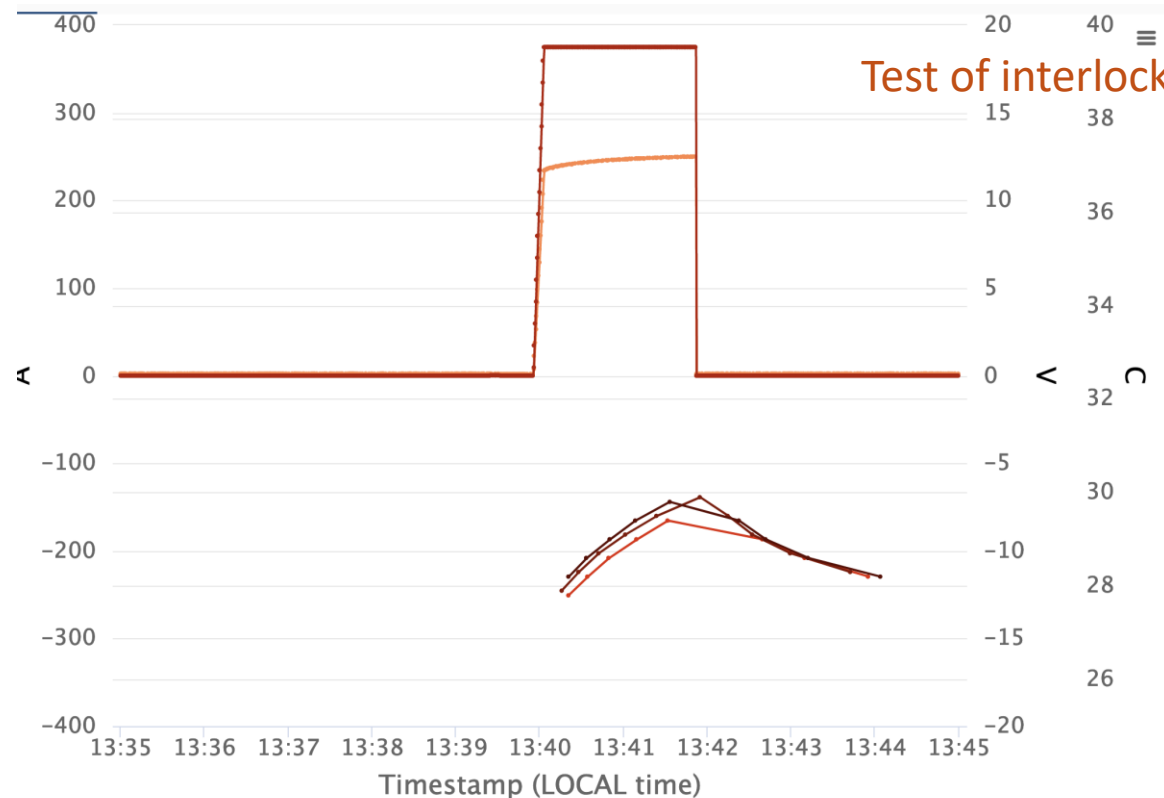
Change of V threshold on TCTPH.4L5.B1 (only on wire concerned) from 2.7 to 2.8V (26 June 2024)

- The threshold voltage on the wire (jaw on tunnel passage side) of the TCTPH.4L5.B1 has been modified from **2.7V to 2.8V**.
- This rise is to compensate for the local overheating of the wire extremities that are shorter (about 2 instead of 3 cm).
- The new threshold was tested with standard procedure.
- Wires have been since regularly powered @350A with no problems observed

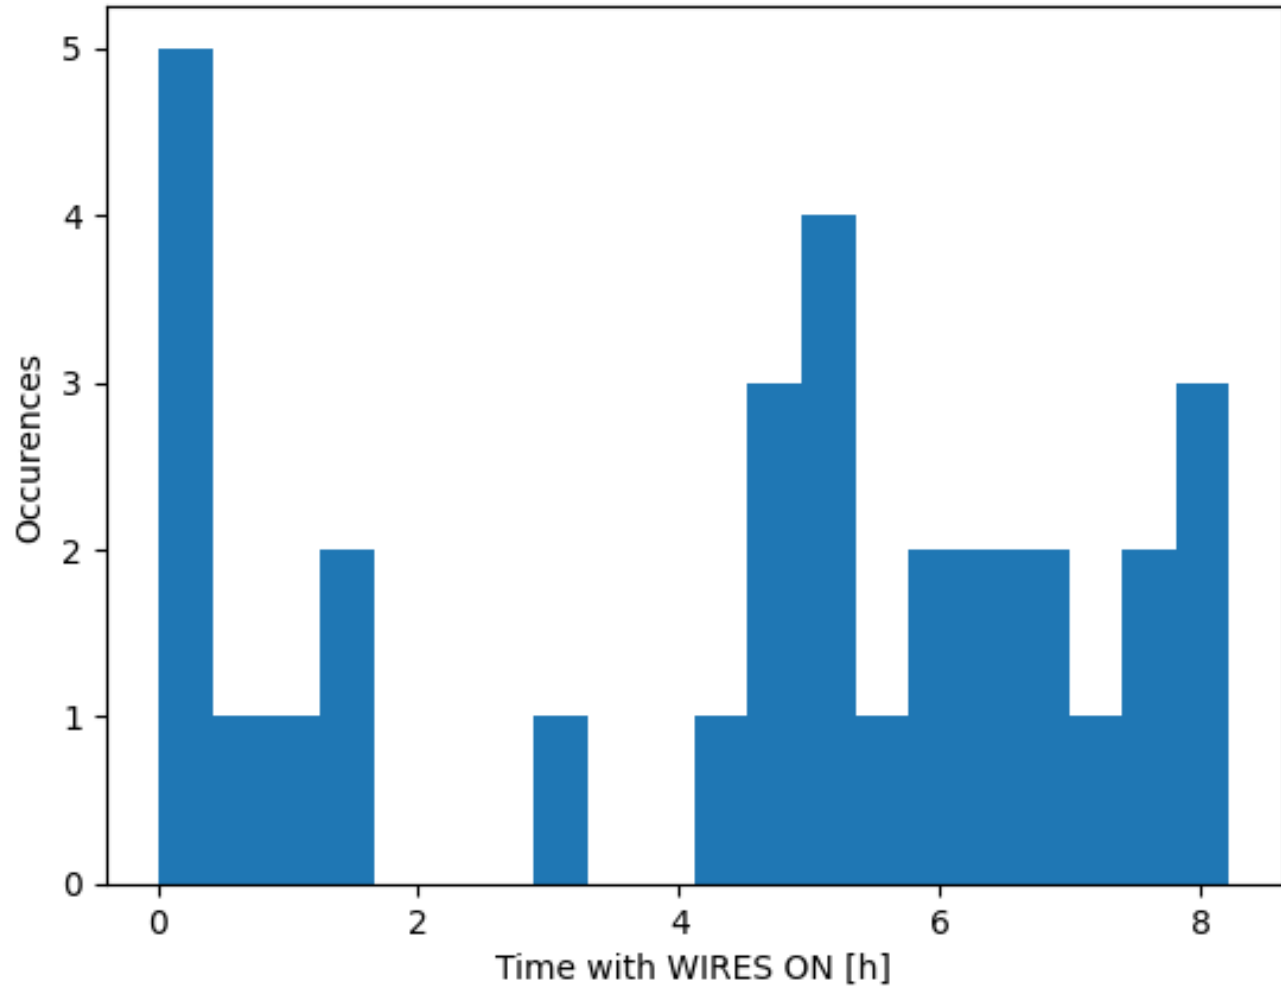
After fix and threshold rise

After the TS1, we had 31 fills with WIRES ON (on average for 4.44 h)
