# MQXFA13 – AUP227 metallographical inspection

# Metallographical analysis of MQXFA13 – AUP227 coil

## **metallographical inspection – pole turn**

## **Extended inspection of pole turn region by deep copper etching and CT analysis**

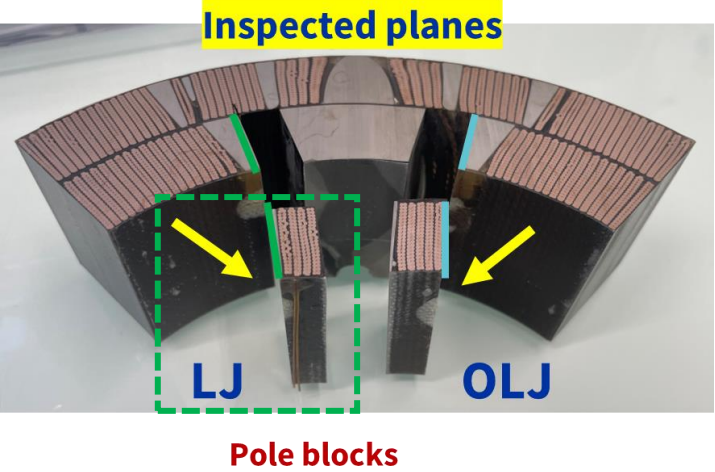
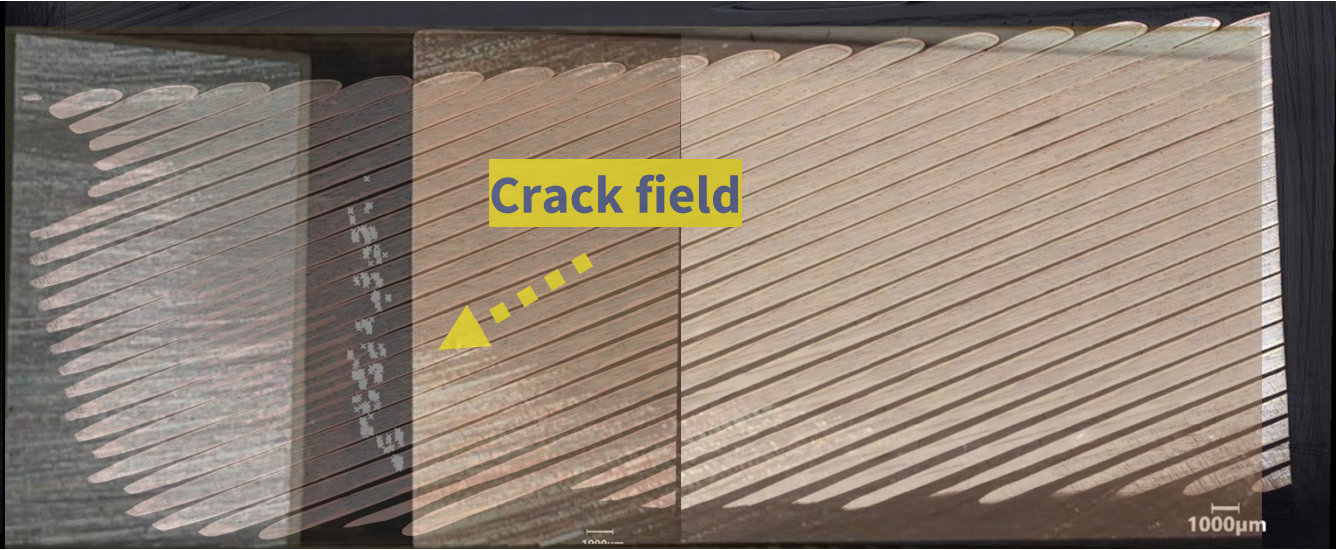
# Pole blocks – connection side (LJ)

- Transversal microcracks seem to follow the end spacer – wedge transition.
- The thickness of a resin is higher than in the previously analysed samples (AUP coils #213 and #214) – 3.6 mm compared to approx. 1.5 mm in AUP214

Calculated number of cracks - 180

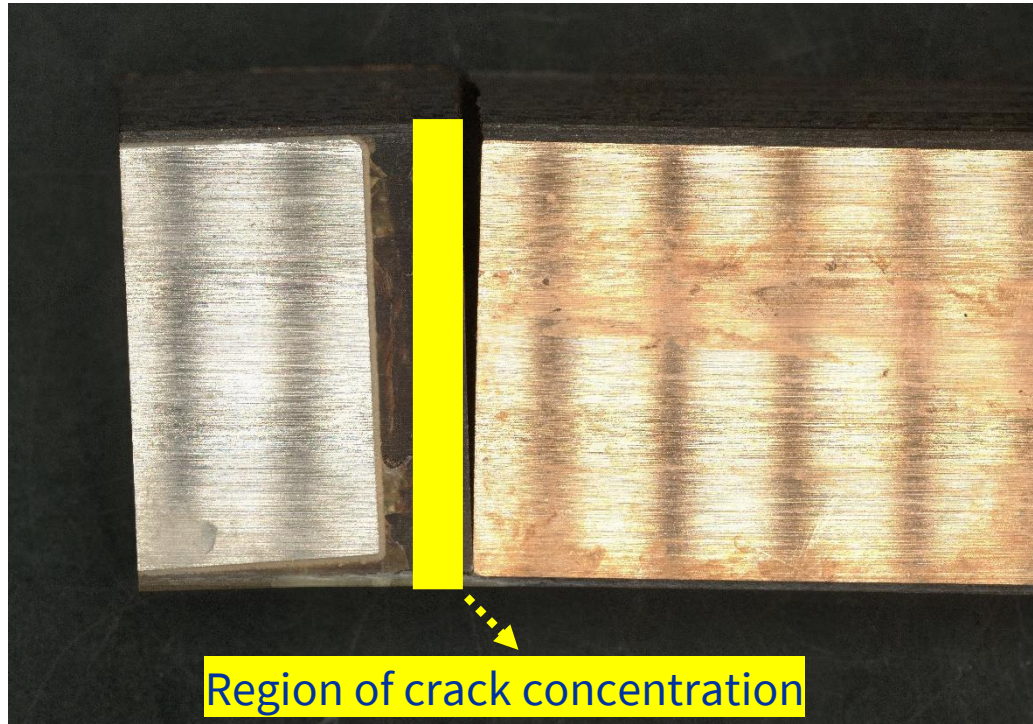
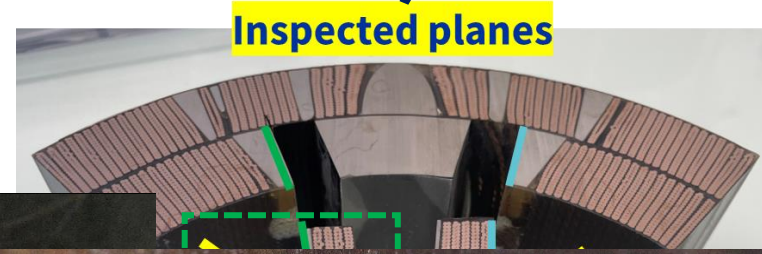
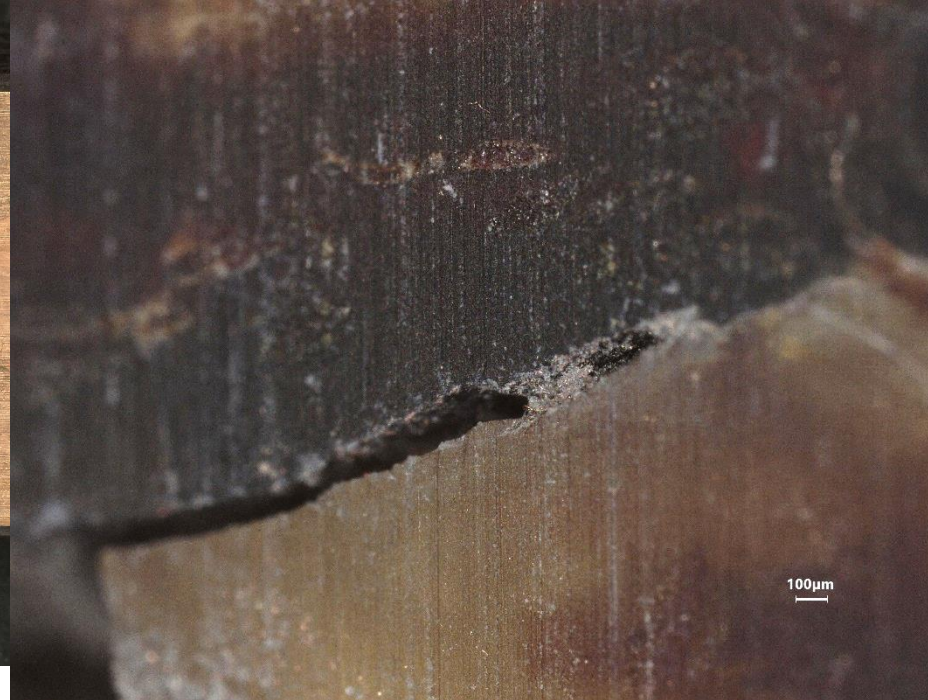
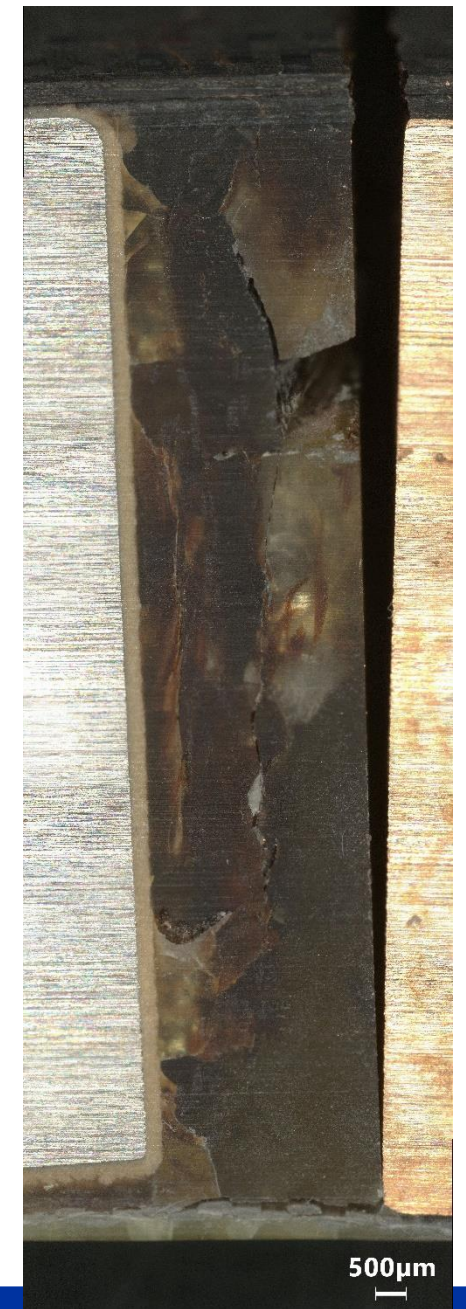
# Resin evaluation (LJ side – pole blocks)

- The resin experienced decohesion after cutting, indicating its poor adhesion to copper block
- Cracks were present in the resin

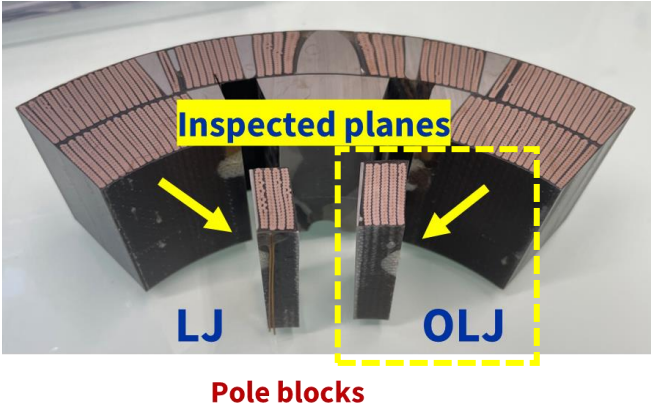
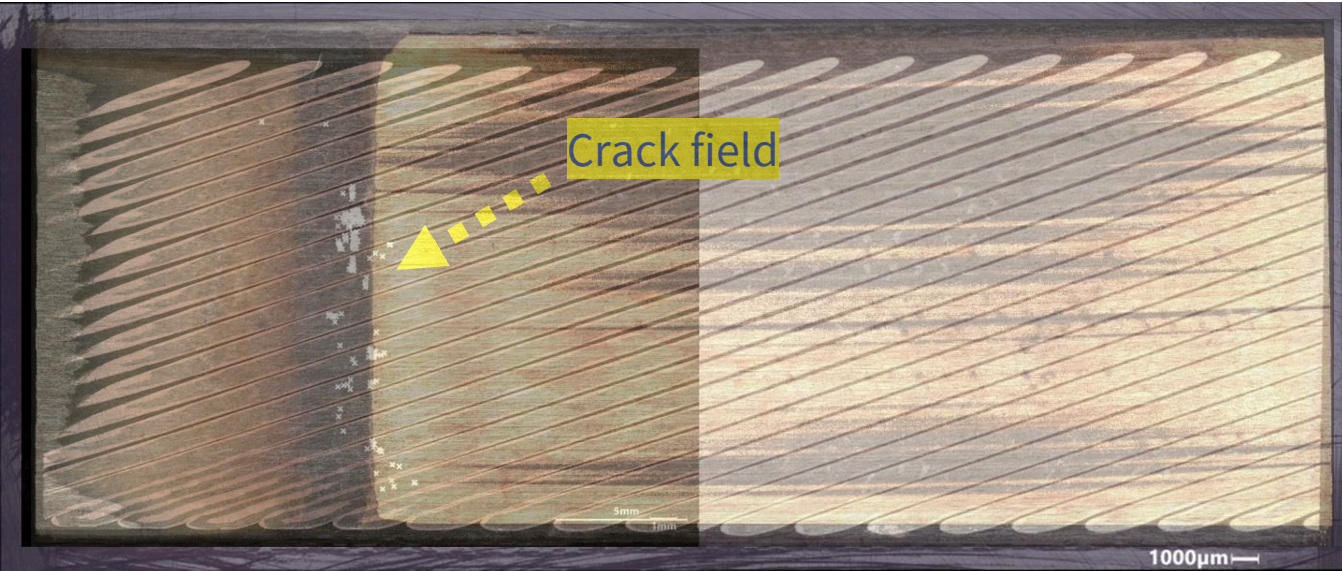
# Pole blocks – connection side (OLJ)

- Microcracks seem to follow the end spacer – wedge transition.
- The thickness of a resin is higher than in the previously analysed samples – 2.8 mm compared to approx. 2 mm in AUP214

Calculated number of cracks - 210

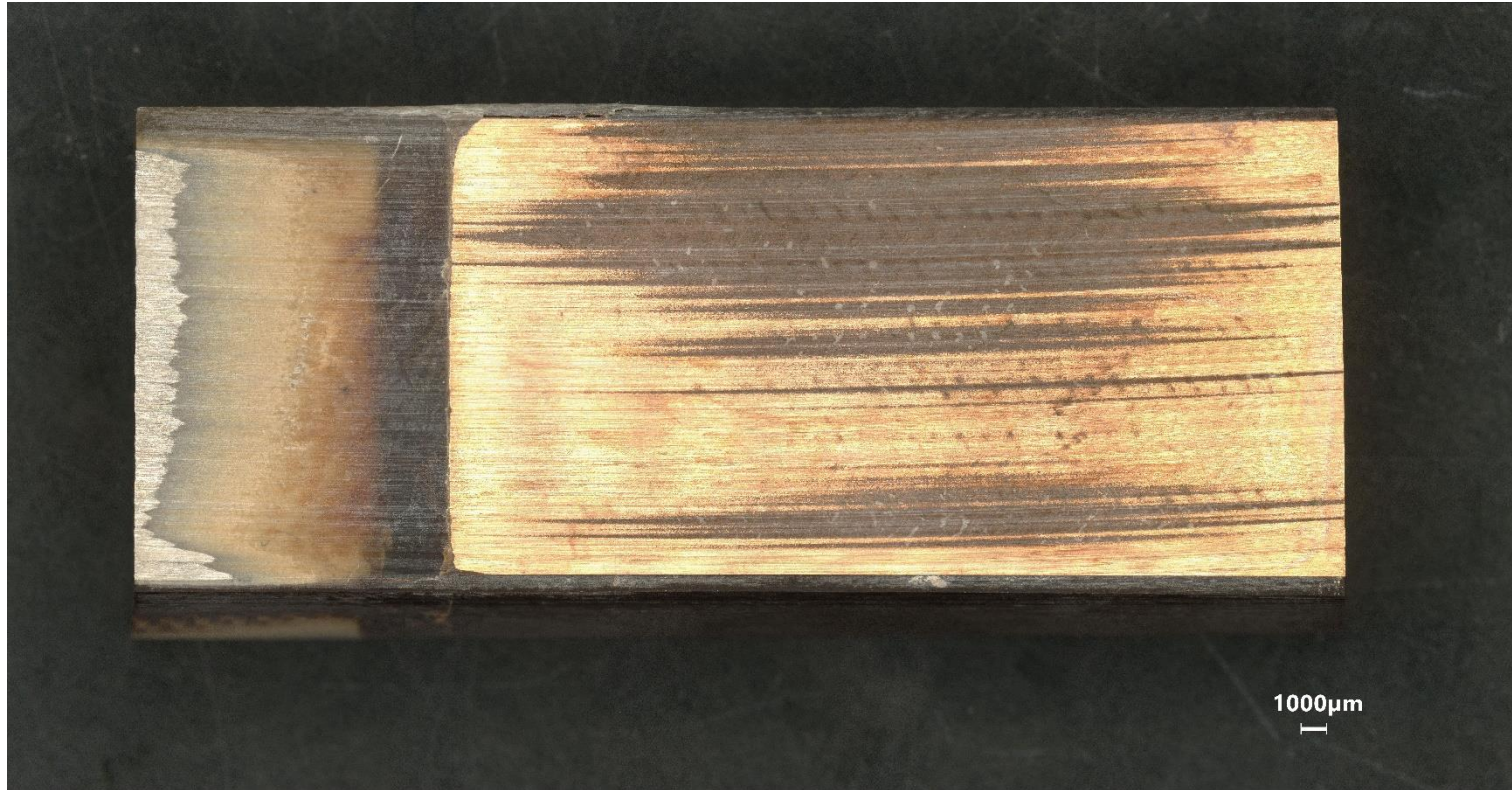
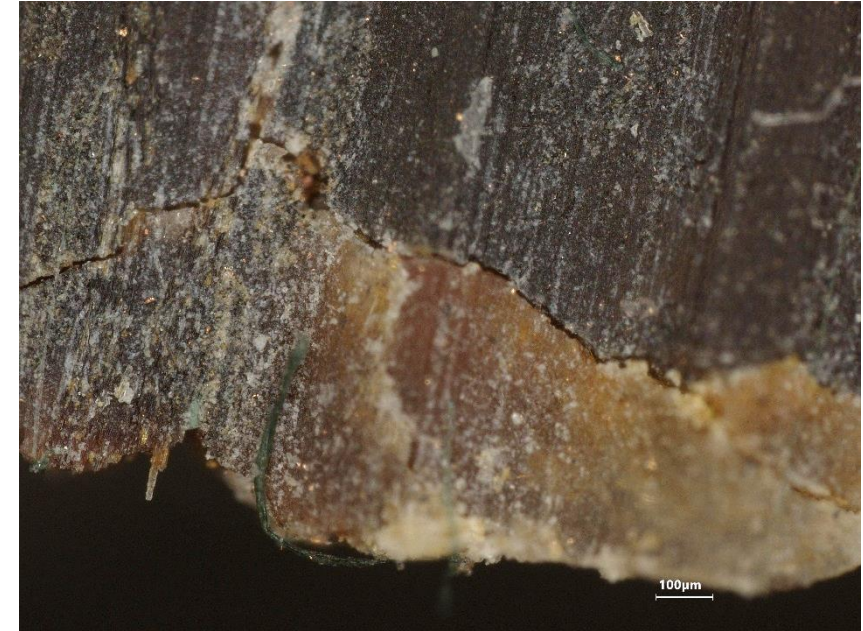
# Resin evaluation (OLJ side – pole blocks)

- Microcracks were observed in the resin, but less numerous than in the LJ side
- Resin thickness is higher than in the previously analyzed coils (for both LJ and OLJ blocks)

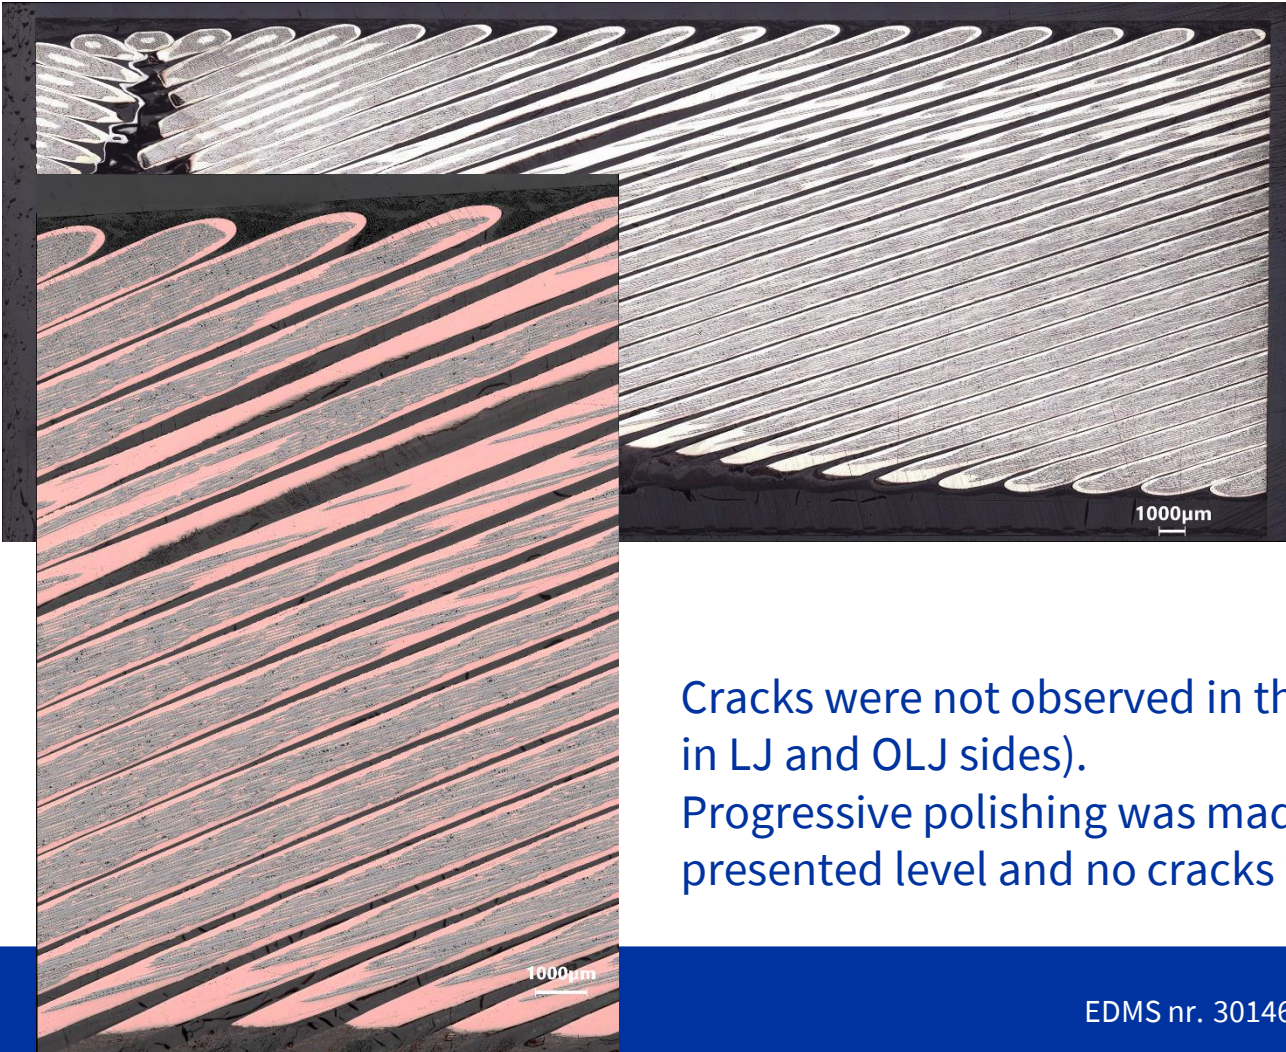
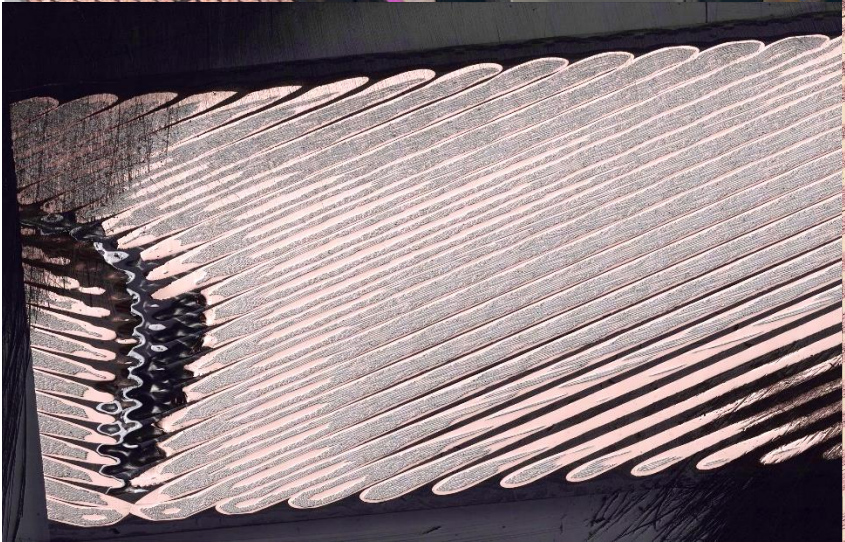
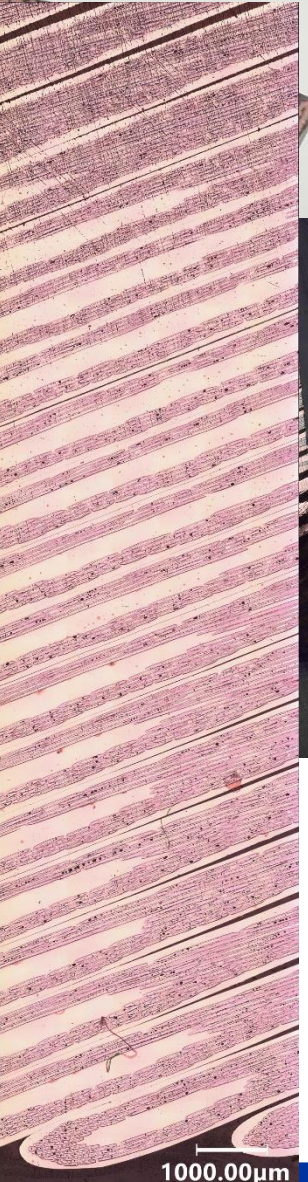
# Midplane blocks (LJ and OLJ)

Cracks were not observed in the midplane blocks (neither in LJ and OLJ sides).  
Progressive polishing was made and examined up to the presented level and no cracks were observed.

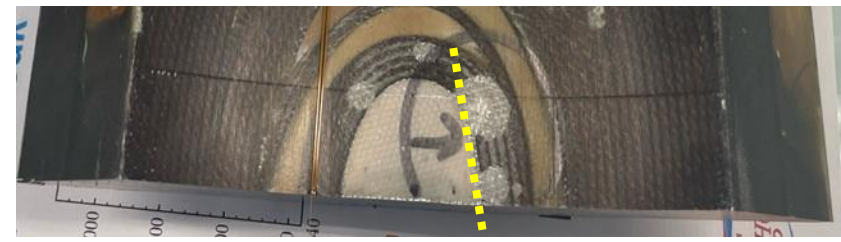
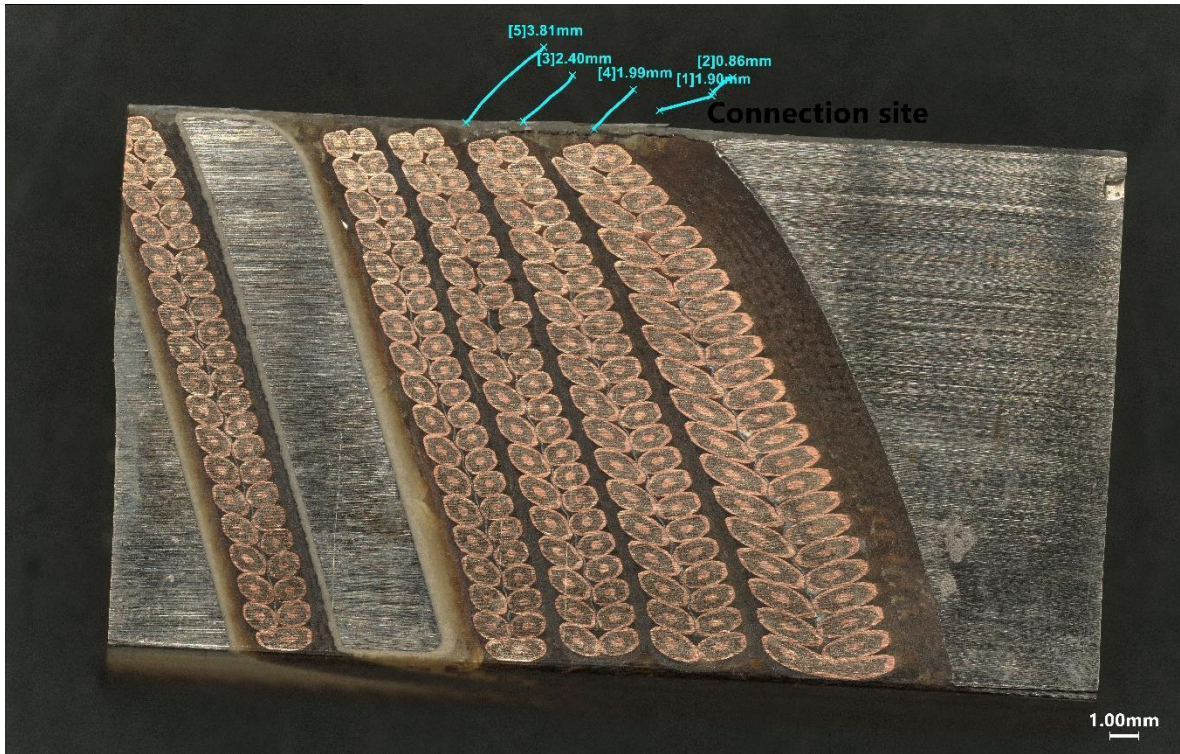
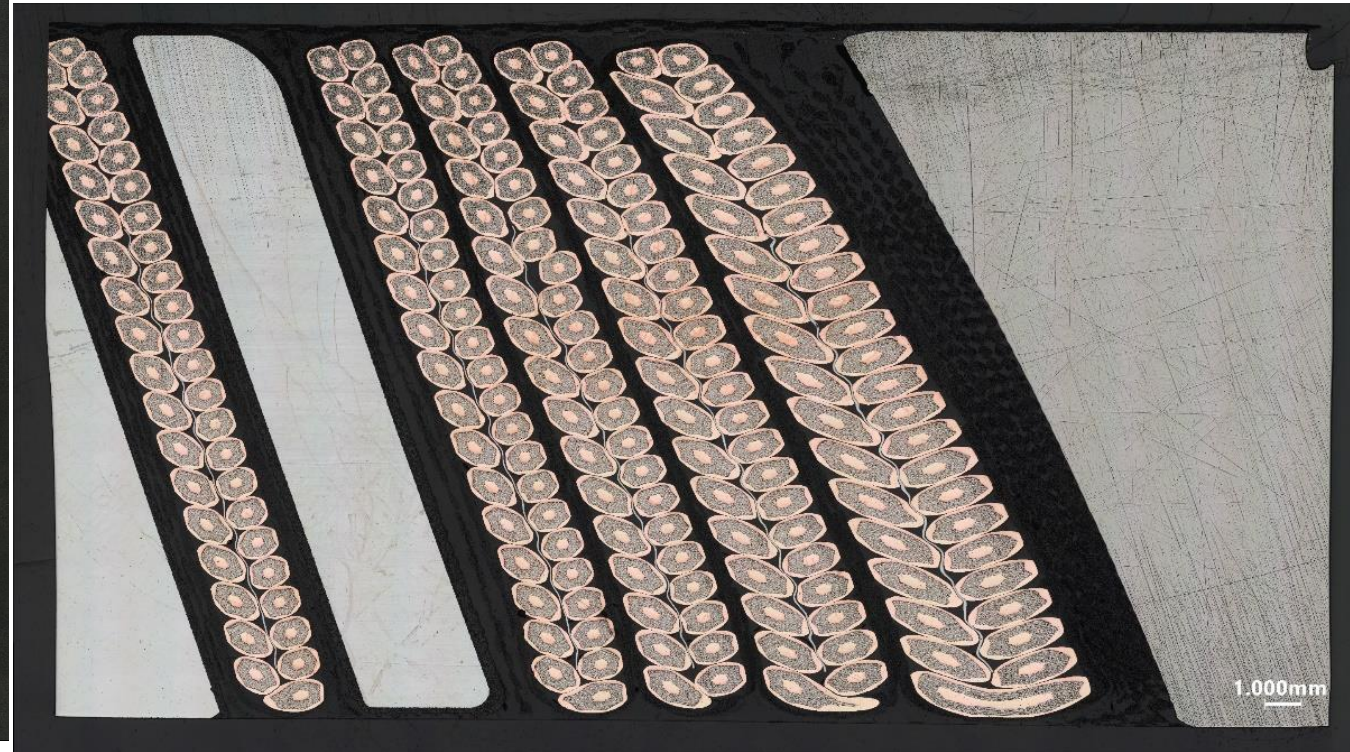
# As-cut surface and 1<sup>st</sup> step polishing

Observations of the as-cut surface revealed only discontinuities in the part of the resin corresponding to the connection side.

Rough polishing step after cutting, followed by optical inspection showed good state of the resin, no major discontinuities were observed.

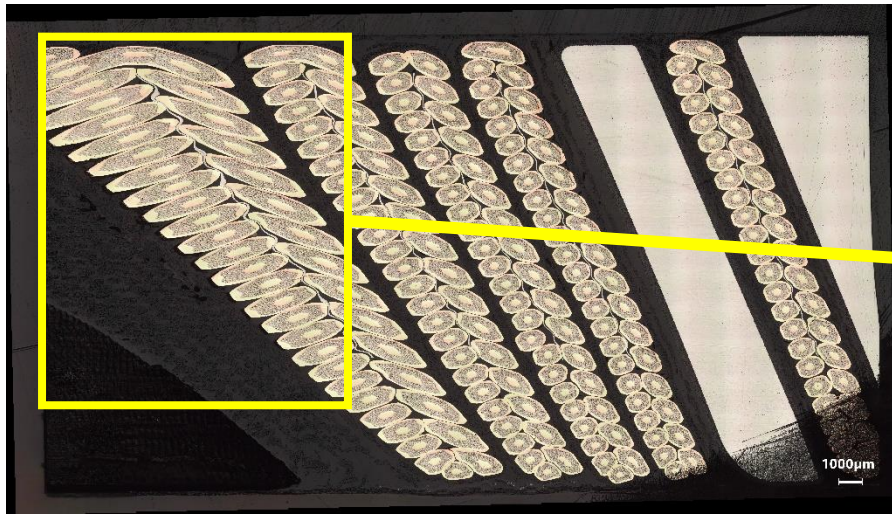
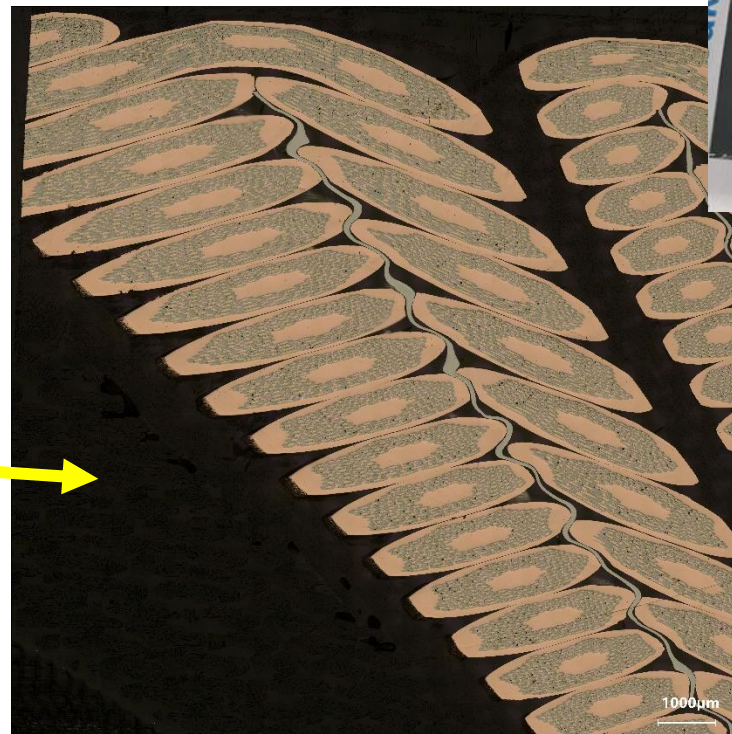
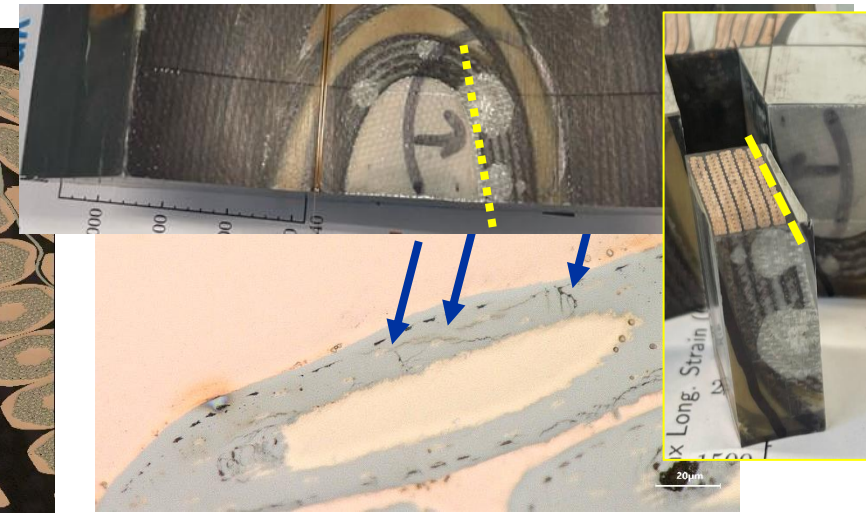
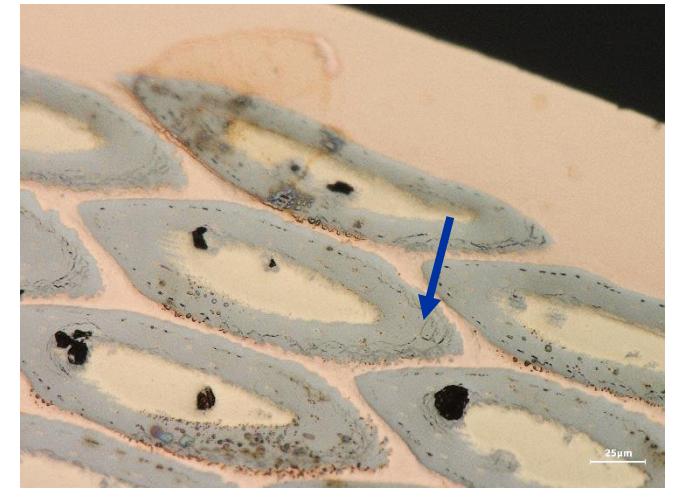
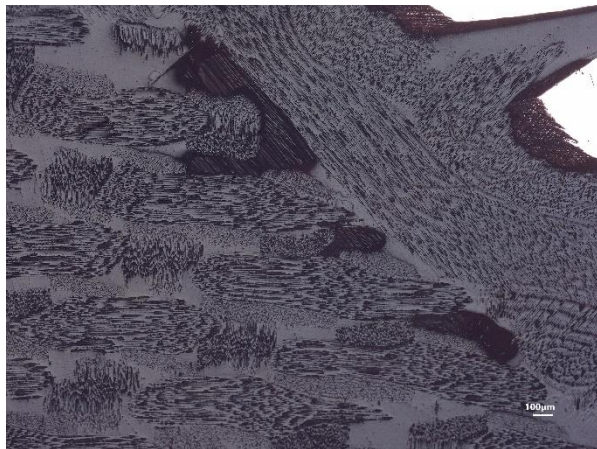
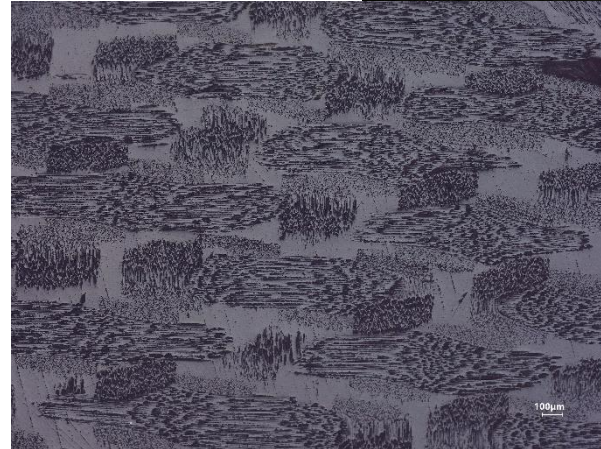
# 2<sup>nd</sup> step polishing

2<sup>nd</sup> polishing step (to reveal the resin state below Ti), did not show cracks in resin. The Nb<sub>3</sub>Sn filaments possess a minor amount of radial cracks, as indicated by blue arrows.

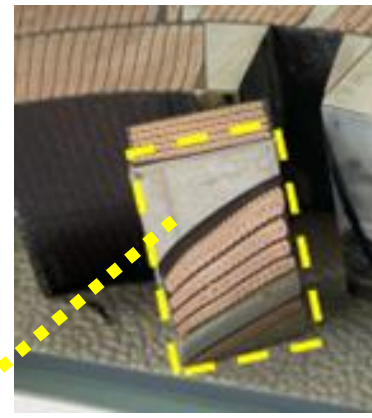
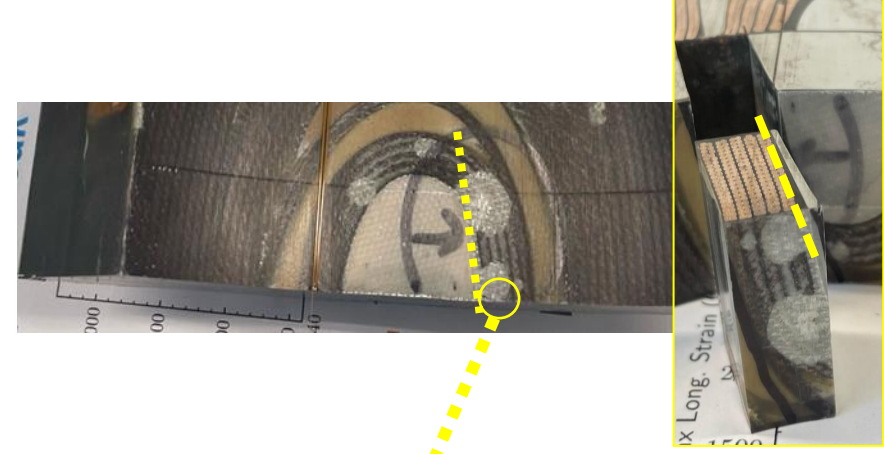
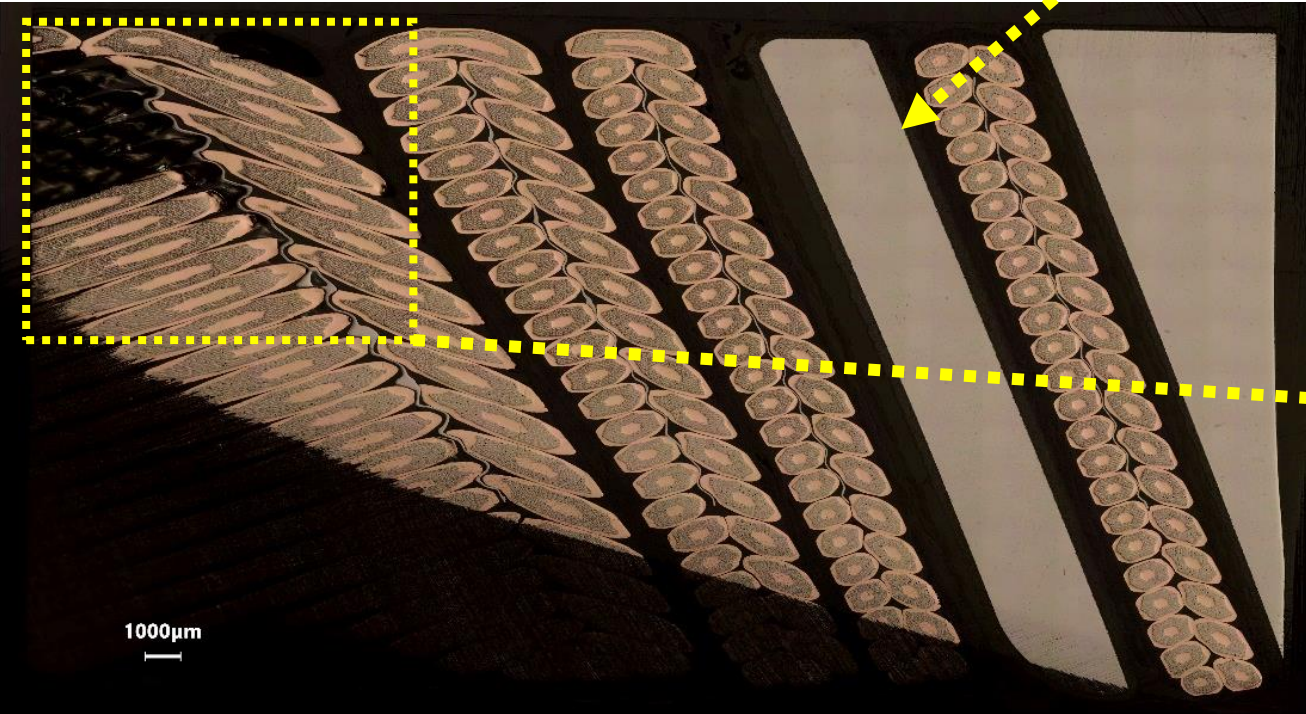
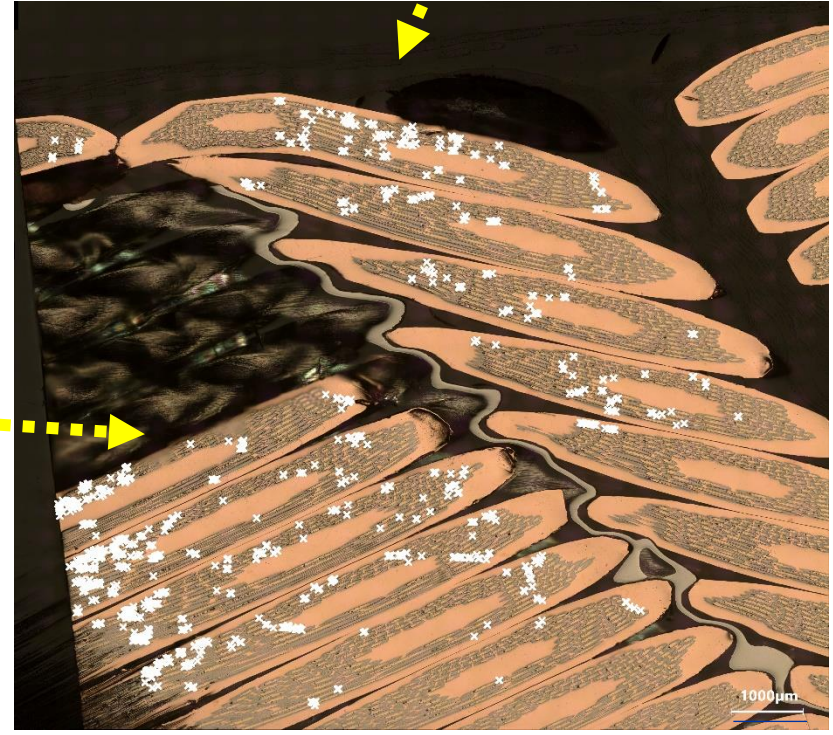
# 3<sup>rd</sup> polishing step (mid plane of Rutheford cable)

Numerous transversal cracks present, up to 10<sup>3</sup> cracks in the highlighted region

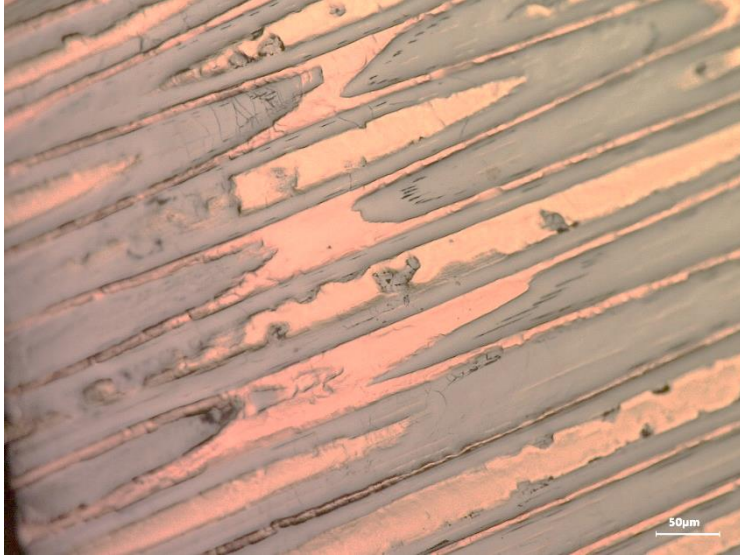
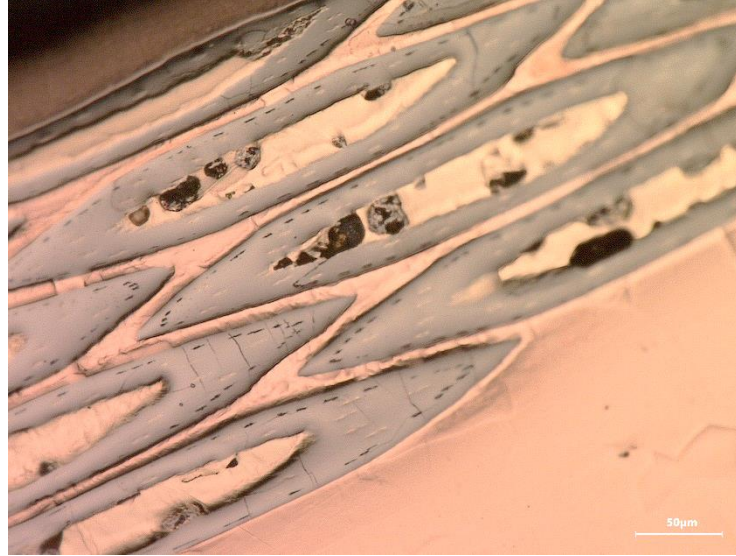
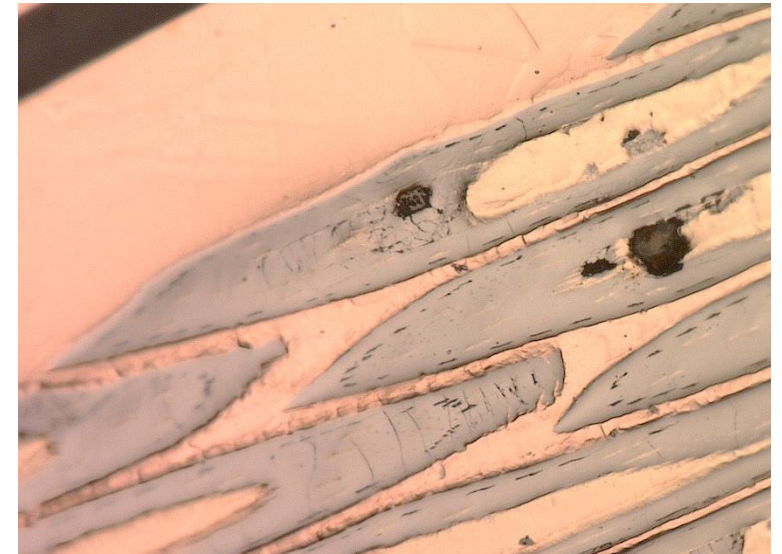
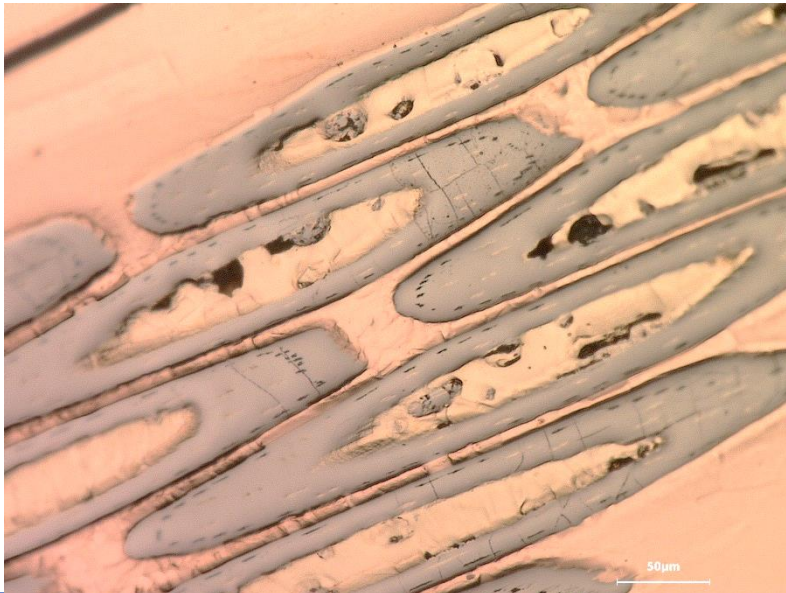
# 3<sup>rd</sup> polishing step (midplane of the Rutheford cable)

Numerous transversal cracks present, up to  $10^3$  cracks in the highlighted region – high resolution images can be found in the EDMS report.

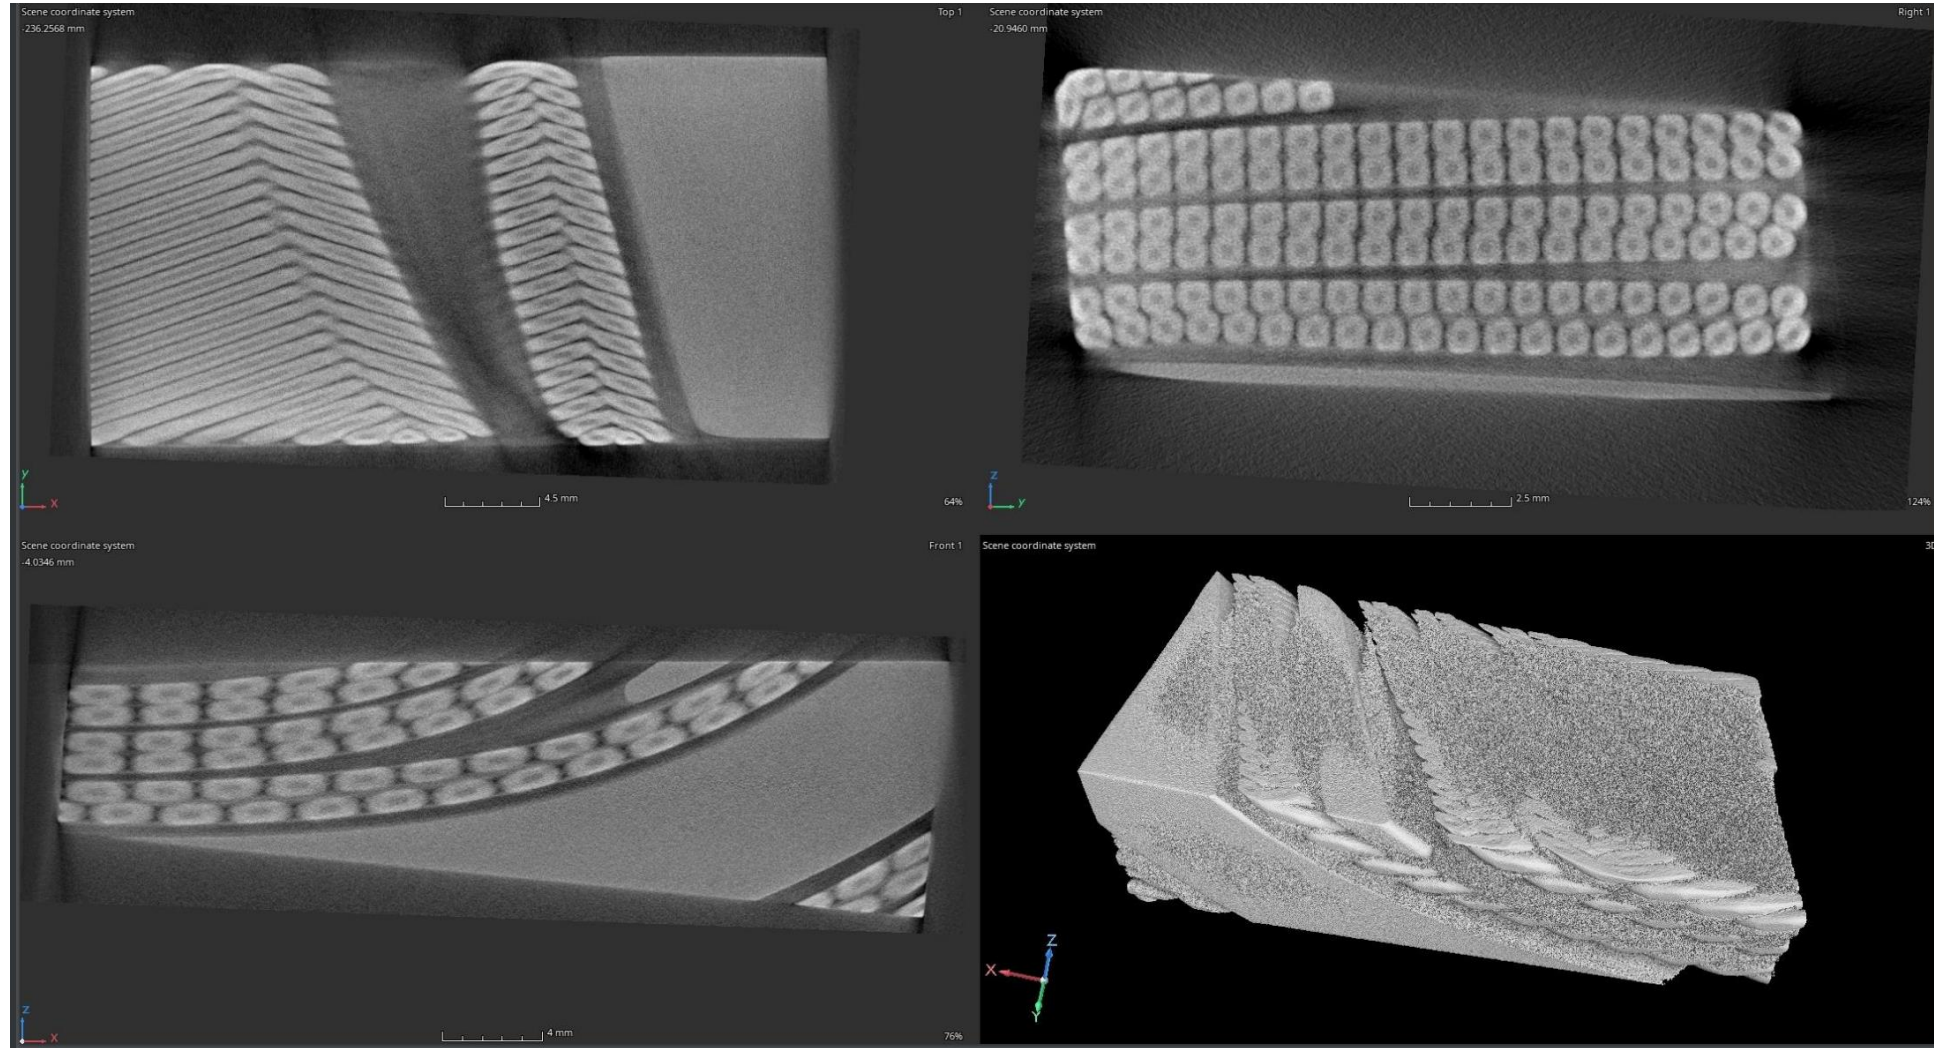
# Computed tomography (CT)

- No events observed during the CT analysis
- Videos in 3 different orientations added to the EDMS document

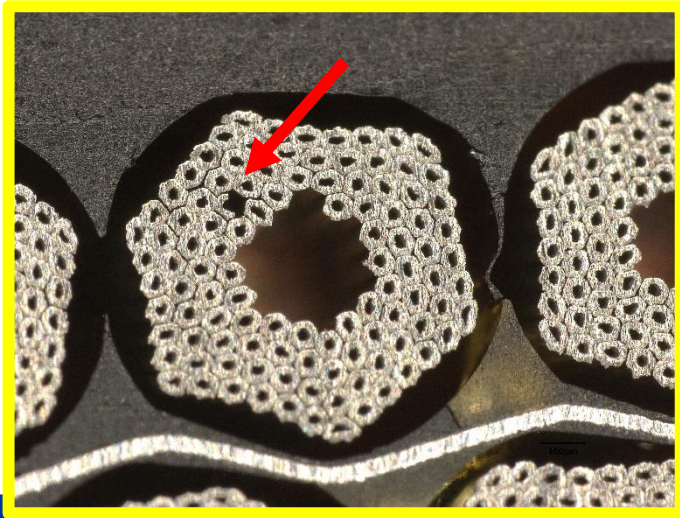
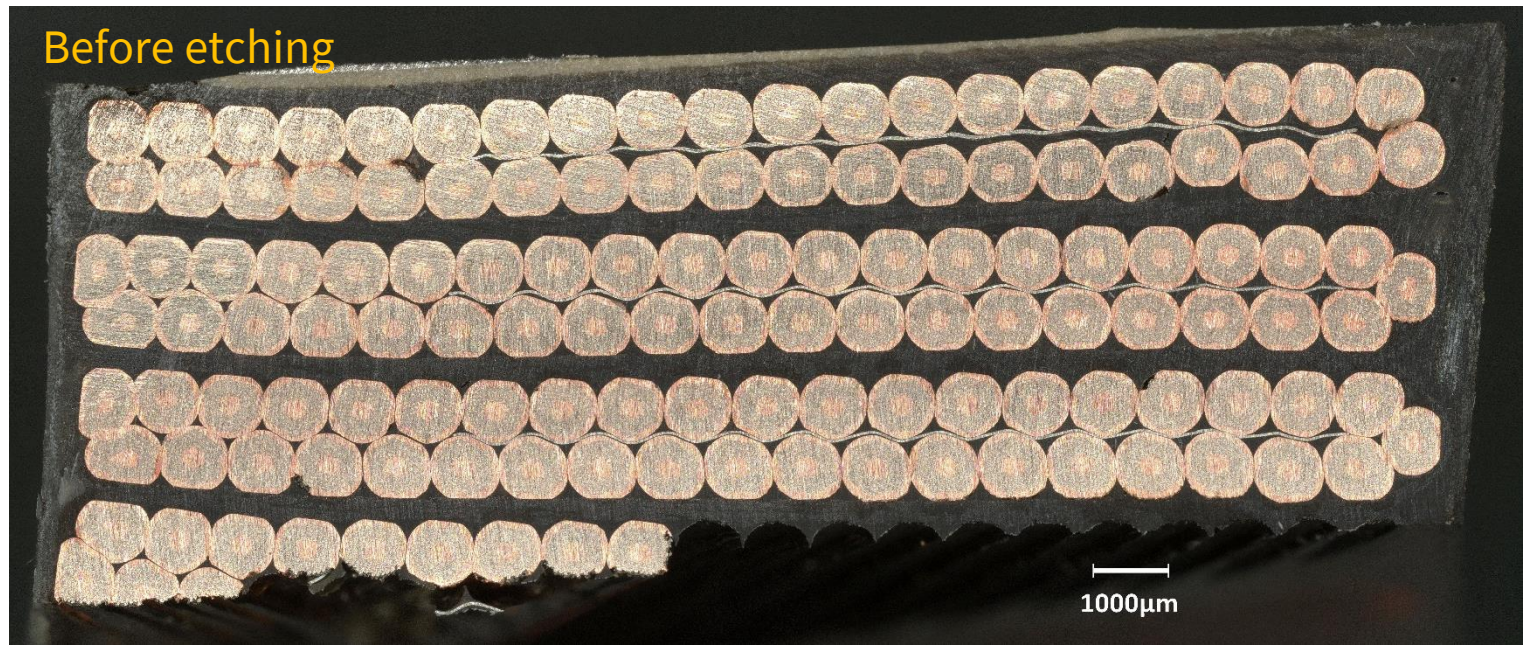
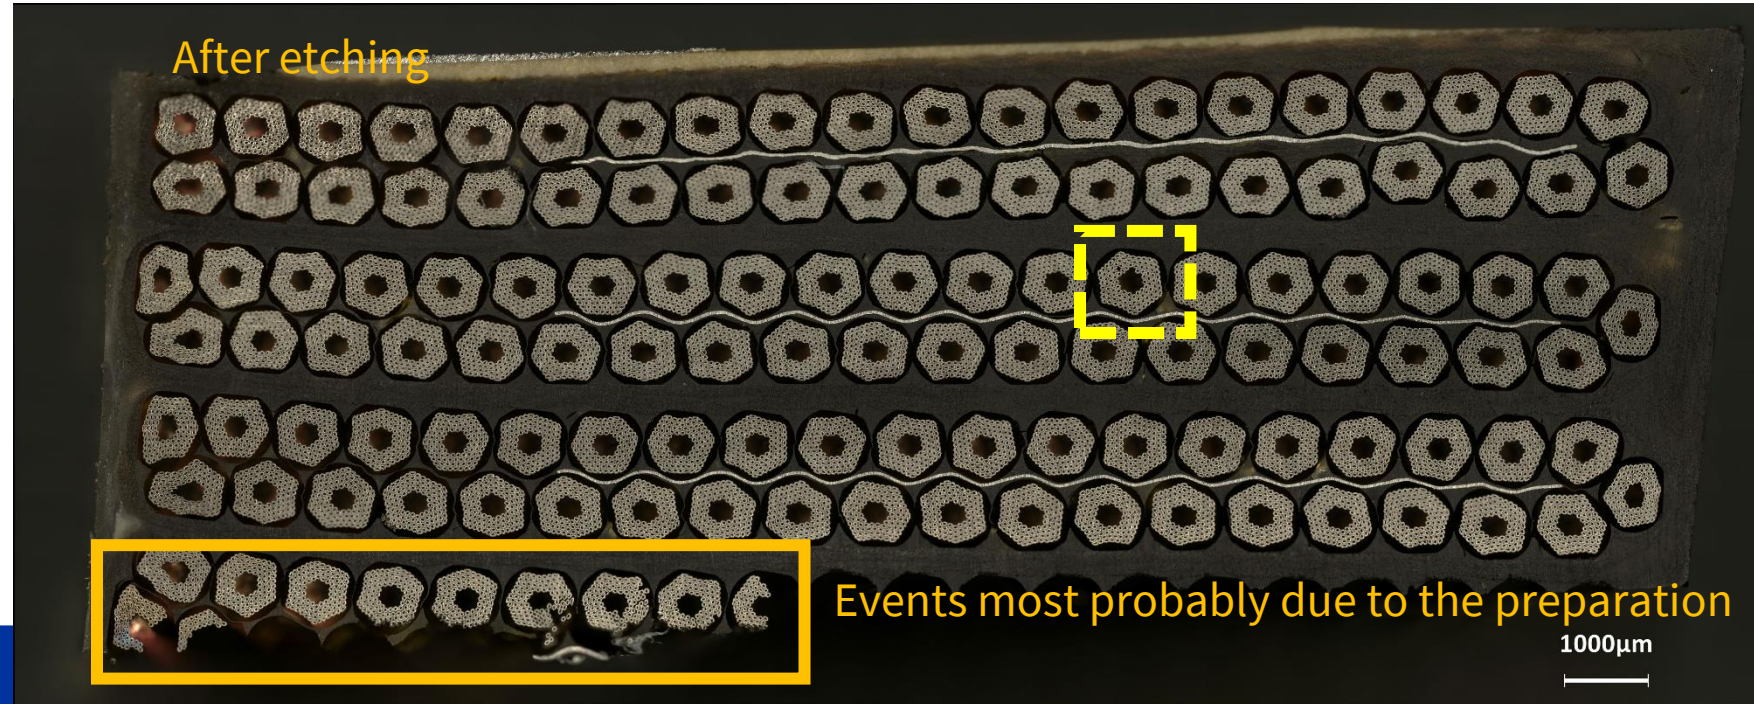
# Deep copper etching

- Around 400  $\mu\text{m}$  of copper has been dissolved
- Events observed in the orange-highlighted zone were considered as a residual of the preparation
- In the remaining rows just one event observed – partially collapsed filament (highlighted by yellow frame and red arrow)
