MQXFB08 Coils: Coil fabrication, manufacturing data and NC

N. Lusa, S. Izquierdo Bermudez, L. Baudin, A. Vieitez Suarez, P. M. Quassolo,
L. Grand-Clement, R. Berthet

06/11/2024

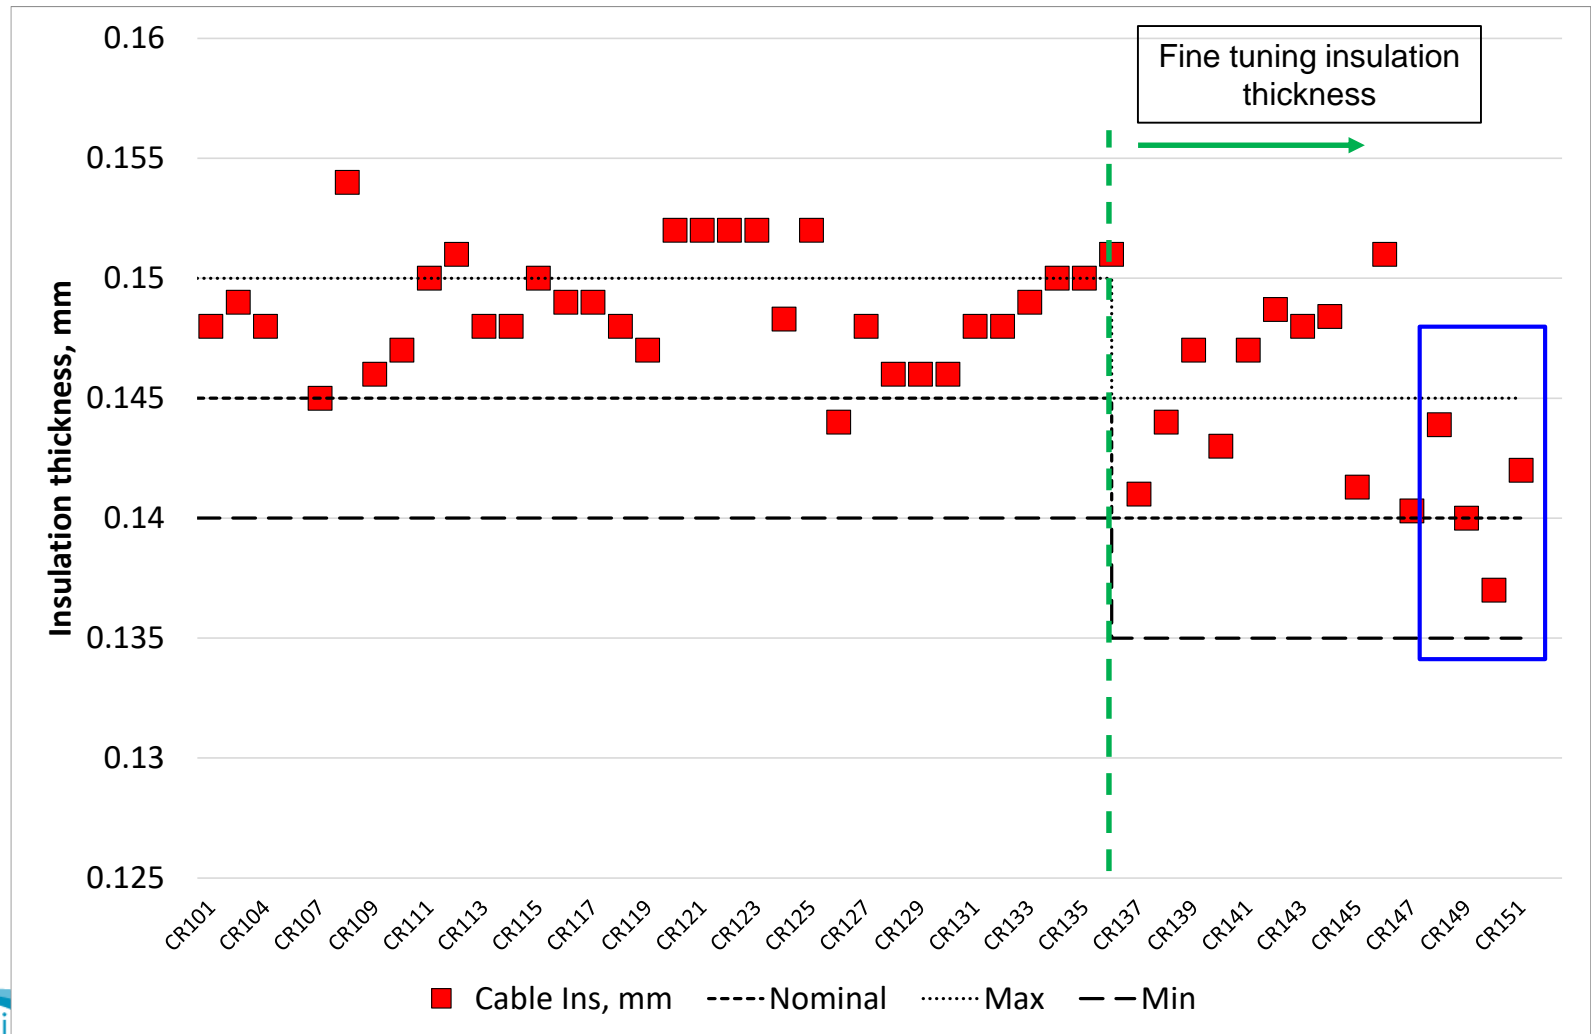
Cable insulation thickness

- Target insulation thickness is 145 (+0 μm /-10 μm)

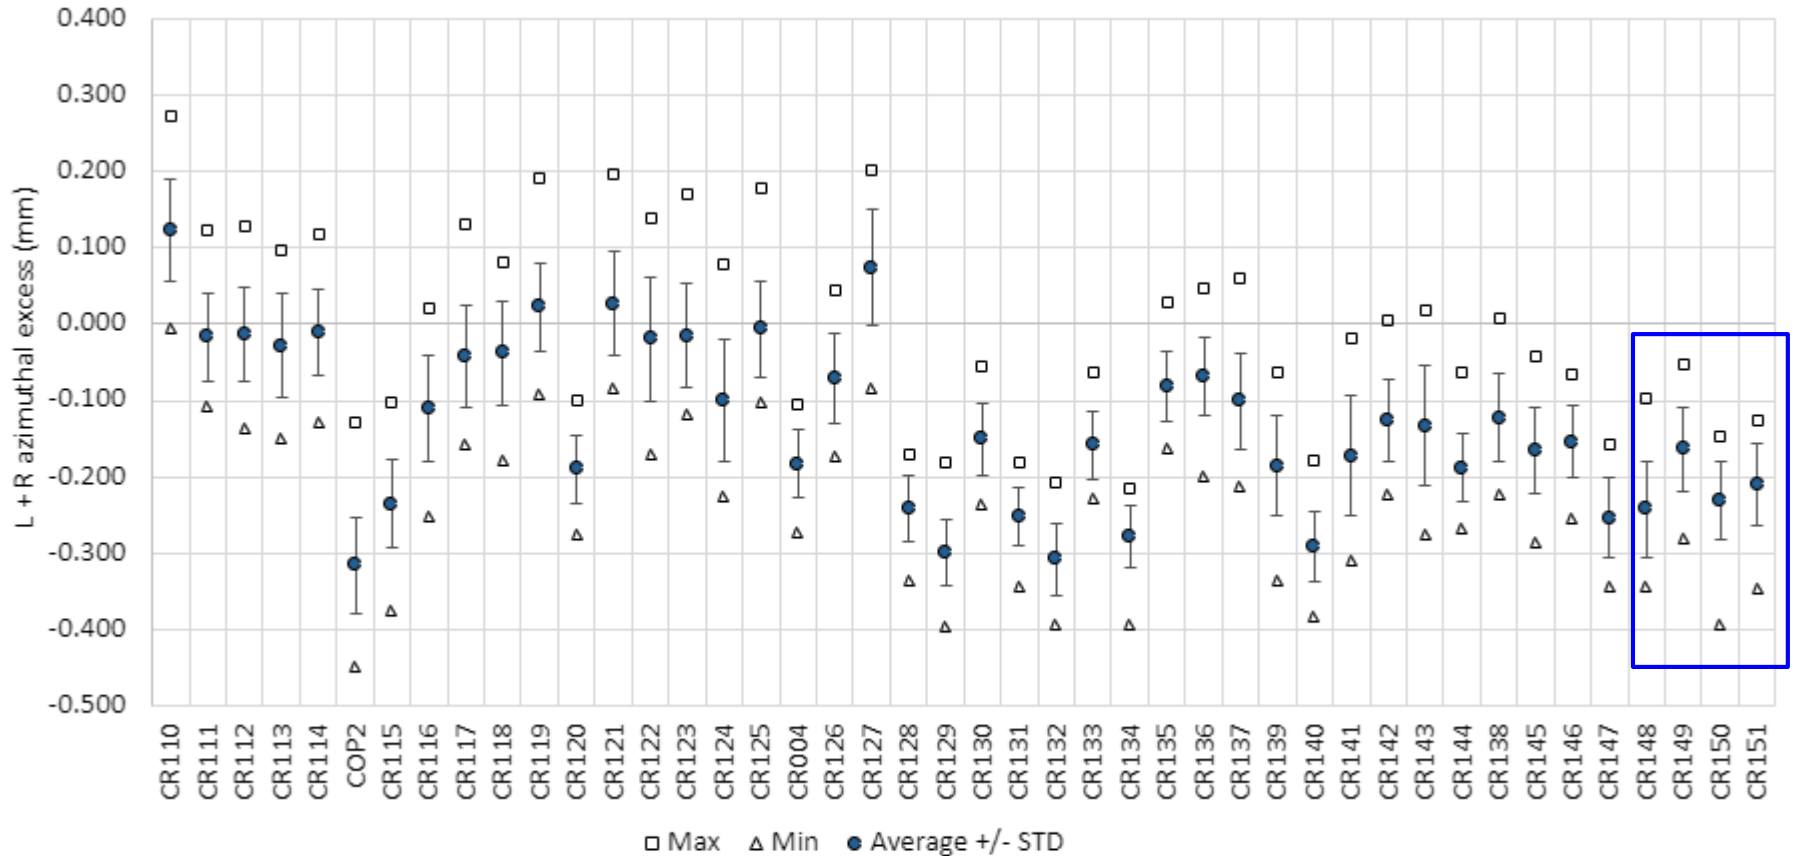
Impregnated coil geometry (Faro arm) - L+R

- The coils do not have 'belly'

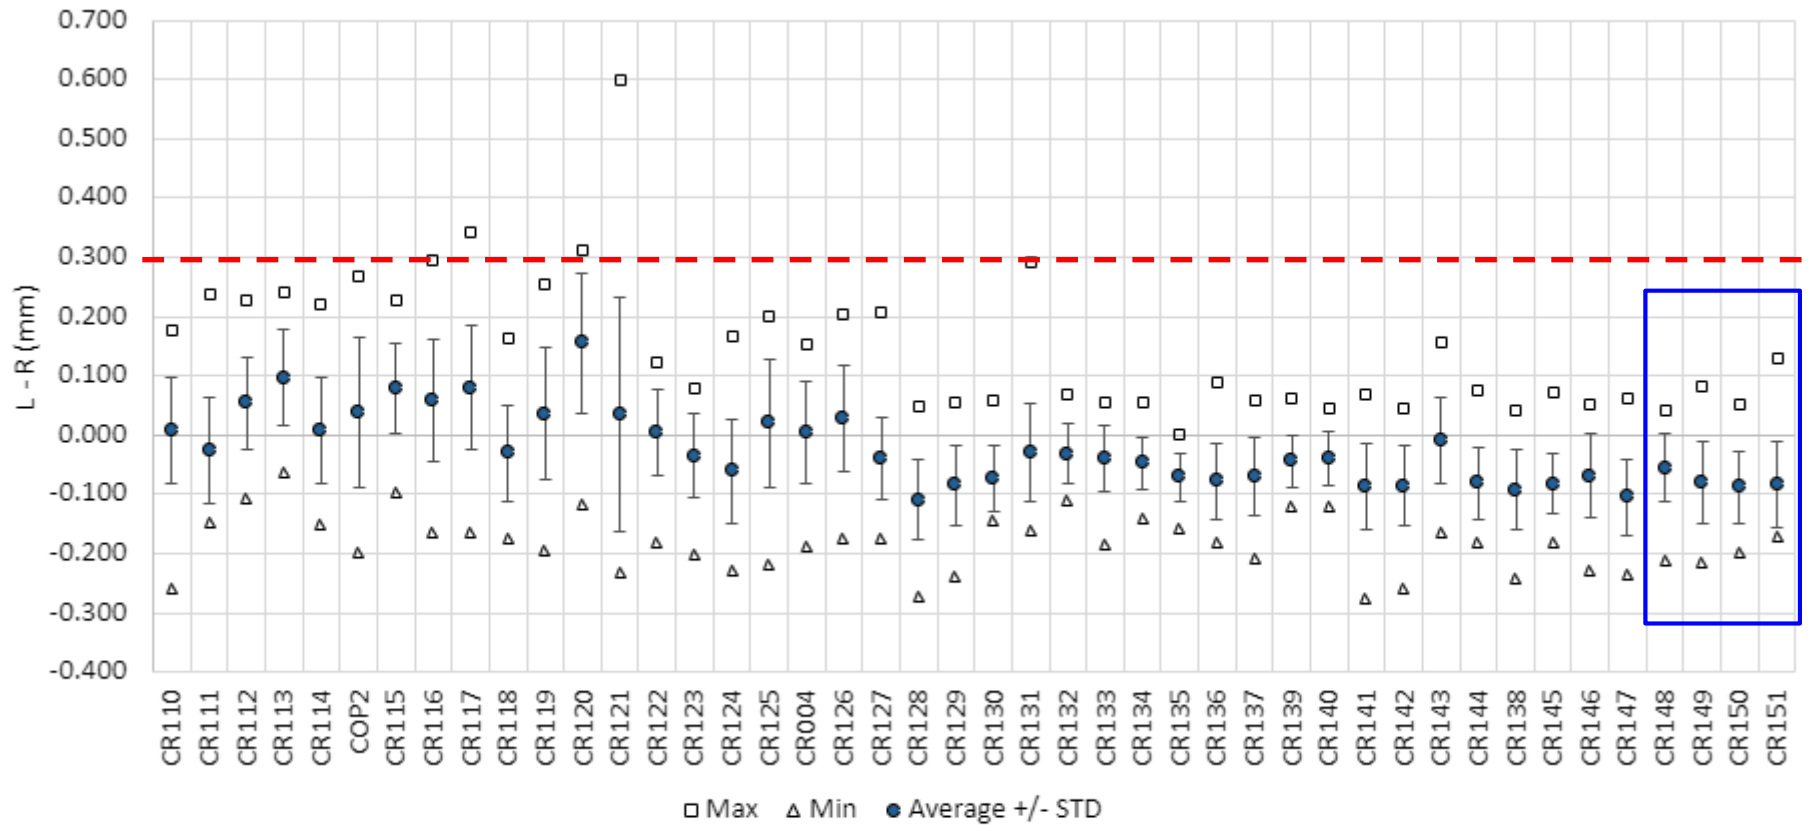
Impregnated coil geometry (Faro arm) – L-R

- In terms of asymmetry, within specification (<0.3 mm) → no need of pole key machining

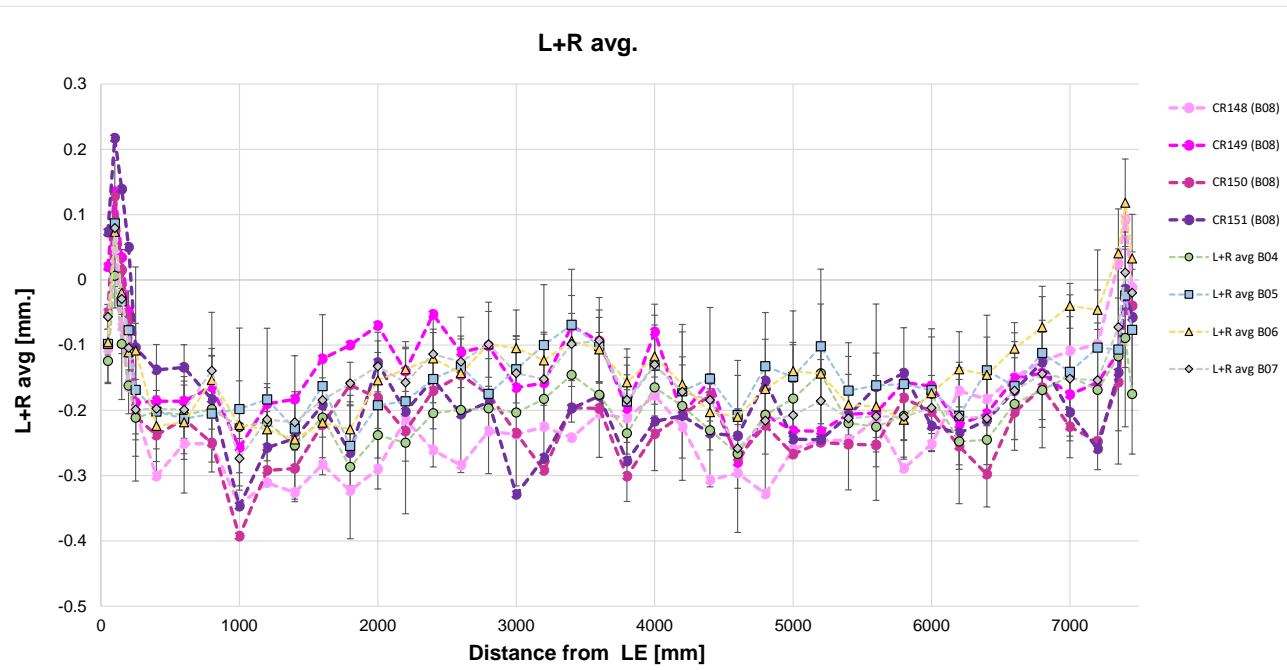
Impregnated coil geometry (Faro arm)

- Systematic behavior in terms of coil shape to previous coils without binder: mid-plane has a little 'wedge' (the coil covers 89.6 degrees instead of 90 degrees)
- Based on FEM we expect ≈ 15 MPa increase in the mid-plane stress (inner edge) under conservative assumptions, confirmed with a mock-up test, see <https://indico.cern.ch/event/1260584/>

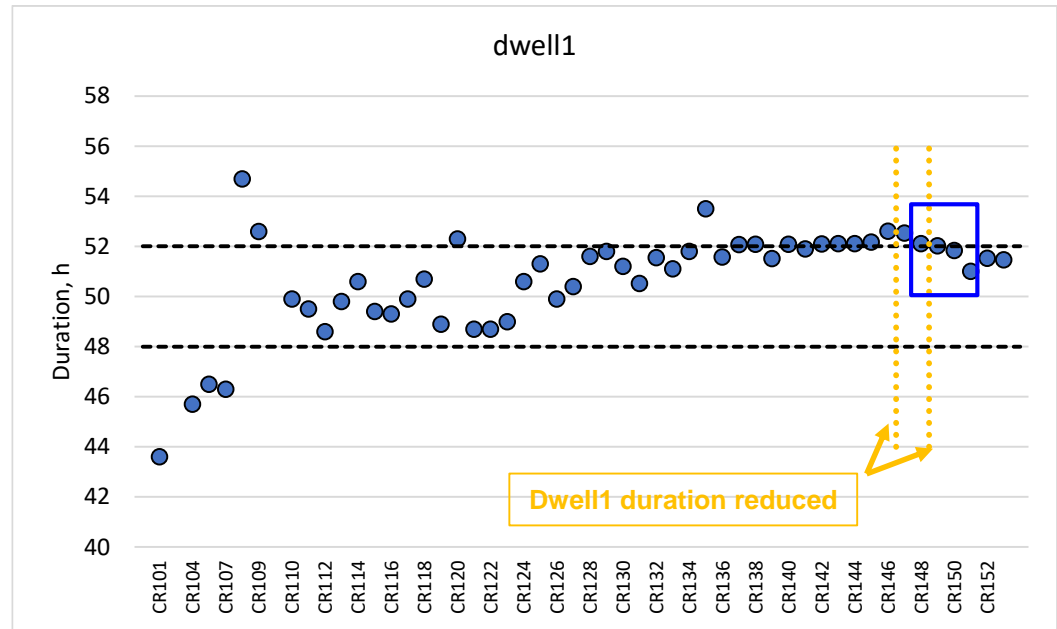
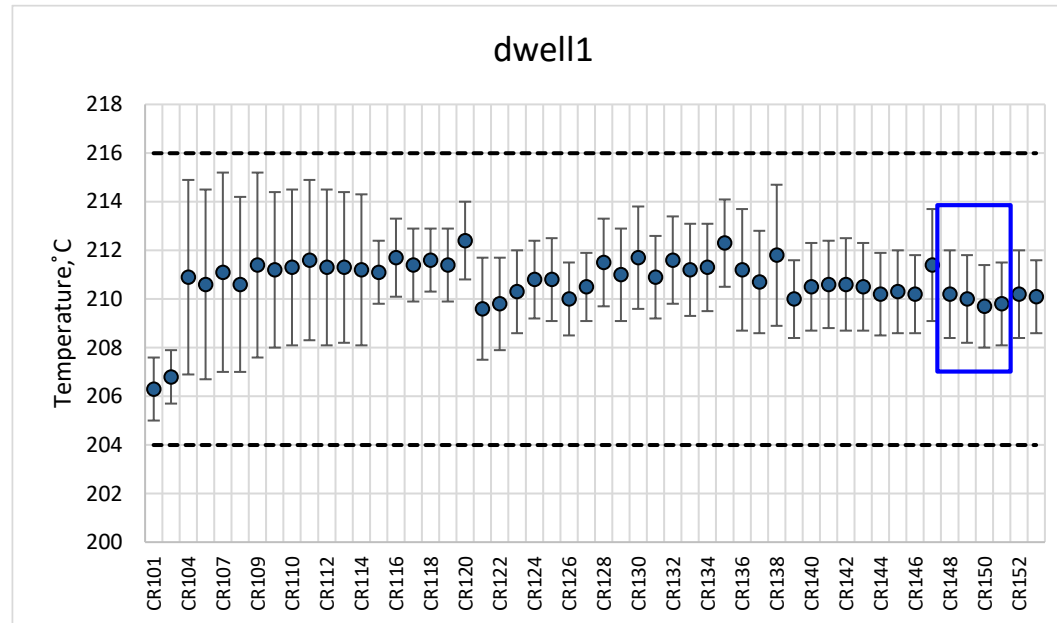
RHT NCR – dwell1

- The duration of dwell1 is slightly out of specification in 2 out of 4 coils:
 - CR148: 52.11 h
 - CR149: 52.02 h
 - CR150: 51.84 h
 - CR151: 51 h
 - Spec. 52 h maximum allowed
- Temperature homogeneity within specification

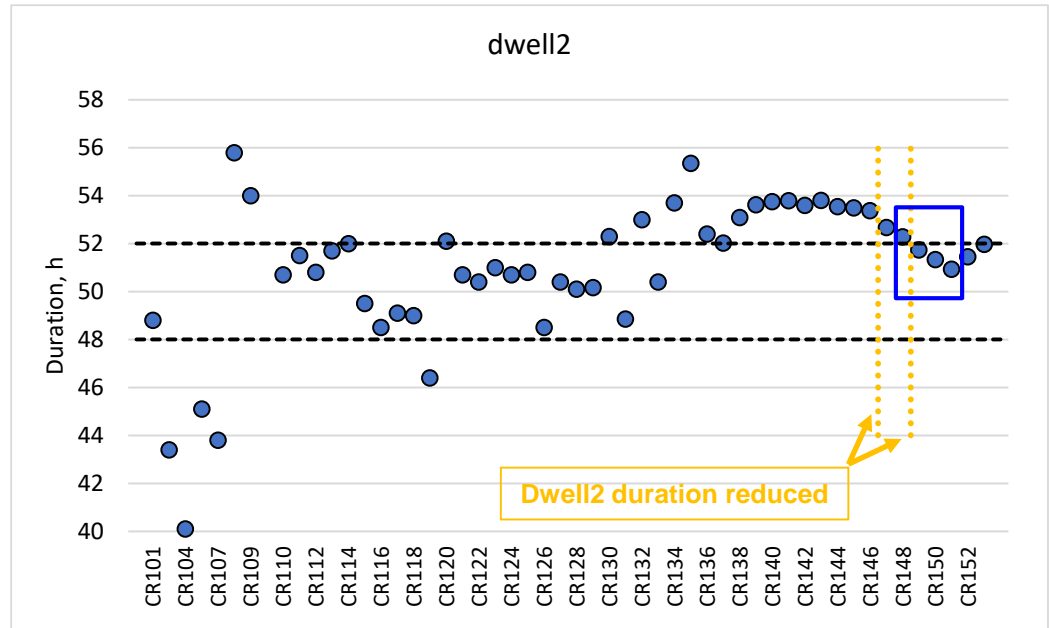
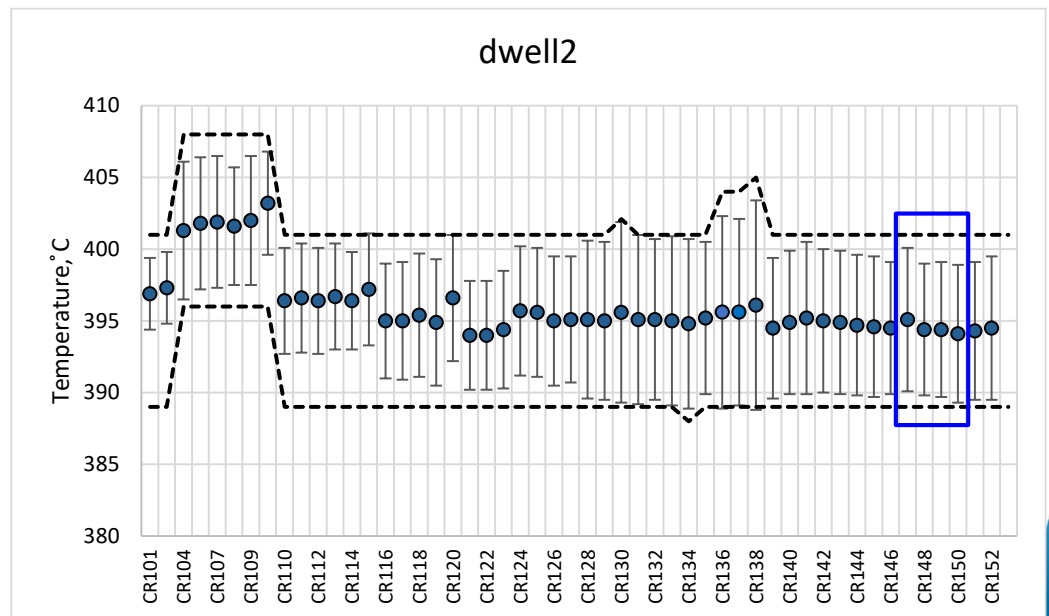
RHT NCR – dwell2

- The duration of dwell2 is out of specification for 1 coil out of 4:
 - CR148: 52.29 h
 - CR149: 51.74 h
 - CR150: 51.34 h
 - CR151: 50.94 h
 - Spec. 52 h maximum allowed
- Temperature homogeneity within specification

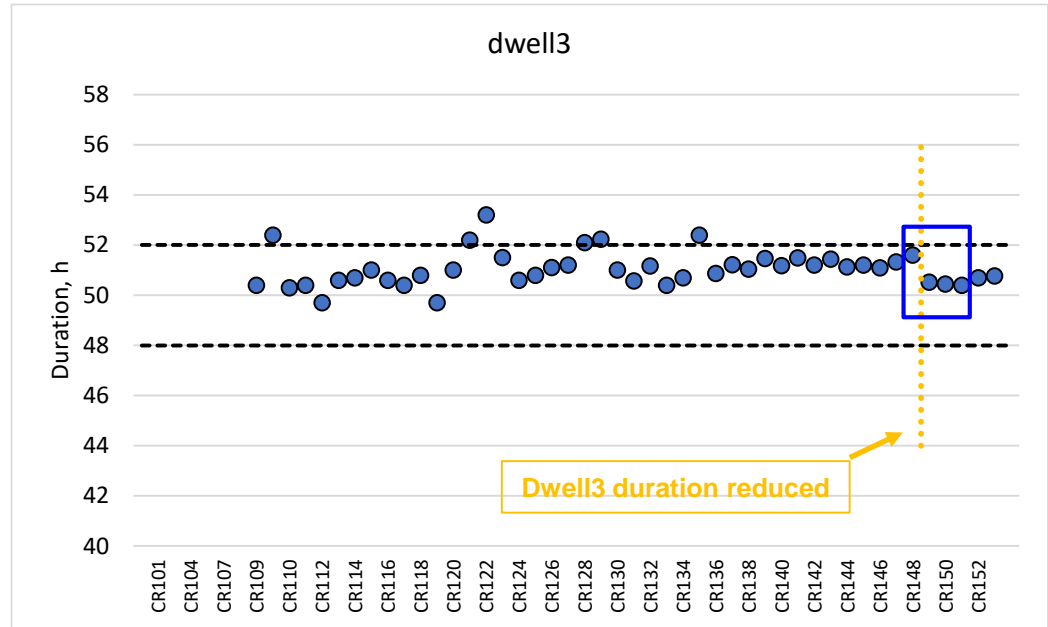
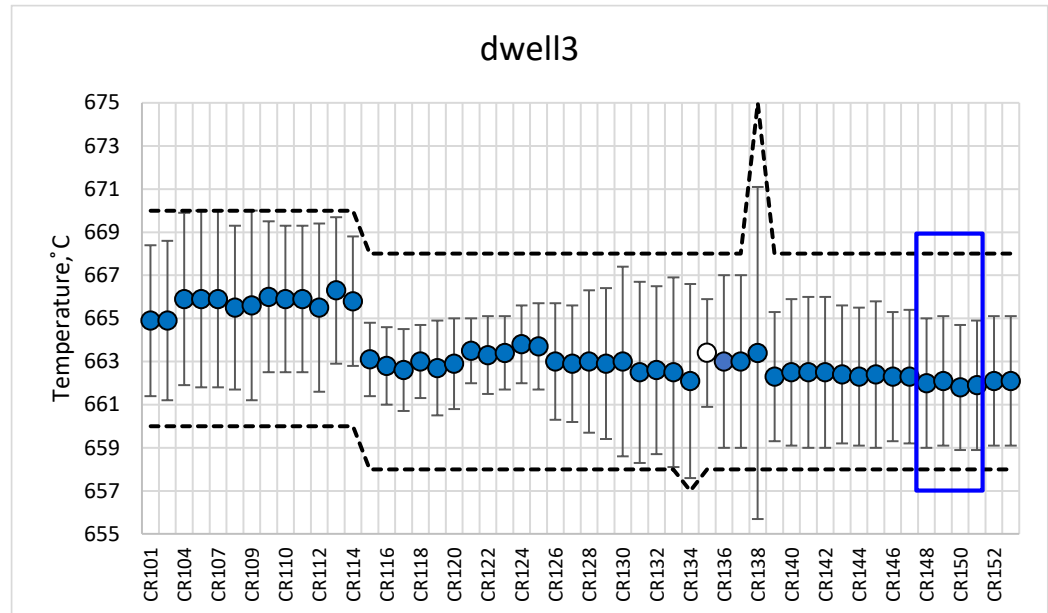
RHT NCR – dwell3

- The duration of dwell3 is within specification for the 4 coils (52 h max. allowed)
- Temperature homogeneity within specification and Dwell3 mean H/2 within specifications

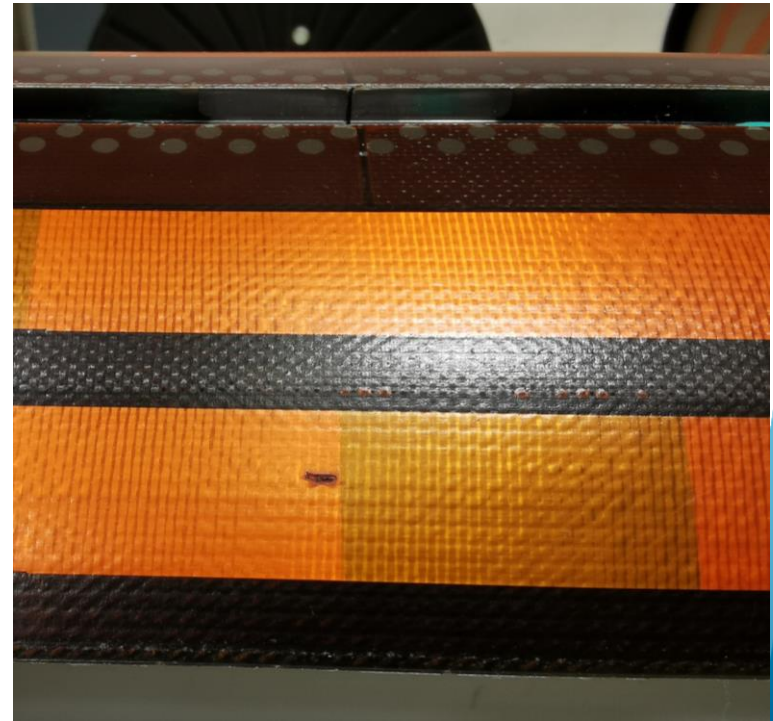
CR149 ([NCR 3154270](#)) → Defect on the QH after impregnation

- Superficial defect on the OD impregnated coil at the level of the heater strip at 5620 mm from LE side
- Pictures taken during preparation for impregnation were checked
 - No defect was present neither on the OD of the reacted coil nor on the QH surface

- Thanks to EN-MME and TE-MS-C-LMF-EE the following steps were performed
 1. Replica of the superficial defect to assess the depth ([EDMS 3155368](#))
 2. Microscopy to better define the defect and its origin ([EDMS 3155368](#))
 3. Staged dielectric test to assess the insulation QH to coil ([EDMS 3156284](#))

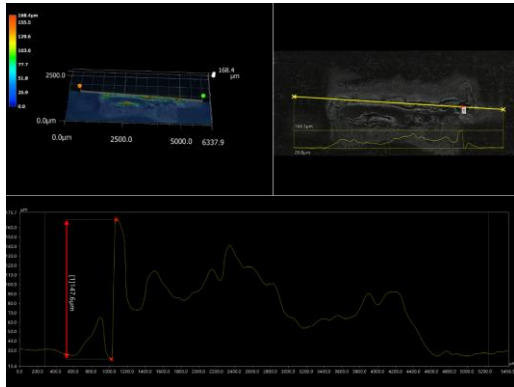
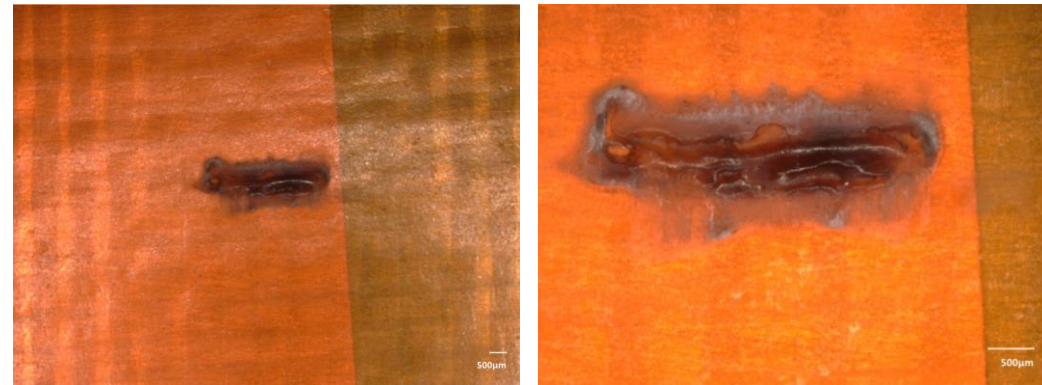
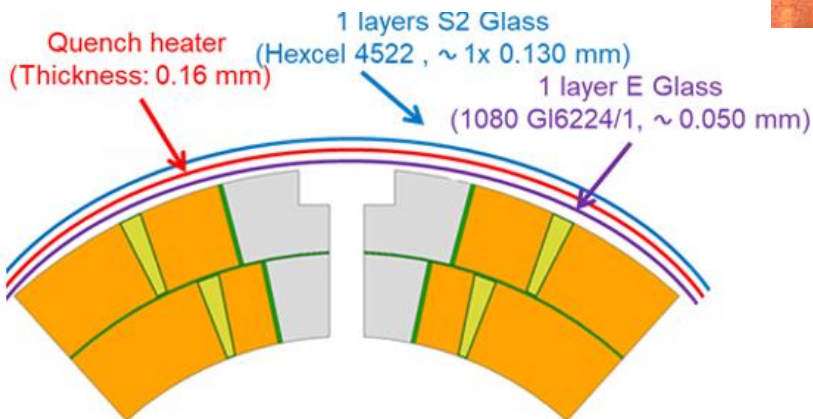
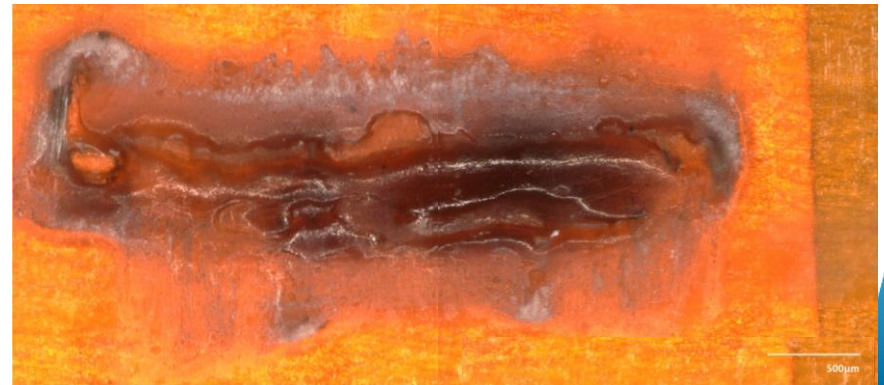
Results 1/2

1. Based on the analysis of the replica the maximum depth of the defect is 150 μ m (in principle above the QH)
2. Inspection of the surface showed a shallow cavity with a burnt aspect and no metallic particle was observed
3. The electrical test passed successfully up to nominal (3.7kV for 120s)

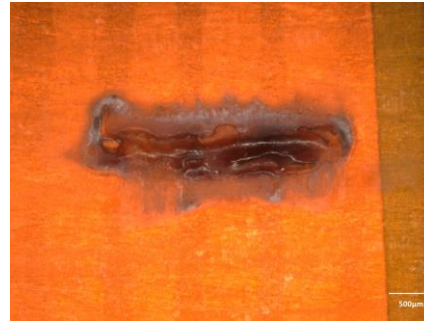
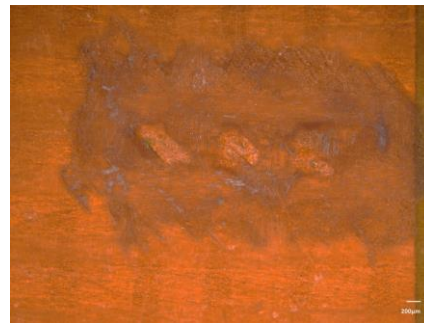
Defect AOI#1

- It was decided to collect samples from the main defect (AOI#1) and from a more standard one (AOI#2) to analyse with SEM-EDS ([EDMS 3175548](#))

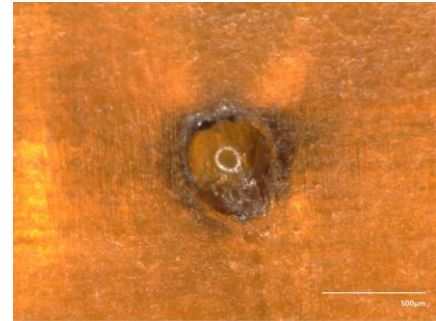
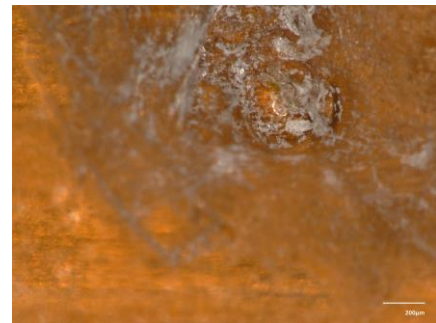
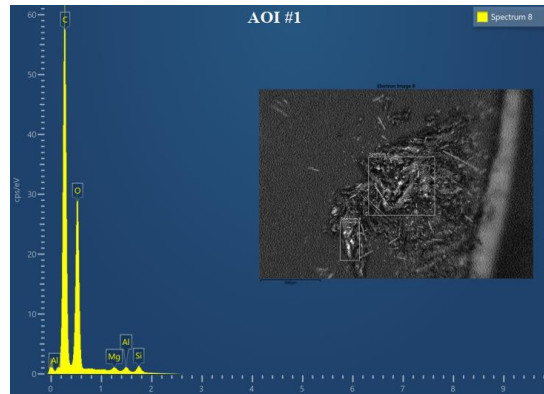
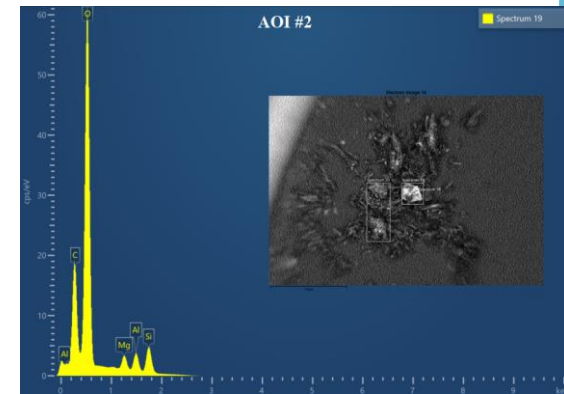
Defect AOI#2

S2 glass composition: 64-66% SiO₂, 9-11% Al₂O₃, 9-11% MgO

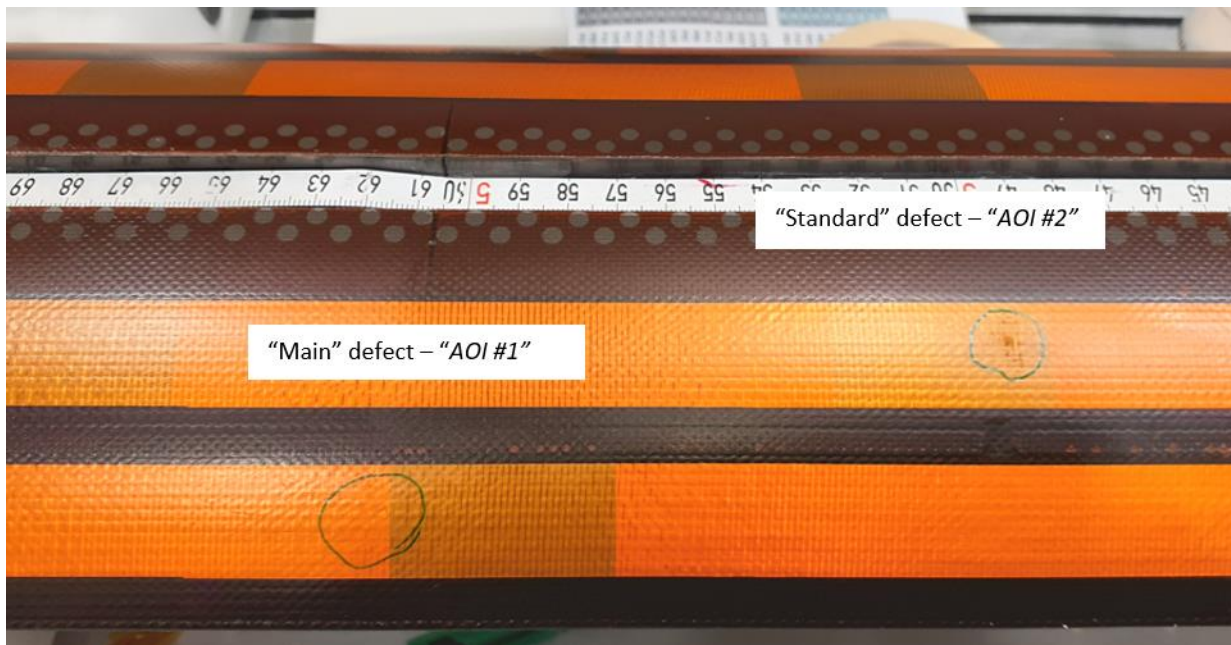
The end of the story

- The main defect AOI#1 disappeared during the manual scratching (very superficial as from replica measurement)
- The integrity of the quench heater was not compromised (confirmed by the microscopy)
- SEM-EDS analysis did not reveal any exogeneous particle (only S2 glass chemical composition)
- Local repair of the scratched area was performed
- Coil acceptance electrical test successfully performed

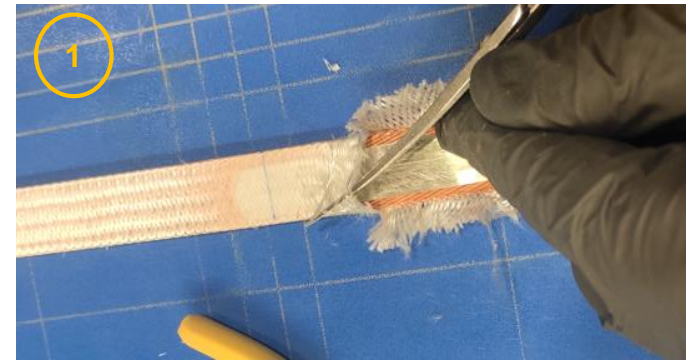
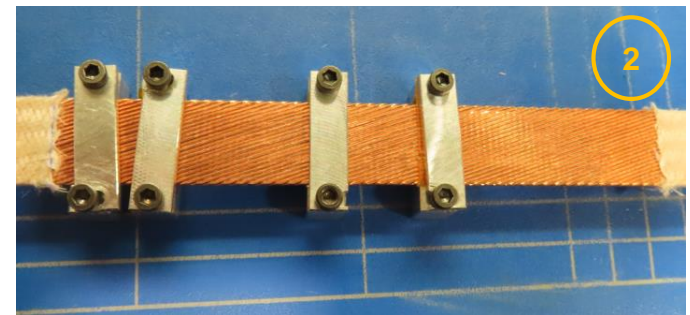
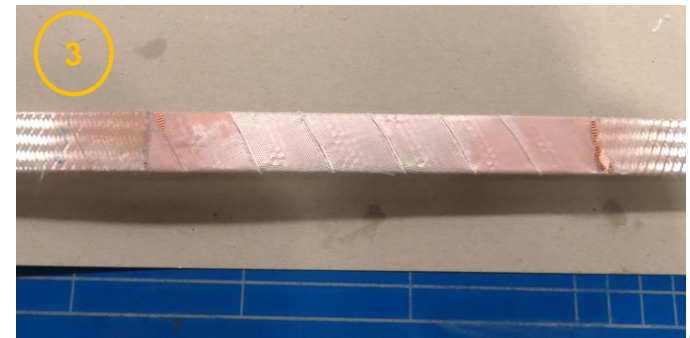
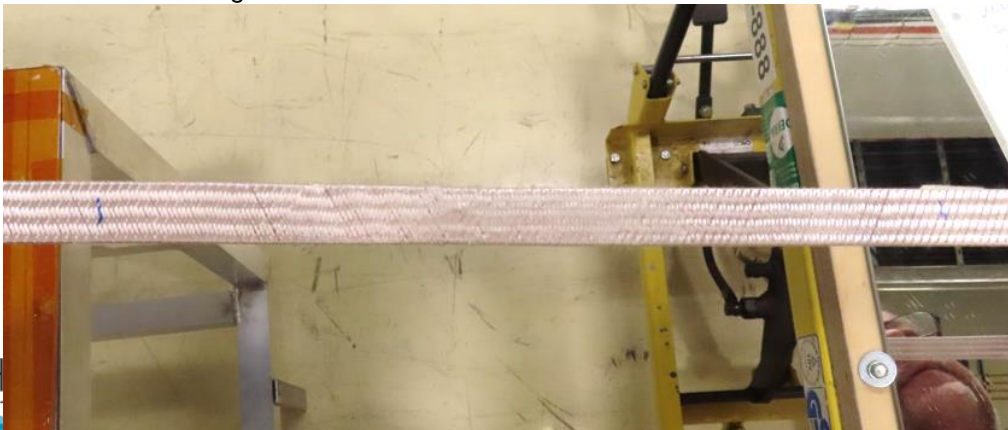
CR150 (NCR 3132312) → Popped strand repair

- During the cable insulation inspection, among several minor popped strands, a more pronounced one was detected at 641m from the beginning of the spool
 - For the major one an in-situ intervention at the supplier company was performed
- Standard 'repair' strategy did not work (overthickness of 0.8mm)
 - Decision to locally remove the S2 glass insulation to set back in place the concerned strand and restore the insulation
 1. S2 glass removal from the concerned area
 2. Strand back in place via dedicated clamps
 3. Restoring of the cable insulation wrapping 1 layer of 0.125 mm S2 glass desized
