AMBER --> Feedback from CEDAR operation

October 2024 Drell-yan run CEDAR performance

CEDAR operation – air contamination

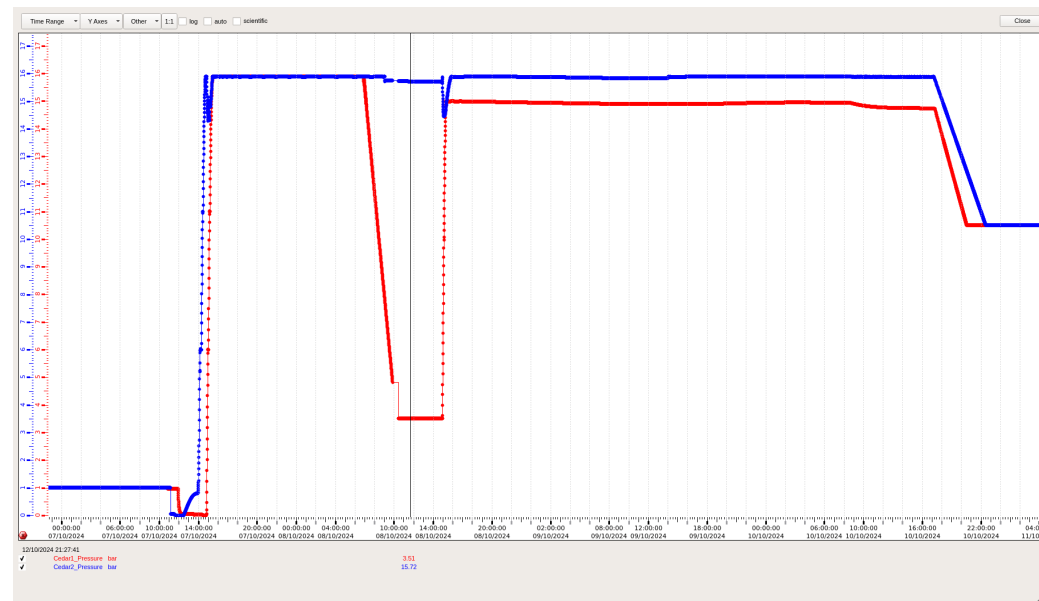
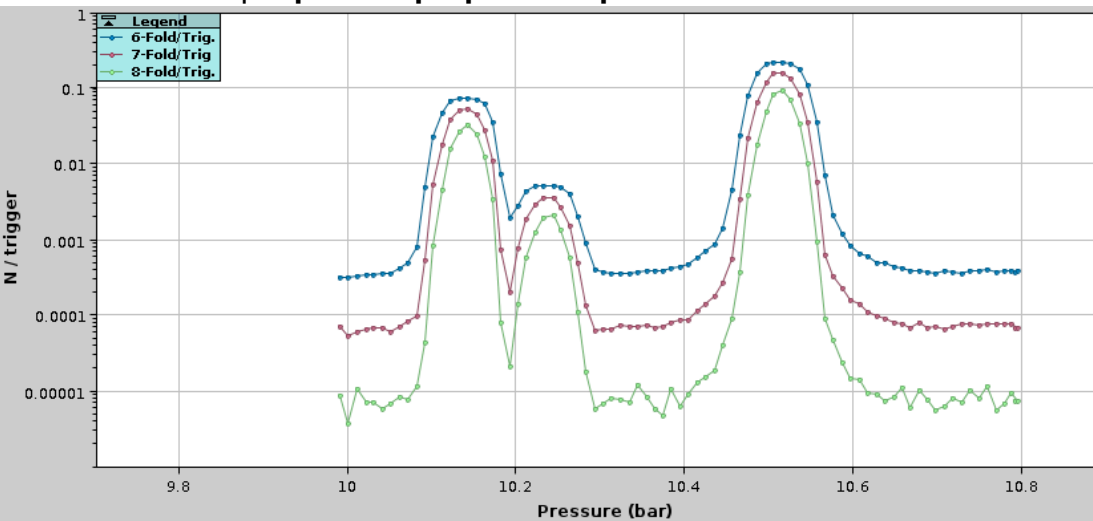
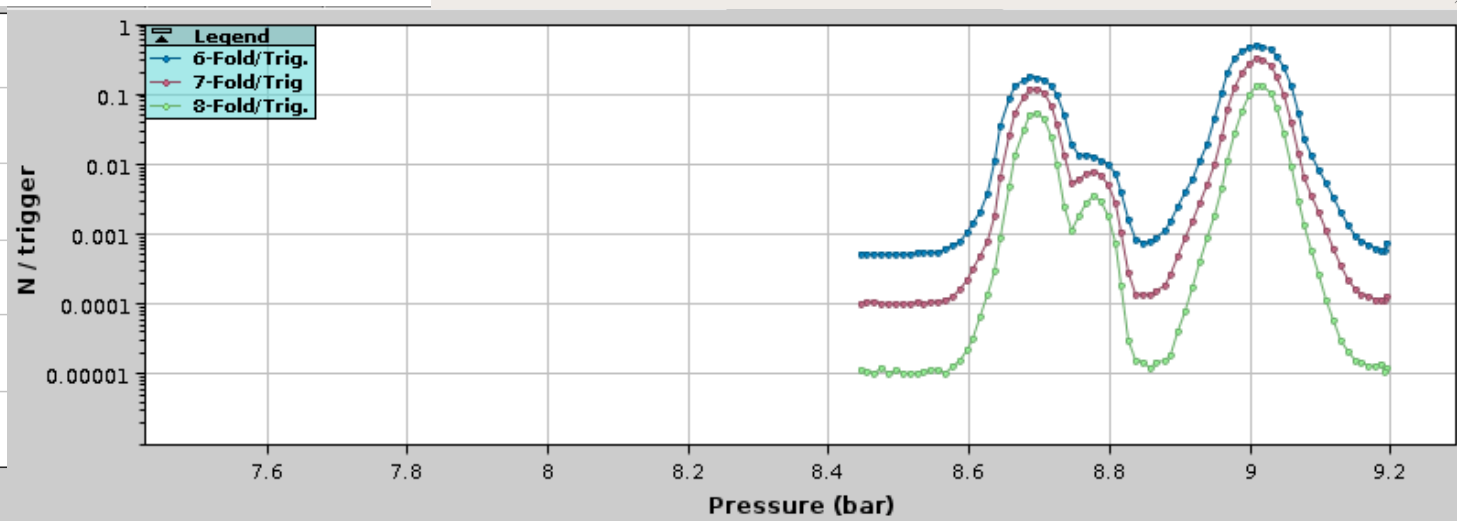
- Peak not found during pressure scan; wider scan revealed it much lower than expected.

- Peak position moved towards the expected value with each scan—indicating air contamination.

- Issue confirmed by emptying to 3 bar and pressurizing back to 12 bar.

- System pumped to vacuum and refilled on Monday. **CEDAR 2** OK, but **CEDAR 1** showed similar problems.

- Issue resolved by **cycling gas volume between 2 and 13 bar** for CEDAR 1.

- Develop a **precise preparation procedure for CEDAR**.

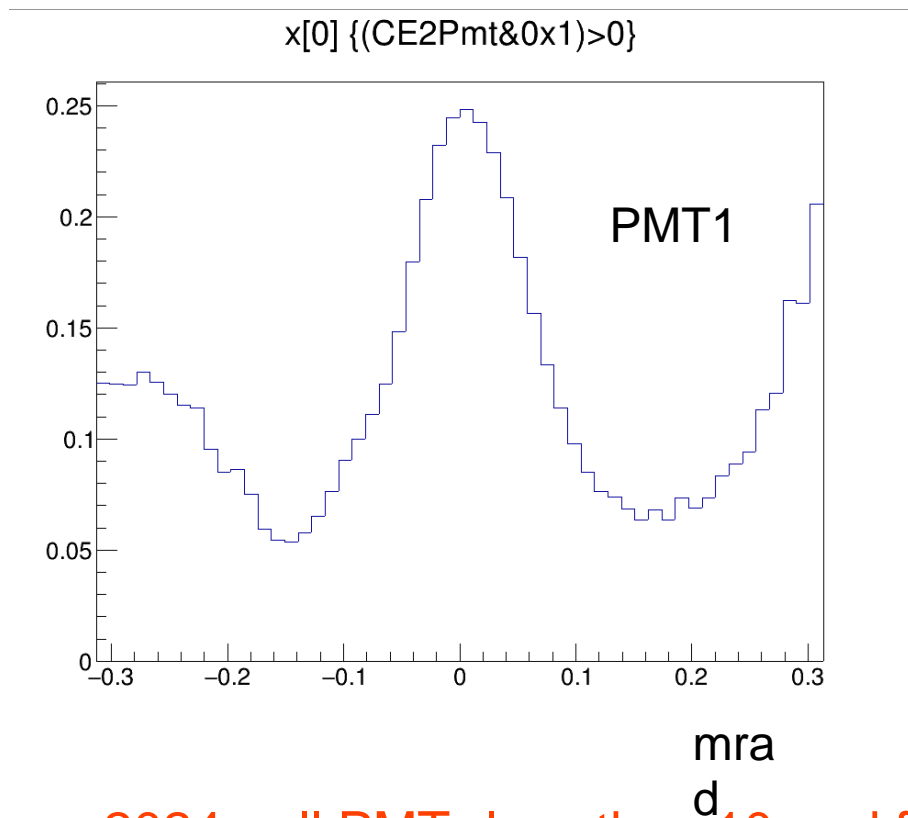
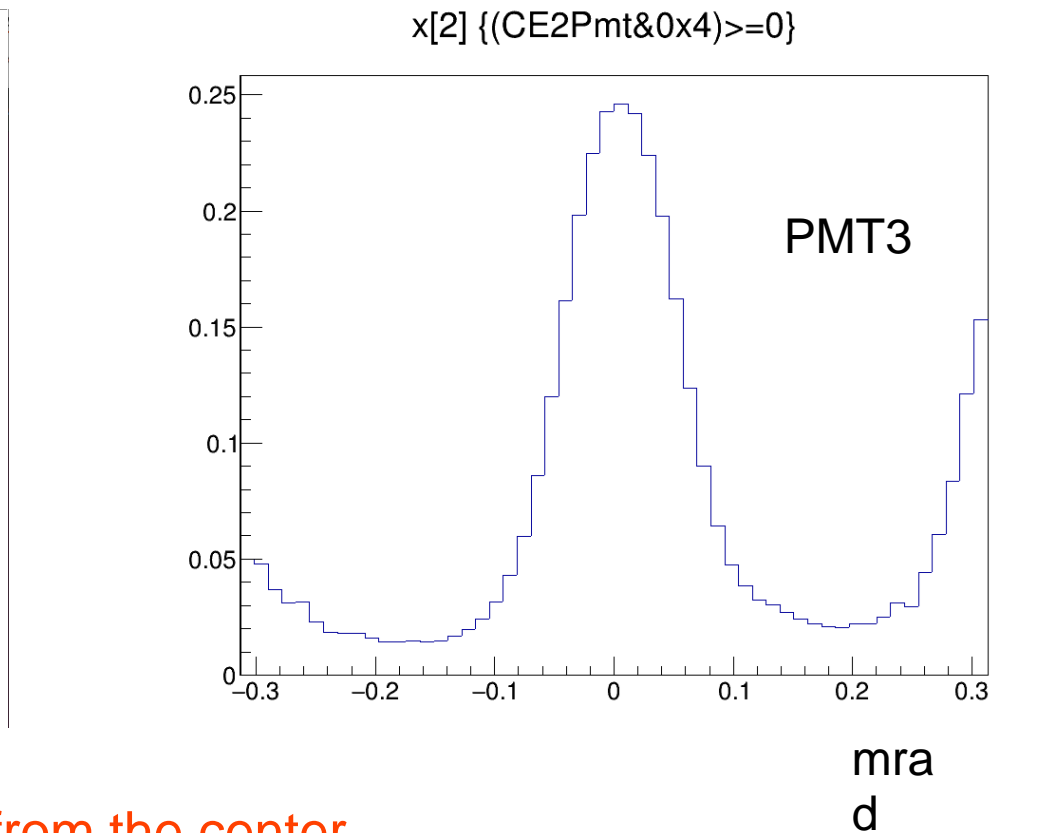
Very good centering of CEDAR w.r.t beam

2024 - all PMTs less than 10urad from the center,
2023 - discrepancies up to 70urad seen....
