MTN.211128 incident and mitigation TE-MSD

Philip Schwarz

26.11.2024

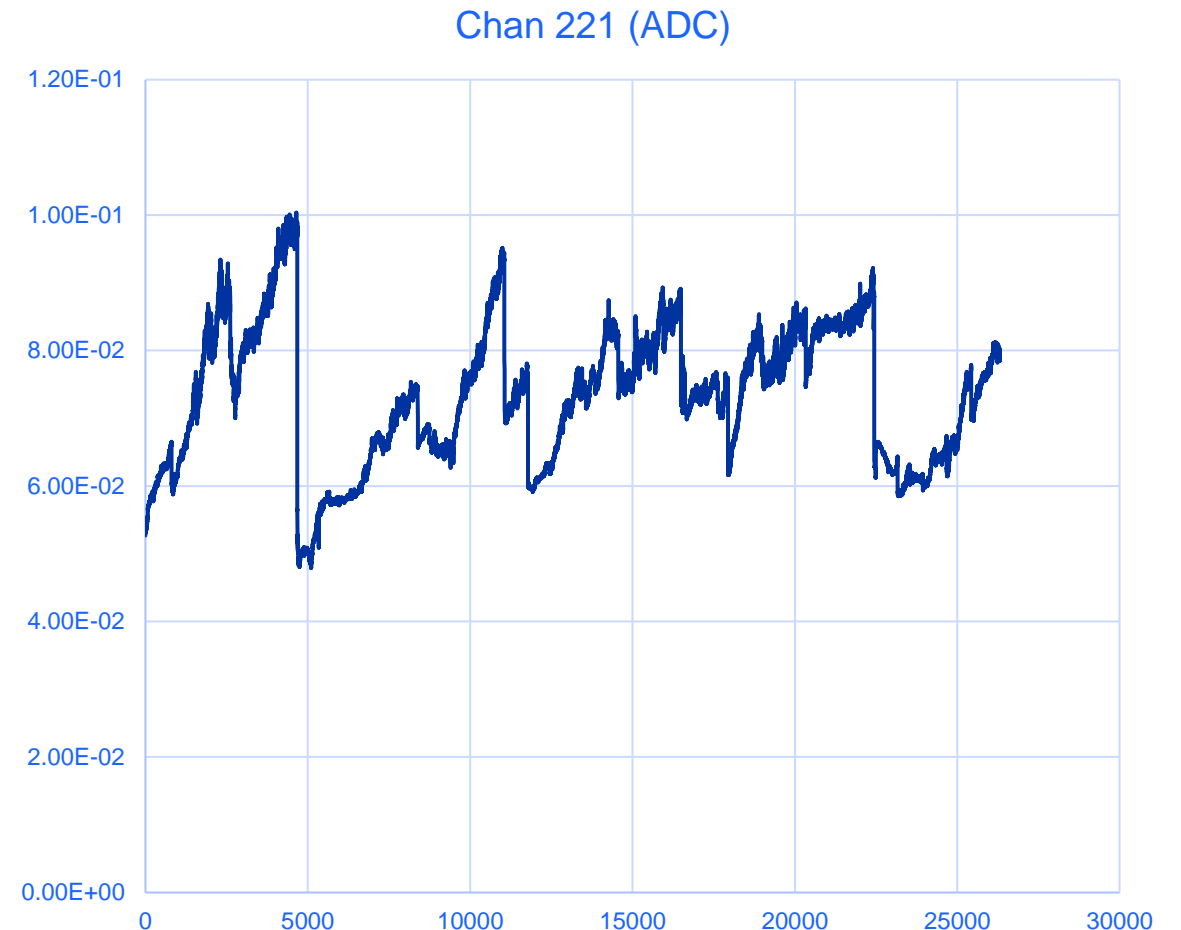
- The circuit did not trip since the incident and occasional measurements of the current-to-ground reveal current-to-ground well below the threshold of even 100 mA
- Installation of datalogger to monitor and record the development of current-to-ground
- Data logs shows hiking current (only sometimes above 100 mA), followed by a drop to lower levels
- Suggests a worsening problem
- Due to radiation environment, a closer investigation during the YETS was planned

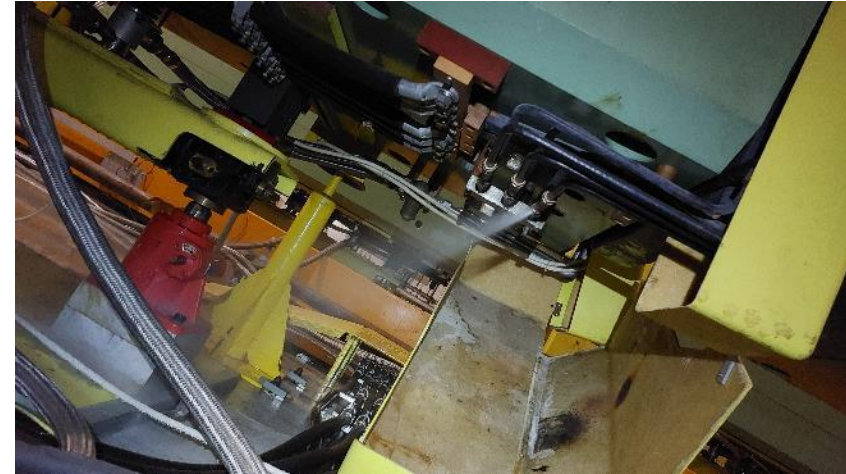
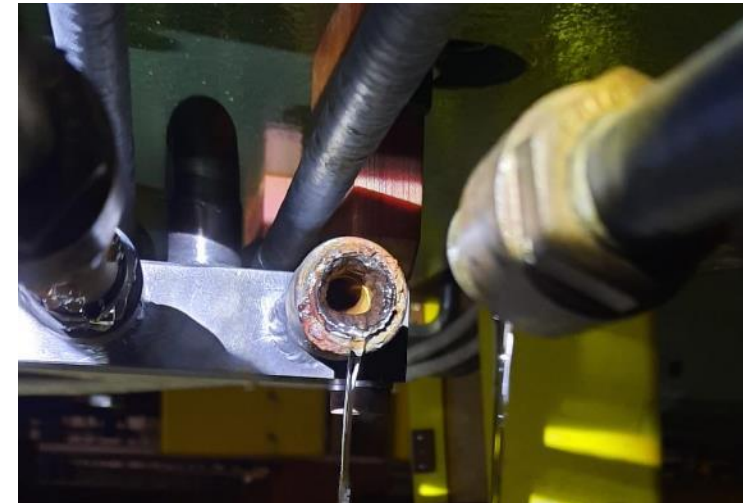
- Access was granted and MTN.241128 found with a leak on a broken insulator
- Replacement of the insulator was not possible within exposure time limits, as part of the broken insulator remains gripped within the fixation nut
- In agreement with the beamline physicists, it was decided to remove the faulty magnet (MTN.241128) from the circuit, as the remaining two magnets were sufficient to enable ion operation

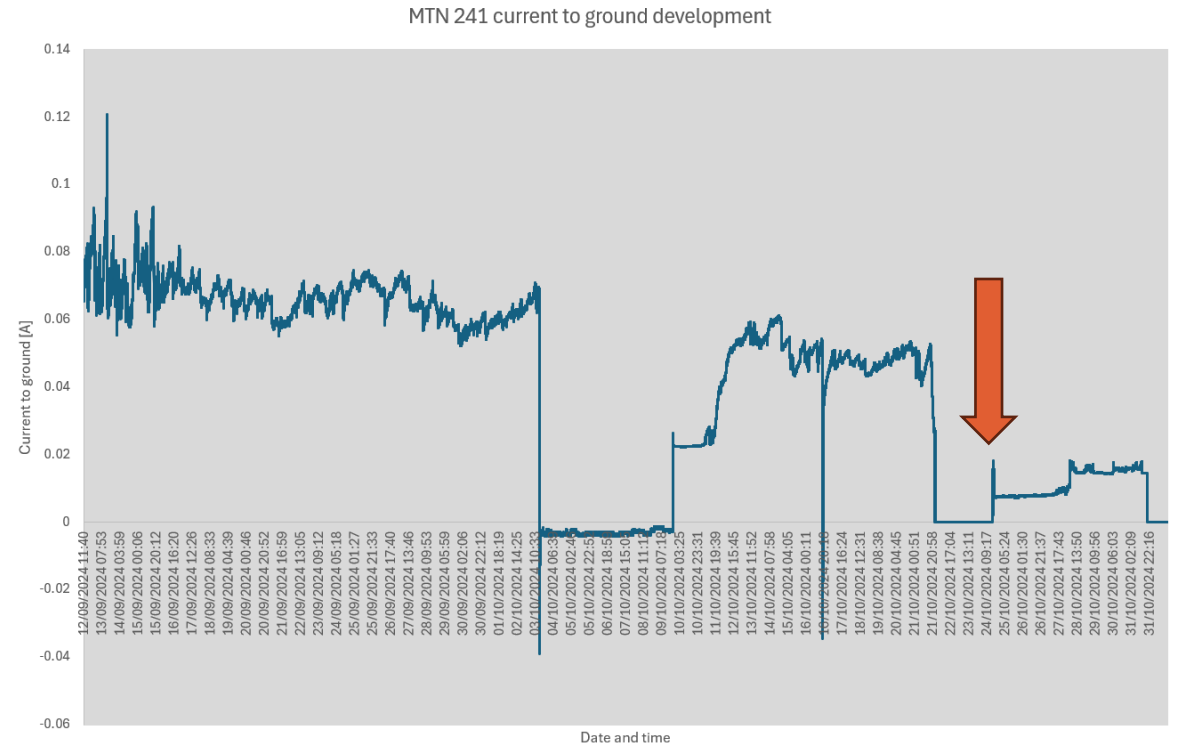
- **Operation was continued with the magnet removed**
 - A significant improvement can be observed in the current-to-ground development after the intervention
 - The current-to-ground levels seem much more in line with typically observed levels
- **MTN.241128 will be exchanged during the YETS**
- **Broken insulator and neighbouring insulators will be analysed for cause of (apparent) corrosion**
