Lessons learned on IT String relevant for HL-LHC installation #3

HL-LHC Integration Meeting, Friday 13th of December

D. Bozzini from TE-MPE-SF, on behalf of WP16 and IT String contributors

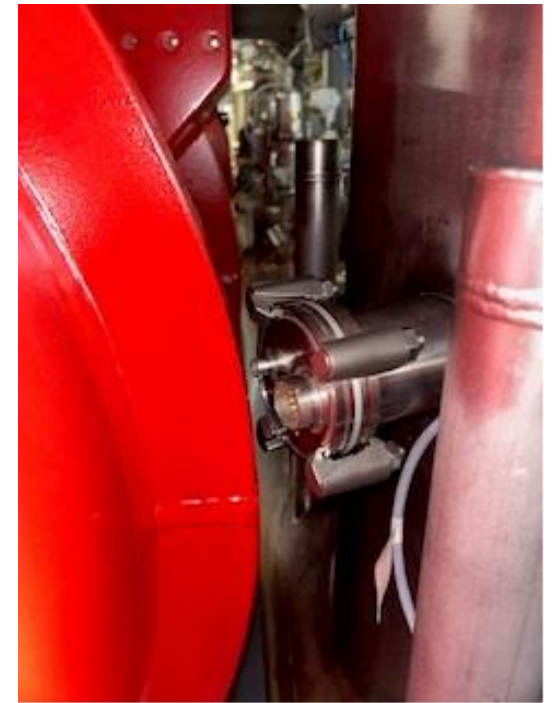
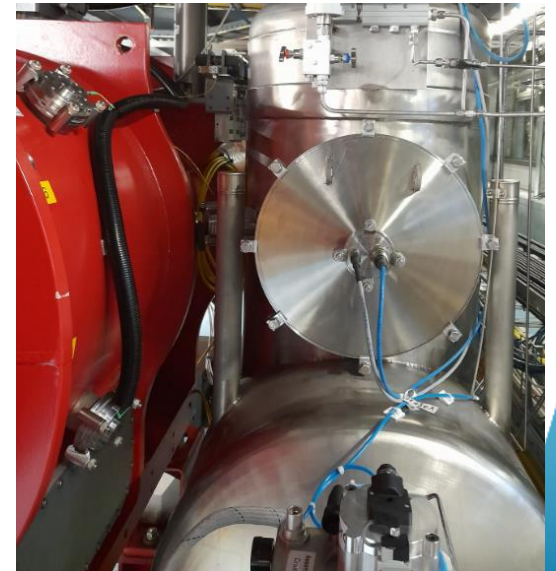
Conflict during Q2a installation

- An instrumentation pick-up flange on the SQXL that was not part of the 3D model

- ([EDMS 3075007](#)) - **Resolved**
- Luckily, there is no mechanical conflict between the SQXL and the Q2a is in its final position
- However, it is impossible to connect the two instrumentation cables which are necessary for the operation of the SQXL

- As-built model shall be provided by equipment manufacturers (in this case SQXL) and implemented in the 3D model
- Surpassing of reserved envelope shall be quickly announced to evaluate impact on neighbouring equipment and overall integration
- The distance between the cryo-magnet and the pick-up reached couple of mm during the installation and alignment. The envelope in the 3D model shall include sufficient margin necessary for the installation manoeuvres which can be more restrictive compared to the envelope once

- TE-CRG has moved the position of the instrumentation pick-up to a more suitable place
- This change has imposed to break the insulation vacuum on the entire SQXL which has been vented to dry air

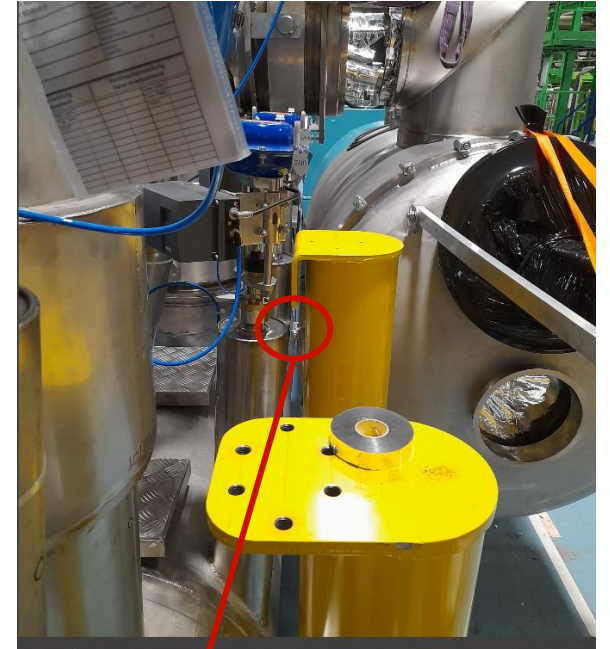
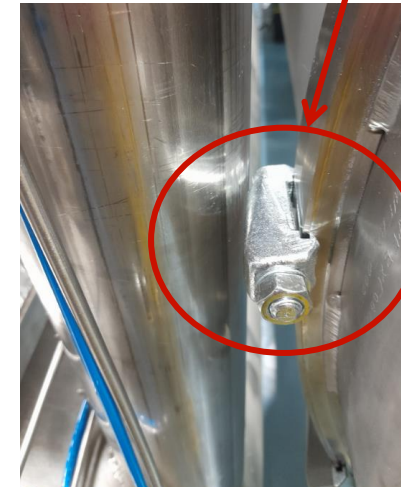
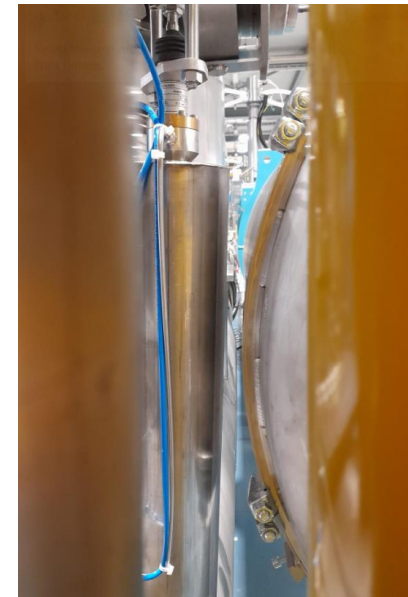
Conflicts during D1 installation

- Distance between SQXL and D1 end cover goes out of specified 3D volume
- Impossibility to install the D1 without removing two clamps of the D1 end cover

- ([EDMS 3075007](#)) - **Resolved**
- Luckily, there is no mechanical conflict between the SQXL and the D1 when it is in its final position

- Clamps volume are not integrated in the 3D model
- Precision of the SQXL is not within the 3D model volumes
- The distance between the D1 end cover and the SQXL reached couple of mm during the cryo-magnet installation and alignment. The envelopes in the model shall include margins necessary for the installation which can be more restrictive compared to the envelopes once installed

- Removal of two clamps during installation of D1
- The removal of the two clamps might have impacted the tightness of the D1 end cover

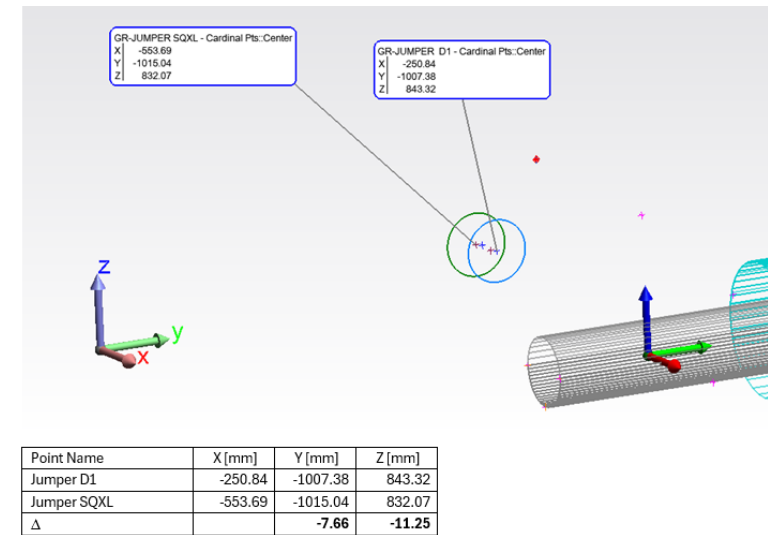
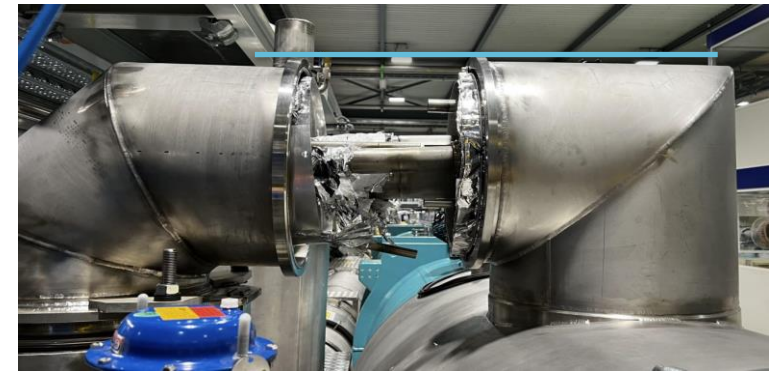
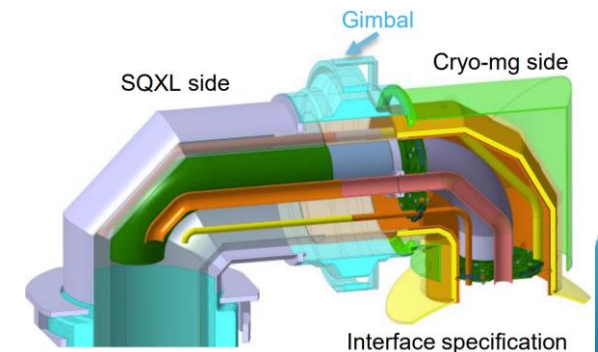
Jumpers

- Real position of D1 jumper interfaces on both sides out of specified tolerances
- Sequence and methodology of gimbal installation not clearly defined
- Complex interface between two entities, TE-CRG on SQXL side and TE-MSD on D1 side
- Two valid but different approaches by TE-CRG and TE-MSD on mechanical assembly methods and specifically on welding techniques

- ([EDMS 3075007](#)) - **Resolved**
- A dimensional non-conformity on the D1 jumper position of – 7.66 mm on Y direction
- An installation non-conformity on the SQXL jumper position of -11.25 mm on Z direction

- Different approaches of designing and working might create blocking points where there are mechanical interfaces
- Get the concerned stakeholders working together already at design phases to find the best possible solution to cope with the possible non-conformities or deviations

- Adaptation of the gimbal to best fit the real situation
- Common approval of installation sequence and responsibilities between TE-CRG and TE-MSD

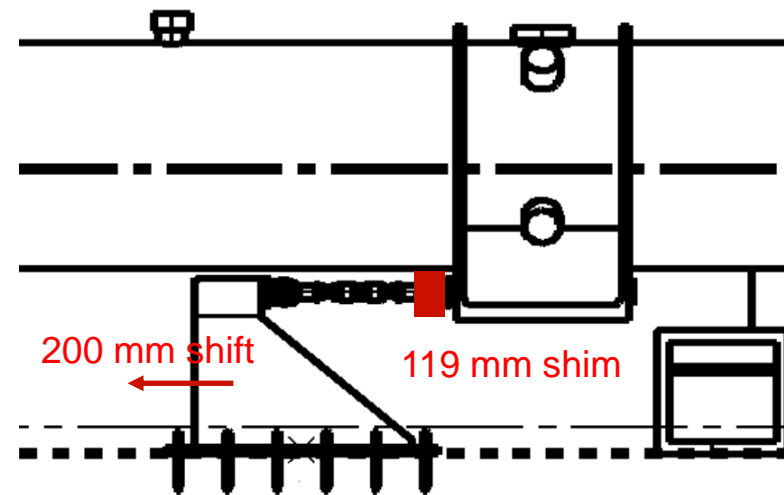
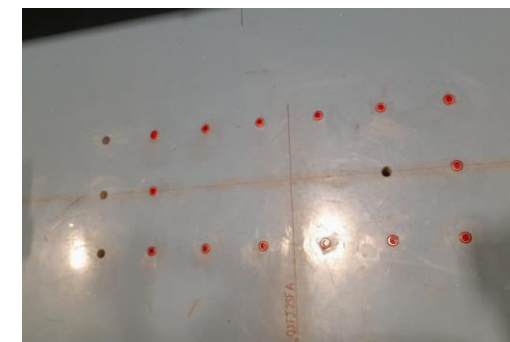
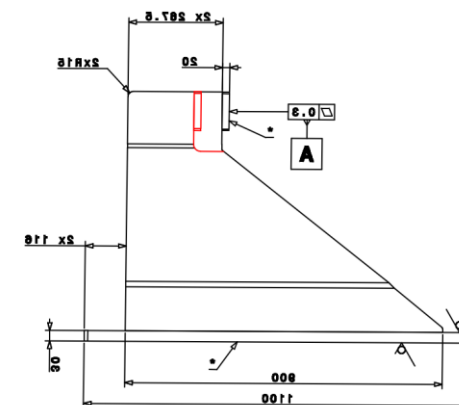
Cryo-magnets anchoring

- Drawing for drilling holes approved but found to have wrong quotes
- Discrepancy between installation and manufacturing of the anchor tie rods length with 600 mm for the installation drawing and 681 mm for the manufacturing drawing

- ([EDMS 3075007](#)) - **Resolved**
- All holes in the concrete have been drilled according to the installation drawing
- Procured 681 mm long tie rods cannot be installed

- Changes on installation or manufacturing drawings shall be disseminated and concerned drawings updated accordingly
- Name and version of manufacturing drawings shall be noted in the installation drawings

- For all cryo-magnets except Q2a already in place. Drilling of four additional holes to shift the anchoring position of 200 mm. Manufacturing of an additional shim of 119 mm to be interleaved between the cryo-magnet and the tie rod extremity
- For the already installed Q2a cryo-magnet the anchoring frame will be machined to shift by 81 mm the interface with the tie rod.

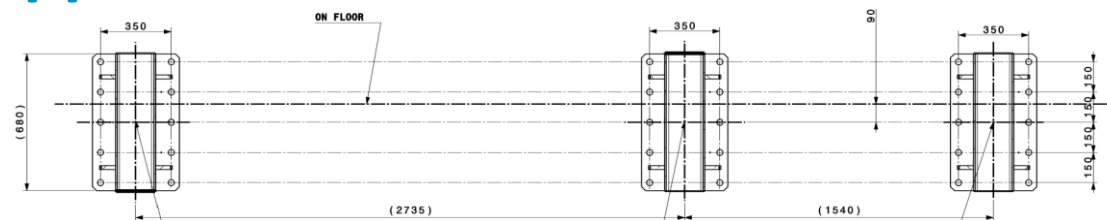
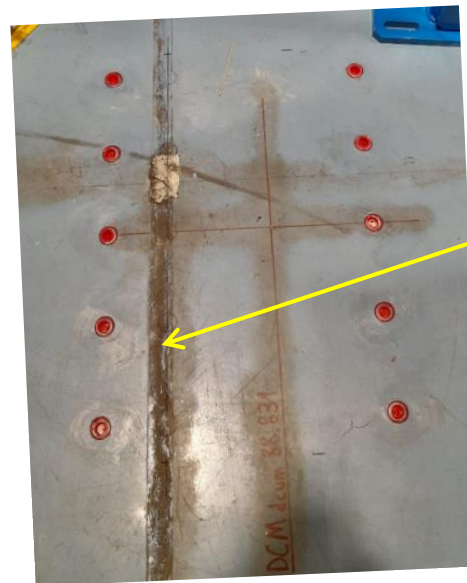
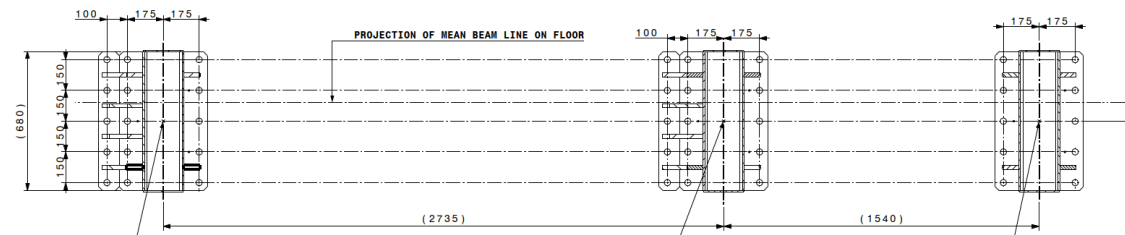
DCM support

- The fixing rods for one of the three DCM frame supports are falling on a silicone joint of the SM18 floor

- ([EDMS 3075007](#)) - **Resolved**
- 5 out of the 10 fixing rods cannot be used as specified

- The real environment might impede the installation of an equipment as designed
- Checks on site of all boundaries will anticipate the identification of discrepancies

- Change the design of the concerned support by adding an extension plate
- Drill 5 additional holes at the due place

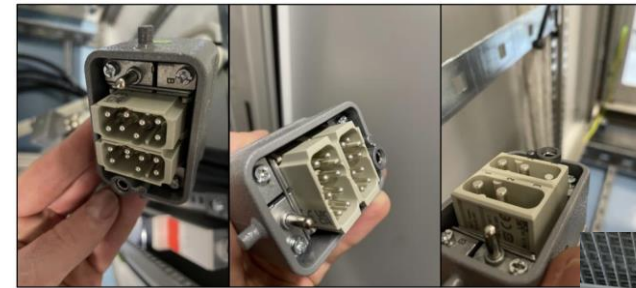
- 14 connectors with visibly recessed (unseated) pins (male and female types) (See appendix - 7.1).
- 1 missing cable ID label.
- 19 cables with one wire whose resistance deviates from the average significantly ($>3\sigma$)
- 4 minor functional positioning errors (excluding DFHX cables not yet routed to the mezzanine).

Figure 2 – Examples of recessed (unseated) pin

- Quality of assembly is still a concern. In particular for the recessed pins that might have major functional implications
- Mounting of nonsymmetric connectors shall be reviewed and the required mounting orientation shall be specified in the DIC by the cable requestor
- WP16 recommends to put protecting covers on connectors at least on machine side (as it was done for the LHC)

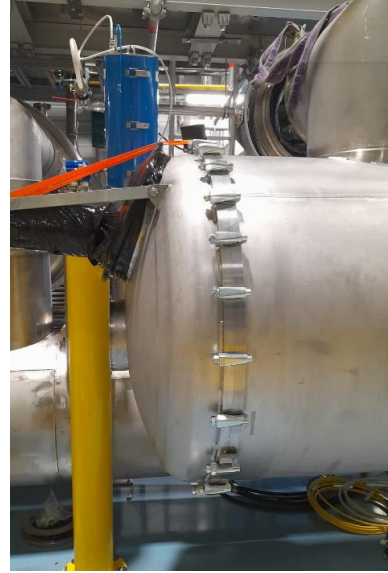
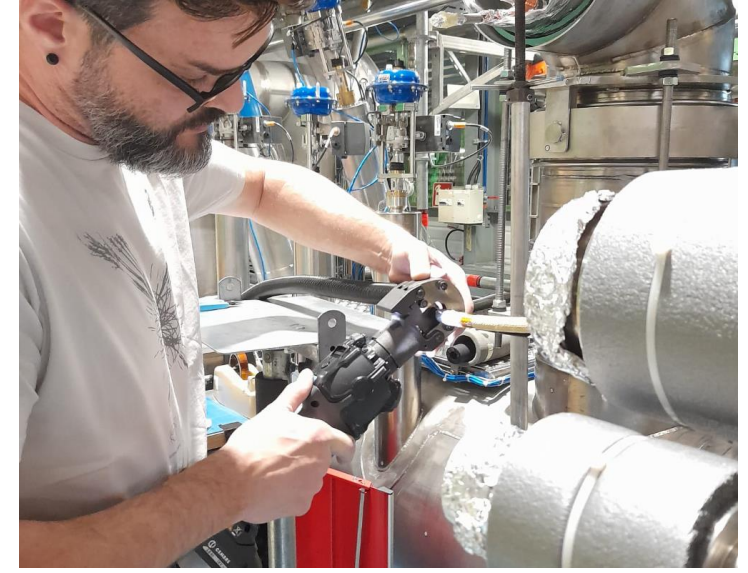
Readiness of equipment

- Q2a has been delivered to IT String with the conductors not adjusted to length and the N cable segment not installed
- D1 has been delivered without the two spares seal joints of the end cover. The tightness of the end cover has not been checked and the feasibility to exchange the sealing joint is not verified by design

- Q2a extremities have been prepared on site ~ 5 days
- D1 joints will be installed on site before installation of DCM
- A feasibility check of a sealing joint replacement will be conducted during the test assembly of the DCM

- For upcoming cryo-magnets deliveries an assessment of the readiness for installation will be done with the participation of WP16, WP3 and the cryo-magnet coordinator
- Delivery of each cryo-assembly will be subject to the termination of all associated tasks (see punch list example for the CP)
