Post-irradiation examination of a prototype tantalum-clad target for the Beam Dump Facility at CERN

(Dated: October 4, 2024)

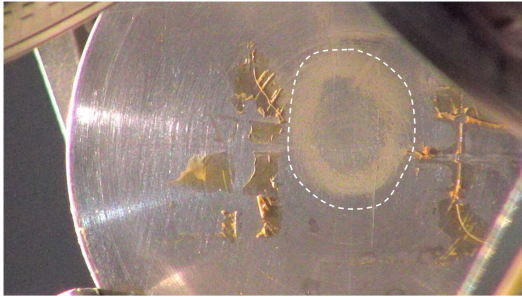
Three approaches were used to determine the origin of the discoloration shown in Fig. 3. First, deposit was extracted from the discolored center region with carbon tape (C-tape) attached to a pin-specimen holder. The chemical composition of this deposit was evaluated using an energy-dispersive X-ray spectroscopy (EDS) system integrated into a scanning electron microscopy (SEM) system. Second, SEM was conducted with EDS analysis to determine the chemical composition of apparent spots in the discolored regions using an acceleration voltage of

FIG. 3. Discoloration visible in the beam-impact area observed during the removal of the prototype target.

The visually observed deposits on the target were revealed by LOM and EDS analysis. The carbon concentrations measured by EDS in the inner and outer block regions were fairly similar, at approximately 1.13 wt % and 1.32 wt %, respectively. The deposits consisted largely of C, N, and O and seemed to have weak bonding with the surface as they were removable by C-tape; no other elements were conspicuous in the list of those detected. The presence of carbon in all the irradiated surfaces was likely caused by the degradation of C–N–O-containing substances due to (or during) the beam exposure—possibly residual hydrocarbon molecules—leading to local surface contamination that was correlated with the beam impact [34, 35]. Therefore, carbon was still regarded as the most likely cause of the discoloration, and further analysis is recommended.

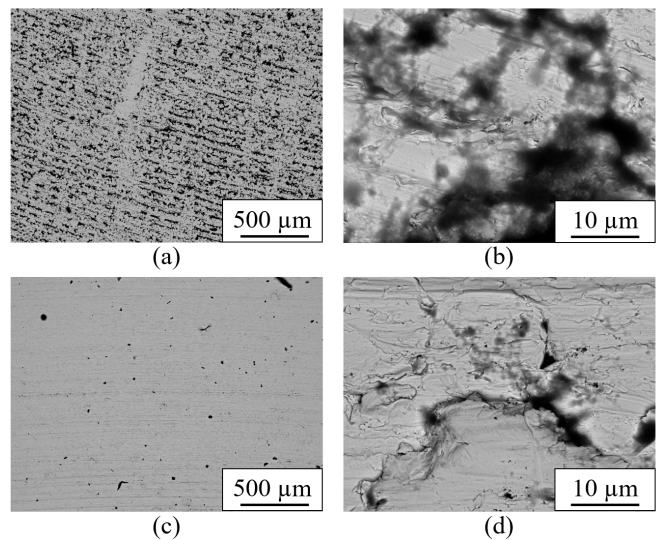
tions, or pores caused by the beam impact; however, the turning grooves in the central region were more strongly pronounced, and lubricant residue was detected. Examination of the discoloration in the center areas revealed that the previously observed orange-like color was caused only by the lighting used during dismantling, and dark gray was seen in the LOM images. Block 3 presented the strongest discoloration, and it was thus analyzed further. The deposit that was extracted from the discolored region using C-tape exhibited multiple elements, with no particular element being clearly prominent. The SEM images of the DS face of Block 3 (Fig. 7) show greater concentrations of deposits in the turning grooves, matching the surface topography. At a higher magnification, spots with a grayish-to-blackish color arranged in an irregular network were observed, and they were denser and more pronounced in the central region. Especially at surface irregularities such as separations, material overlaps, or scratches, dense deposits were detected in all regions. EDS analyses were performed, focusing on apparent spots that showed carbon and nitrogen as the main elements. Areas in the central and outer regions that exhibited no evident spots were also investigated. Using a low acceleration voltage of 5 kV, it was found that the area of

FIG. 7. Light optical microscopy images taken in the (a),(b) central region and (c),(d) outer area on the DS side of Block 3.

discoloration in the center had a carbon concentration of approximately 1.13 wt%, and the outer region had a carbon concentration of approximately 1.32 wt%. In addition to carbon, oxygen and tantalum were detected, but nitrogen was not present.

No relevant geometrical changes such as swelling, corrosion, cracks, separations, pores, or melting were observed in the Ta alloys; therefore, it was considered that both cladding materials—Ta and Ta2.5W—were reliable. The flat surfaces in the center region exhibited Ra values above the expected threshold and strongly pronounced turning grooves; this led to a higher level of carbon deposition in combination with the beam impact. It was suspected that this was caused by insufficient lubrication during the turning process after HIPing. In addition, lubricant residue was observed, which can cause local heating and increase the carbon concentration. As carbon deposition on the target blocks is undesirable, it is recommended that the surface roughness in the center should be decreased and the cleaning process of the blocks should be improved.

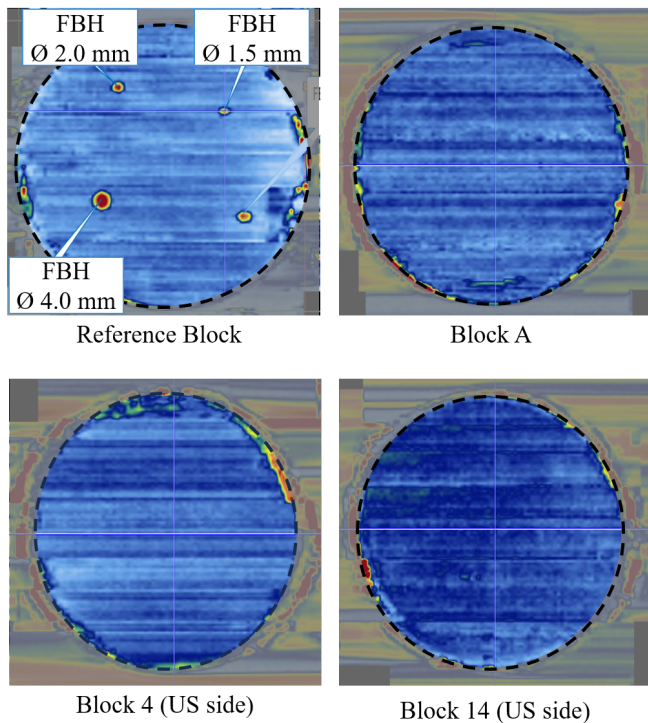
All bonding interfaces (US and DS) of all (un)irradiated blocks were inspected by UT (Fig. 8). No indications of debonding—such as cracks parallel to the surface, delamination, or volumetric flaws—were detected at the interfaces or in their vicinities. Some blocks exhibited

FIG. 8. Ultrasonic C-scan results, in which discontinuity is shown in red and continuity is shown in blue. FBH: flat bottom hole.

an increased echo close to the interface depth; however, this was homogeneous over the blocks' surfaces without deflections, and it was far below the detection threshold for discontinuity. Different echo levels were observed mostly at W interfaces without evident correlation to their radiation levels.

The interface echoes during UT were below the indication threshold for debonding, hence confirming the absence of surface-parallel cracks, delaminations, or volumetric flaws at the interface or in its vicinity. Increased interface echo occurred in the W blocks due to the different reflection coefficients at the interfaces: while 0.4% of the ultrasonic waves are reflected at a Ta/TZM interface, 7.8% are reflected at a Ta/W interface, and this can cause higher echo amplitudes.

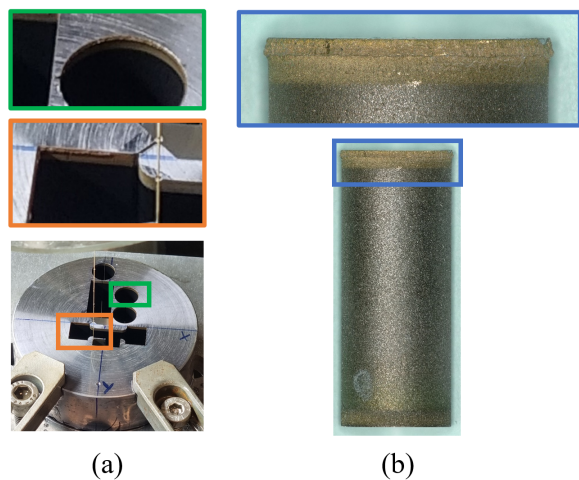
FIG. 9. Burrs detected on the upper side of (a) Block A and (b) the thermal-diffusivity cylinder after the first cutting step.

During the specimen extraction, the EDM wire consistently fractured and needed to be re-fed continuously during the first separation cuts from the blocks. The morphology of the W surface after EDM cutting showed intergranular separations and areas with detached W grains. In addition, the tensile specimen 14T3 and the shear specimen 14S2 fractured during their final EDM cutting steps before testing. The fracture of 14T3 appeared close to the interface on the DS side. During the first cutting steps, deformations inside the cladding bulk material were detected (see Fig. 9). This behavior was only observed sporadically on the upper block sides that had first contact with the water jet.

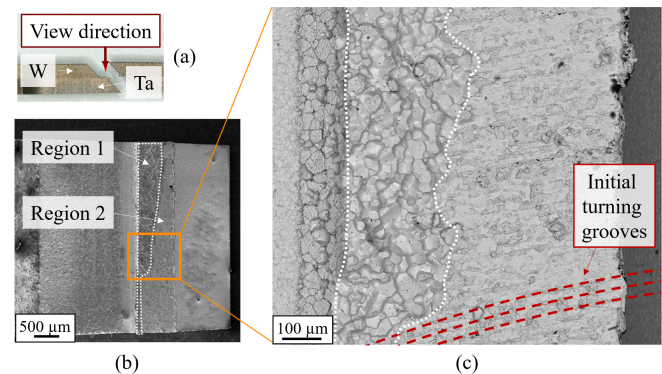
A comprehensive fractography examination of 14S2 was performed by analyzing the Ta cladding side using SEM (see Fig. 10). The fracture occurred along the interface, and two fracture regions (regions 1 and 2) were distinguished. SEM and EDS assessed Region 1 as comprising intergranular fractures through the W material, appearing parallel to the interface, and with sporadic cleavage-fracture characteristics; the visible homogeneous grain size matched the grain size found in the bulk W material. Region 2 exhibited interleaved bands with different fracture characteristics, and these bands showed a curvature attributable to concentric circles. At the microscopic level, multiple fracture modes were detected. Most frequently encountered were areas with no distinct fracture characteristics, in which the fracture-initiation site and propagation direction could not be determined.

FIG. 10. Examination of 14S2, which fractured during the final cutting step, revealed an intergranular fracture at the interface in Region 1; in contrast, Region 2 showed no distinct fracture characteristics.

Indications of inadequate diffusion bonding were also observed in the fractured shear specimen 14S2 (see Fig. 10). Region 2 exhibited concentric circles, which can be interpreted as the initial turning grooves from the Ta or W blocks; hence, it was concluded that a decohesion fracture was initiated in Region 2 and progressed toward Region 1.

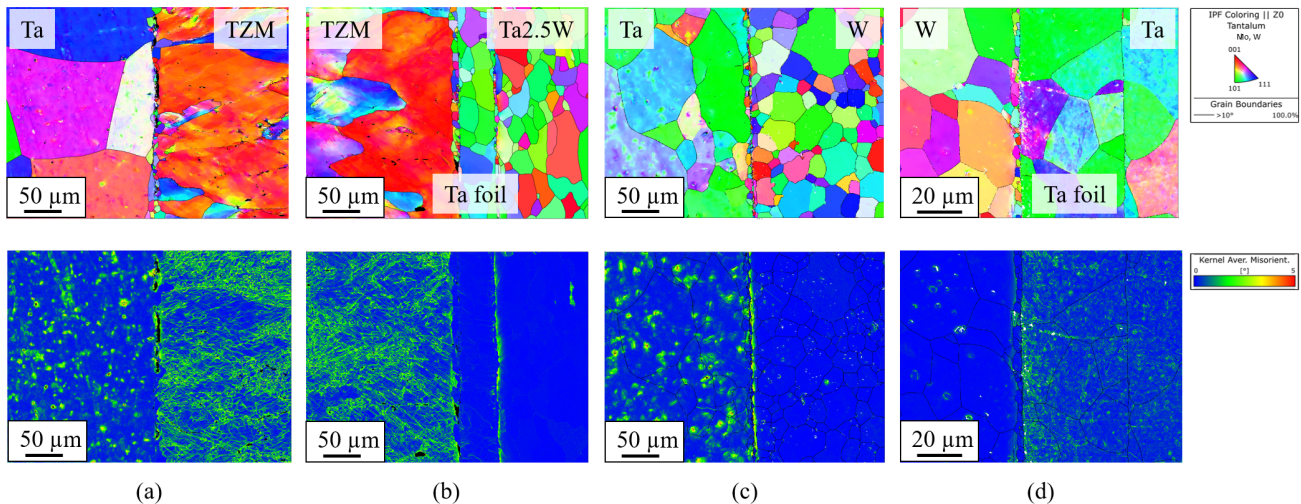
FIG. 11. EBSD inverse pole figures (IPFs) in z direction and local misorientation maps at the interfaces of (a) Block A, (b) Block 4 (DS side), (c) Block B, and (d) Block 14 (DS side).

Figure 11 shows EBSD and local misorientation maps close to the interfaces. The TZM core material presented elongated grains oriented in the axial direction of the blocks and an intragrain area with a recovered microstructure, which is characteristic of stress-relieving heat treatment; no recrystallization was observed. The subgrains were well distinguishable within the parent grains. Different kinds of second-phase particles, nonmetallic inclusions, and precipitates were observed; specifically, second-phase particles such as oxidic nonmetallic inclusions, Ti carbides, and complex Zr/Ti carbides were visible. The microstructure near the interface was equivalent to that of the core. The W core materials exhibited a fully recrystallized microstructure featuring inter- and intragranular porosity.

Narrow recrystallized bands with fine grains were observed at the bonding interfaces (see Fig. 11). It is assumed that plastic deformation was induced in the near-surface region during machining; after this, HIPing with elevated temperature and pressure (1200 °C and 150 MPa) initiated recrystallization near the surface region. In addition, during the cool-down phase of the HIPing process, the interfaces were exposed to particularly high stresses, and this aided the formation of recrystallized bands because increased stresses lower the recrystallization temperature. In general, their presence has no negative effect on the quality of the bonding interfaces.

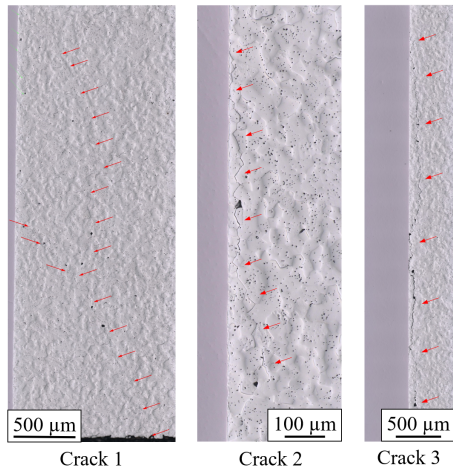
Several cracks were revealed in 14M1 at the US Ta/W interface (see Fig. 13). Two cracks, cracks 1 and 2, were located close to the beam-impact axis, and Crack 3 was detected approximately 16 mm from the beam-impact axis. Crack 1 had a length of approximately 3 mm parallel to the interface and extended approximately 1 mm into the core. Cracks 2 and 3 propagated along the interface on the core side, with lengths of 0.8 and 4.3 mm, respectively. Figure 14 displays EBSD and phase images of Crack 3, showcasing the fracture in the W core material. The crack propagation was intergranular, in the W core and directly at the interface; hence, these cracks were not considered to be detachments of the interface.

FIG. 13. Light optical microscopy of 14M1 (W) showing the three cracks detected in the W.

Multiple factors were taken into consideration when attempting to establish the origin of the W cracks in 14M1 (US). During the examination of 14S2, intergranular separations, areas with detached W grains, and a recast layer were observed along the cutting plane induced by the EDM. A recast layer can develop tension stresses, which can support the development of hot or cold cracks. In addition, the sample exhibited high brittleness originating from a fully recrystallized grain structure and high porosity resulting from sintering. For example, the tensile specimen 14T3 broke during the cutting process on the DS side within the W material. While the exact levels of residual stresses in the materials were unknown, very high values—especially close to the interface—were expected according to the results of simplified simulations, the large differences in the thermal-expansion coefficients of Ta and W (6.1×10^{-6} and 4.1×10^{-6} K⁻¹ at 25 °C, respectively [24]), and the continuous breakage of the cutting wire during specimen extraction. Dye PT of 14M1 identified superficial cracks, while similar cracks were found in the unirradiated BM2 sample close to the interface. In addition, one crack was observed in the center close to the final separation cut that had propagated through both samples (BM1 and BM2). Nonetheless, based on the results of the simplified simulations, low residual stresses were expected in the center after HIPing. Additionally, the results of UT of all flat surfaces revealed neither the cracks in 14M1 nor those in BM2 that were parallel to the interface. It is suspected that the combination of high residual stresses, brittleness, damage to the grain structure during EDM cutting, and potentially beam-induced thermal stresses contributed to the development of these cracks. Hence, based on the findings from the unirradiated samples, the cracks observed in 14M1 were not considered to be caused by the beam.

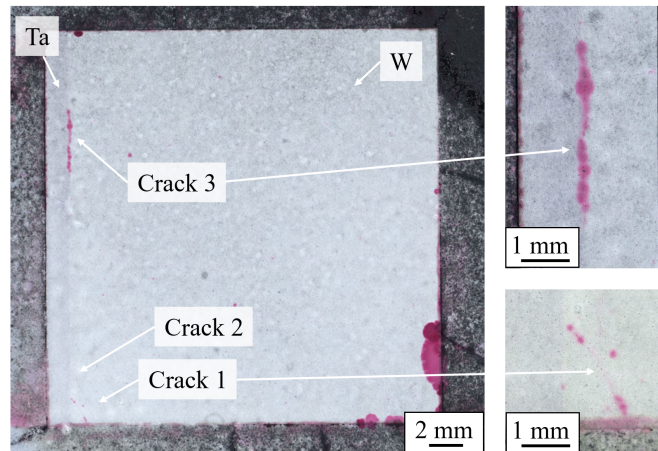
Dye PT was performed on 14M1, detecting cracks 1 and 3; Crack 1 was only partially reproduced, and Crack 2 was not identified at all (see Fig. 15). Figure 16 shows the dye PT results for BM1 and BM2; a reddish color was present in the background due to the unpolished surface. SEM images were taken at the PT-indicated locations, and it was found that BM1 featured grinding marks, detached W grains, and intergranular separations in the W bulk material. Specimen BM2 showed several linear diffuse indications in the area of the interface, while none were visible in BM1. Figure 17 presents the unpolished surface of BM2 at the interface and at the core close to the cutting edge. Both areas of the W surface exhibited similar characteristics, such as intergranular cracks and detached W grains, while the majority of the surface was covered by a recast layer due to the EDM. Considering the penetration and dwell time, the coloration indicated

FIG. 15. Sample 14M1 after dye penetrant testing, which did not indicate Crack 2.

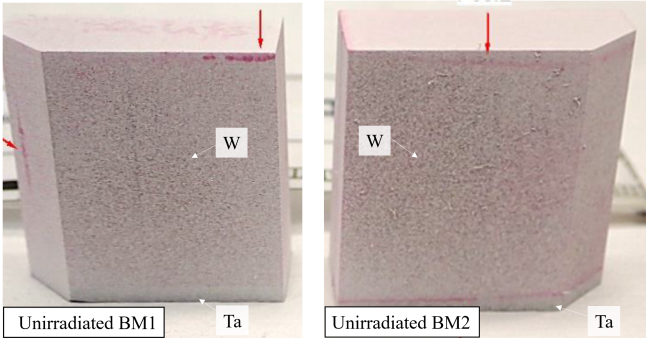
that all the cracks observed in 14M1, BM1, and BM2 were superficial.

FIG. 16. Dye penetrant testing performed on the unirradiated samples BM1 and BM2.

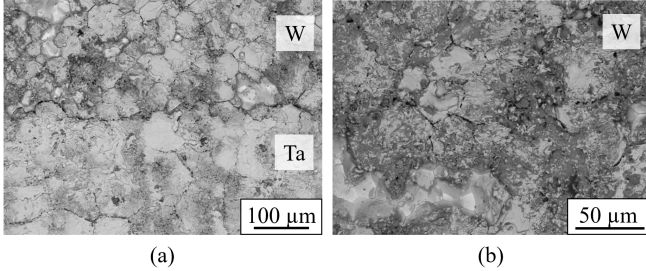
FIG. 17. SEM images of cracks found in the unpolished specimen BM2 (a) at the interface and (b) in the core close to a cutting edge.

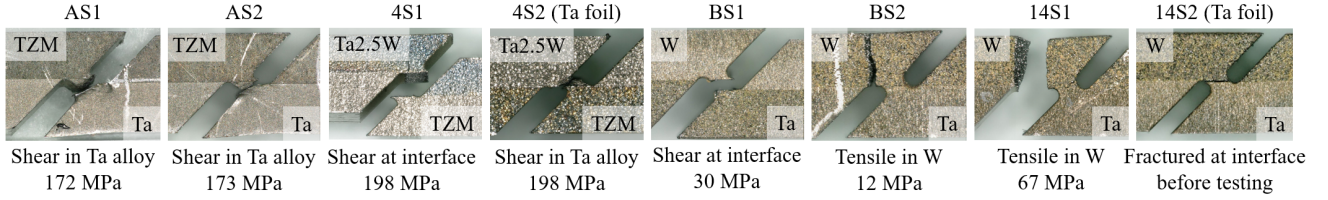
During the shear-specimen testing, different types of fracture were observed, such as tensile fractures in the W and shear fractures in the cladding material or at the interface (see Fig. 18). The reported stresses were calculated with an interface area of $1.0 \times 3.6 \text{ mm}^2$ for each specimen. For the TZM core materials, the extension to fracture was in the range 80–750 μm, with the unirradiated samples (AS1 and AS2) failing at higher strain values than the irradiated ones (4S1 and 4S2). Sample 4S1 showed the lowest overall strain and presented the only shear fracture at the interface, while the other three [AS1, AS2, and 4S2 (Ta foil)] failed in the Ta alloy close to the interface. All W shear specimens exhibited very low extension to their fracture values (<10 μm). Two specimens (BS2 and 14S1) displayed tensile fractures in the W bulk material far away from the interface region: BS1 had a shear fracture at the interface, and 14S2 fractured at the interface during the final EDM cutting step (before testing).

FIG. 18. Fractures of the shear specimens after testing with each fracture type, position, and breaking strength at 22 °C.

The shear specimens that did not fracture at the interface presented higher interface strengths than the fractured bulk materials (see Fig. 18). The breaking strength of the shear fractures that occurred in the Ta cladding (AS1 and AS2) were slightly above the previously derived USS of Ta (150 MPa). Samples 4S1 (shear fracture at the interface) and 4S2 (Ta foil; shear fracture in the cladding close to the interface) had the same breaking strength (198 MPa) despite presenting different fracture types. Sample 4S1 exhibited a secondary crack inside the Ta2.5W cladding, and both values were close to the previously calculated USS of Ta2.5W (215 MPa). Hence, good diffusion bonding was observed in all TZM shear specimens due to their high interface strengths.

The conclusions for the W shear specimens were not as clear (see Fig. 18). Half of the specimens (BS2 and 14S1) showed tensile fracture in the W bulk material far away

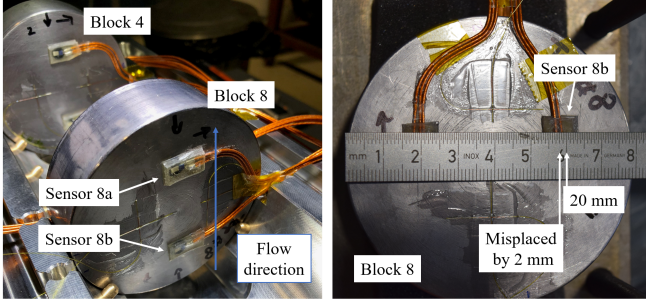
FIG. 19. Temperature instrumentation installed on Block 8 before irradiation.

During the operation of the prototype BDF target, increased temperatures were measured by one of the sensors attached to Block 8. The PIE did not result in any findings for Block 8 that could explain the behavior of Sensor 8b (see Fig. 19); however, upon examination of past data from the target instrumentation, some observations stand out. Sensor 8b was placed in the only water channel that had temperature sensors on both sides (US and DS). In general, the water channels had a width of only 5 mm, and the temperature sensor on the opposite side to Sensor 8b failed during operation. The flow of the cooling water started from Block 1 and passed sensors 8b and 9b of blocks 8 and 9 first; this could have resulted in a small amount of turbulence due to the sudden change of flow. The sensor was constantly attached to the block, because no noise was measured and its temperature reading showed an appropriate reaction to the pulse-cycle time. It was determined that no cavities were present in the cover agent because the base temperature was not increasing. The heating ramps observed during impacts correlated with those from the other three sensors in the same water channel, but the cooling rate measured by Sensor 8b did not match those of the other sensors.

None of the findings from this study can explain the elevated temperature measured by Sensor 8b (see Fig. 19). In summary, this sensor did not malfunction, the temperature curve measured during beam impact behaved correctly, and the values were physically realistic; however, the cooling rate seemed to be compromised. It is possible that impairment of the cooling rate could have been caused by a thicker layer of cover agent or by compromised water flow due to the presence of sensors on both sides of the water channel. In addition, Sensor 8b was placed slightly closer to the beam-impact location than intended, and the beam was offset toward the sensor. For future instrumentation, it is recommended that temperature sensors should only be installed on one side of a water channel.

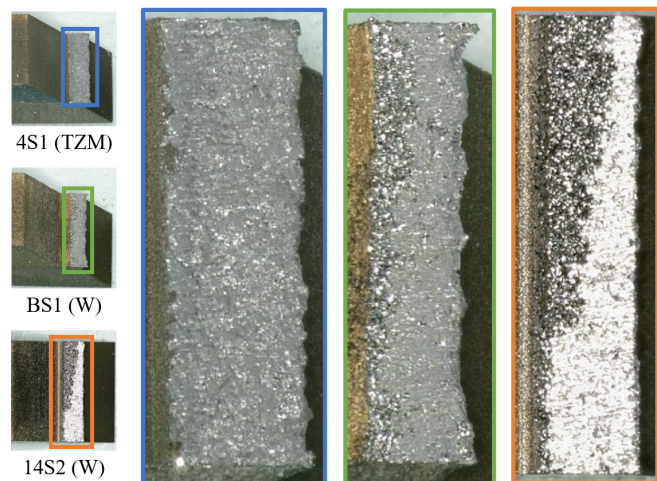
FIG. 20. Comparison of a shear fracture at the interface of TZM shear specimen 4S1 and the W samples BS1 and 14S2 (Ta foil). The fracture of 4S1 presented a uniform surface, while two separate fracture regions were visible in both BS1 and 14S2.
