Integration and System Qualification of the ATLAS Pixel Detector

Markus Keil

On behalf of the ATLAS Collaboration

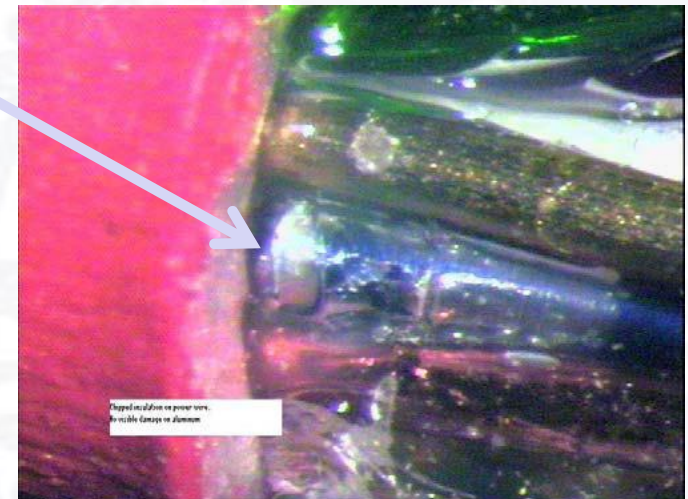
Example of damaged
cables: the insulation is
broken, leaving the cable
very vulnerable to failure
with even very delicate
handling or with thermal
cycling

- Reproduced enough cables for layer-0, layer-1 and part of layer-2
- For rest of layer-2 accepted part of initial production after stricter quality control
 - Mechanical stress testing
 - Electrical test and visual inspection before and after stress testing
- After that only very few failures of type-0 cables and not clearly related to the old failure mode

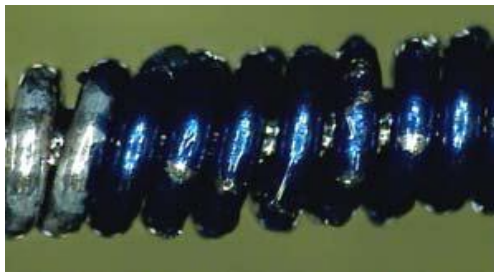
Bent then heated:

- Wires were bent before stripping, separating thin and thick wires (to be stripped in two different phases)
- Stripping solution is molten NaOH ($T \sim 400^\circ\text{C}$)
- Pictures of insulation heated above 250°C :

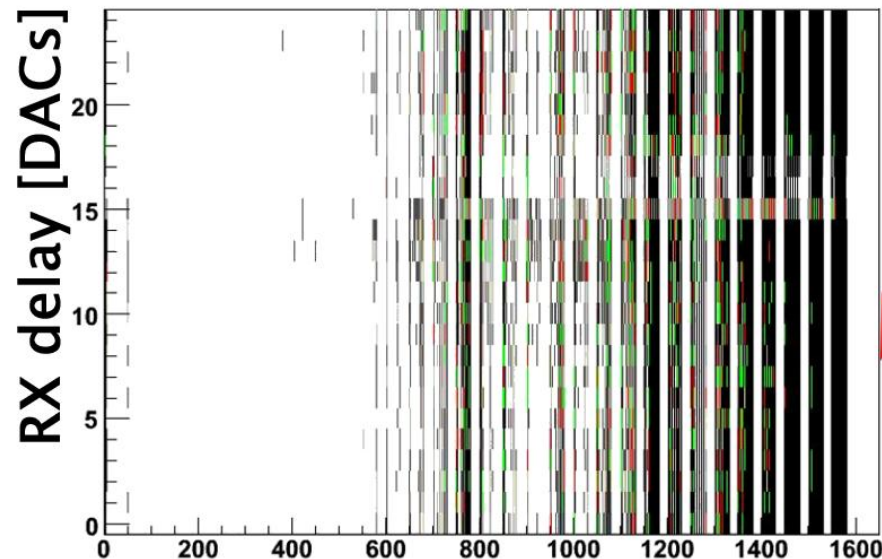
Decoded data-stream:

- Problem I: Discovered opto-board channels with slow turn-on
 - Would have led to data corruption during operation
 - Added additional QA step for the opto-boards in the final service quarter panels
 - Several opto-boards with slow turn-on found and exchanged
