A FLØW RATE ISSUES IN THE ALICE SPD COOLING

Rosario Turrisi

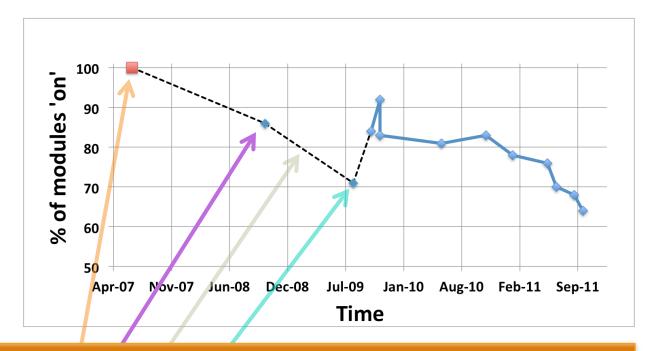
DSF status (tests pre-installation): efficiency = 100%

First switch on after installation: efficiency = 87%

Long stop (you know why...) – minor rerouting of return pipes

Restart after long stop: efficiency = 71%

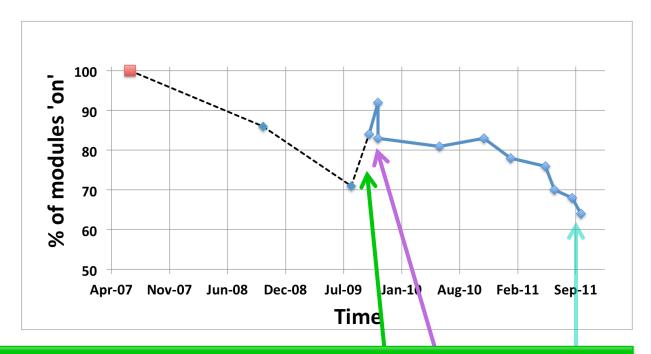
Interventions in fall 2009

Stable after interventions: efficiency = 83%

Last resume after tech stop: efficiency = 64%

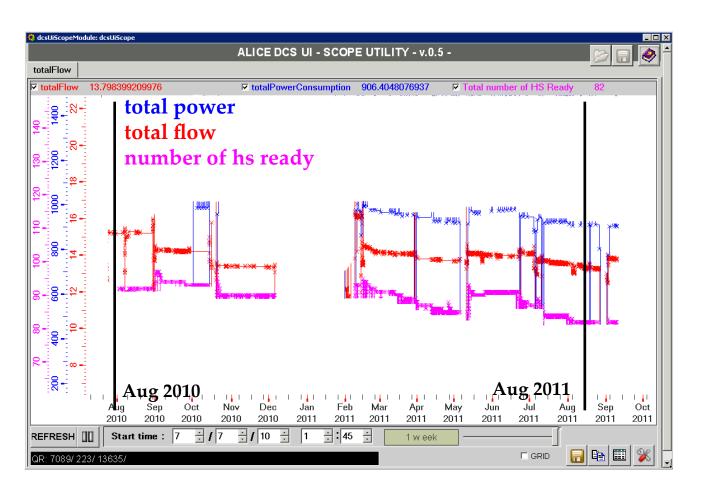
+ Flow/power correlation

- Slowly decreasing trend of flow
- The flow doesn't tell the whole story stable # of modules must depend on local thermodynamical conditions (not monitored)

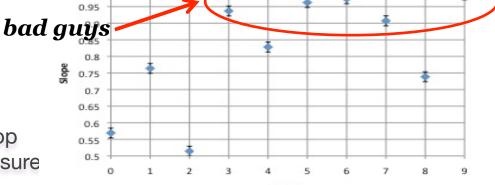
Principle: look at the correlation (slope)
 between the pressure set at the plant and the pressure close to the detector

Observed behaviors:

- 1. "Good" sectors have a higher pressure drop
- 2. "Bad" sectors are more "sensitive" to pressure changes ...

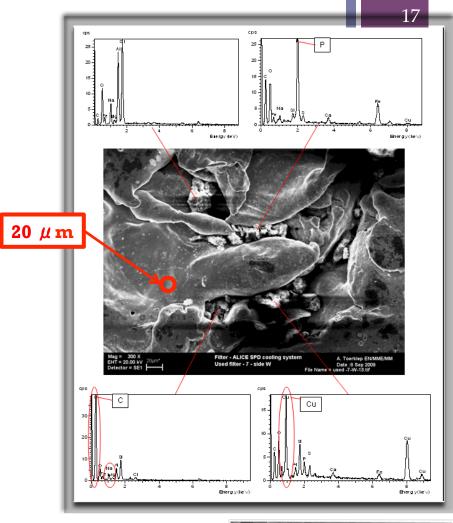
_SEM analysis

Analysis of a filter taken from PP4, in place for 1 year approx.

Results and conclusions: "In the used filters several exogenous fragments were located clogging the filter. There were several fragments containing different composition elements. In addition to elements from the Stainless steel, the following traces of elements were found: O, Al, K, C, Sn, Cu, P, Ca, Cu, Na, Cl and Zn."

Possible origin of the fragments:

- •pumps (graphite)
- hydrofilter (aluminium oxide)
- •weldings (TIG weldings remnants)

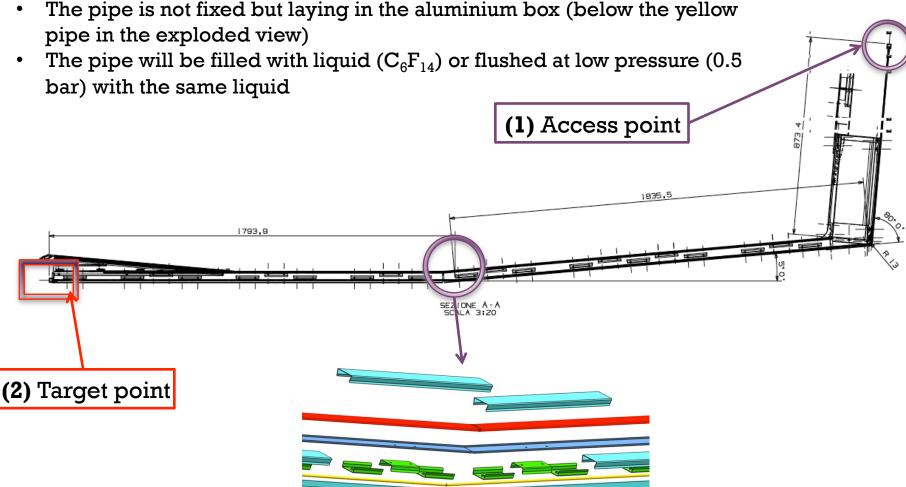
+ Layout of the circuit

- The pipe is in yellow
- The access point (1) is \sim 4.5 m away from the target point (2).
- The pipe is not fixed but laying in the aluminium box (below the yellow pipe in the exploded view)

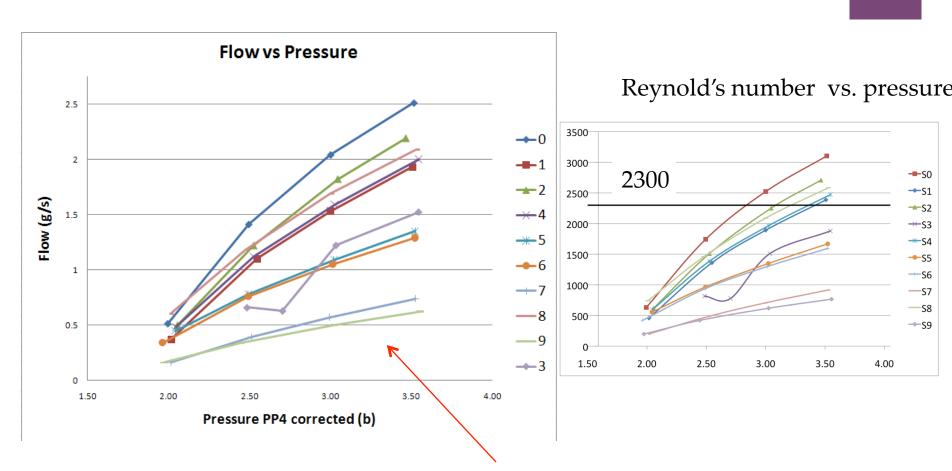
_Measurement of flow

Very low flow rate in sectors 7 and 9;
